VEHICLE INSPECTION REPORT

YP66XKL

Volkswagen Touran 1.6 TDI 115 S 5dr DSG

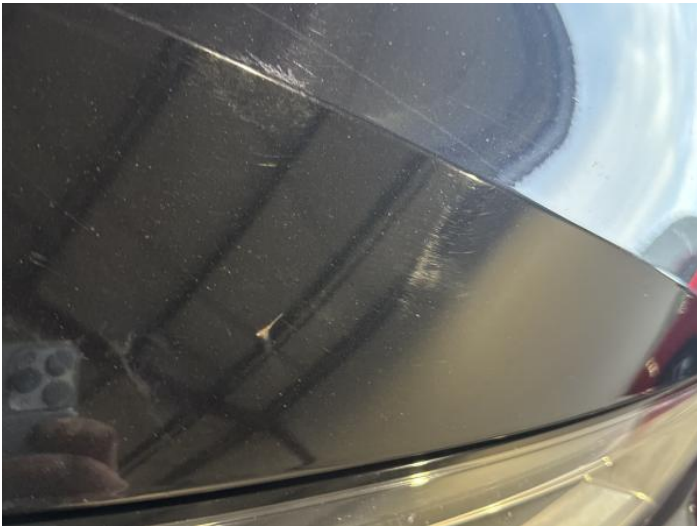
1: Bonnet
Chipped
Multiple Chips

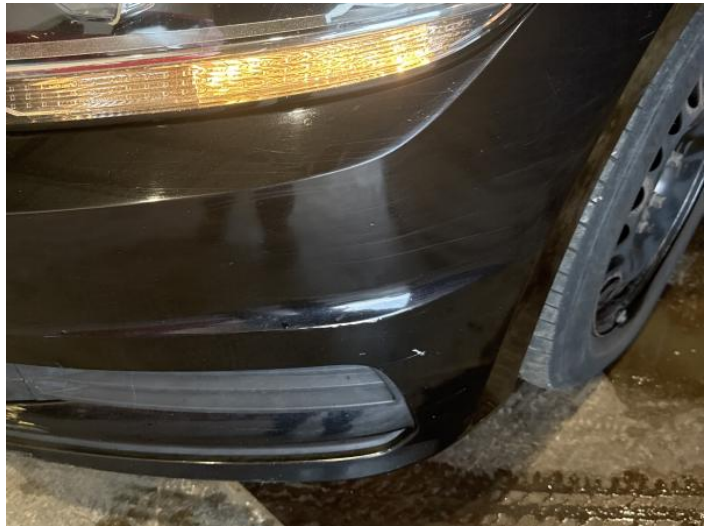
2: Bumper Front
Scratched
Over 100mm Thru Paint

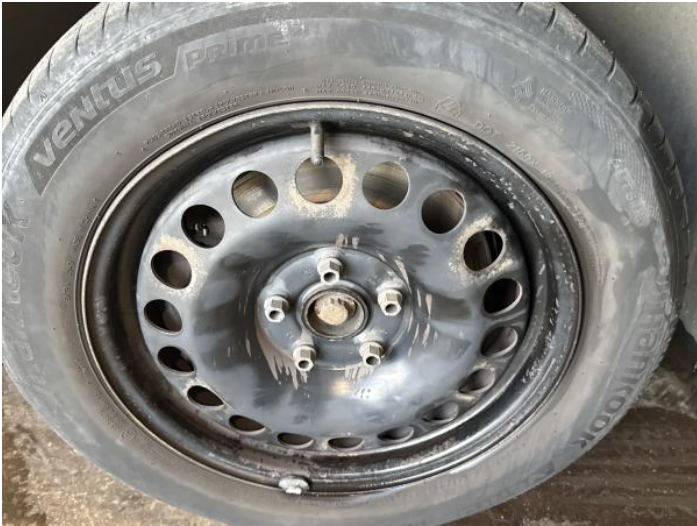
3: Wheel Trim nsf
Missing
Replace

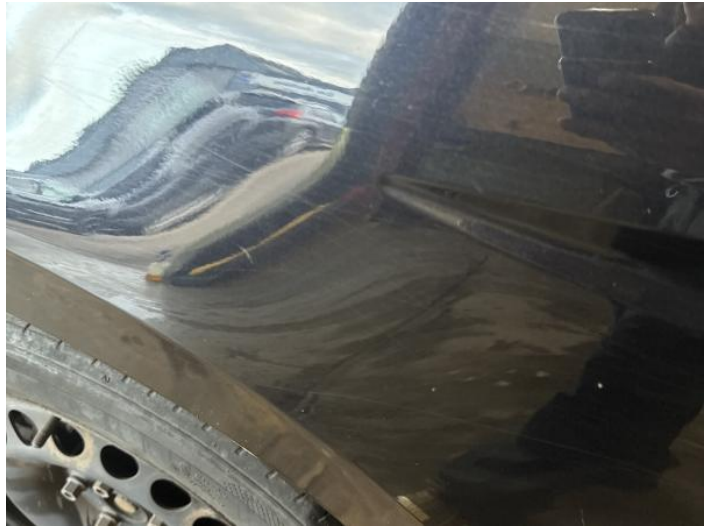
4: Wing nsf
Chipped
Multiple Chips

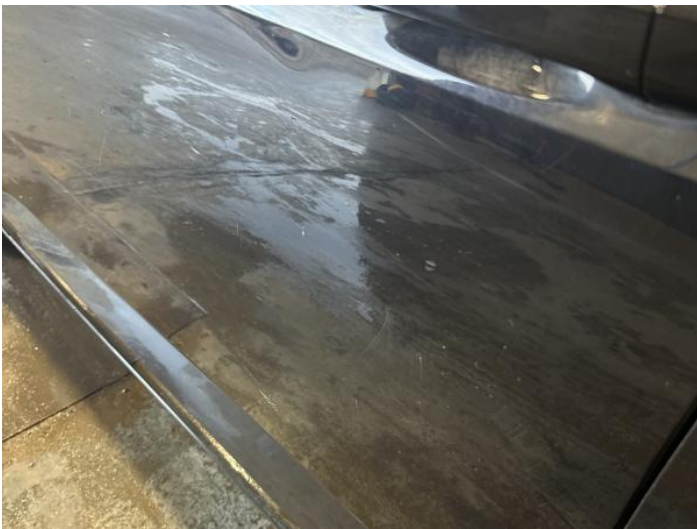
5: Door nsf
Scratched
Over 25mm Thru Paint

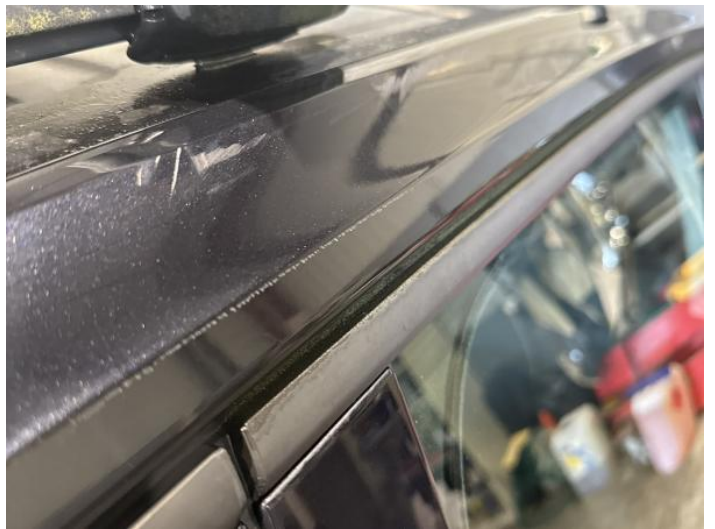
6: B Post ns
Dented
Between 10mm + 30mm

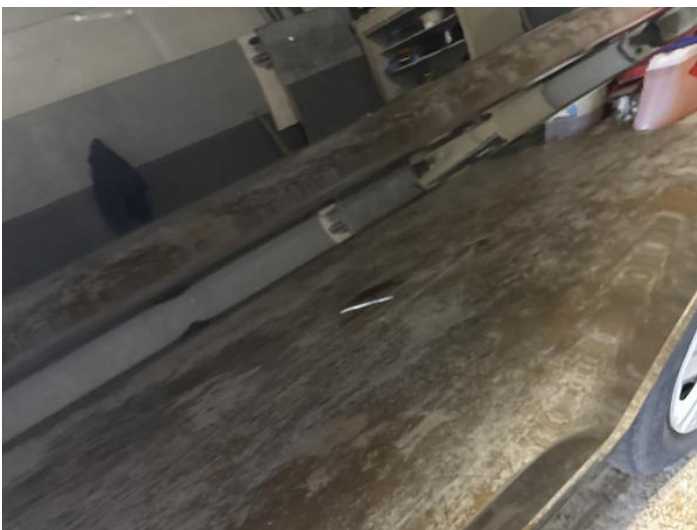
7: Door nsr
Dented
With Paint Damage

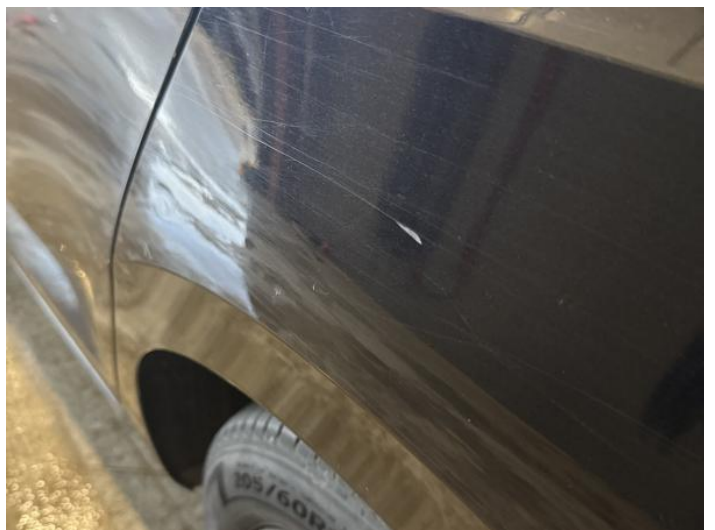
8: Qtr Panel nsr
Dented
With Paint Damage

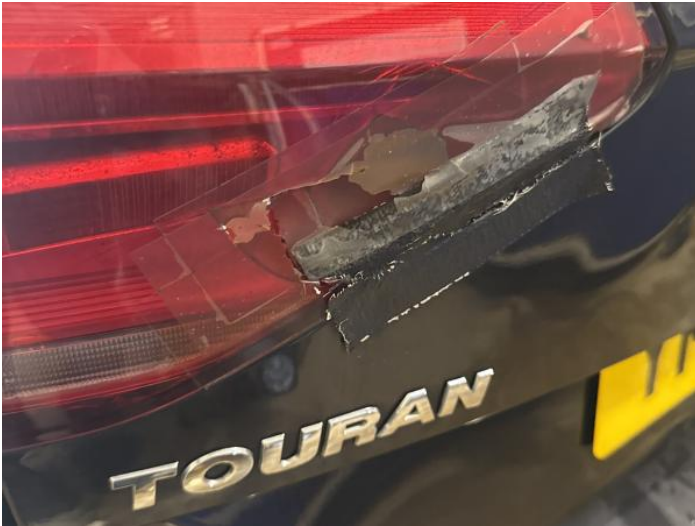
9: Lamp nsr
Broken
Replace

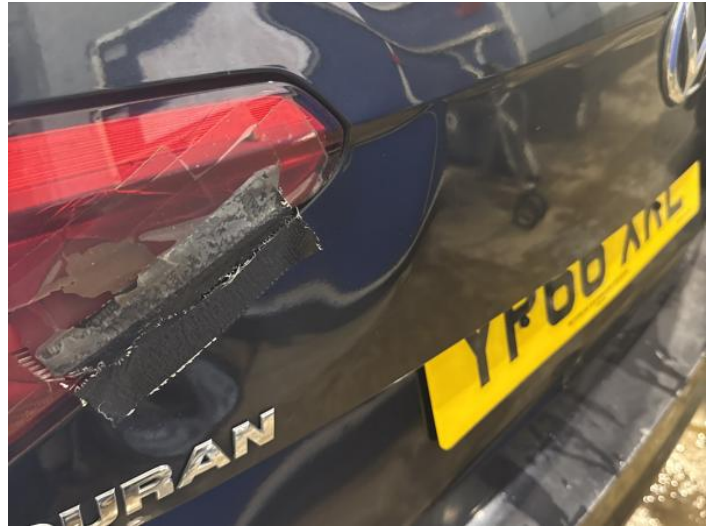
10: Tailgate
Dented
Over 30mm

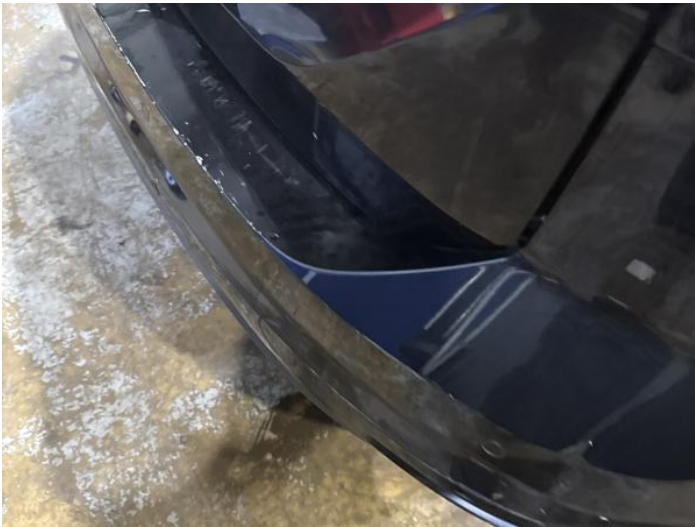
11: Bumper Rear
Scratched
Over 100mm Thru Paint

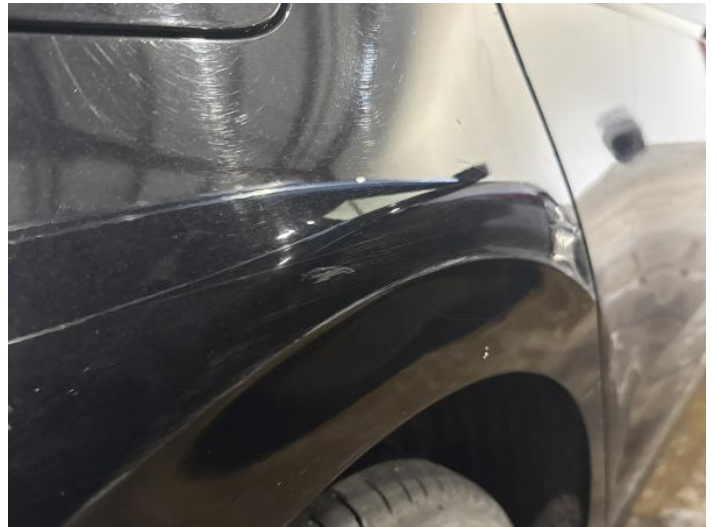
12: Qtr Panel osr
Dented
With Paint Damage

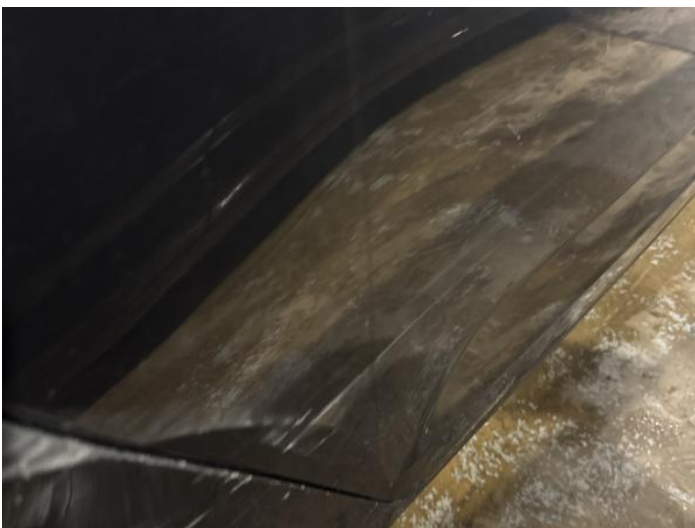
13: Door osr
Dented
With Paint Damage

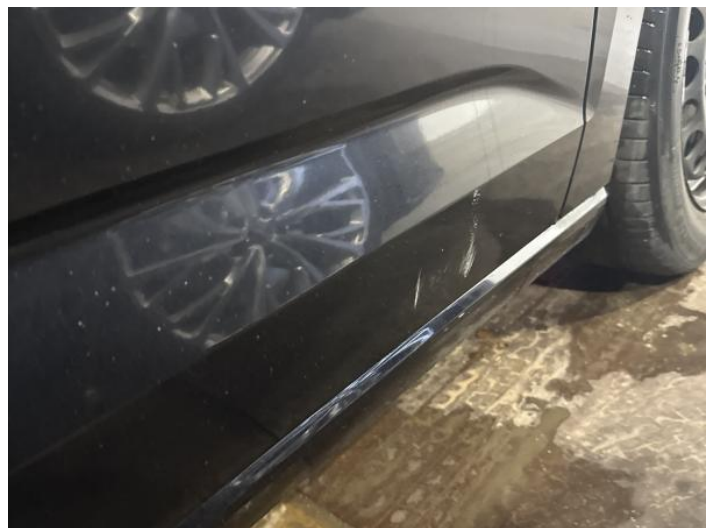
14: Door osf
Scratched
Over 25mm Thru Paint

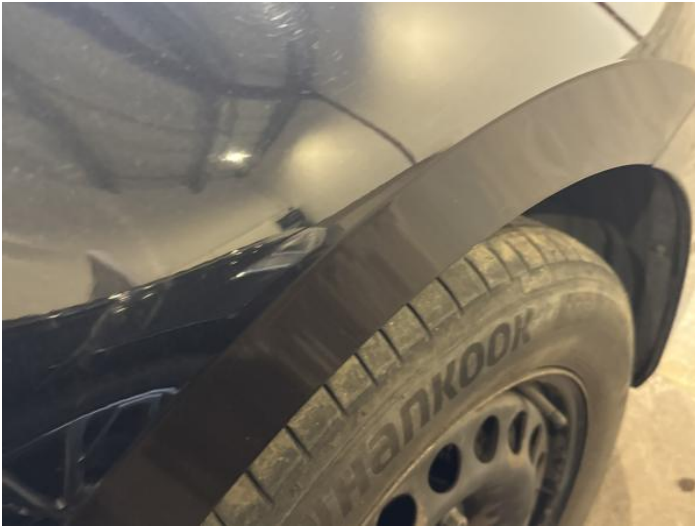
15: Wing osf
 Scratched
 UpTo 25mm Thru Paint

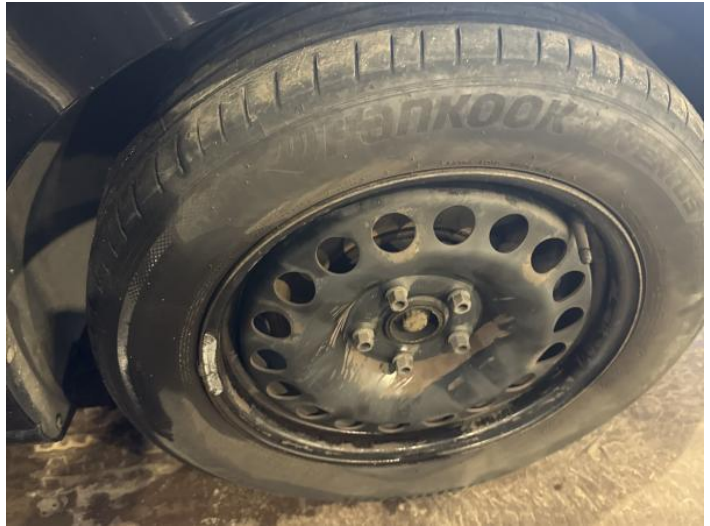
16: Wheel Trim osf
 Missing
 Replace

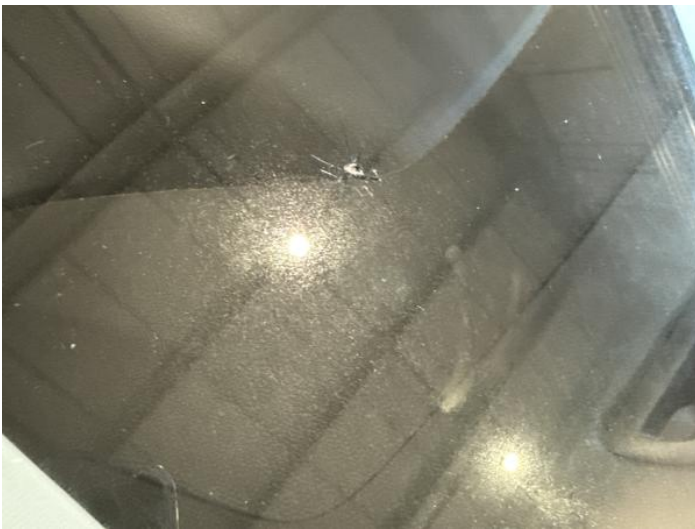
17: Screen Front
 Cracked
 Replace
