VEHICLE INSPECTION REPORT

GY11AVE

Suzuki SX4 1.6 SZ-L 5dr

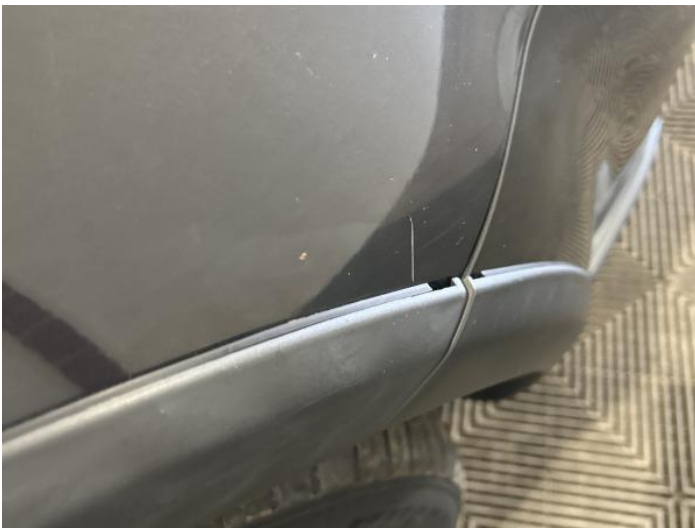
1: Wing osf
Chipped
1 To 5

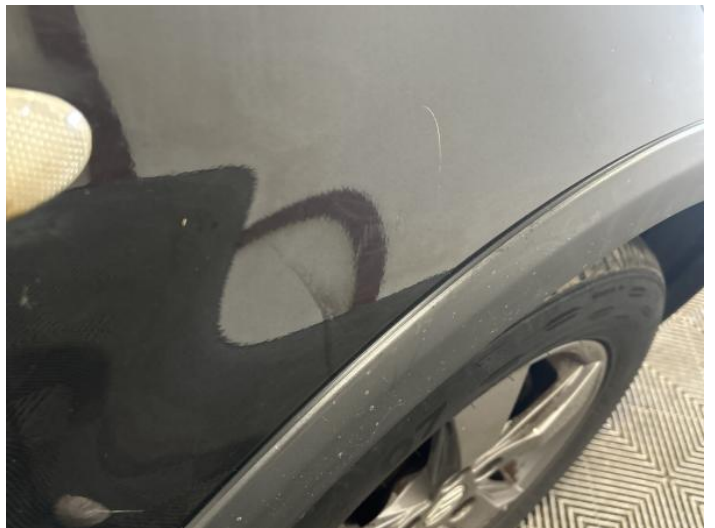
2: Wing osf
Scratched
Over 25mm Not Thru Paint

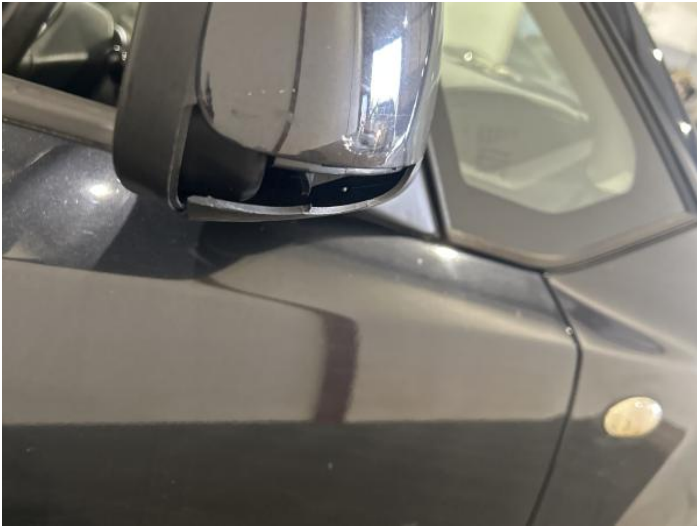
3: Door Mirror Assy osf
Broken
Replace

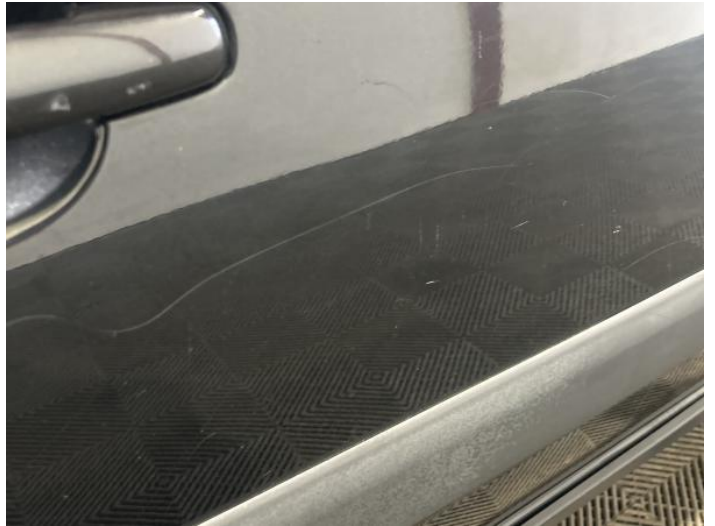
4: Door osf
Scratched
Over 25mm Thru Paint

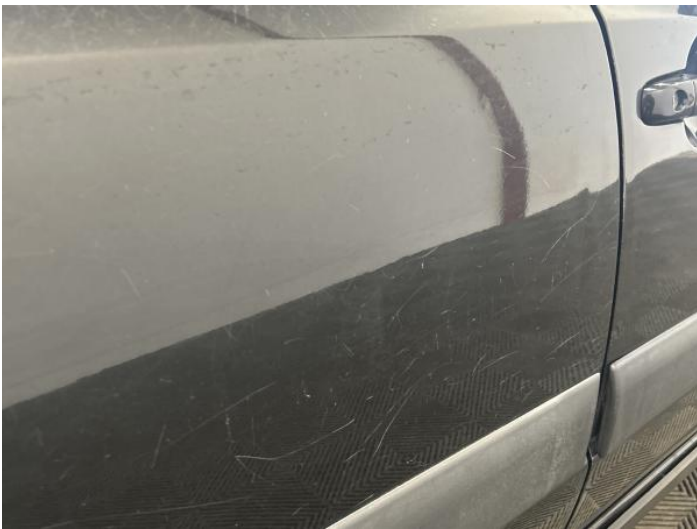
5: Door osr
Scratched
Over 25mm Thru Paint

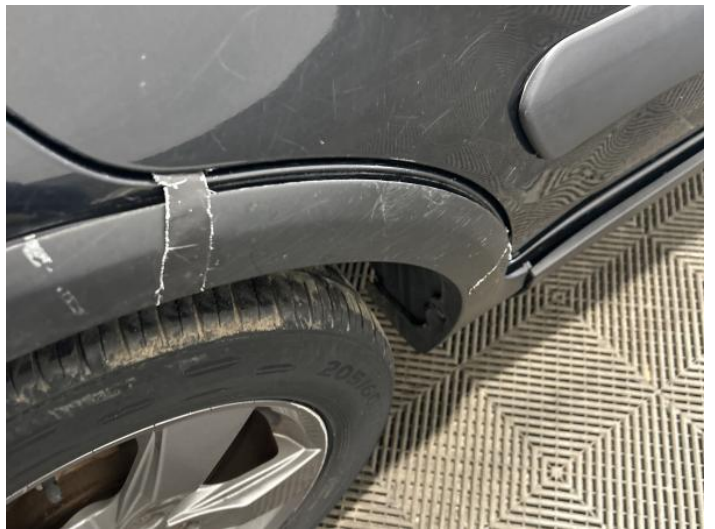
6: Qtr Panel Moulding os
Broken
Replace

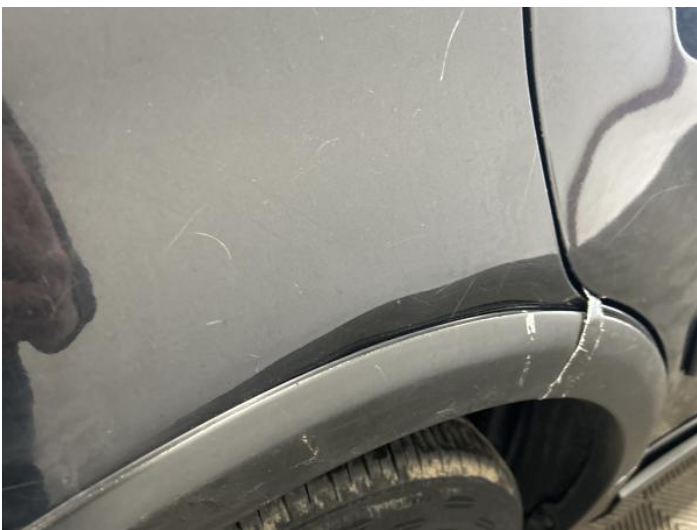
7: Qtr Panel osr
Dented
With Paint Damage

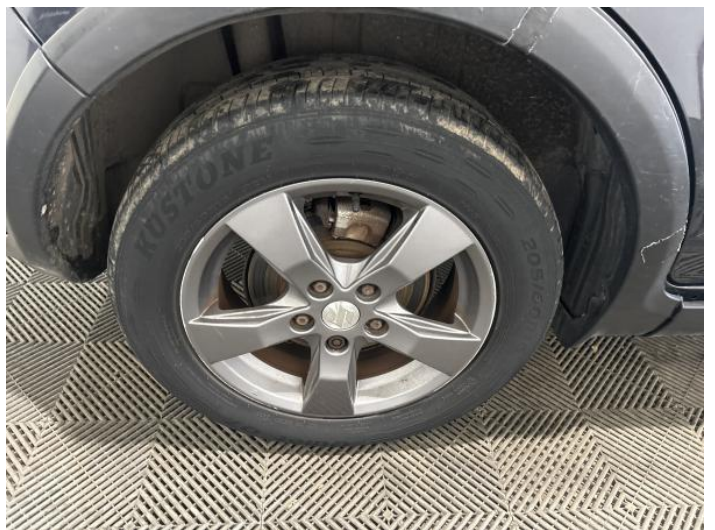
8: Wheel osr
Scratched
Over 50mm

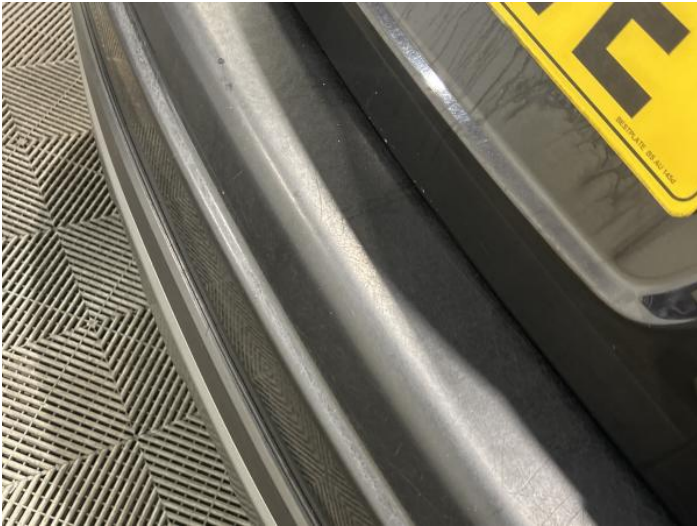
9: Bumper Rear
Poor Previous Repair
Poor Paint

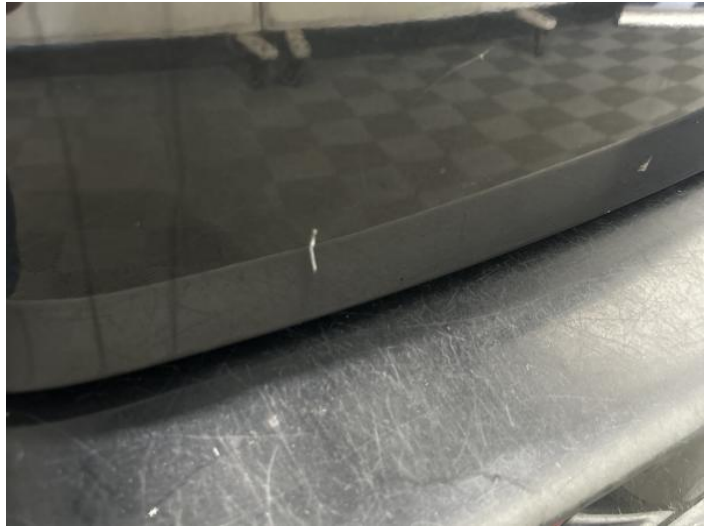
10: Tailgate
Scratched
Up To 25mm Thru Paint

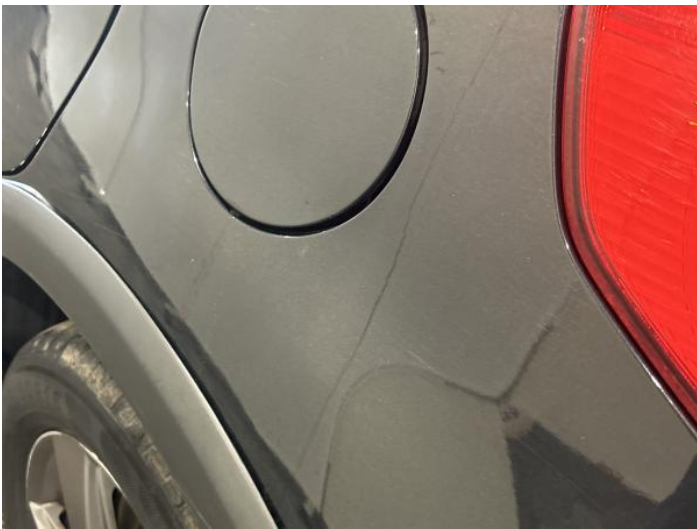
11: Qtr Panel nsr
Scratched
Over 25mm Not Thru Paint

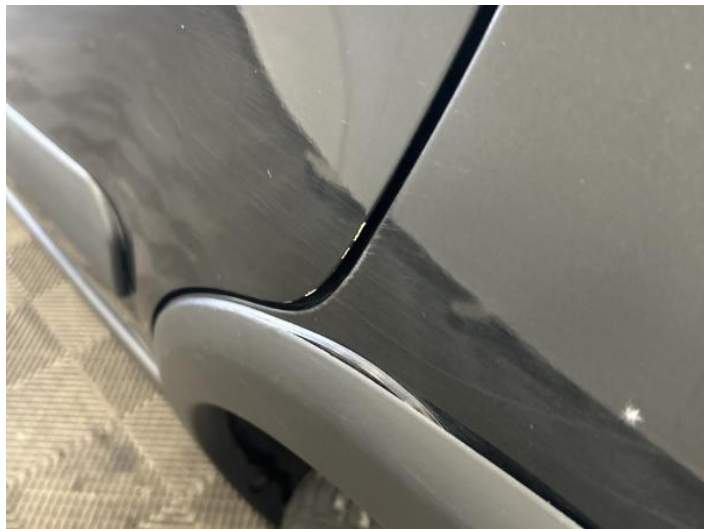
12: Door nsr
Chipped
Edge Chip

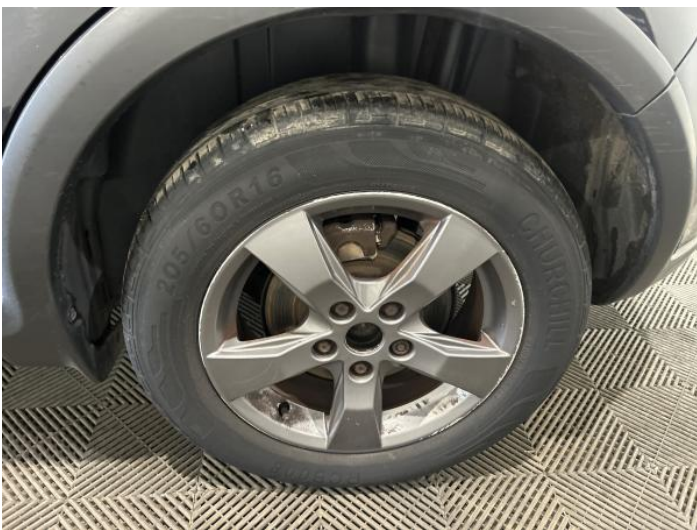
13: Wheel nsr
Scratched
Over 50mm

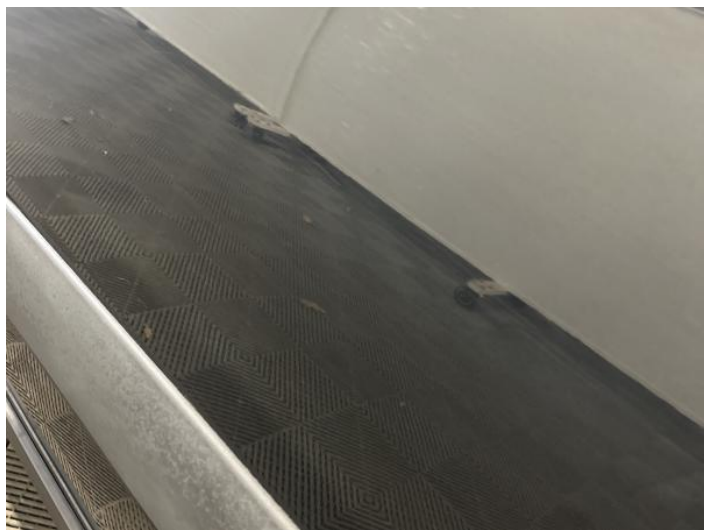
14: Door nsr
Scratched
Over 25mm Not Thru Paint

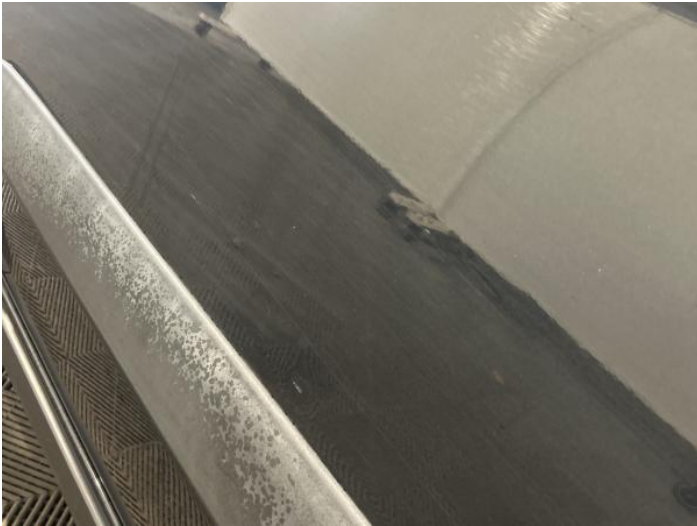
15: Door nsf
Scratched
Over 25mm Not Thru Paint

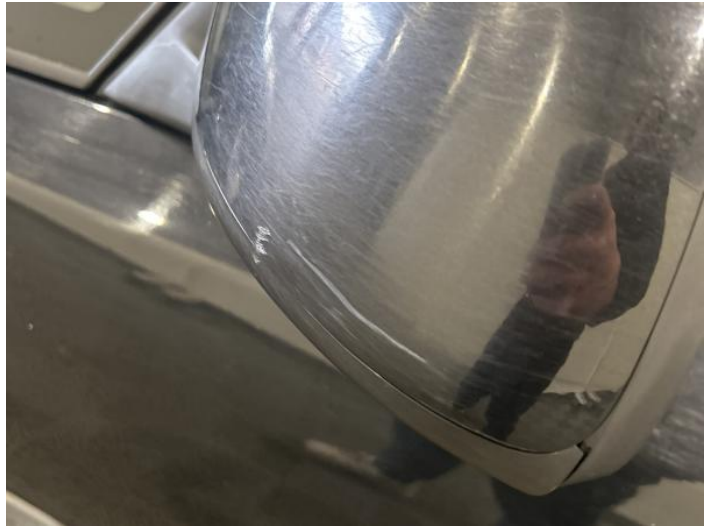
16: Door Mirror Assy nsf
Scratched (Painted)
Over 25mm Thru Paint

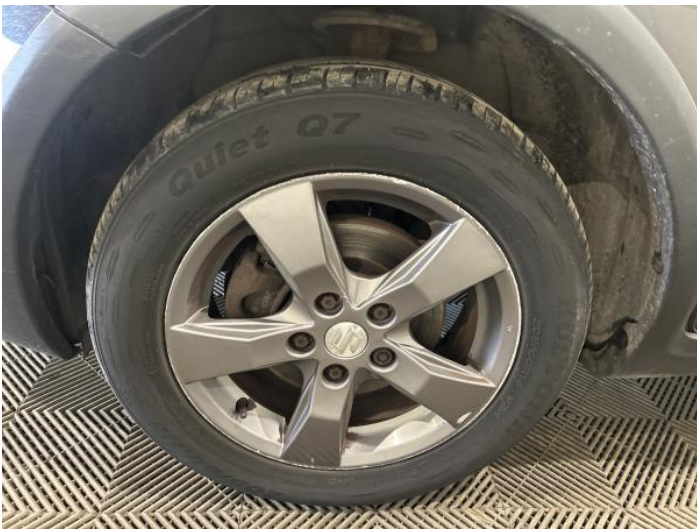
17: Wheel nsf
Scratched
Over 50mm

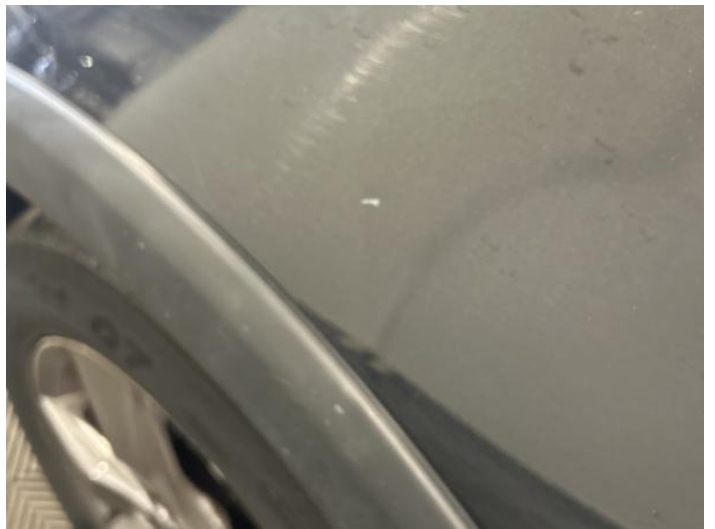
18: Wing nsf
Chipped
1 To 5

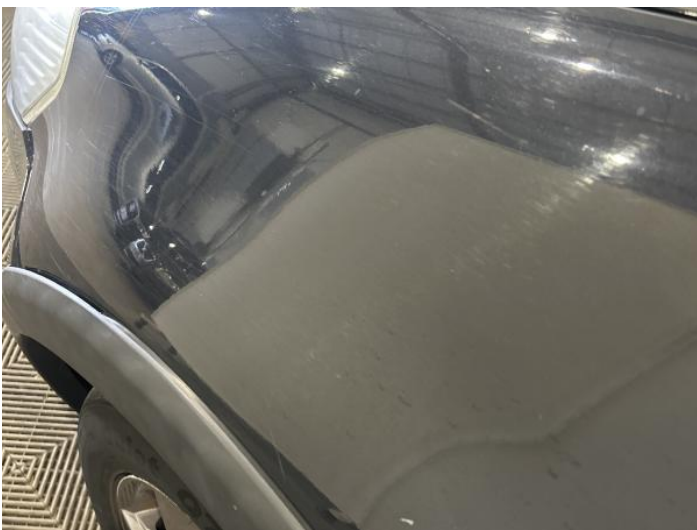
19: Wing nsf
Scratched
Over 25mm Not Thru Paint

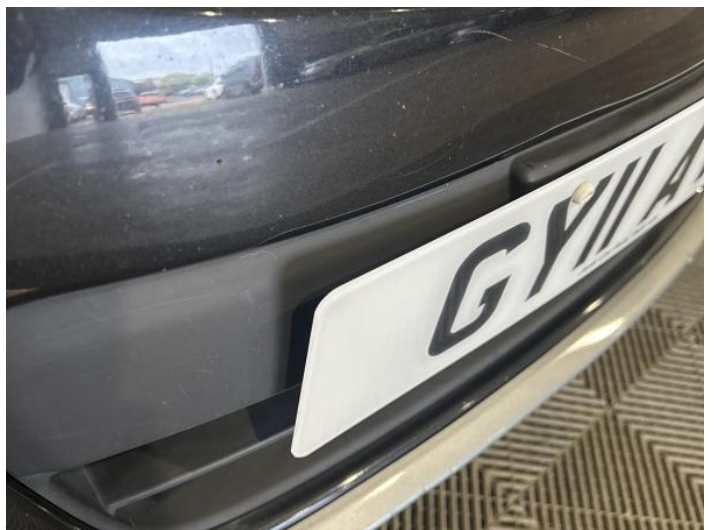
20: Bumper Front
Scratched
25 to 100mm Thru Paint

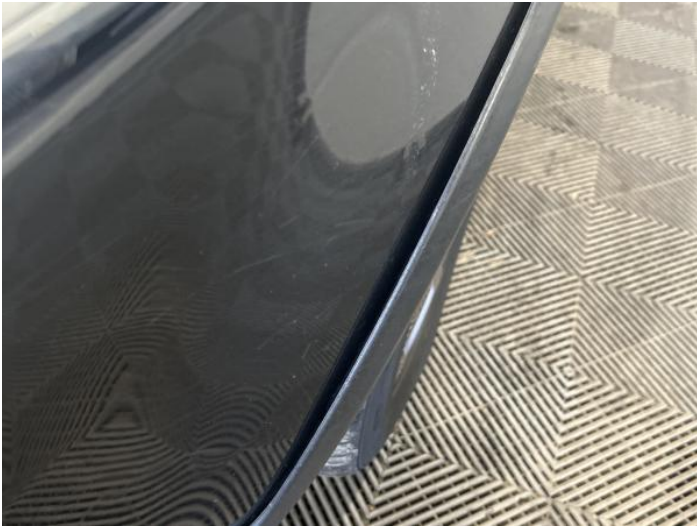
21: Bumper Front
 Scratched
 Over 25mm Not Thru Paint

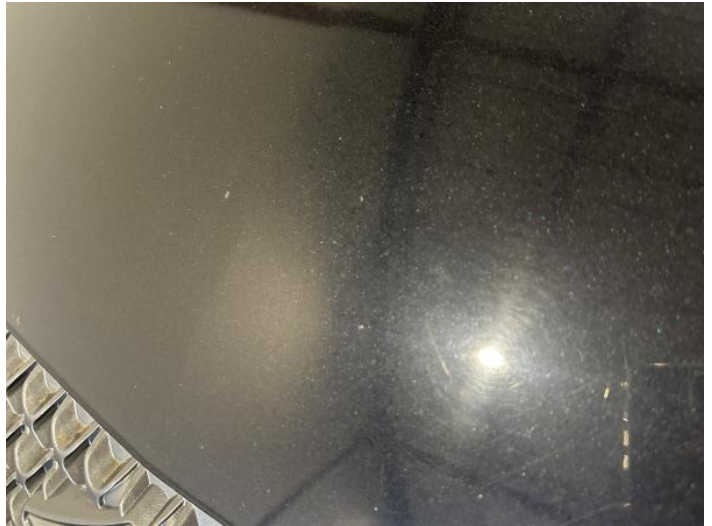
22: Bonnet
 Chipped
 1 To 5

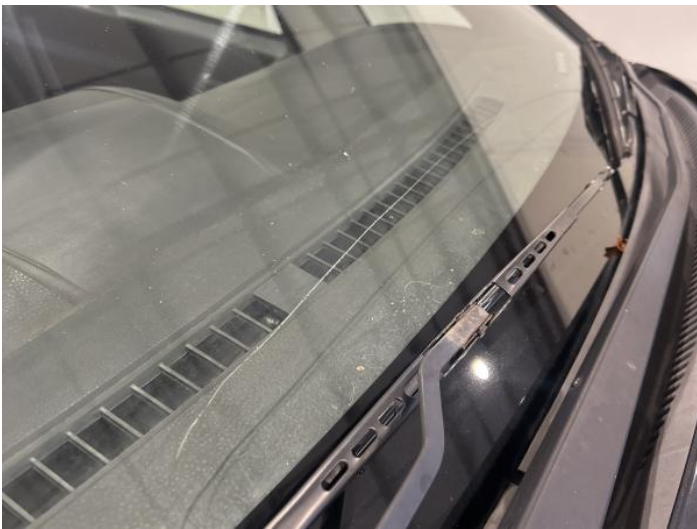
23: Screen Front
 Cracked
 Replace

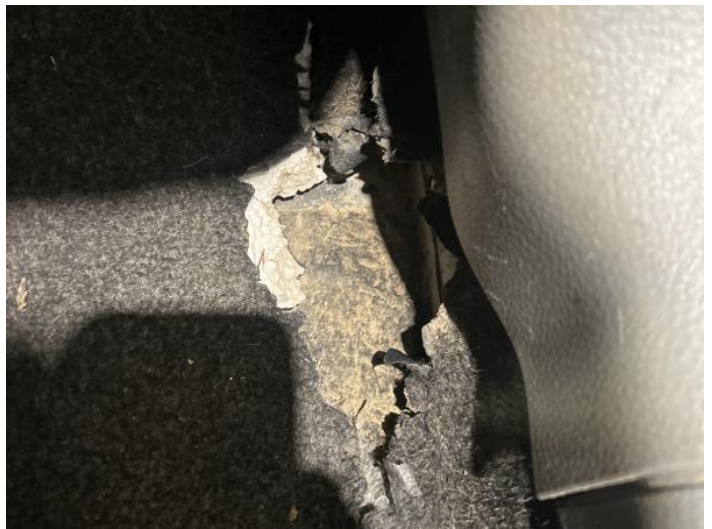
24: Carpets Front
 Holed
 Over 3mm

Carpet Condition Poor
Seat Condition Poor
