# VEHICLE INSPECTION REPORT

**GU66DHF**

## Fiat 500x 1.4 Multiair Cross 5dr

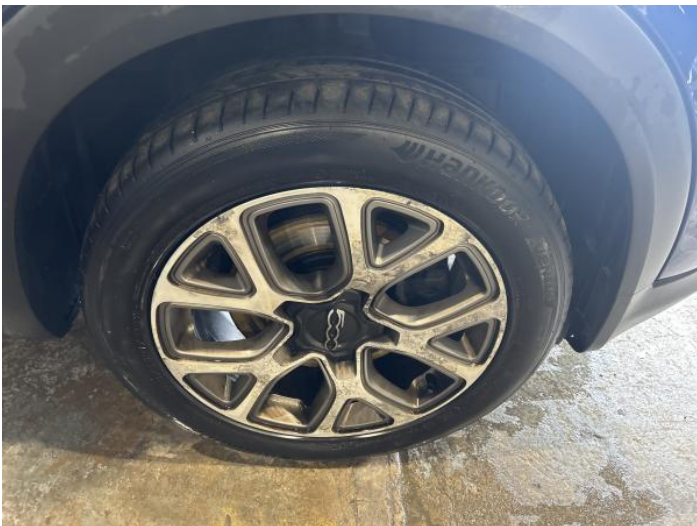
1: Wheel of  
Corroded  
Light

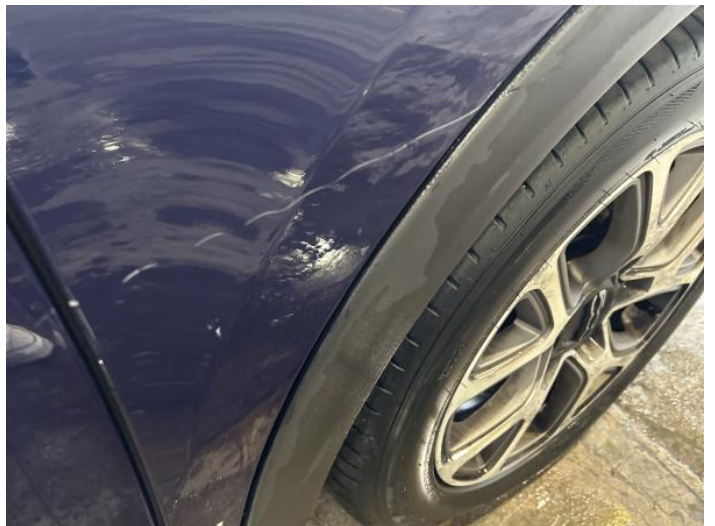
2: Wing of  
Scratched  
Over 25mm Thru Paint

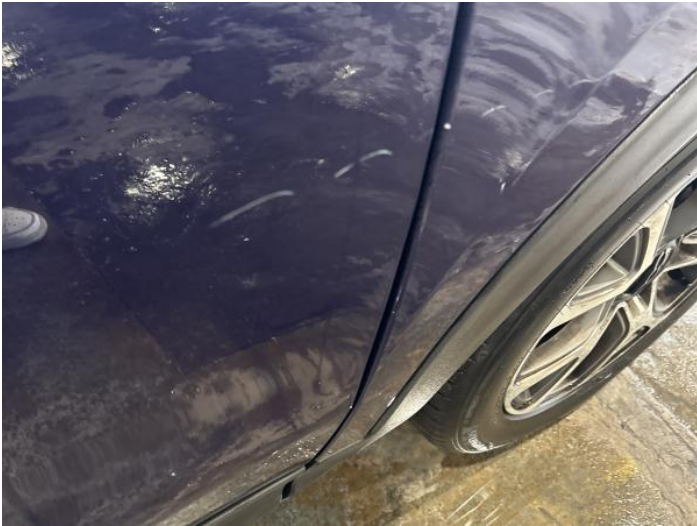
3: Door osf  
Scratched  
Over 25mm Thru Paint

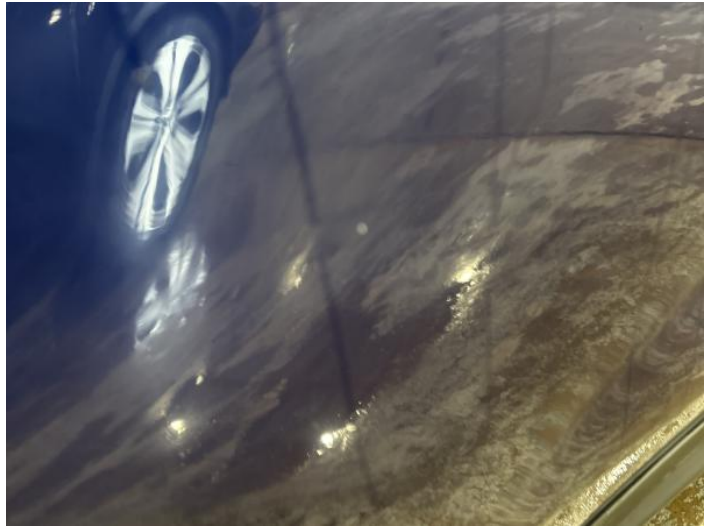
4: Door osr  
Chipped  
1 To 5

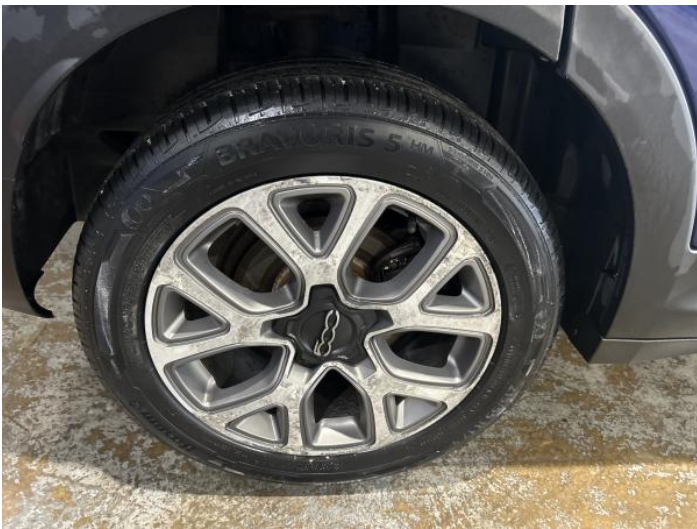
5: Wheel osr  
Corroded  
Light

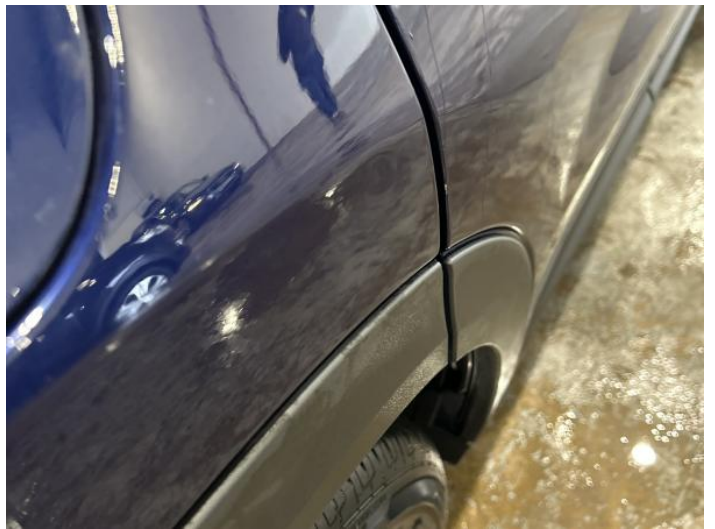
6: Qtr Panel osr  
Dented  
2 Or Less UpTo 10mm

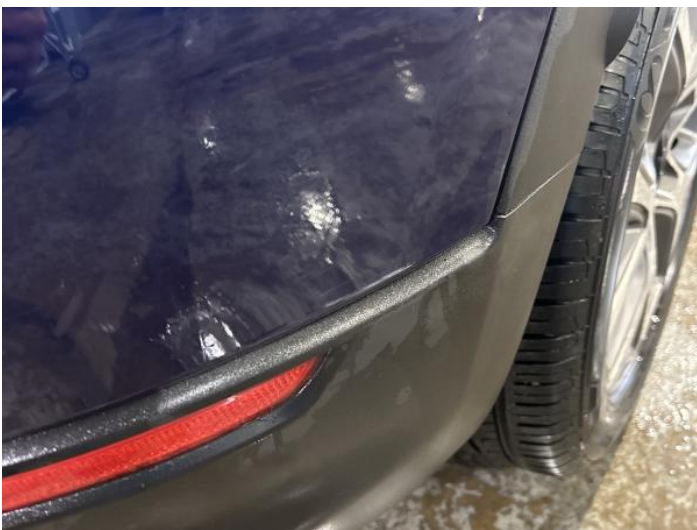
7: Bumper Rear  
Scratched  
25 to 100mm Thru Paint

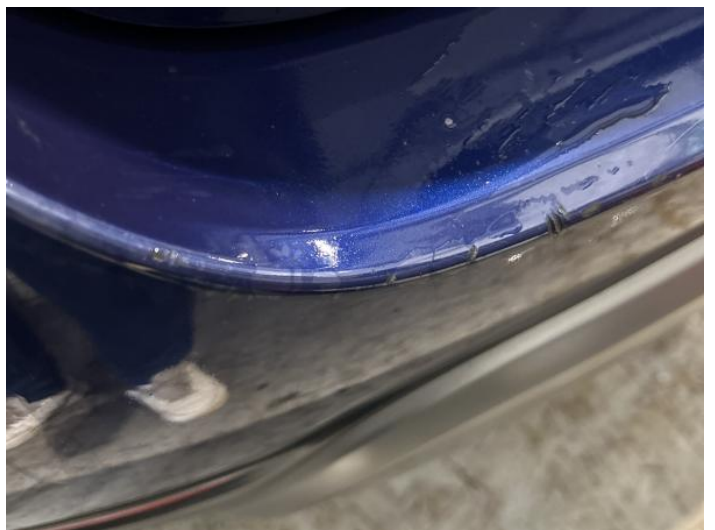
8: Bumper Rear  
Chipped  
Multiple Chips

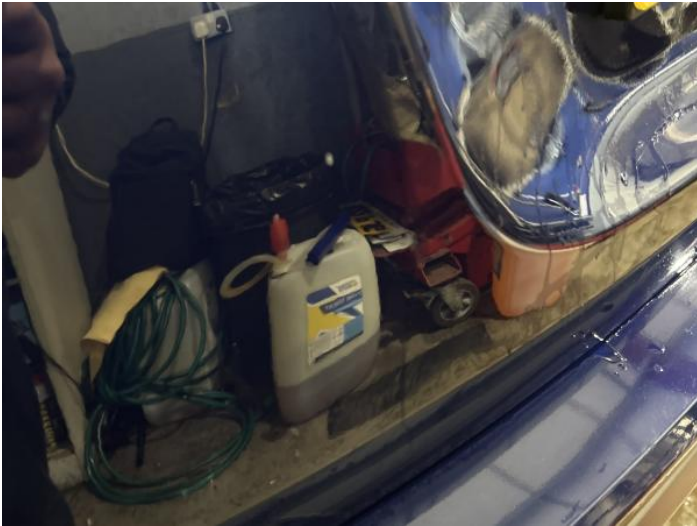
9: Tailgate  
Chipped  
1 To 5

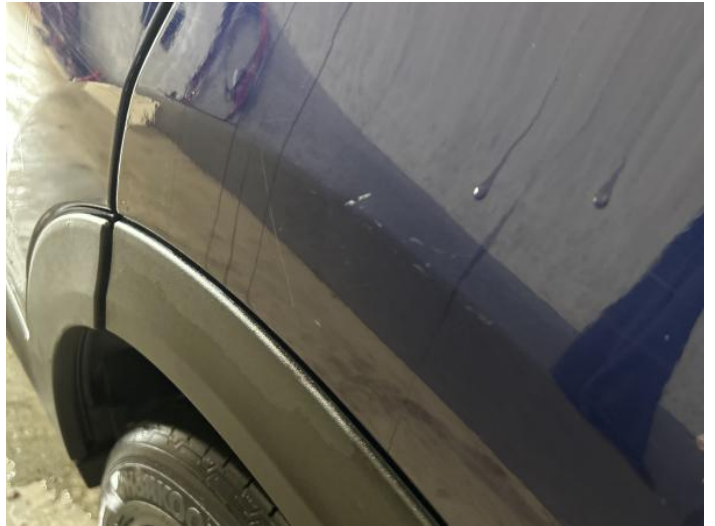
10: Qtr Panel nsr  
Scratched  
Over 25mm Not Thru Paint

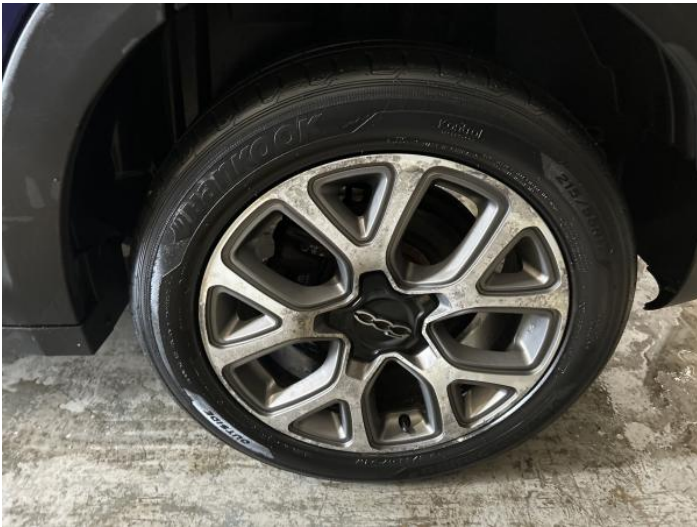
11: Wheel nsr  
Corroded  
Light

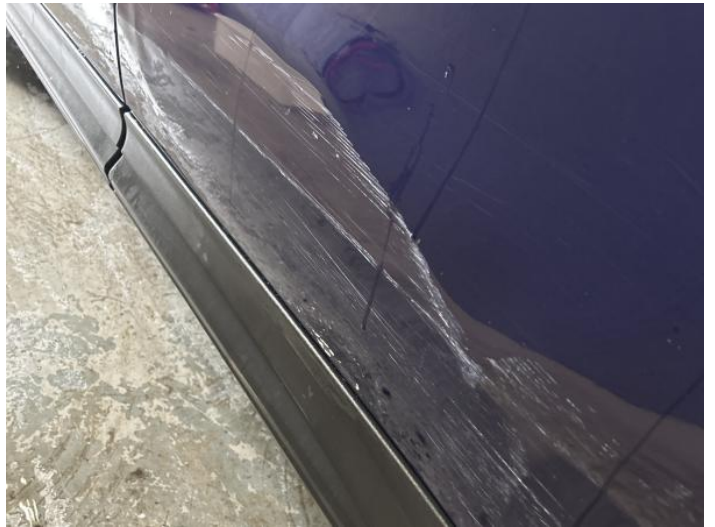
12: Door nsr  
Dented  
With Paint Damage

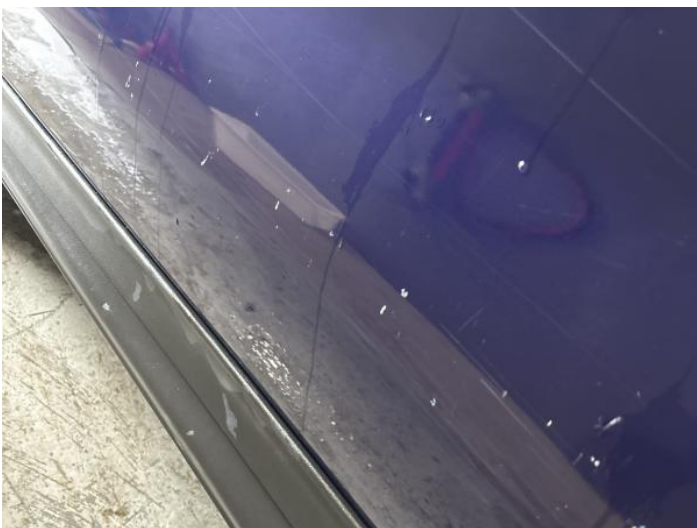
13: Door nsf  
Chipped  
Multiple Chips

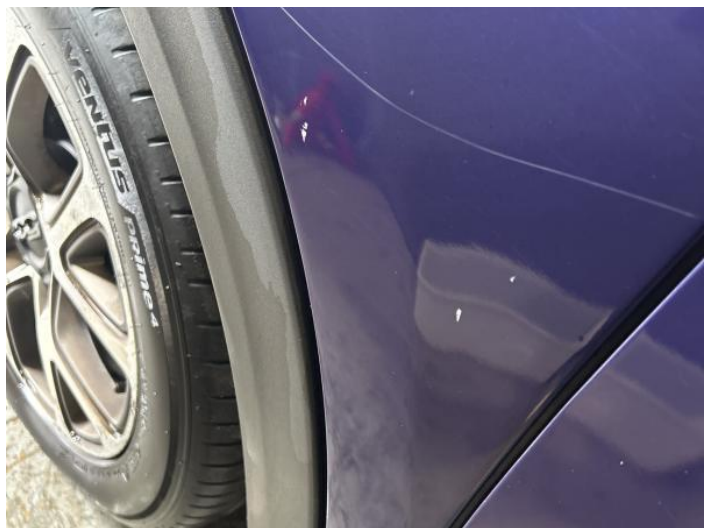
14: Wing nsf  
Chipped  
1 To 5

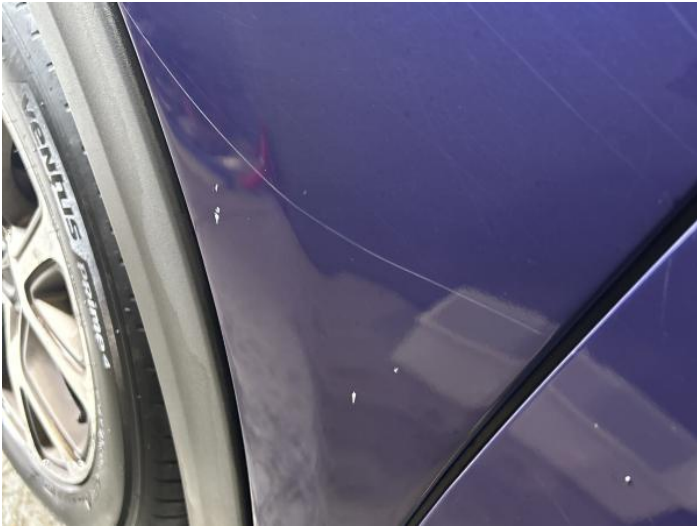
15: Wing nsf  
Scratched  
Over 25mm Not Thru Paint

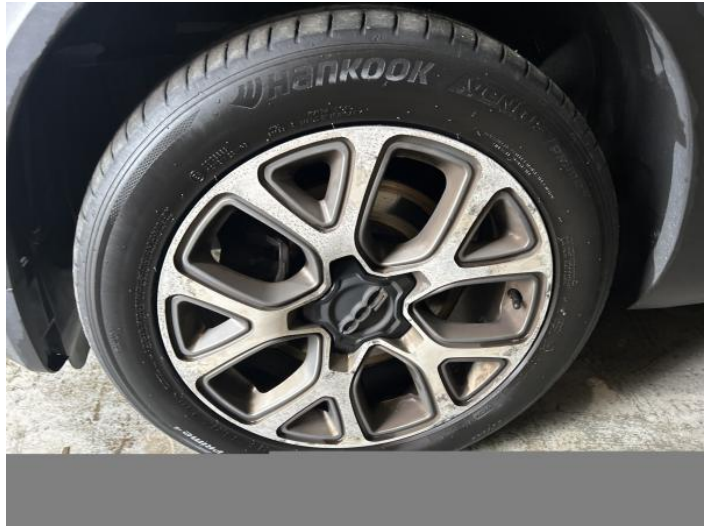
16: Wheel nsf  
Corroded  
Light

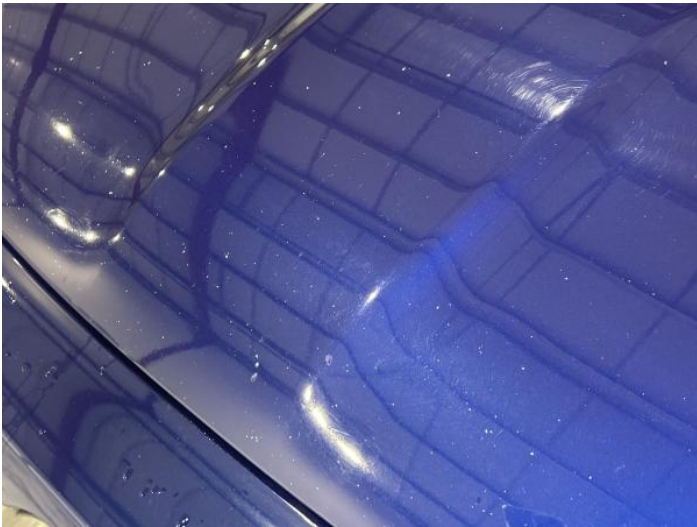
17: Bonnet  
Chipped  
Multiple Chips

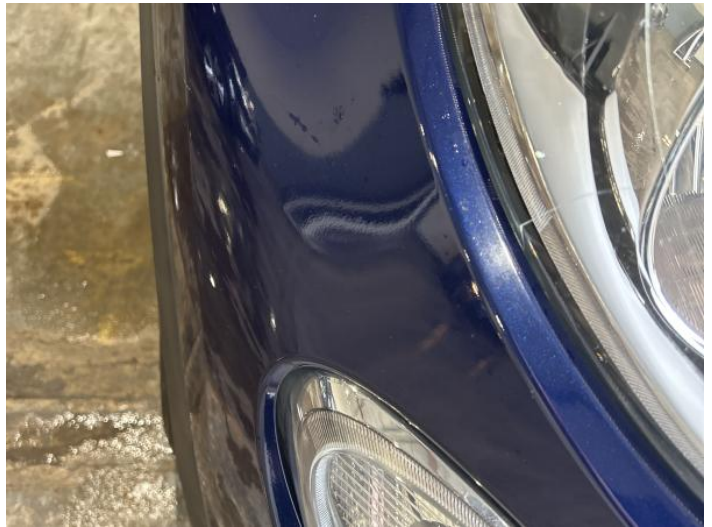
18: Bumper Front  
Poor Previous Repair  
Poor Paint
