# VEHICLE INSPECTION REPORT

**YF62EXC**

## Peugeot Partner Tepee 1.6 HDi 115 Outdoor 5dr

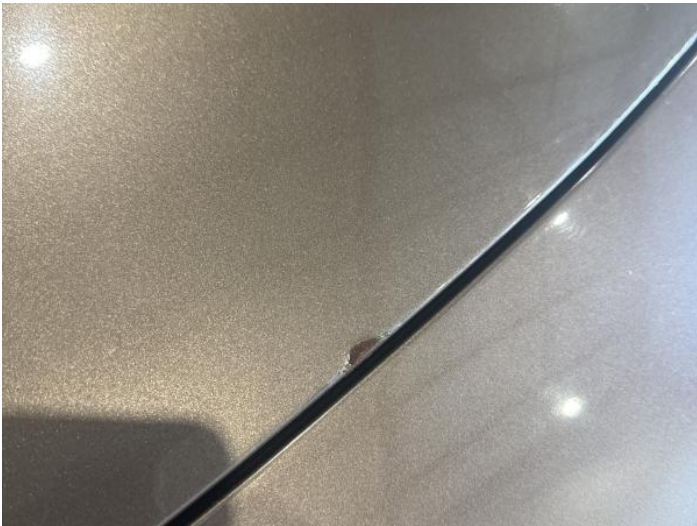
1: Bonnet  
Scratched  
Rusted

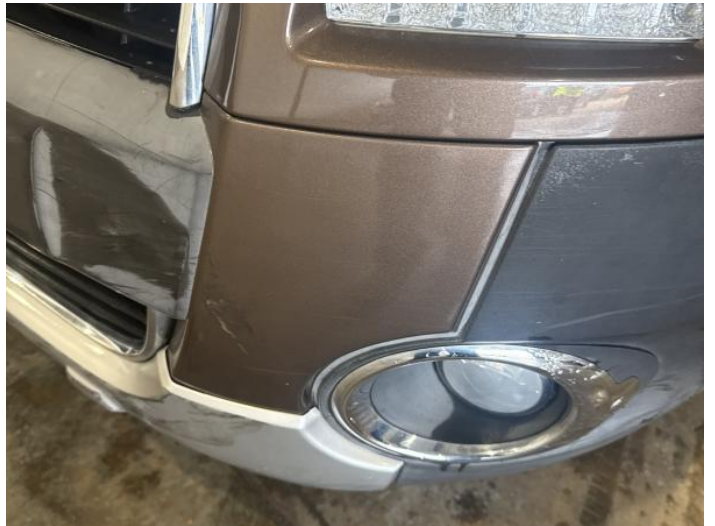
2: Bumper Front  
Scratched  
25 to 100mm Thru Paint

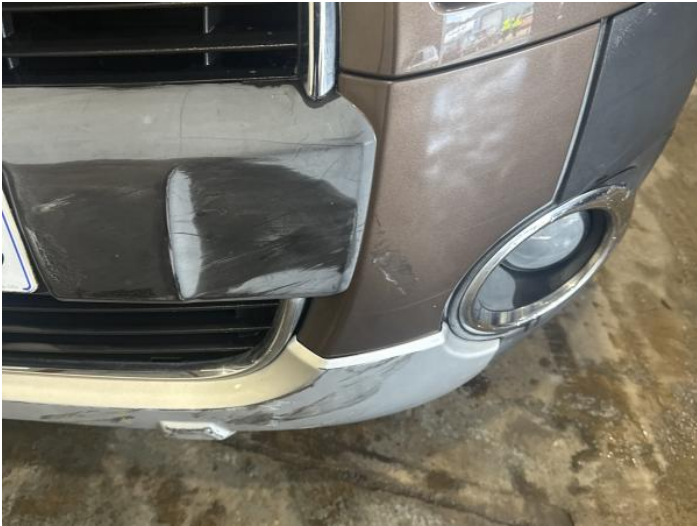
3: Bumper Front Moulding  
Scuffed (Unpainted)  
Over 100mm

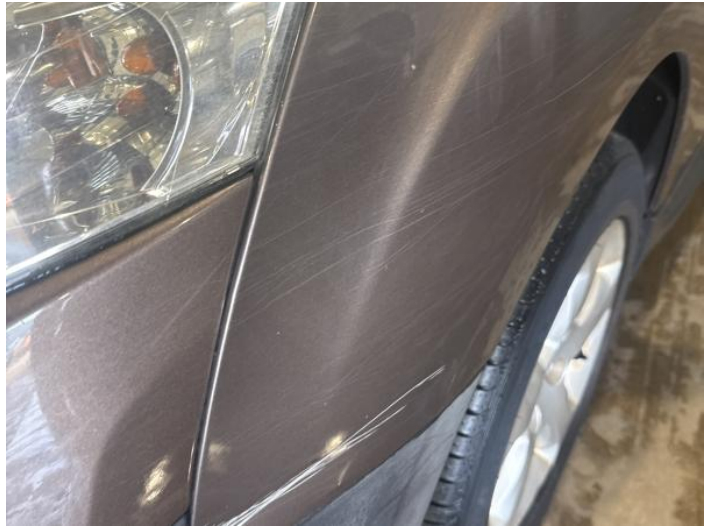
4: Wing nsf  
Scratched  
Over 25mm Thru Paint

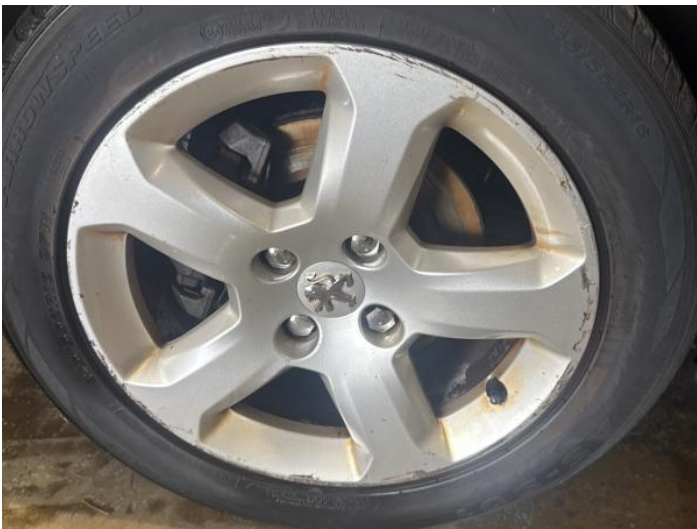
5: Wheel nsf  
Scratched  
Over 50mm

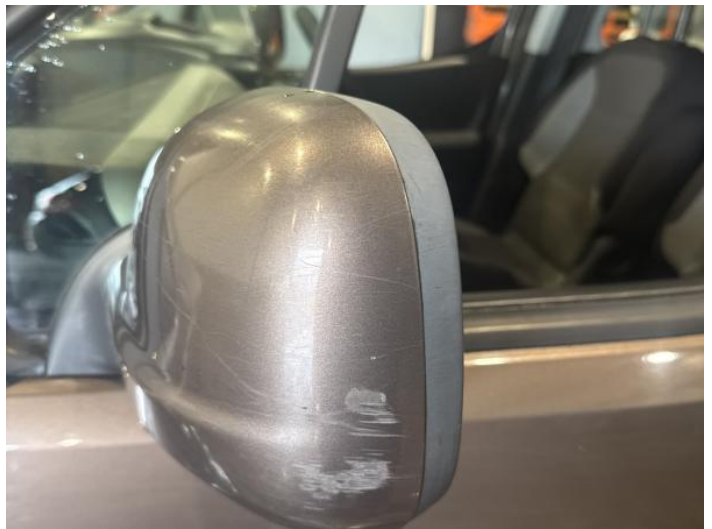
6: Door Mirror Assy nsf  
Scratched (Painted)  
Over 25mm Thru Paint

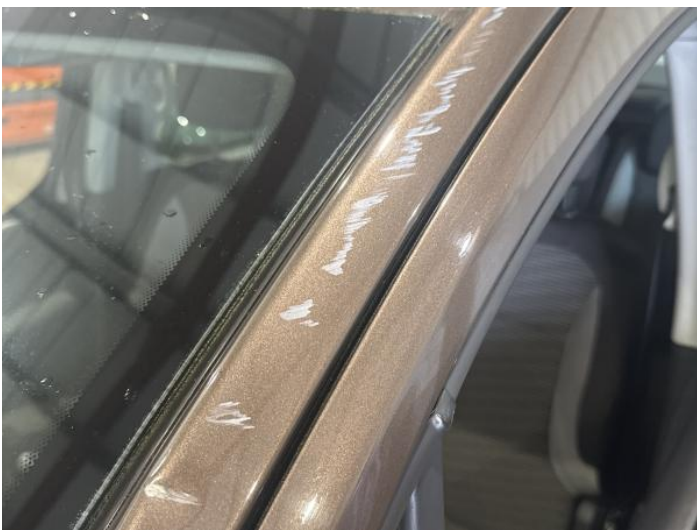
7: A Post ns  
Dented  
With Paint Damage

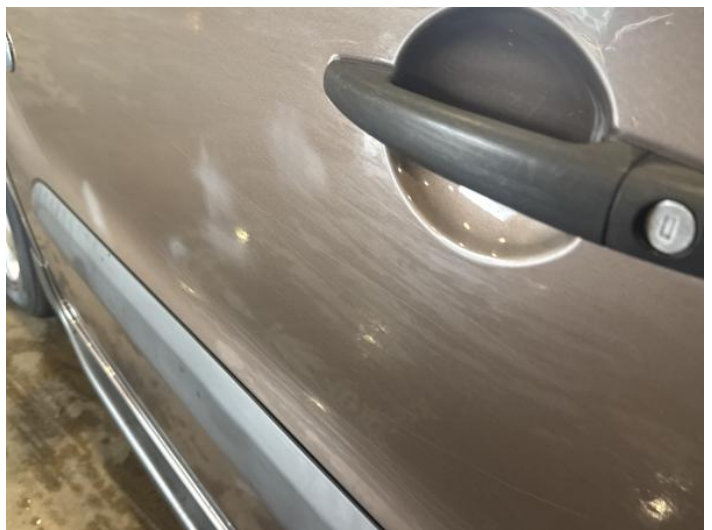
8: Door nsf  
Scratched  
Over 25mm Thru Paint

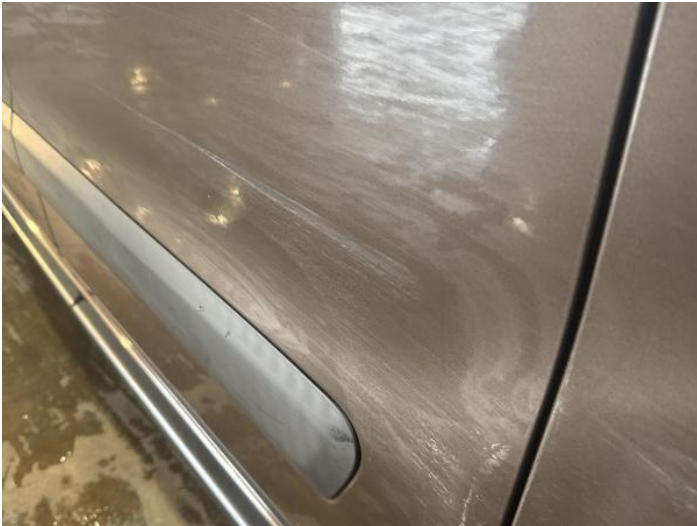
9: Door nsr  
Scratched  
Over 25mm Thru Paint

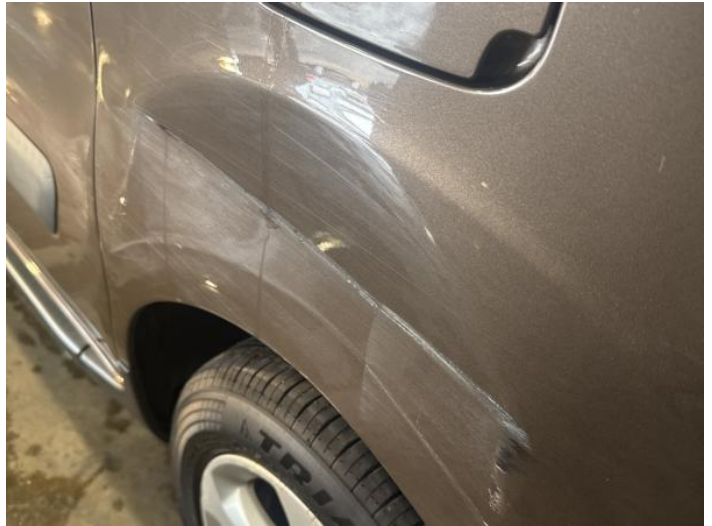
10: Qtr Panel nsr  
Dented  
With Paint Damage

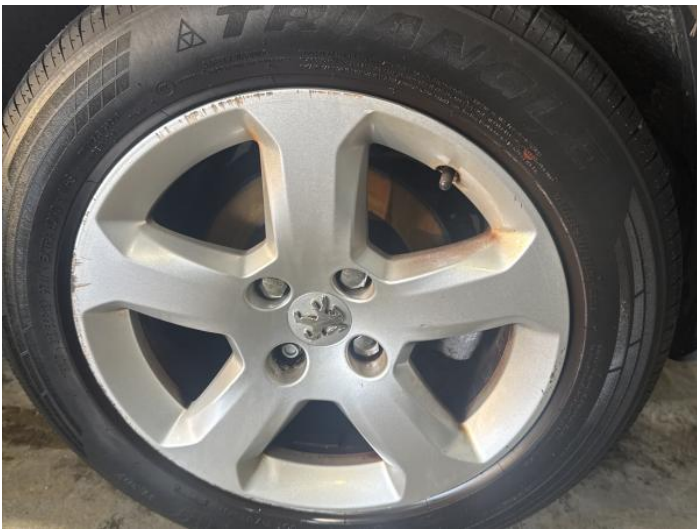
11: Wheel nsr  
Scratched  
Over 50mm

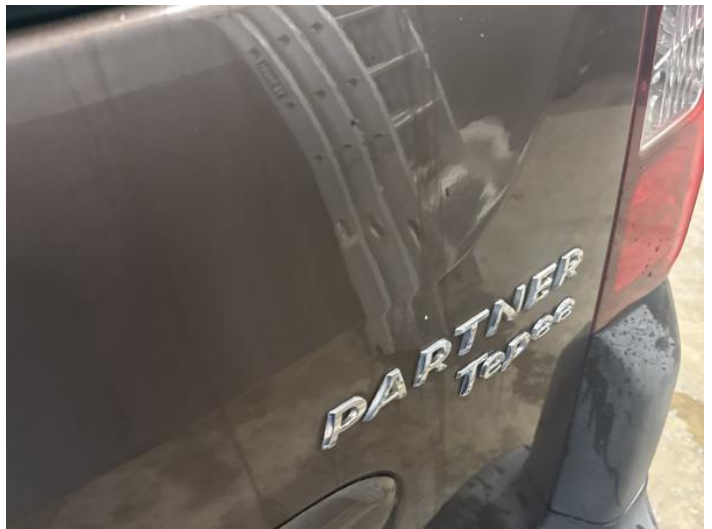
12: Tailgate  
Dented  
Between 10mm + 30mm

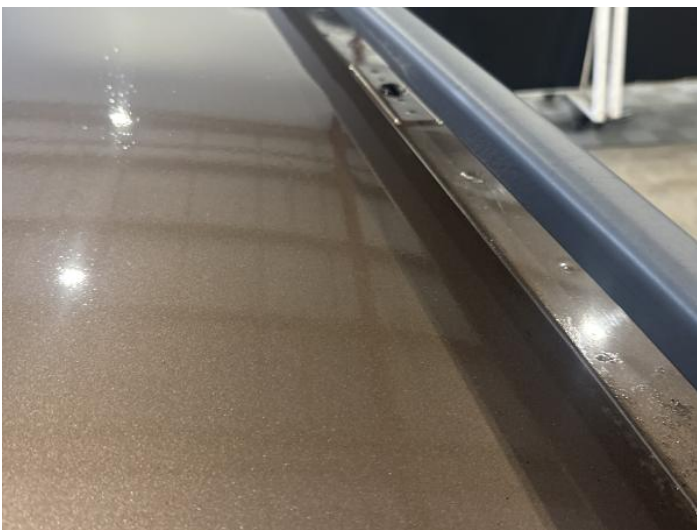
13: Roof  
Dented  
Between 10mm + 30mm

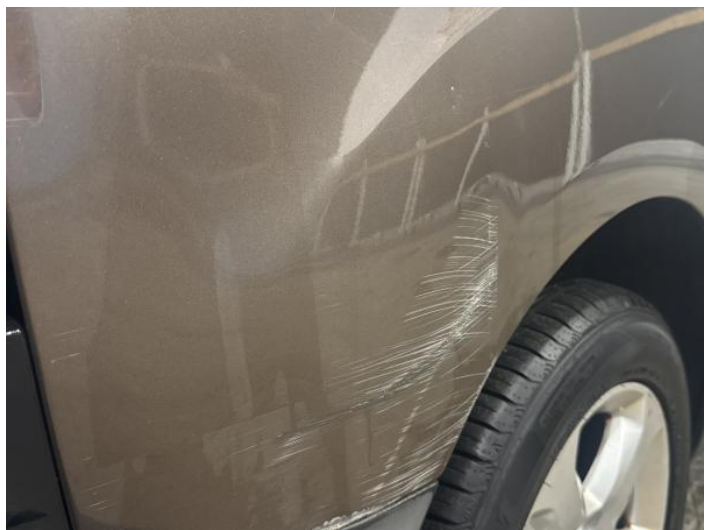
14: Qtr Panel osr  
Dented  
With Paint Damage

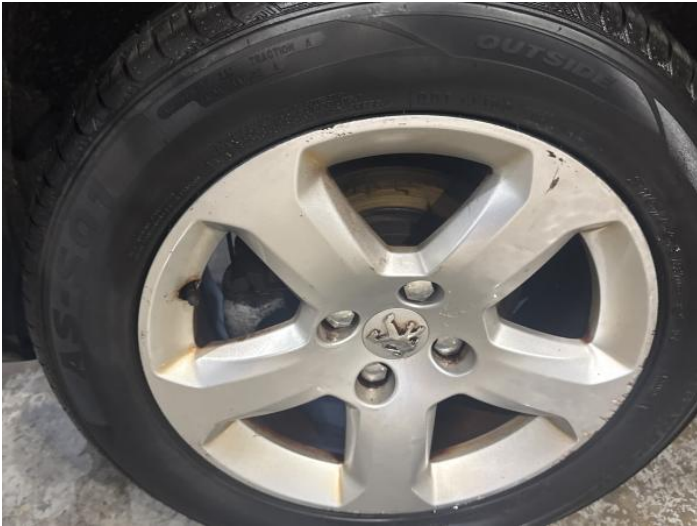
15: Wheel osr  
Scratched  
Over 50mm

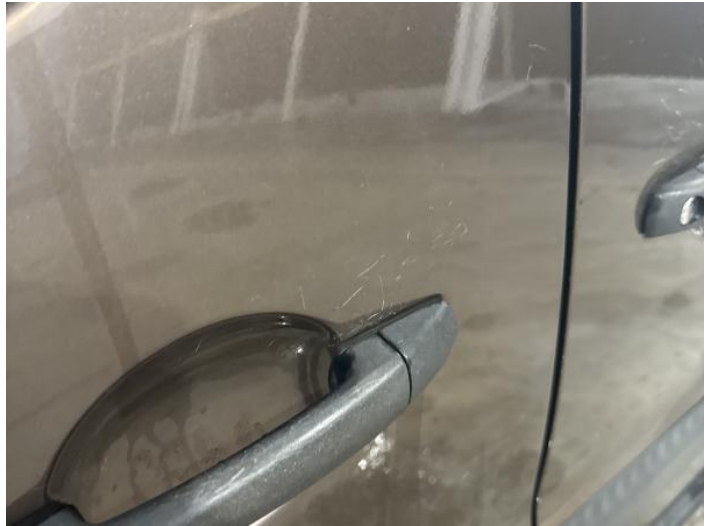
16: Door osr  
Scratched  
Over 25mm Thru Paint

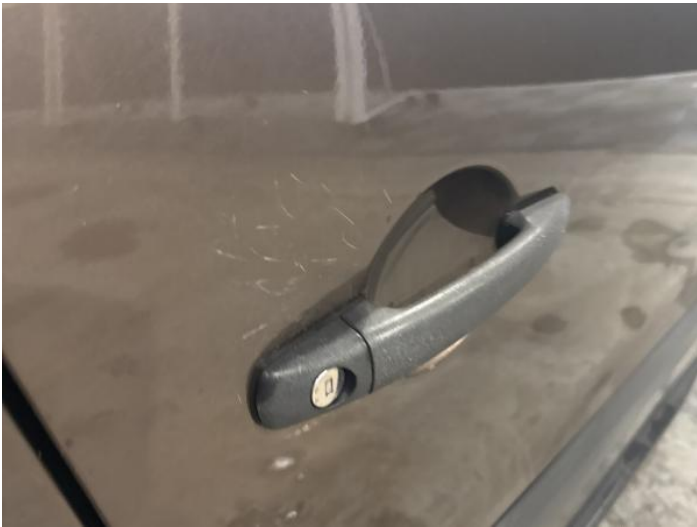
17: Door osf  
Scratched  
Over 25mm Thru Paint

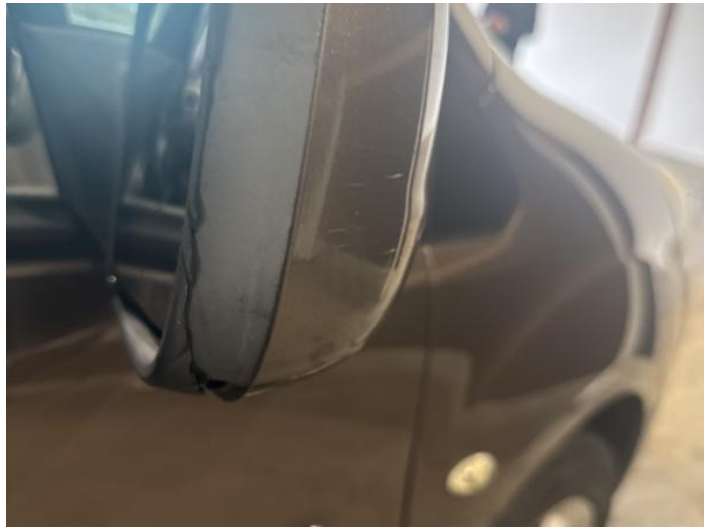
18: Door Mirror Assy nsf  
Broken  
Replace

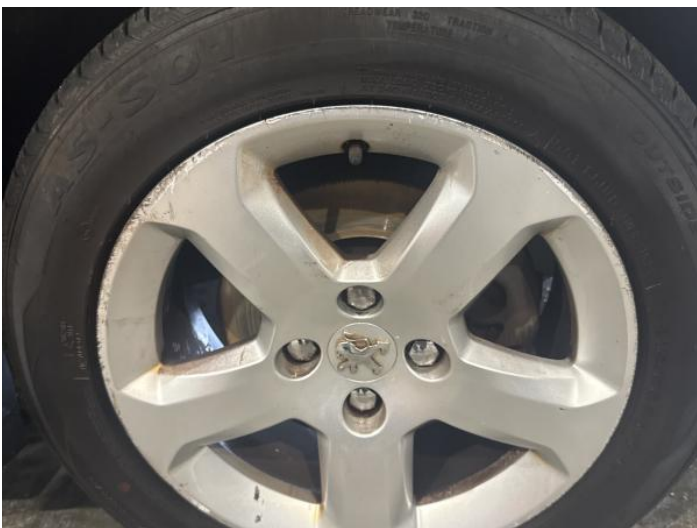
19: Wheel osf  
Scratched  
Over 50mm

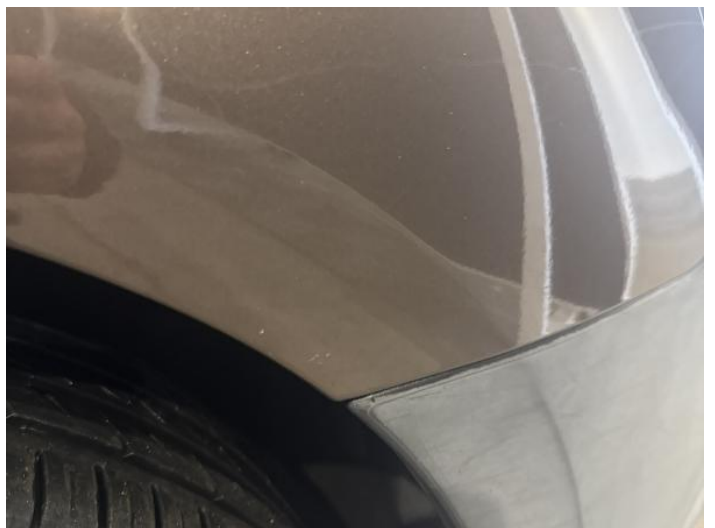
20: Wing osf  
Chipped  
1 To 5

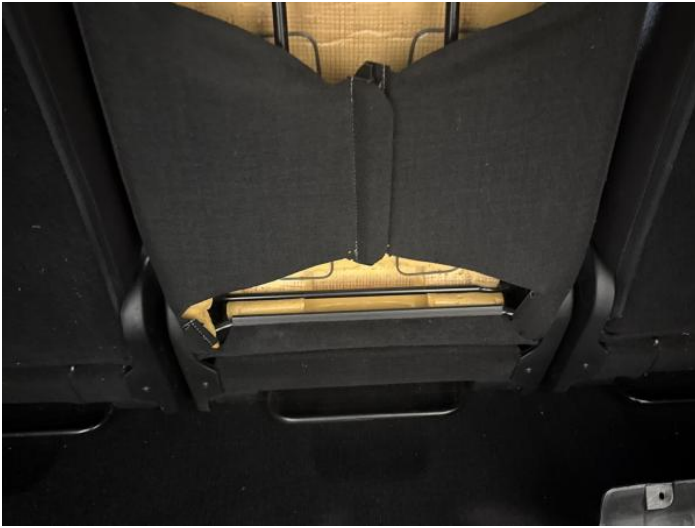
21: Seat Back Cover nsr  
Scuffed  
Over 25mm
