# VEHICLE INSPECTION REPORT

**LF17CNC**

## Land Rover Range Rover Evoque 2.0 Si4 HSE Dynamic 5dr Auto

nama  
GRADE  
**3**

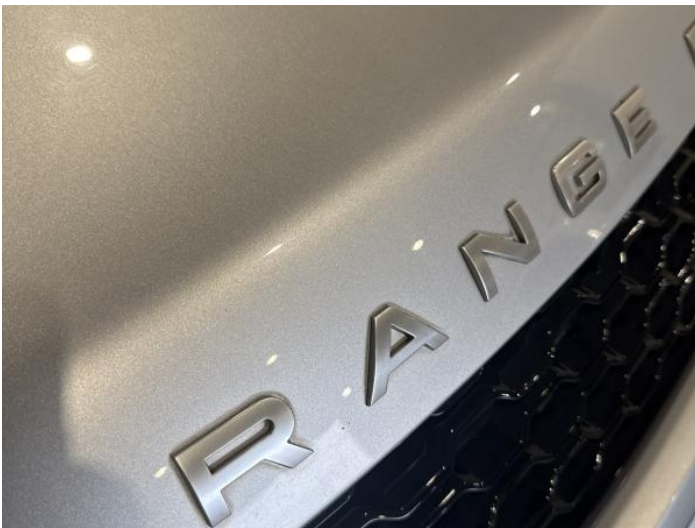
1: Bonnet  
Chipped  
1 To 5

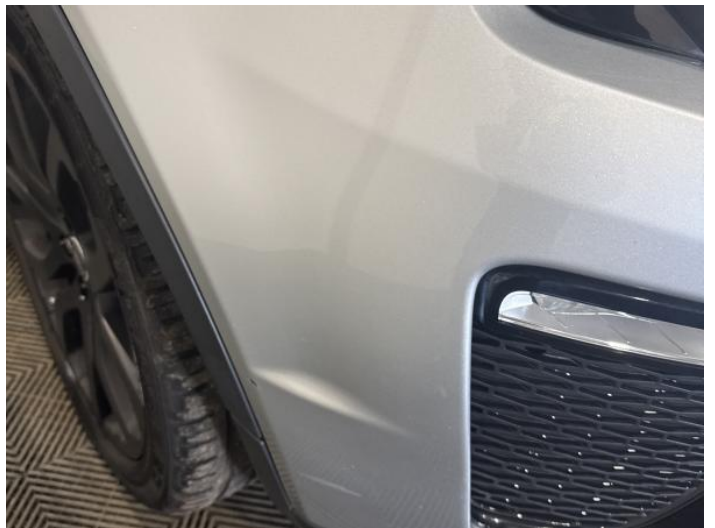
2: Bumper Front  
Scratched  
25 to 100mm Thru Paint

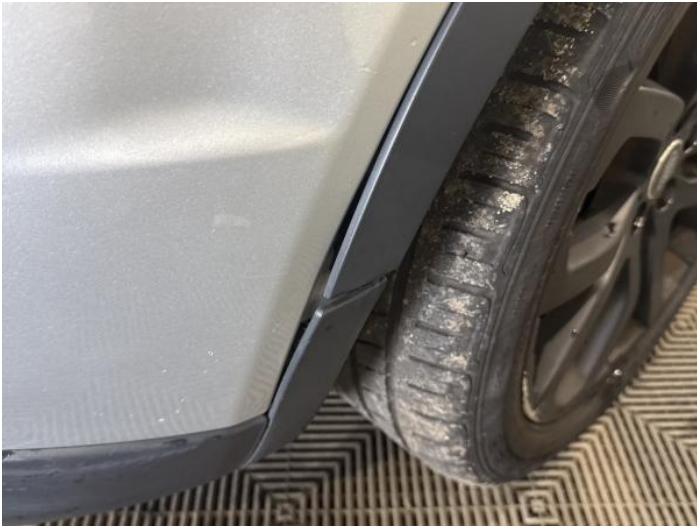
3: Bumper Front Moulding  
Scuffed (Unpainted)  
Over 100mm

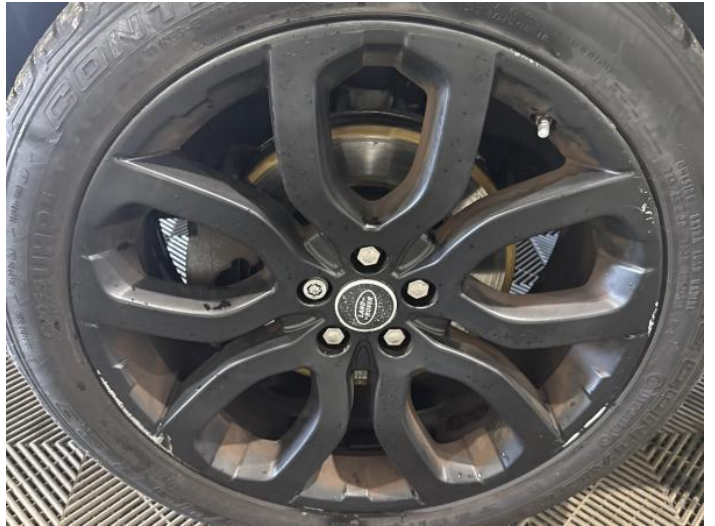
4: Wheel nsf  
Scratched  
Over 50mm

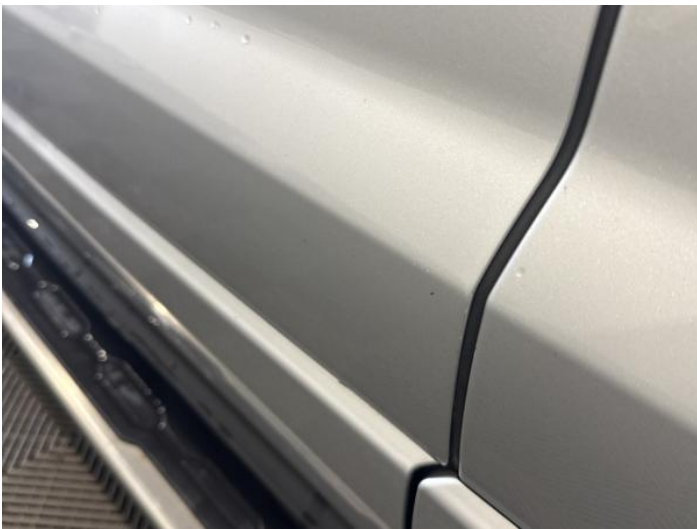
5: Door nsf  
Chipped  
1 To 5

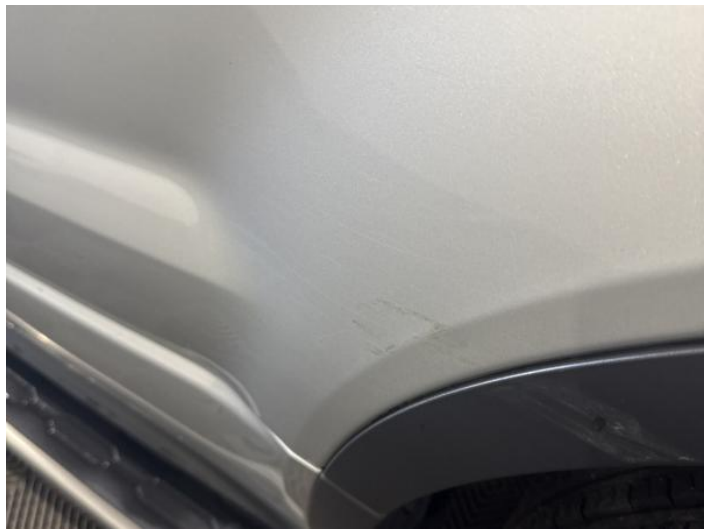
6: Door nsr  
Scratched  
Over 25mm Thru Paint

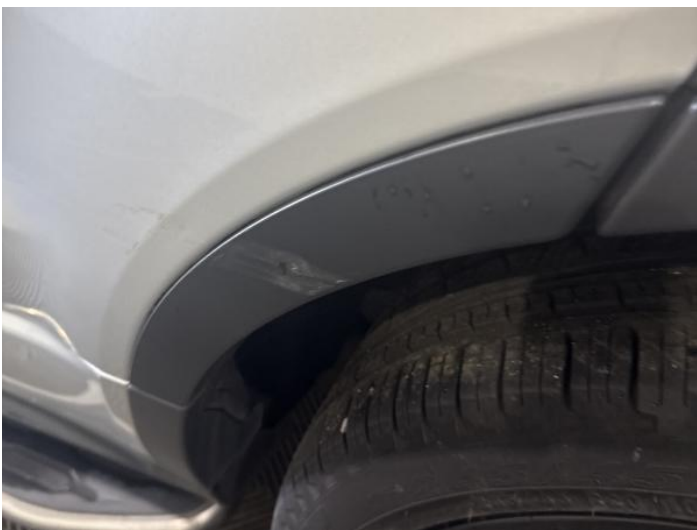
7: Door Moulding nsr  
Scuffed (Unpainted)  
Up To 100mm

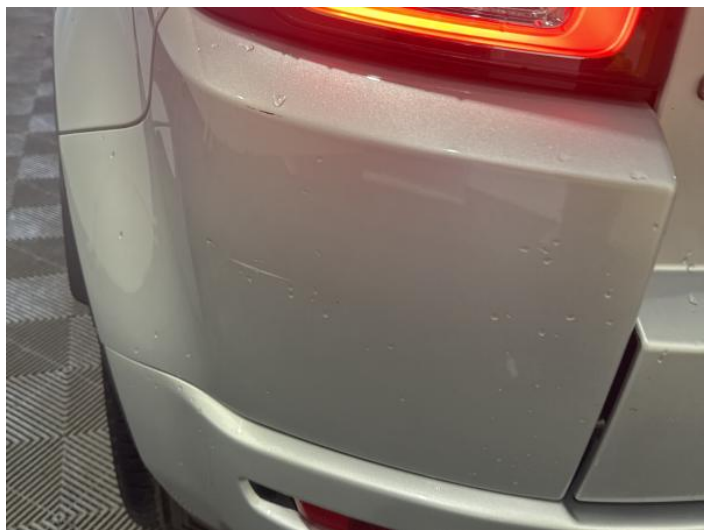
8: Bumper Rear  
Scratched  
25 to 100mm Thru Paint

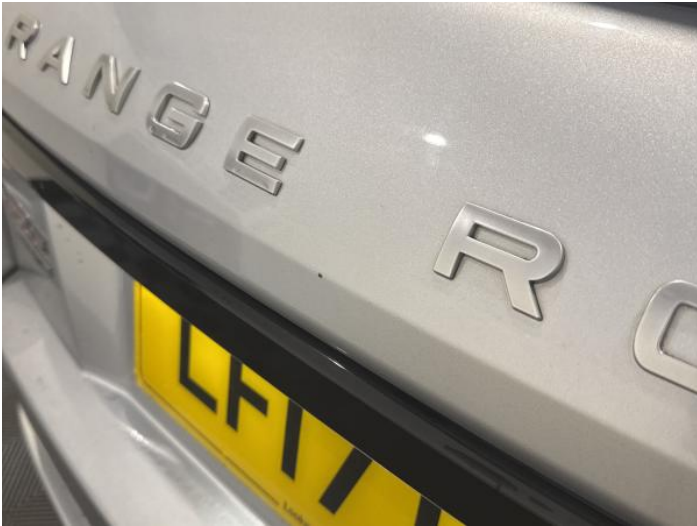
9: Tailgate  
Chipped  
1 To 5

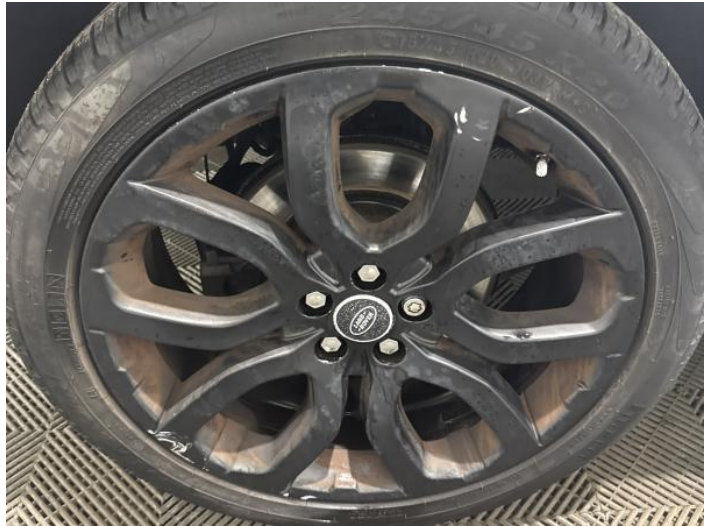
10: Wheel osr  
Scratched  
Over 50mm

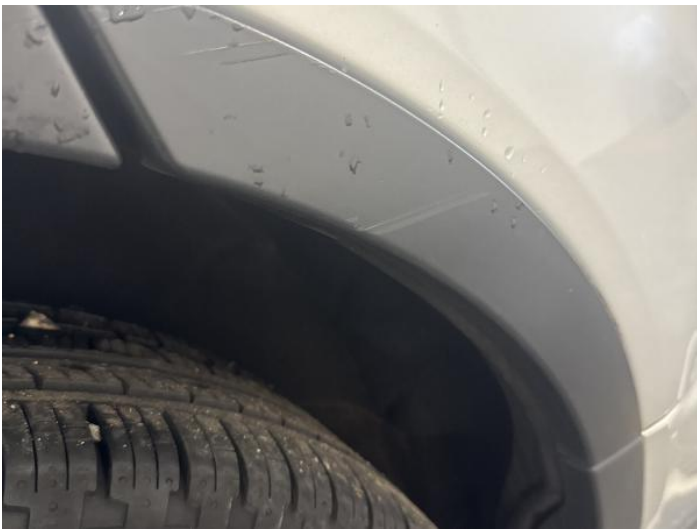
11: Door Moulding osr  
Scuffed (Unpainted)  
UpTo 100mm

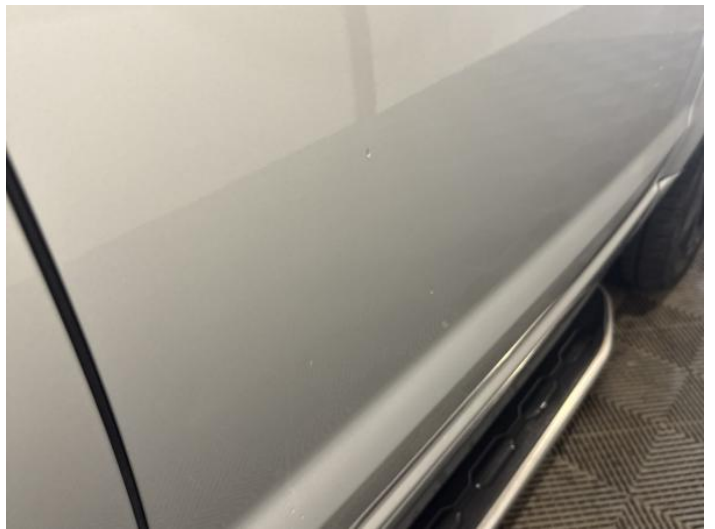
12: Door osf  
Dented  
Over 30mm

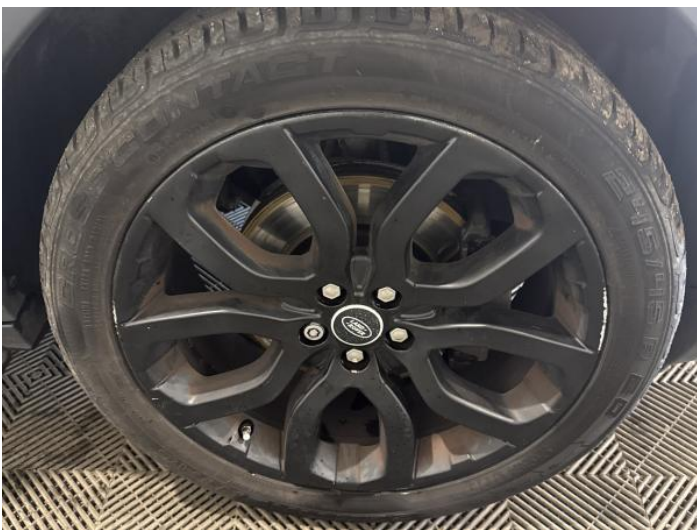
13: Wheel osf  
Scratched  
Over 50mm

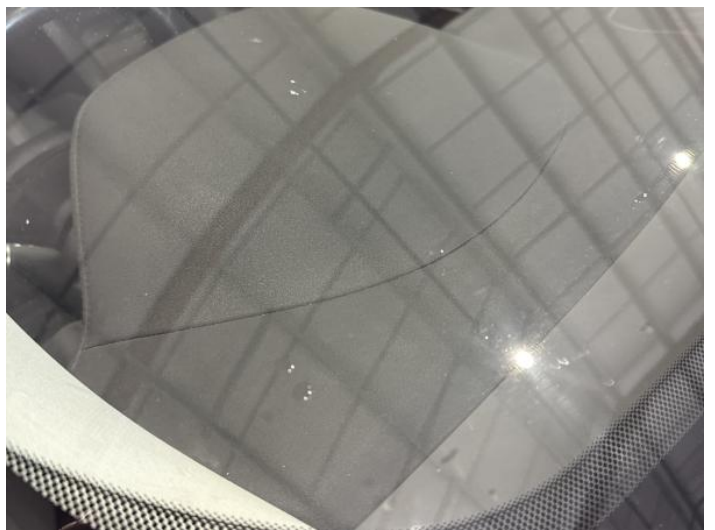
14: Screen Front  
Chipped  
UpTo 10mm

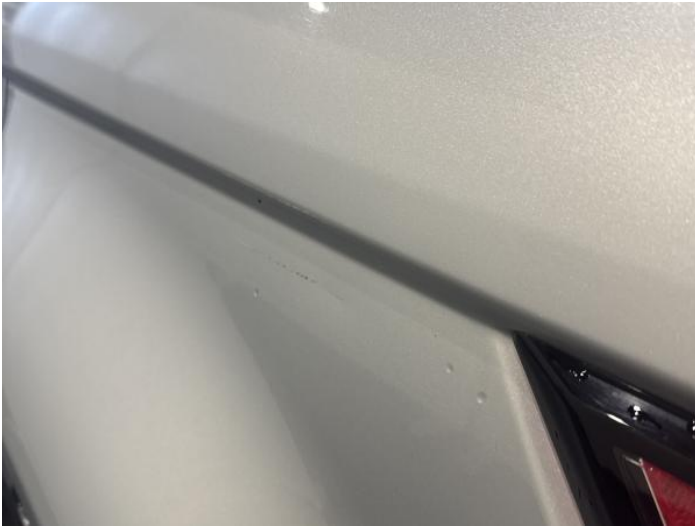
15: Qtr Panel osr  
 Scratched  
 Over 25mm Thru Paint
