VEHICLE INSPECTION REPORT

WP11JPJ

Ford Focus 1.6 125 Zetec 5dr

nama
 GRADE
3

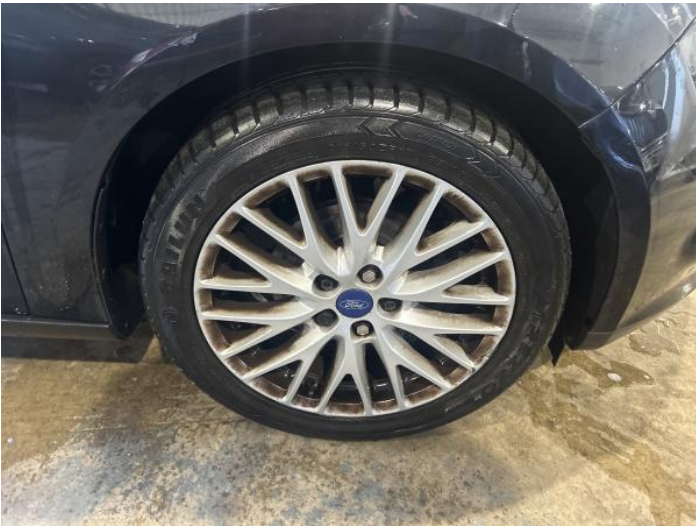
1: Wheel of
Scratched
Over 50mm

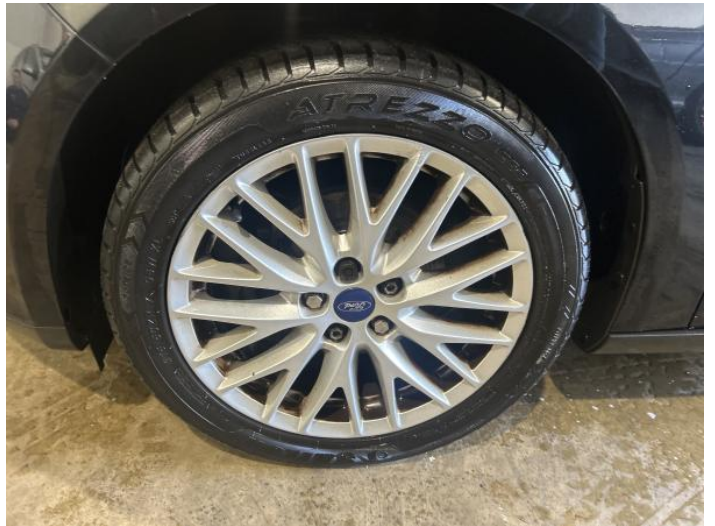
2: Wheel of
Scratched
Up To 50mm

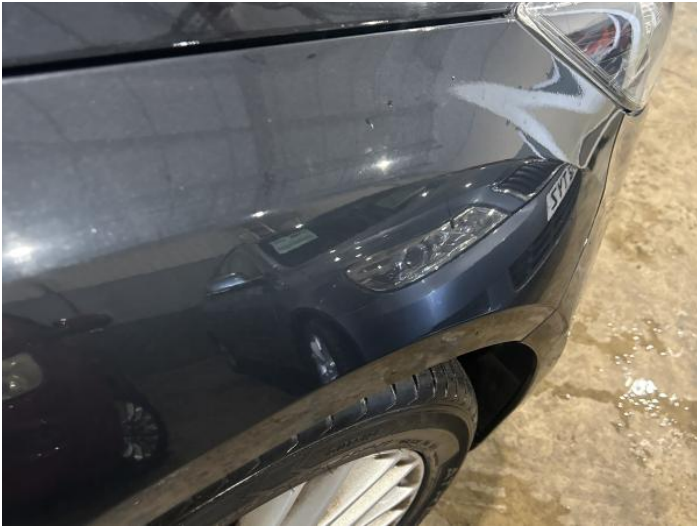
3: Wing osf
Scratched
Over 25mm Not Thru Paint

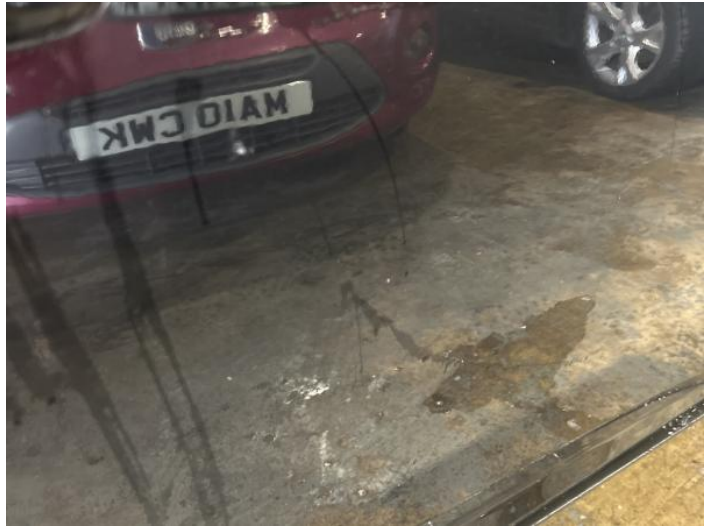
4: Door osf
Chipped
1 To 5

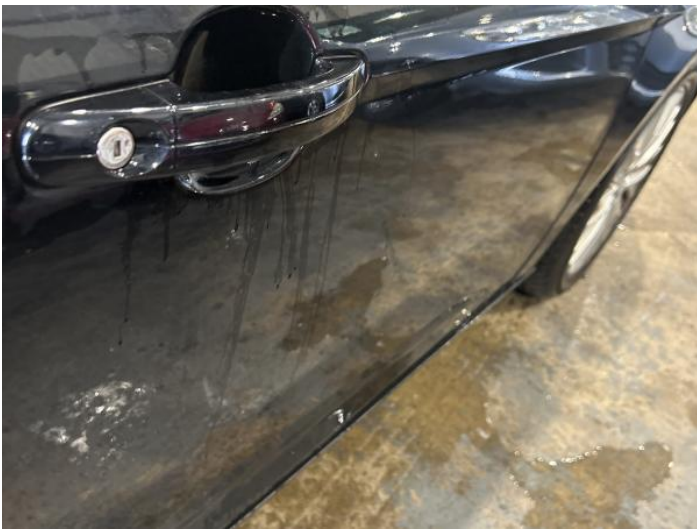
5: Door osf
Scratched
Over 25mm Not Thru Paint

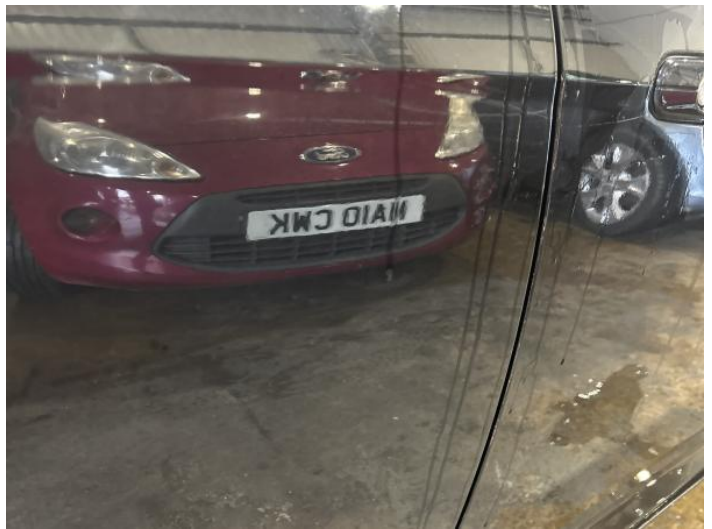
6: Door osr
Scratched
Over 25mm Not Thru Paint

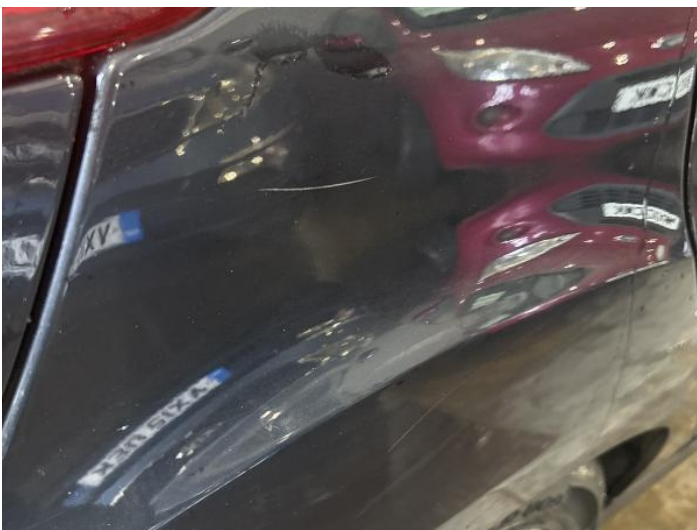
7: Qtr Panel osr
Scratched
UpTo 25mm Thru Paint

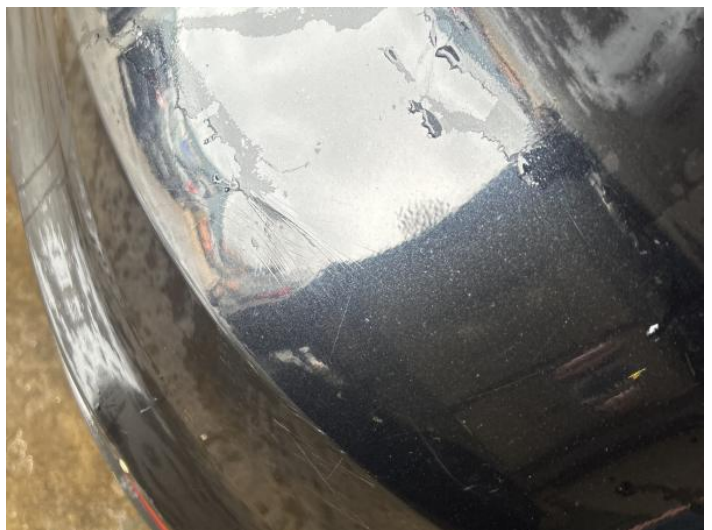
8: Bumper Rear
Poor Previous Repair
Paint Flake

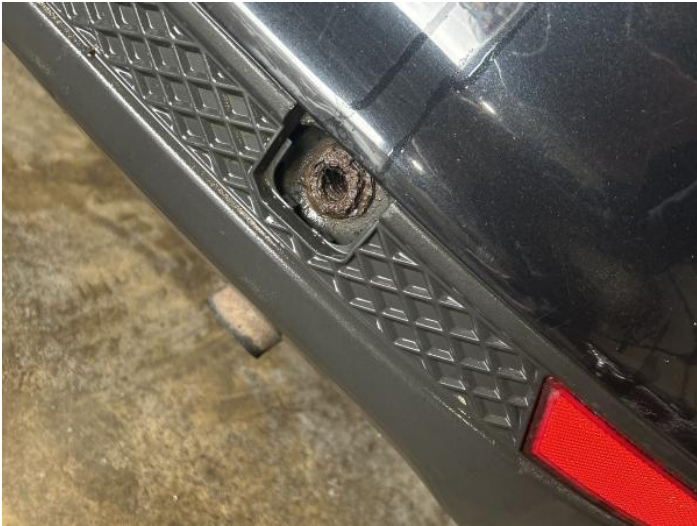
9: Rear TowEye Cvr
Missing
Replace

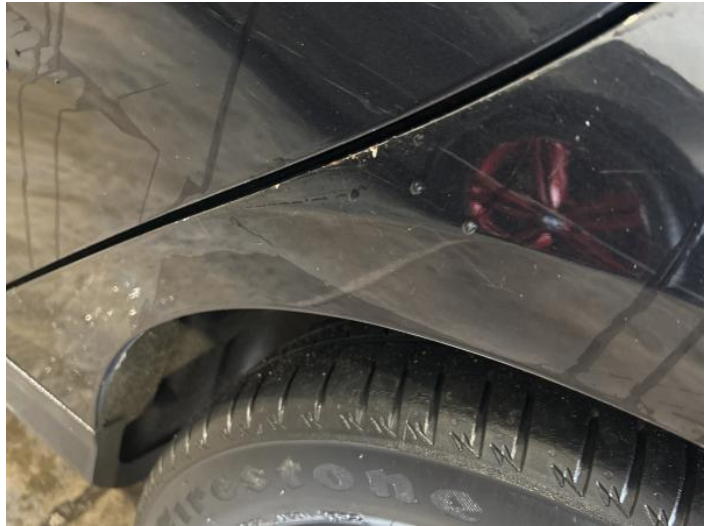
10: Qtr Panel nsr
Chipped
1 To 5

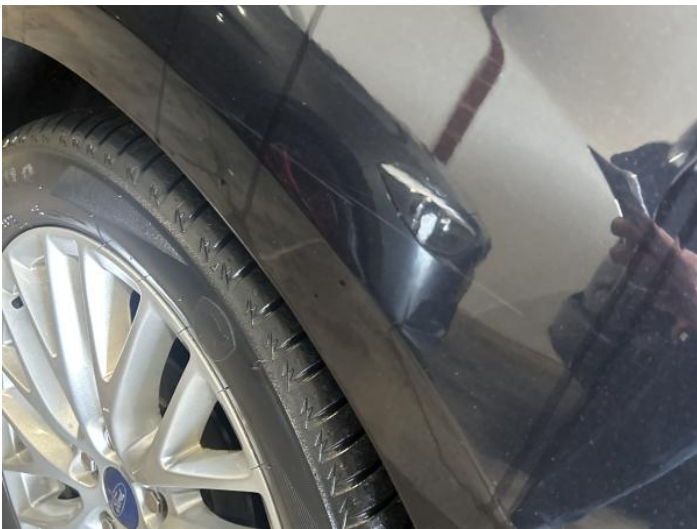
11: Qtr Panel nsr
Scratched
Over 25mm Not Thru Paint

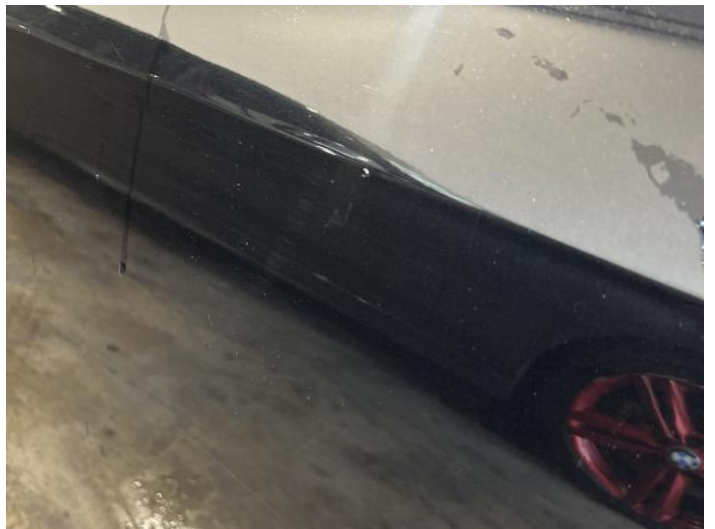
12: Door nsr
Chipped
1 To 5

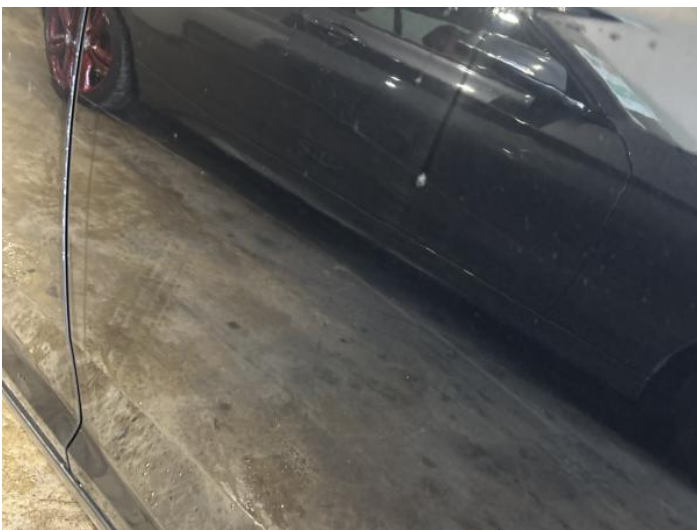
13: Door nsr
Scratched
Over 25mm Not Thru Paint

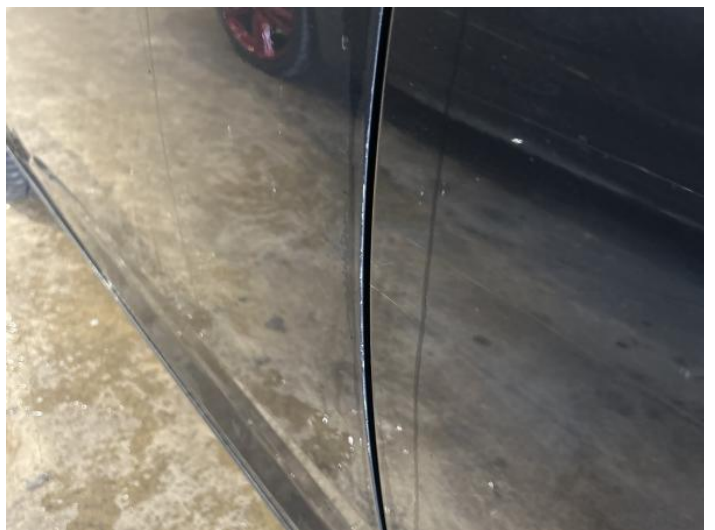
14: Door nsf
Chipped
Edge Chip

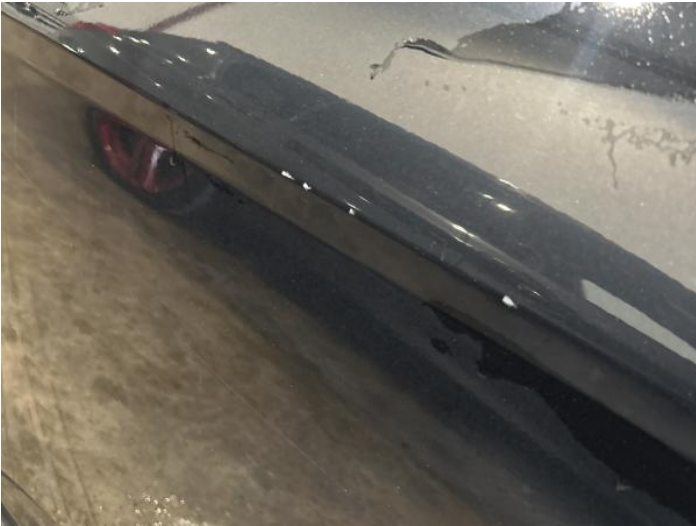
15: Door nsf
Chipped
1 To 5

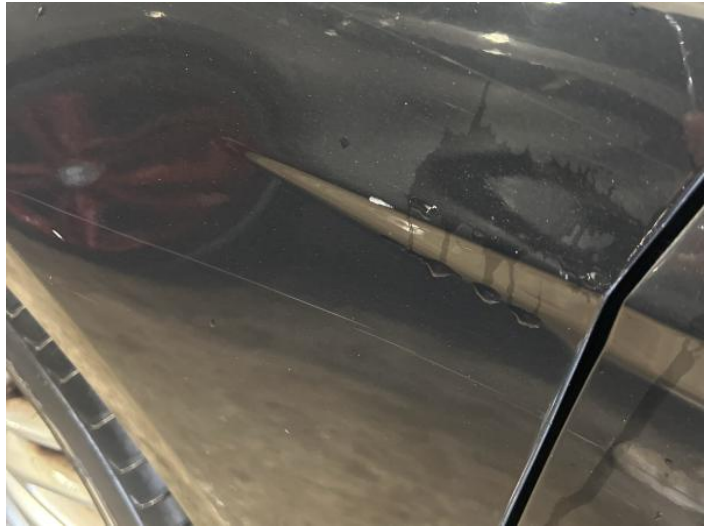
16: Wing nsf
Chipped
1 To 5

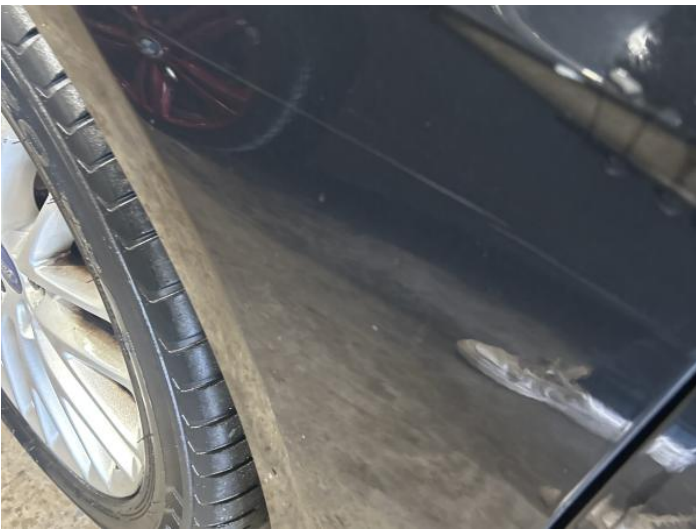
17: Wing nsf
Scratched
Over 25mm Not Thru Paint

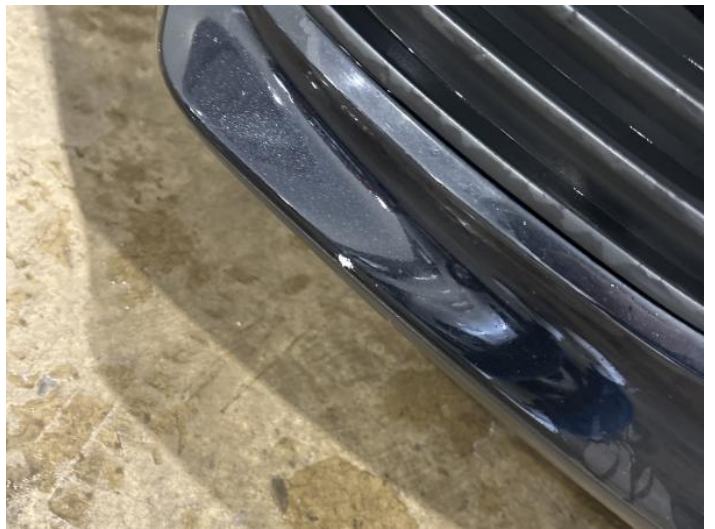
18: Bumper Front
Chipped
Multiple Chips

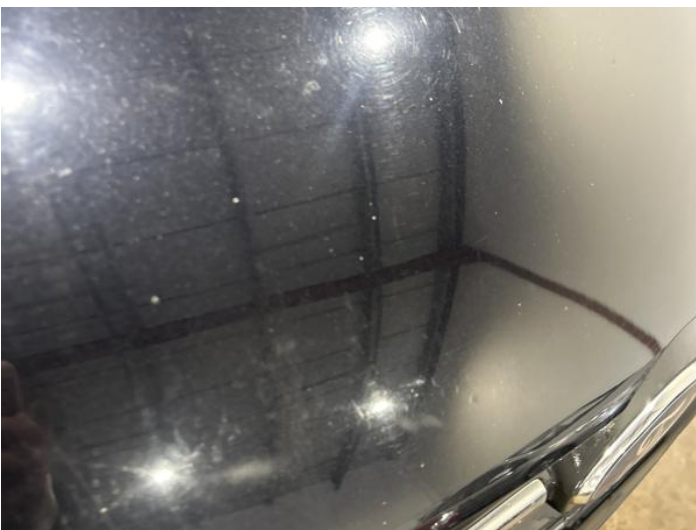
19: Bonnet
Chipped
1 To 5

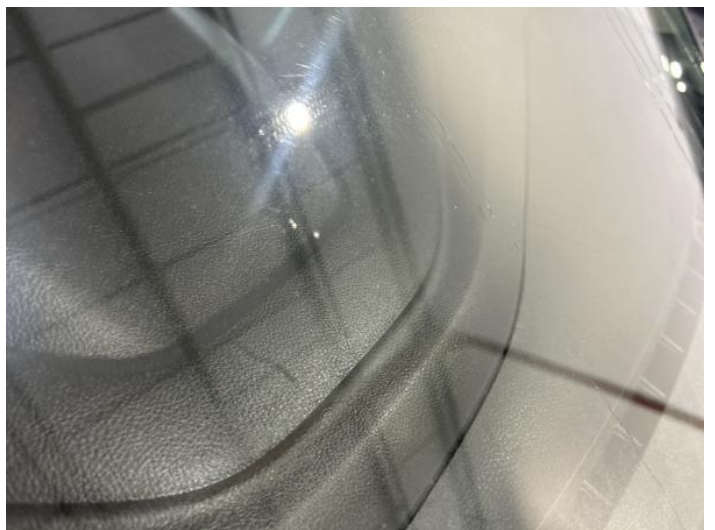
20: Screen Front
Chipped
UpTo 10mm

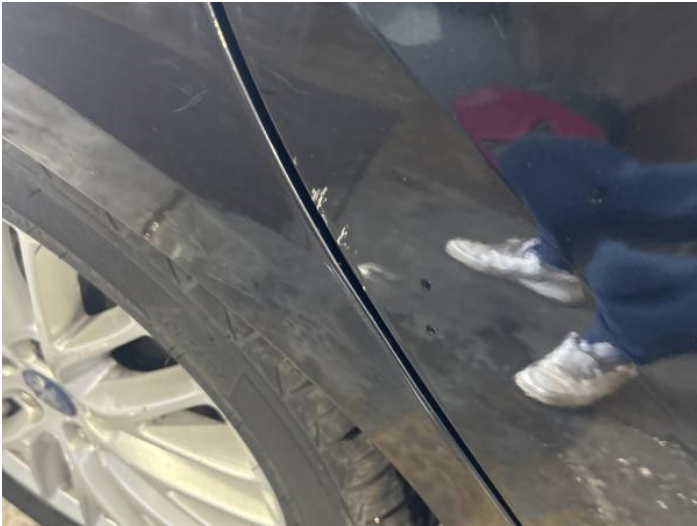
21: Door osr
Chipped
1 To 5

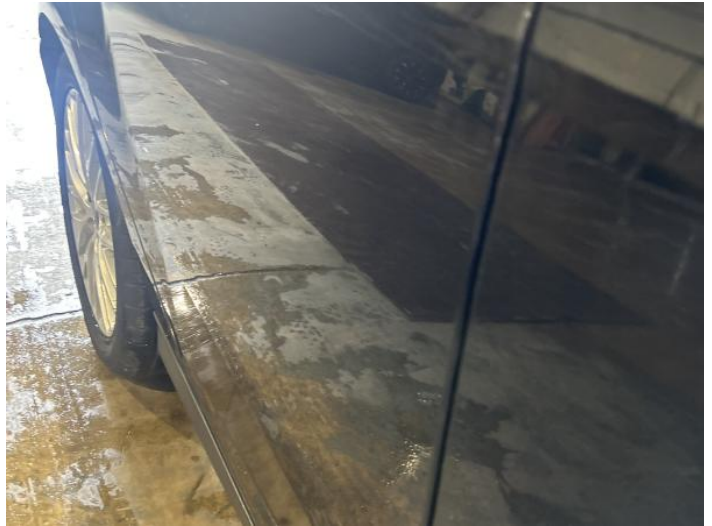
22: Door osr
Dented
Between 10mm + 30mm

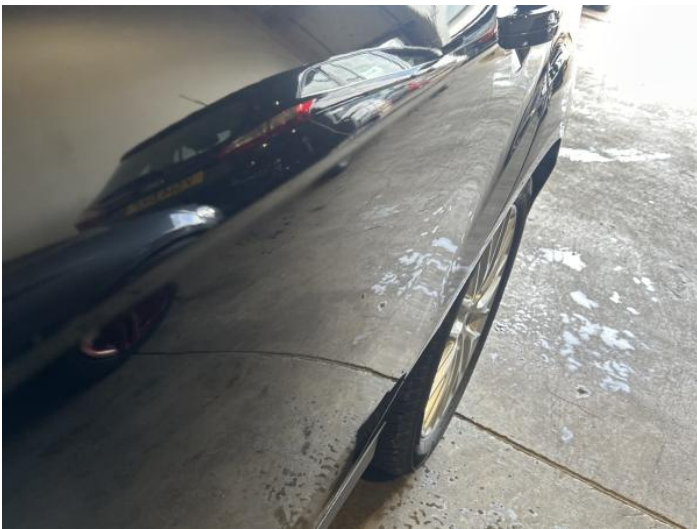
23: Door nsr
Dented
Over 2 UpTo 10mm

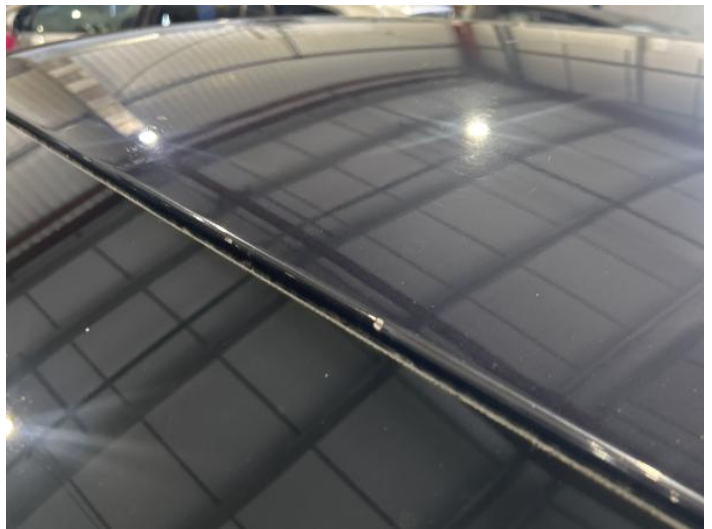
24: Roof
Chipped
1 To 5

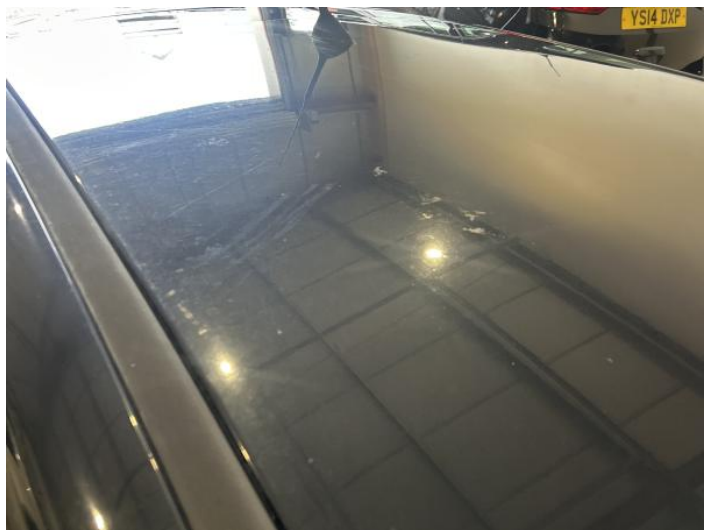
26: Roof
Scratched
Over 25mm Not Thru Paint

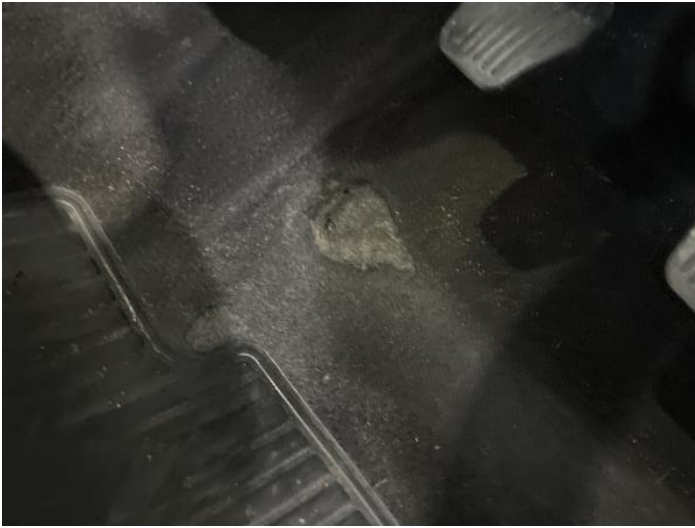
27: Carpets Front
Holed
Over 3mm

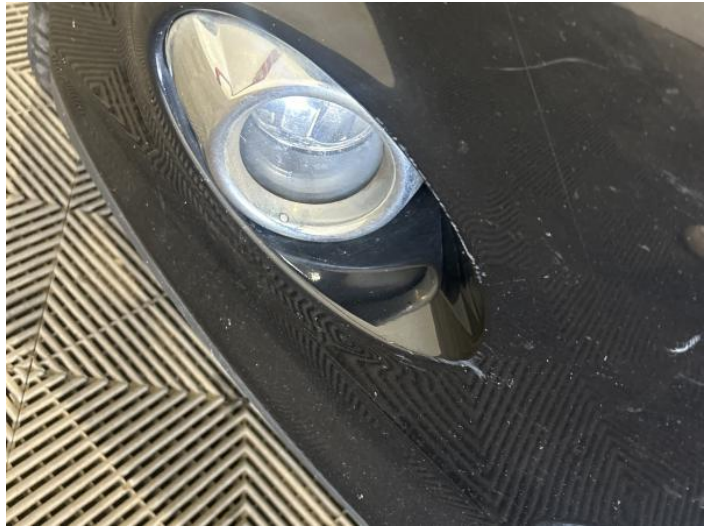
28: Bumper Front
Scratched
25 to 100mm Thru Paint
