VEHICLE INSPECTION REPORT

GF65JJX

Peugeot 308 1.6 BlueHDi 120 Active 5dr

nama
GRADE
4

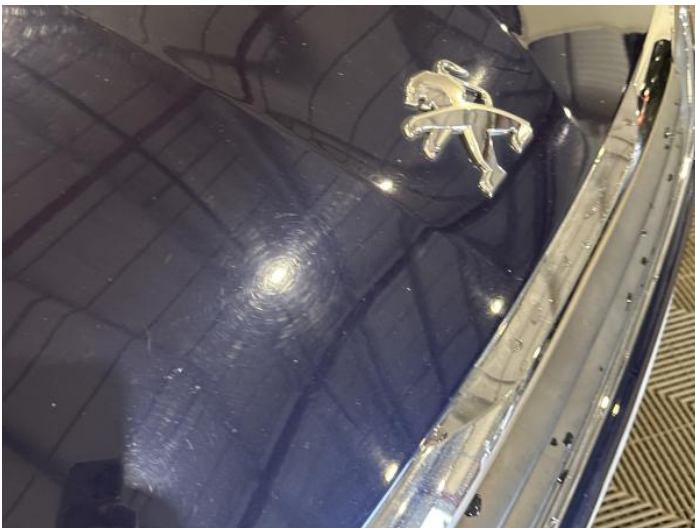
1: Bonnet
Chipped
Multiple Chips

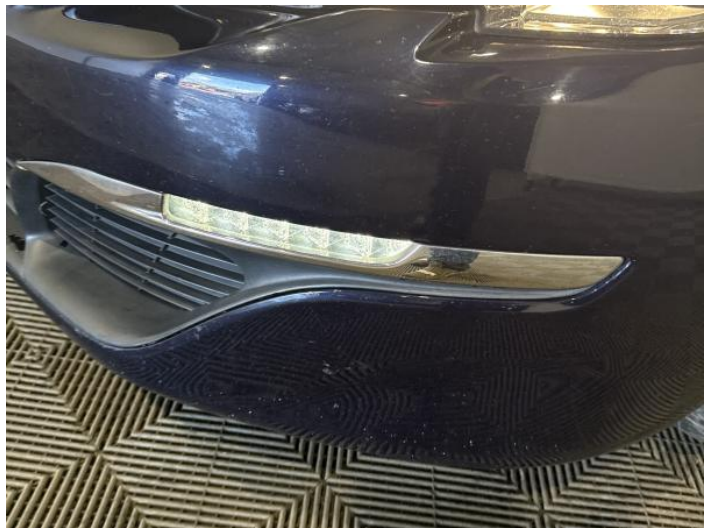
2: Bumper Front
Chipped
Multiple Chips

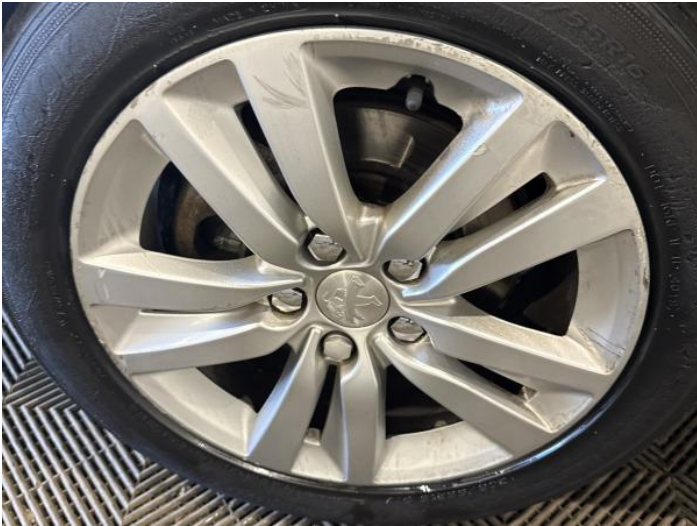
3: Wheel nsf
Scratched
Over 50mm

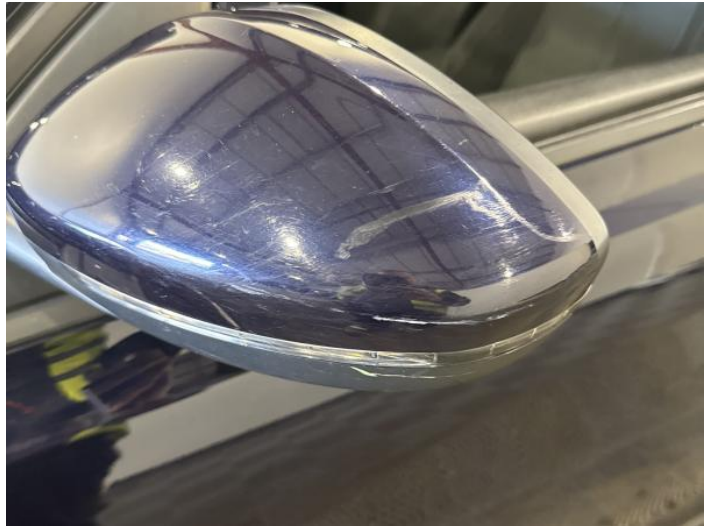
4: Door Mirror Assy nsf
Scratched (Painted)
Over 25mm Thru Paint

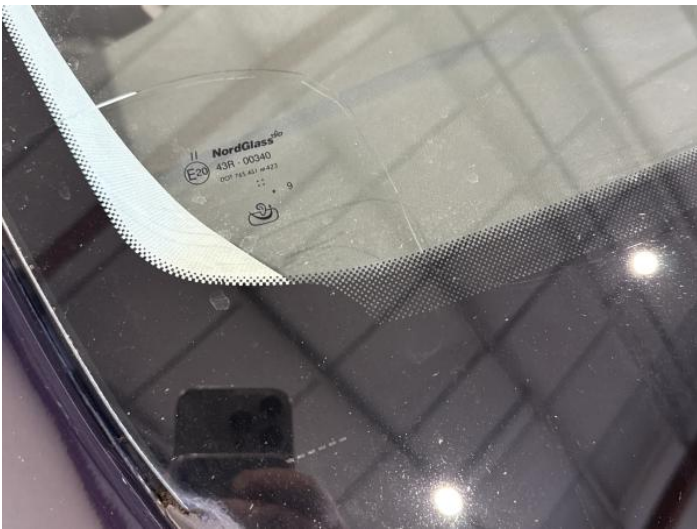
5: Screen Front
Cracked
Replace

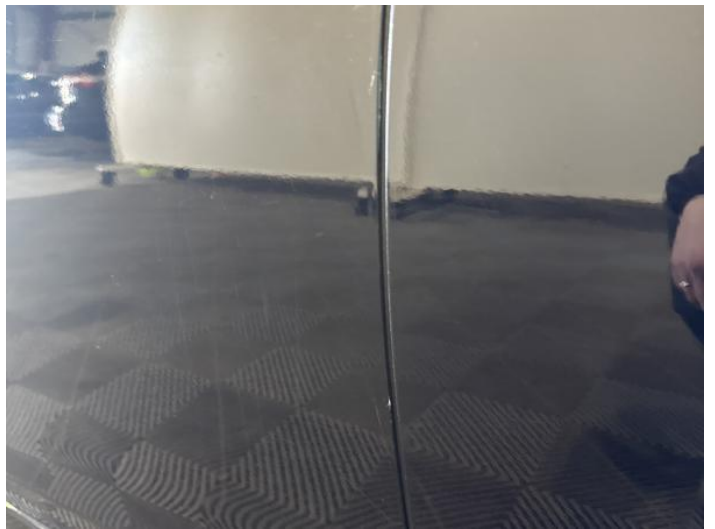
6: Door nsf
Scratched
Up To 25mm Thru Paint

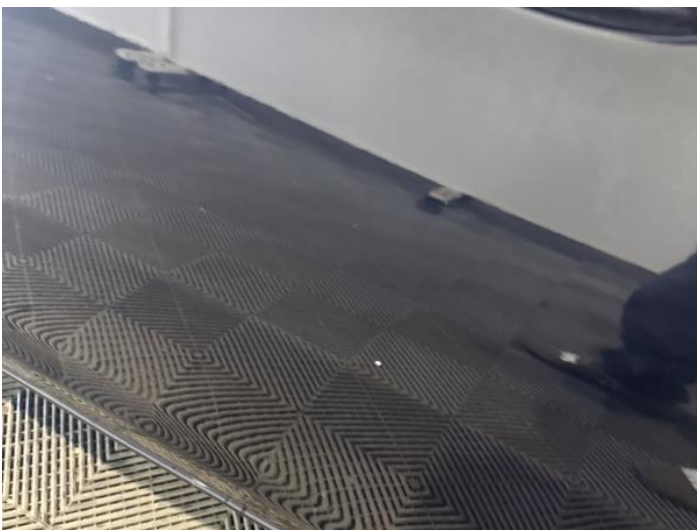
7: Door nsr
Chipped
1 To 5

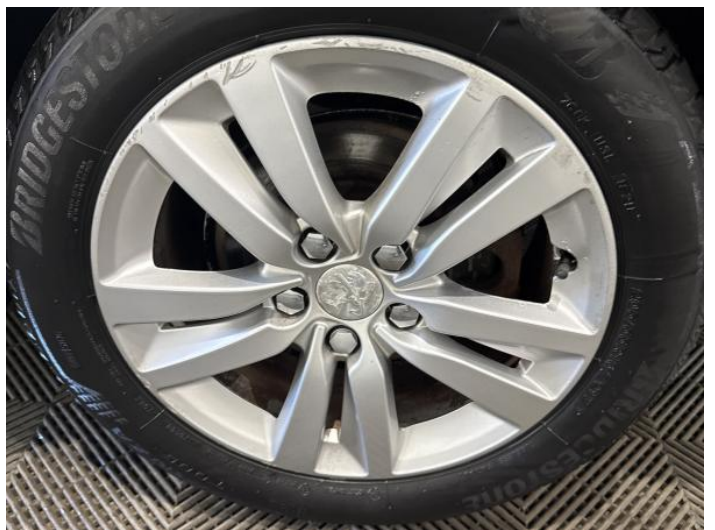
8: Wheel nsr
Scratched
Over 50mm

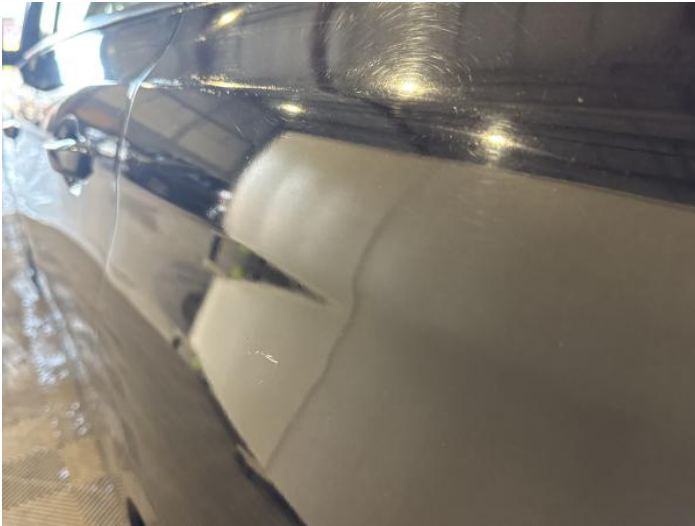
9: Qtr Panel nsr
Scratched
Over 25mm Thru Paint

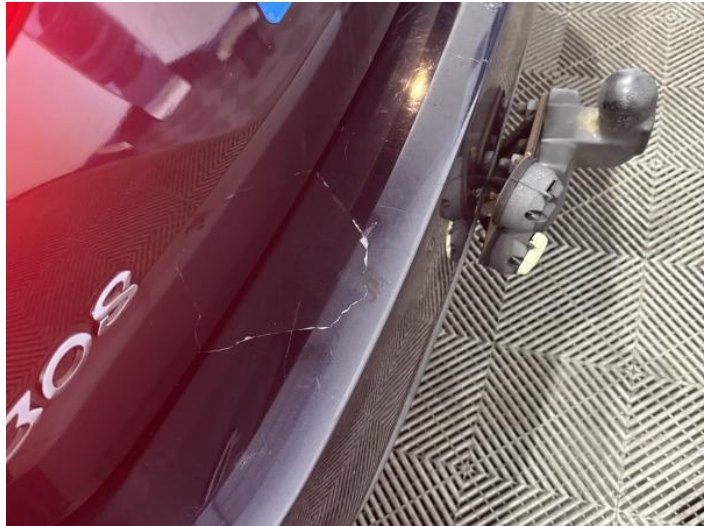
10: Bumper Rear
Poor Previous Repair
Paint Flake

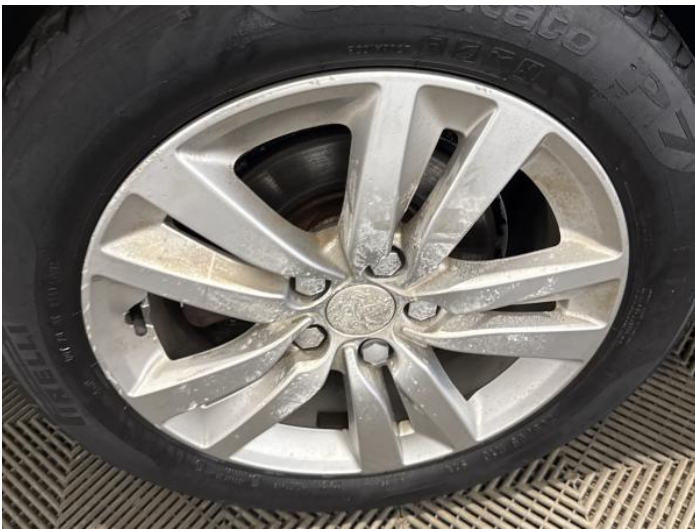
11: Wheel osr
Scratched
Over 50mm

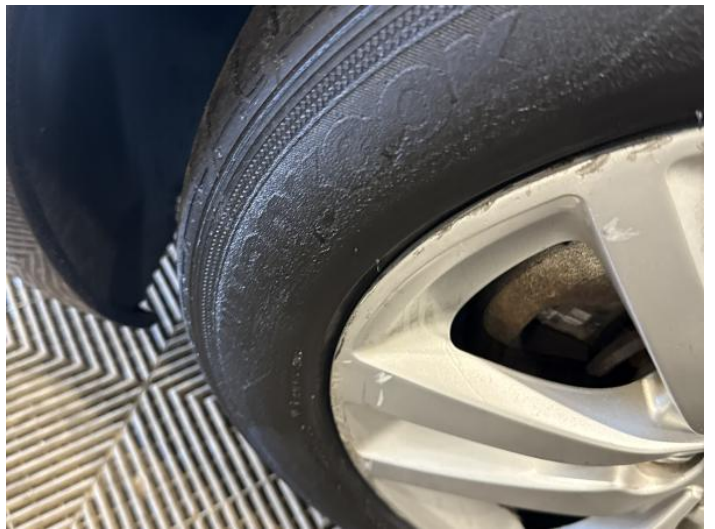
NSF	HANKOOK	Damaged
NSR	BRIDGESTONE	5.0mm
OSF	HANKOOK	3.0mm
OSR	PIRELLI	5.0mm
Spare

12: Tyre nsf
Damaged
Replace

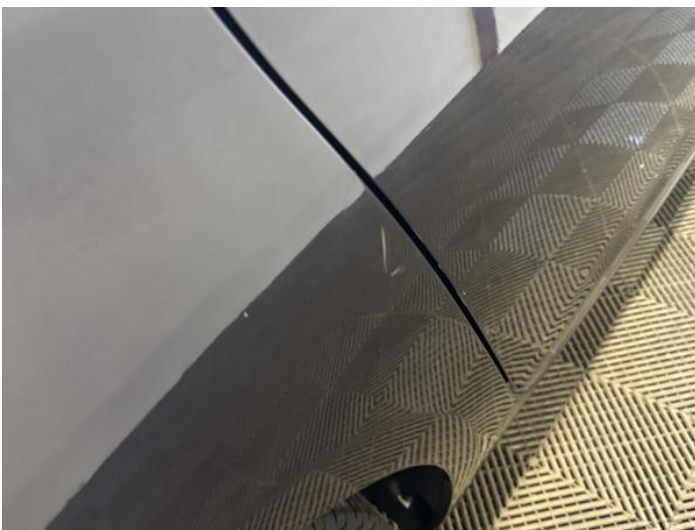
13: Qtr Panel osr
Scratched
Over 25mm Thru Paint

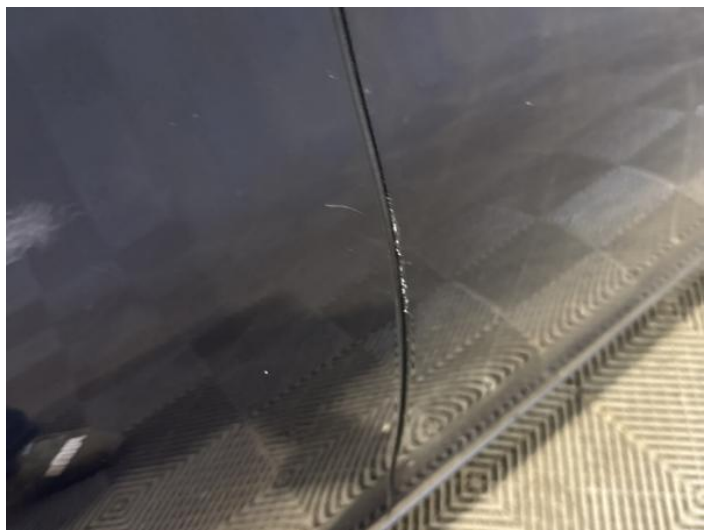
14: Door osr
Scratched
UpTo 25mm Thru Paint

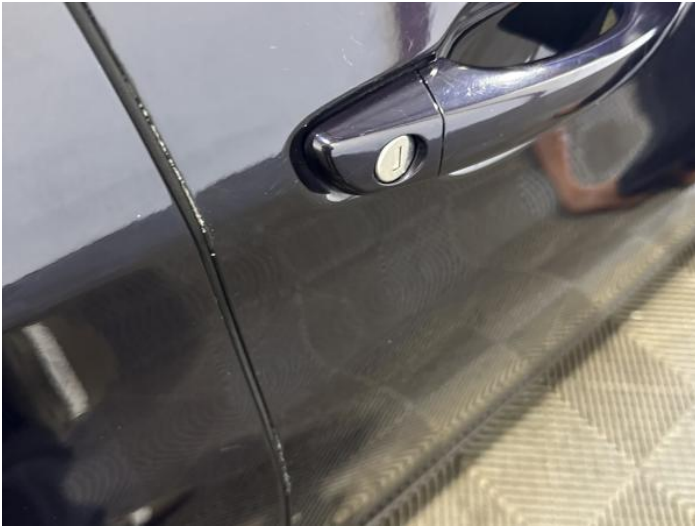
15: Door osf
Chipped
Edge Chip
