VEHICLE INSPECTION REPORT

OU60BZE

Volkswagen Golf 1.6 TDi 105 SE 5dr

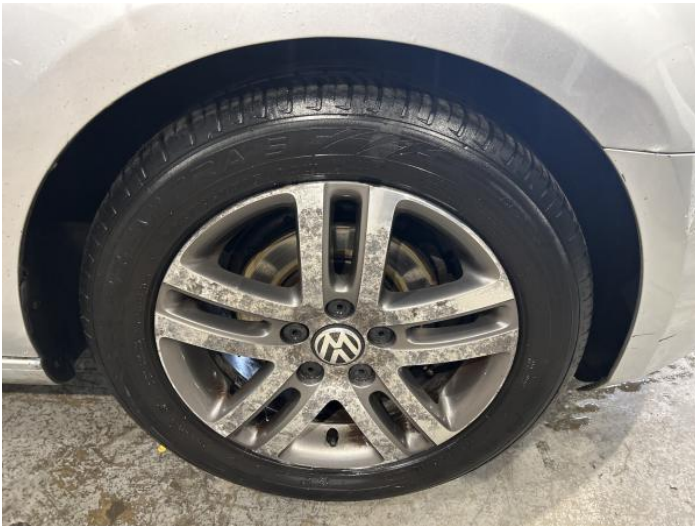
1: Wheel osf
Corroded
Light

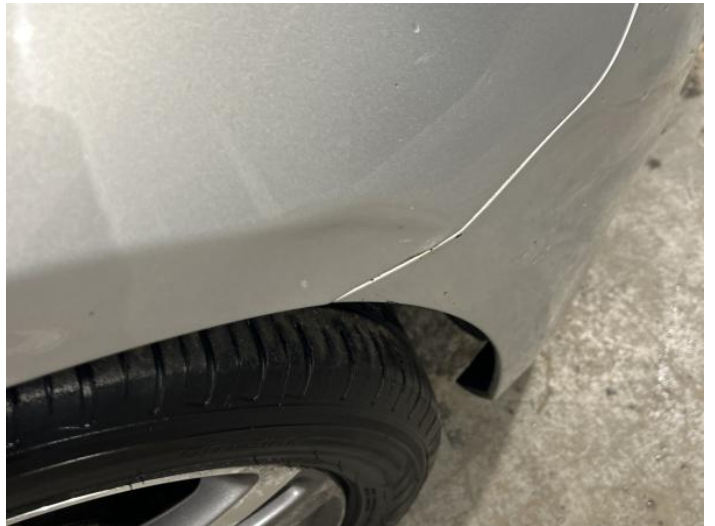
2: Wing osf
Dented
Over 30mm

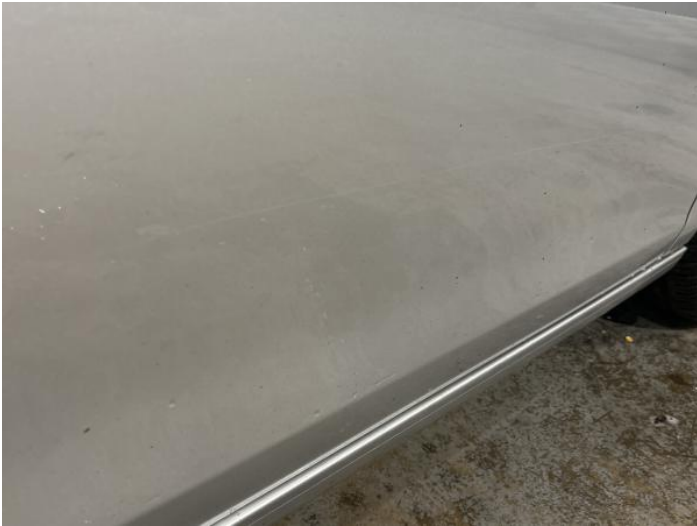
3: Door osf
Scratched
Over 25mm Not Thru Paint

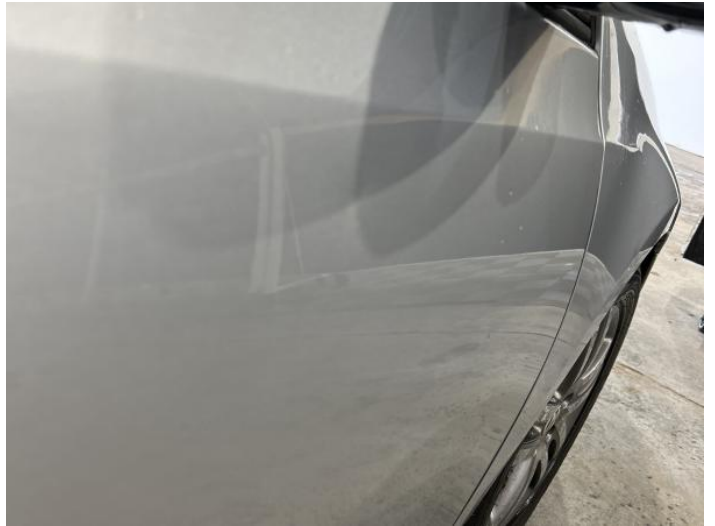
4: Door osf
Dented
2 Or Less Up To 10mm

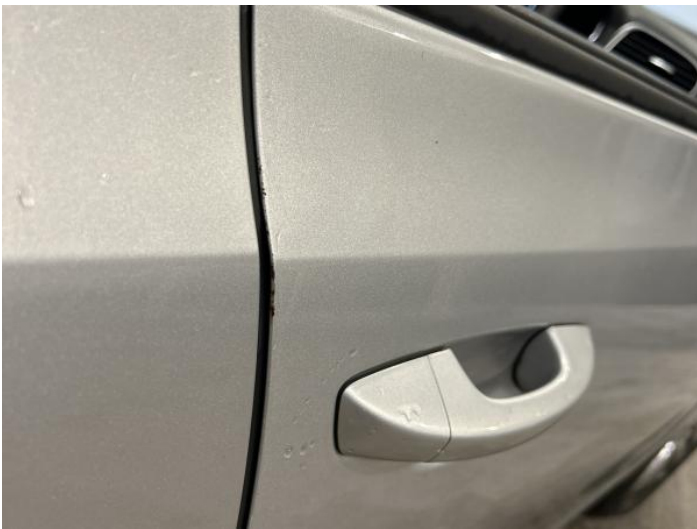
5: Door osf
Chipped
Edge Chip

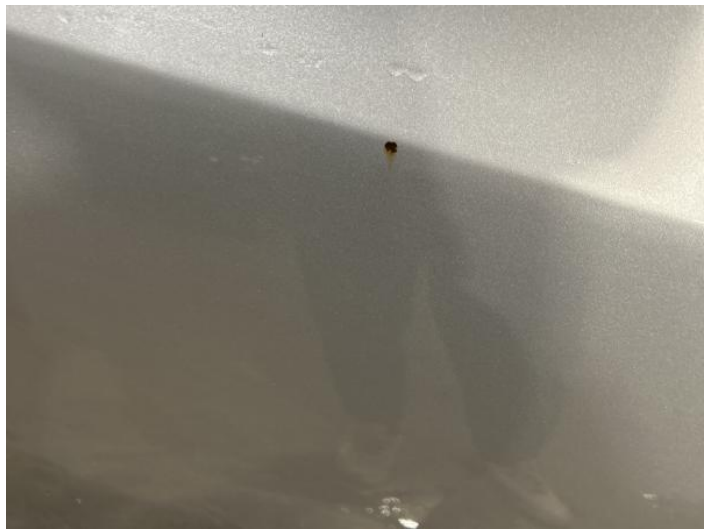
6: Door osr
Chipped
1 To 5

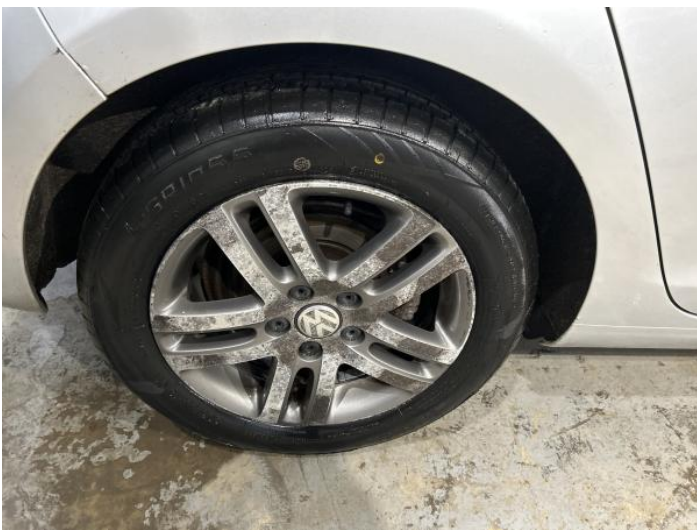
7: Wheel osr
Corroded
Light

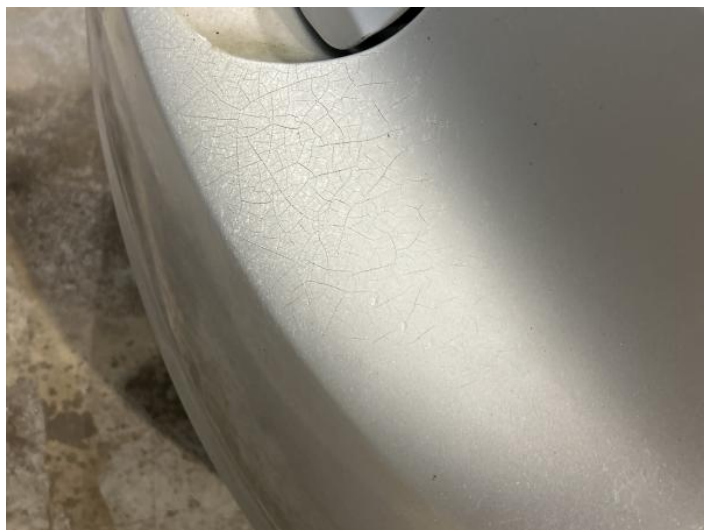
8: Bumper Rear
Poor Previous Repair
Paint Flake

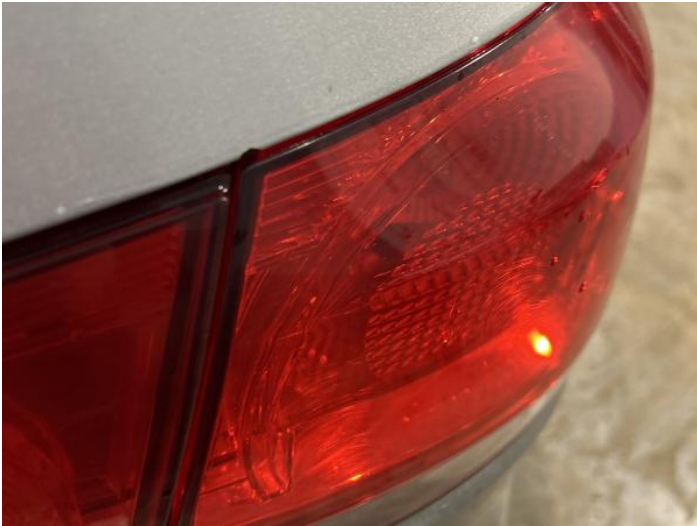
9: Tailgate
Chipped
1 To 5

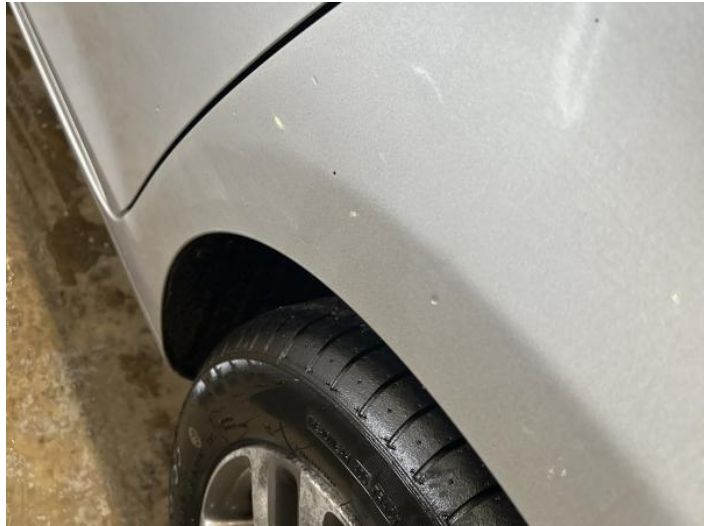
10: Qtr Panel nsr
Dented
Over 30mm

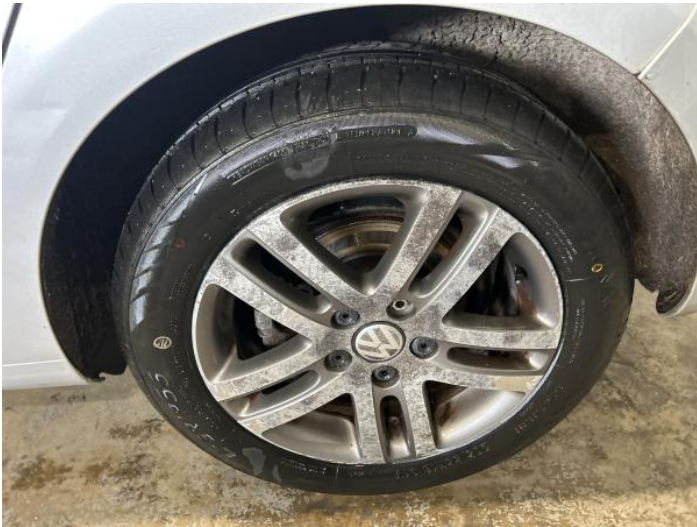
11: Wheel nsr
Corroded
Light

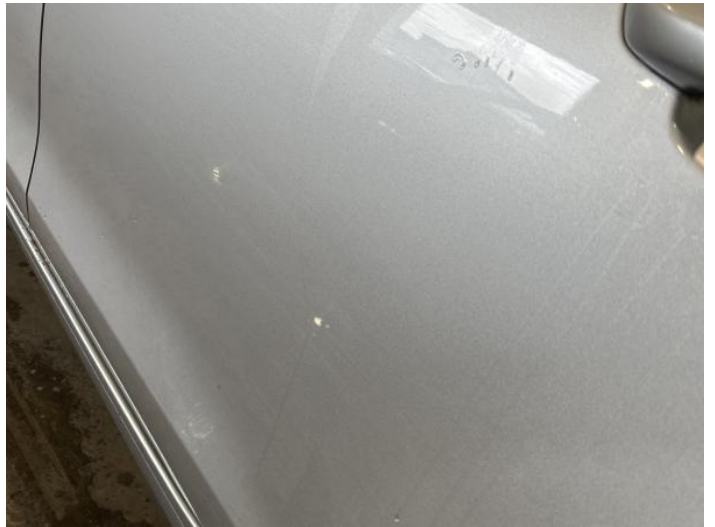
12: Door nsr
Scratched
Over 25mm Not Thru Paint

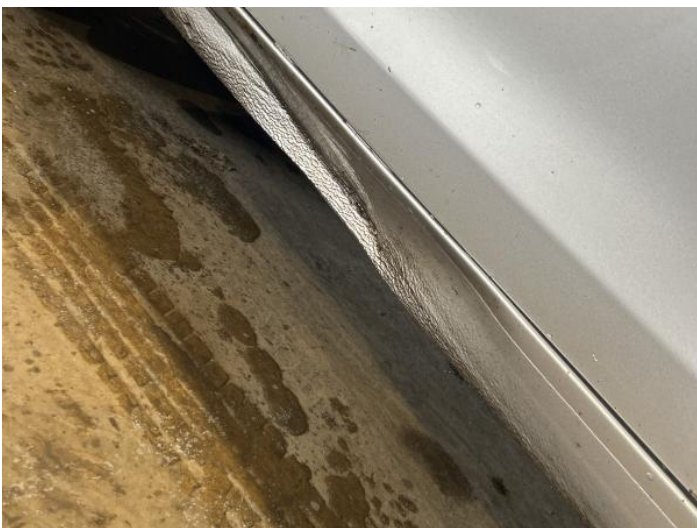
13: Sill ns
Dented
Over 30% Of Panel

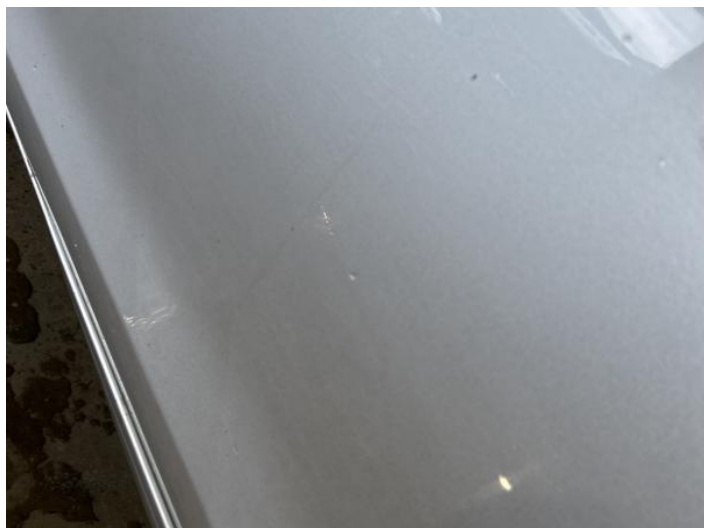
14: Door nsf
Scratched
Over 25mm Not Thru Paint

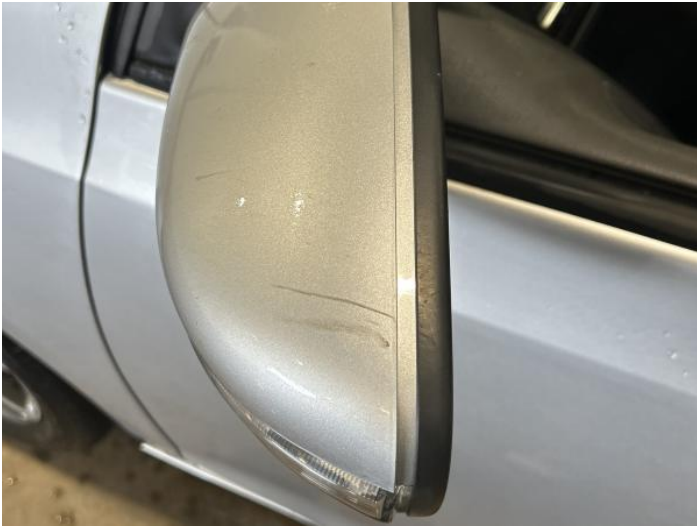
15: Door Mirror Assy nsf
Scratched (Painted)
Over 25mm Not Thru Paint

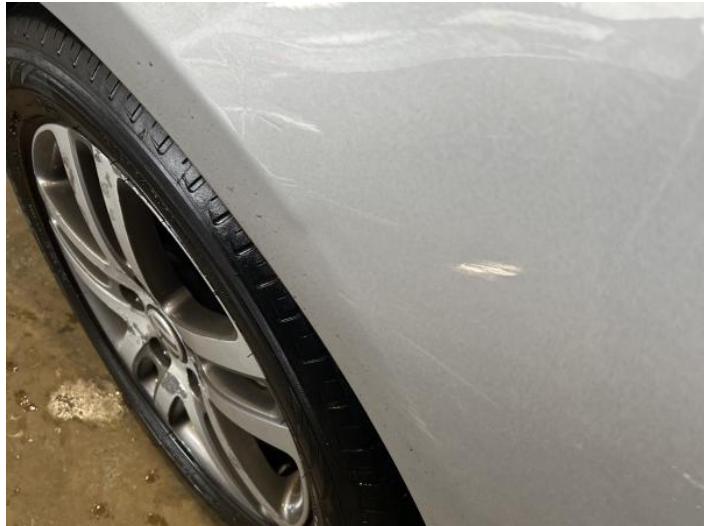
16: Wing nsf
Dented
Between 10mm + 30mm

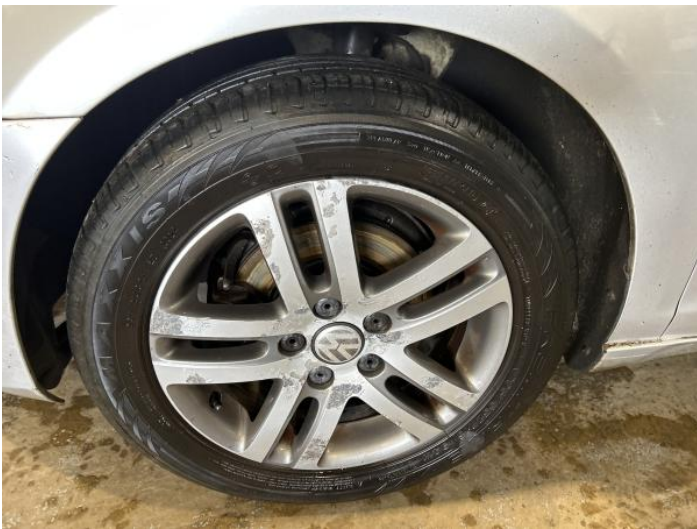
17: Wheel nsf
Corroded
Light

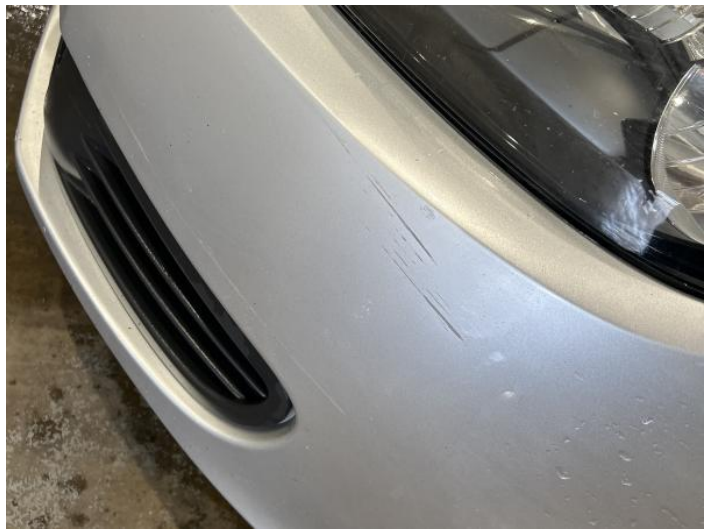
18: Bumper Front
Scratched
Over 100mm Thru Paint

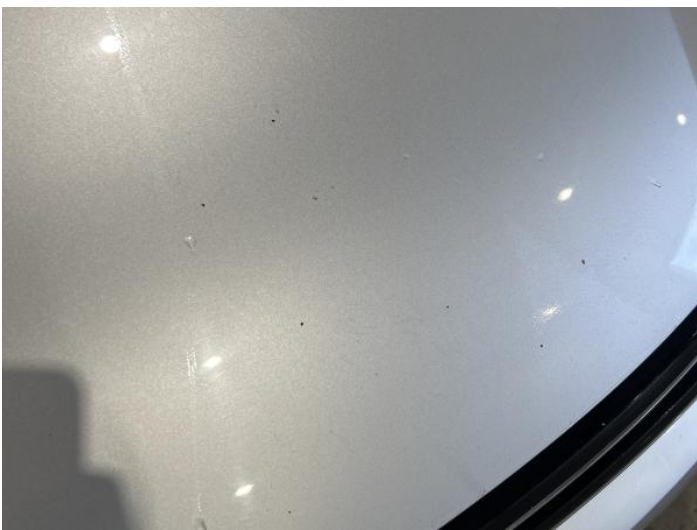
19: Bonnet
Chipped
Multiple Chips

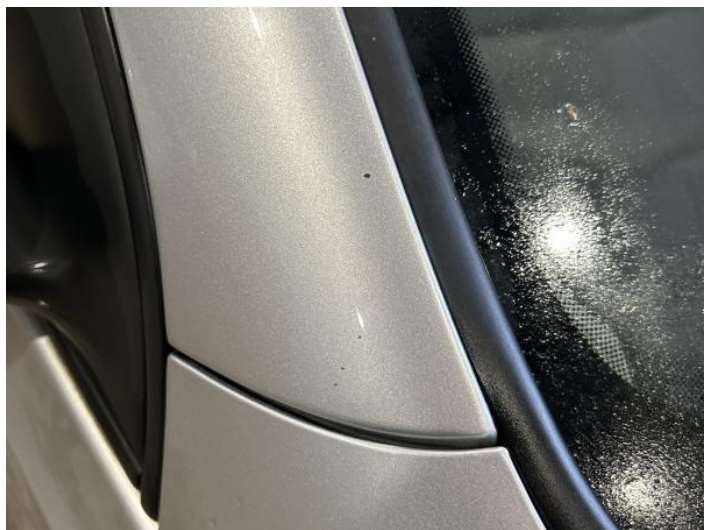
20: A Post os
Chipped
1 To 5
