VEHICLE INSPECTION REPORT

AY14RXU

Kia Sportage 2.0 CRDi KX-4 5dr Auto

nama
 GRADE
3

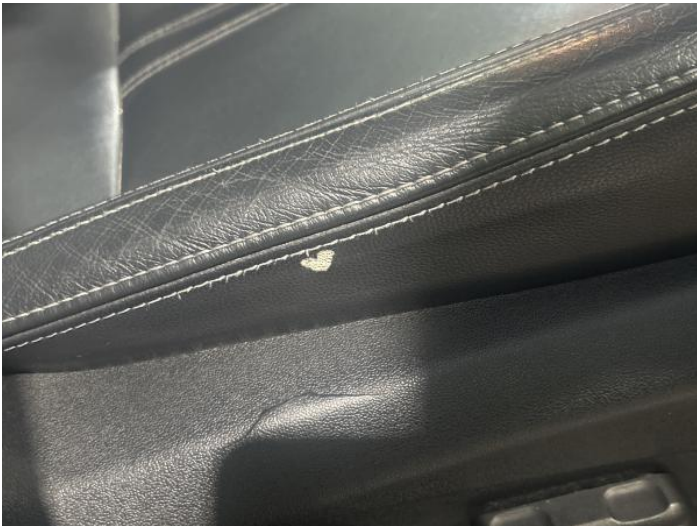
1: Seat Base Cover of
Torn
UpTo 3mm

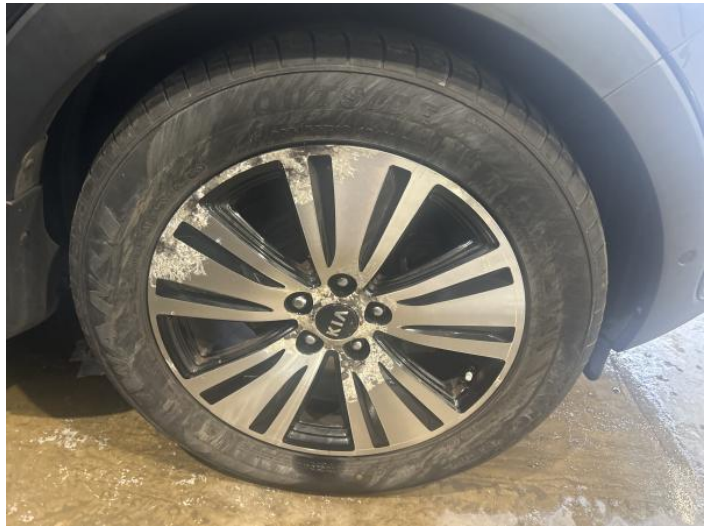
2: Wheel of
Corroded
Light

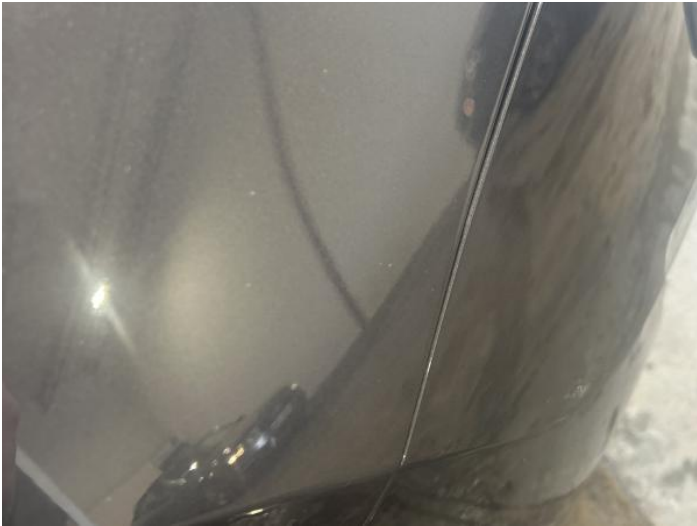
3: Wing osf
Chipped
1 To 5

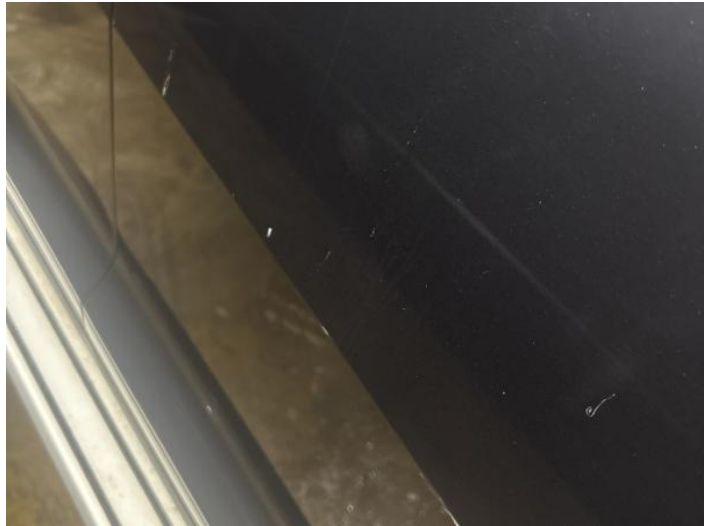
4: Door osf
Scratched
Over 25mm Thru Paint

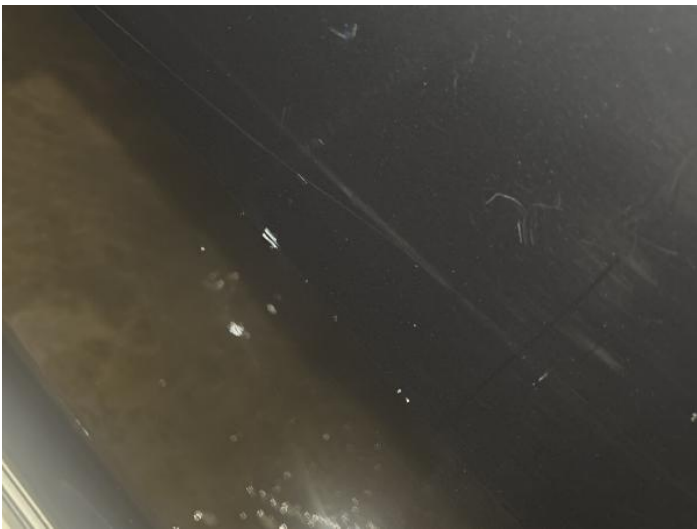
5: Door osr
Chipped
1 To 5

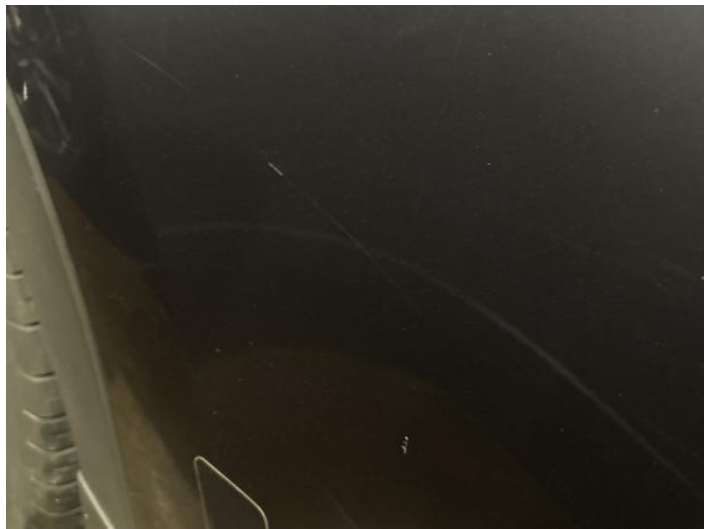
6: Door osr
Scratched
Over 25mm Not Thru Paint

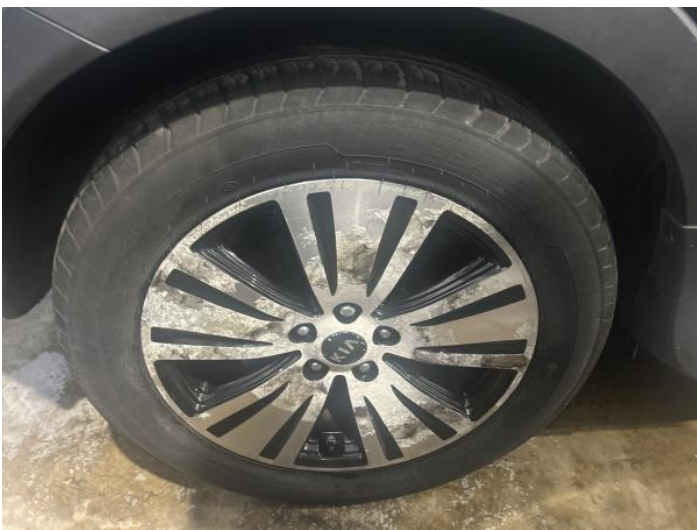
7: Wheel osr
Corroded
Light

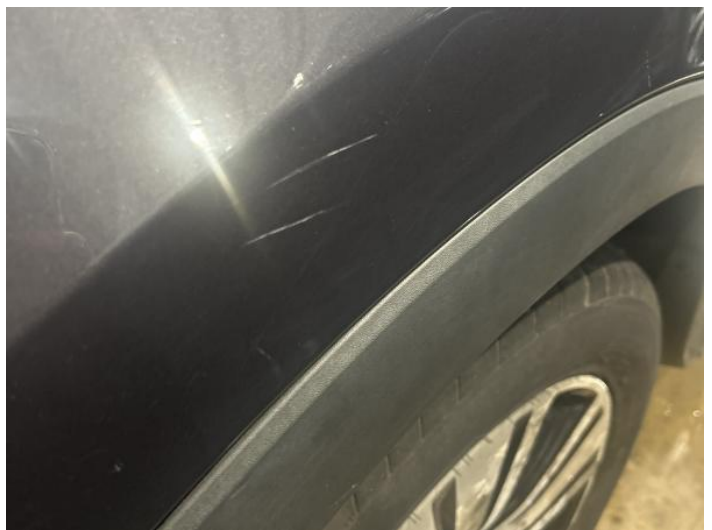
8: Qtr Panel osr
Scratched
Over 25mm Not Thru Paint

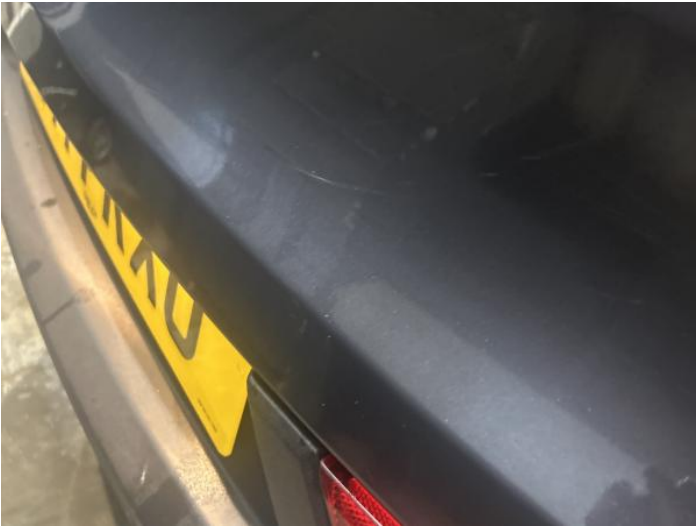
9: Tailgate
Scratched
Over 25mm Not Thru Paint

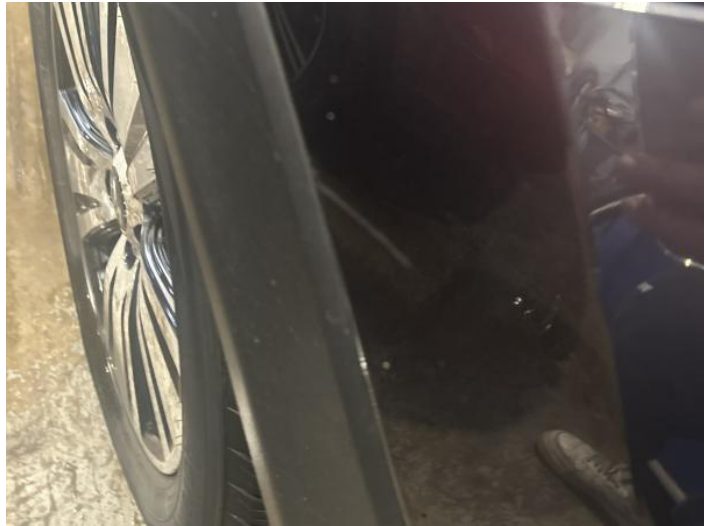
10: Bumper Rear
Scratched
Up To 25mm Thru Paint

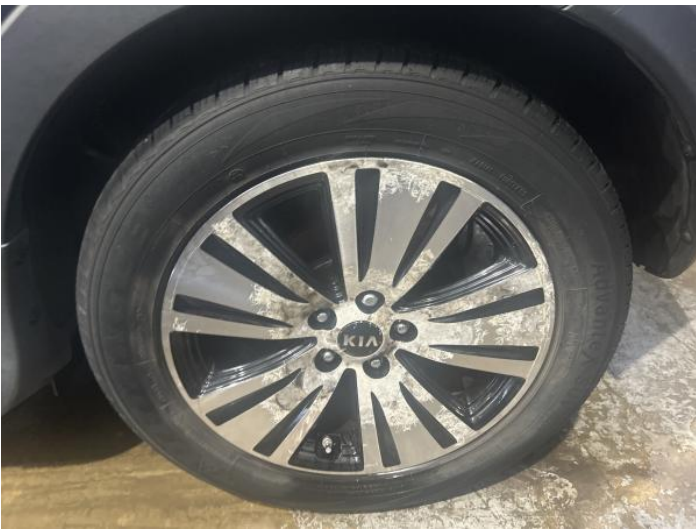
11: Wheel nsr
Corroded
Light

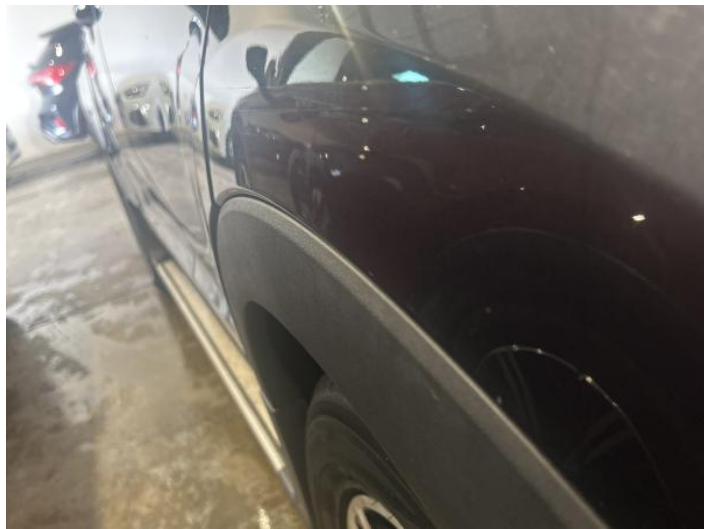
12: Qtr Panel nsr
Dented
2 Or Less Up To 10mm

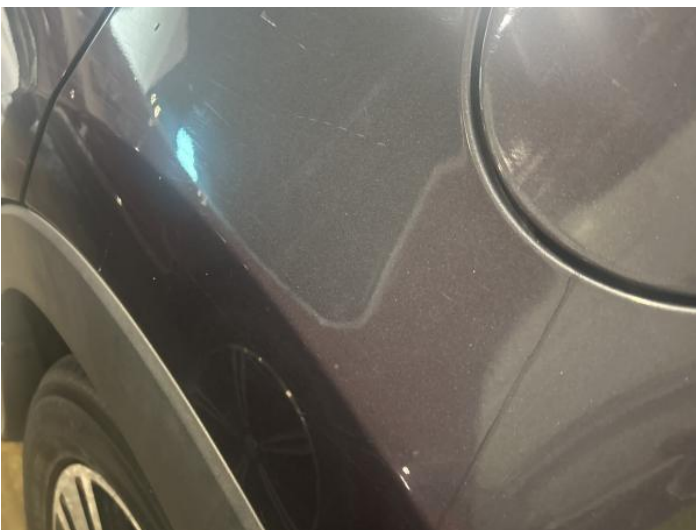
13: Qtr Panel nsr
Scratched
Over 25mm Not Thru Paint

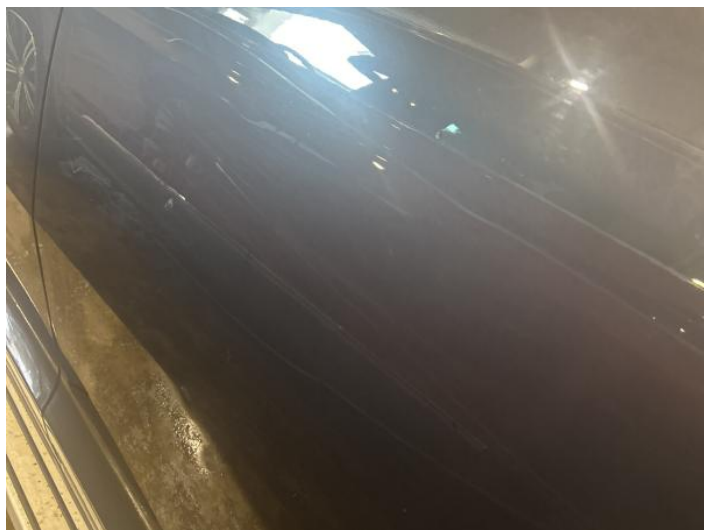
14: Door nsr
Scratched
Over 25mm Not Thru Paint

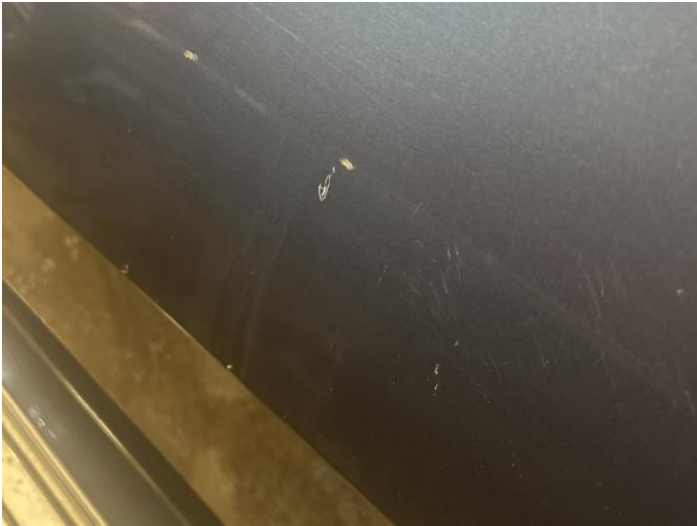
15: Door nsf
Chipped
1 To 5

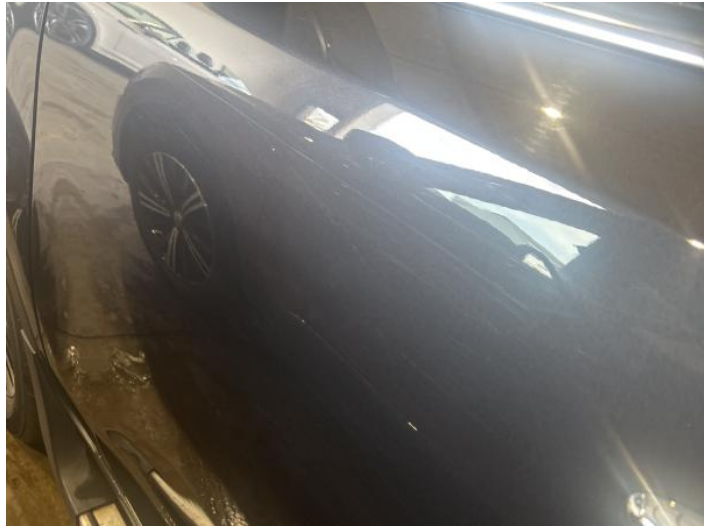
16: Door nsf
Scratched
Over 25mm Not Thru Paint

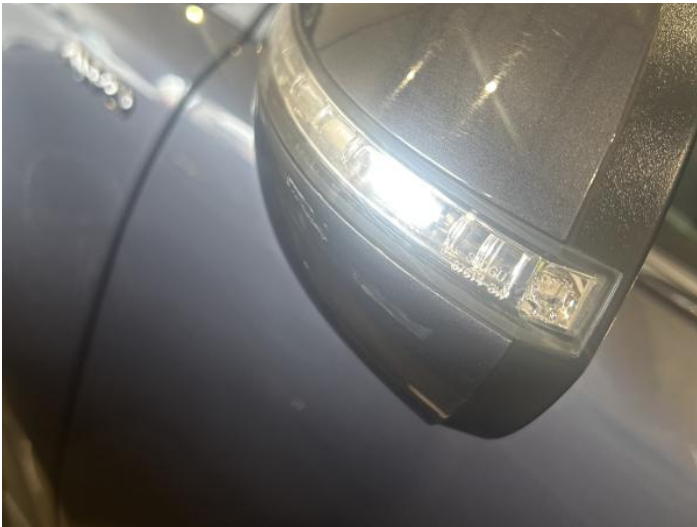
17: Door Mirror Assy nsf
Scratched (Painted)
Over 25mm Not Thru Paint

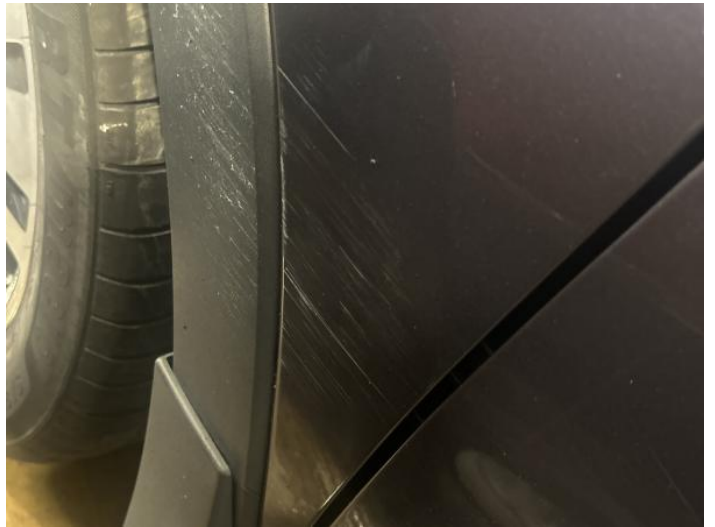
18: Wing nsf
Scratched
Over 25mm Thru Paint

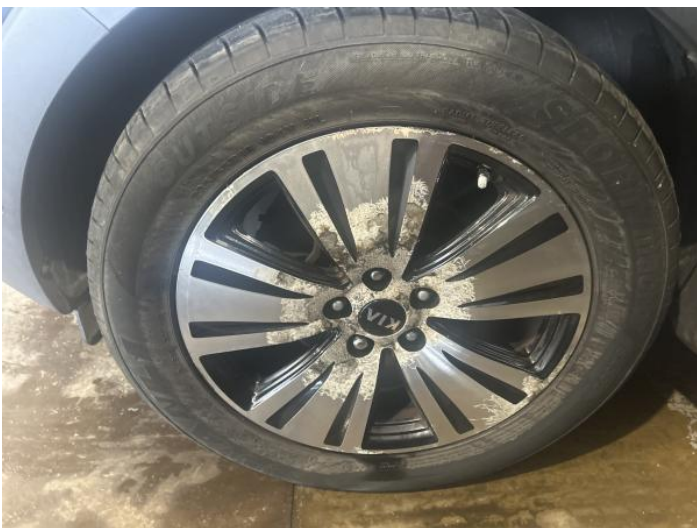
19: Wheel nsf
Corroded
Light

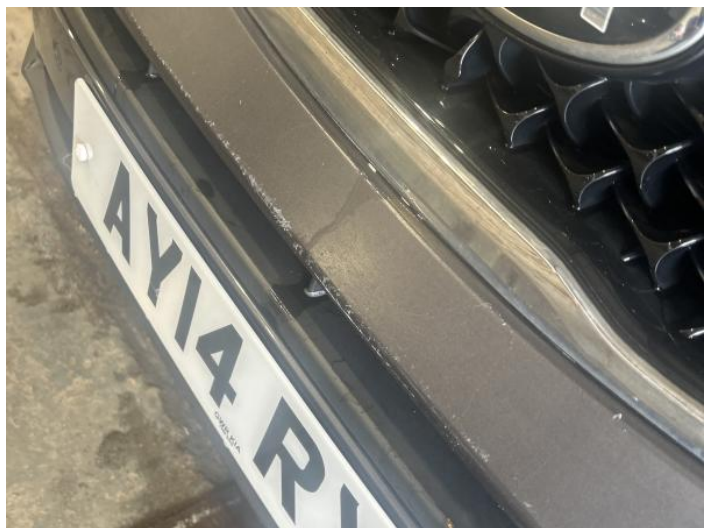
20: Bumper Front
Scratched
Over 100mm Thru Paint

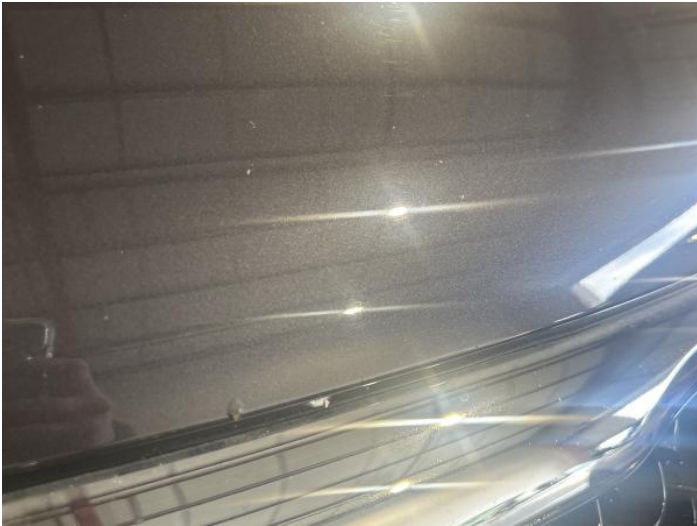
21: Bonnet
Chipped
1 To 5

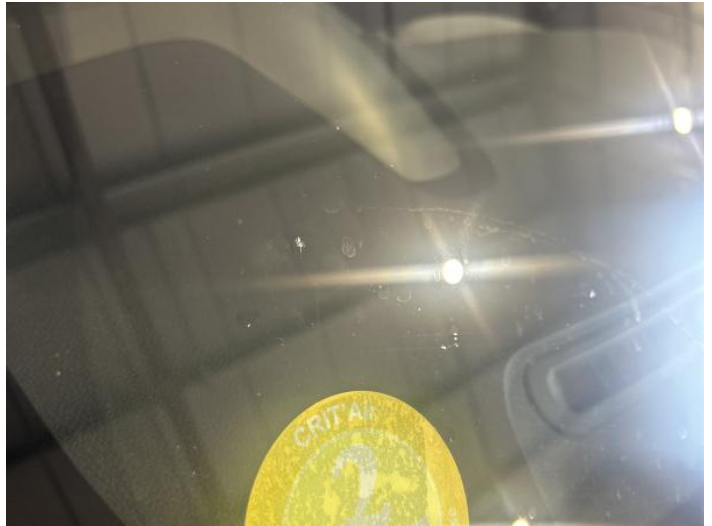
22: Screen Front
Chipped
UpTo 10mm

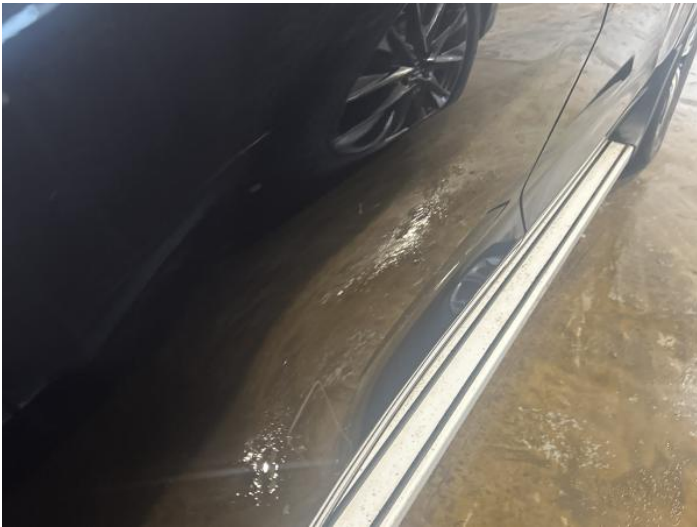
23: Door osr
Dented
2 Or Less UpTo 10mm

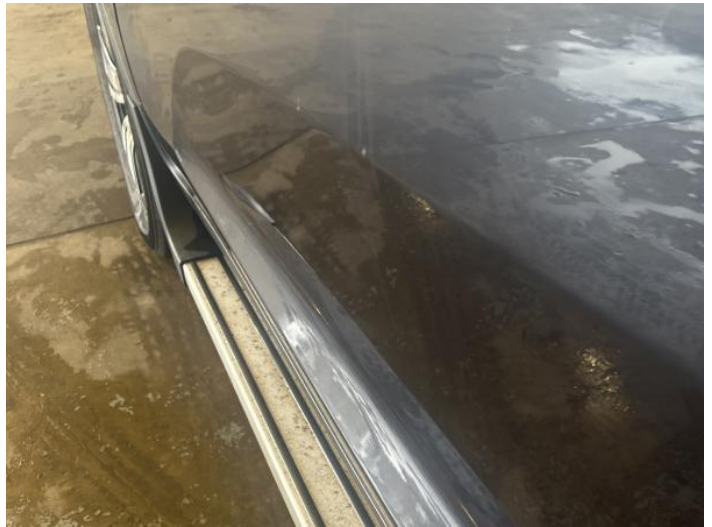
24: Door nsf
Dented
2 Or Less UpTo 10mm
