VEHICLE INSPECTION REPORT

YC12WGO

BMW 6 Series 640d SE 2dr Auto

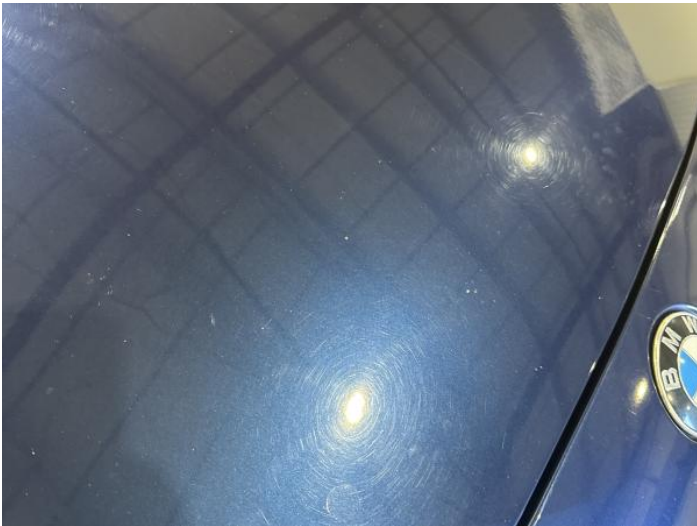
1: Bonnet
Chipped
Multiple Chips

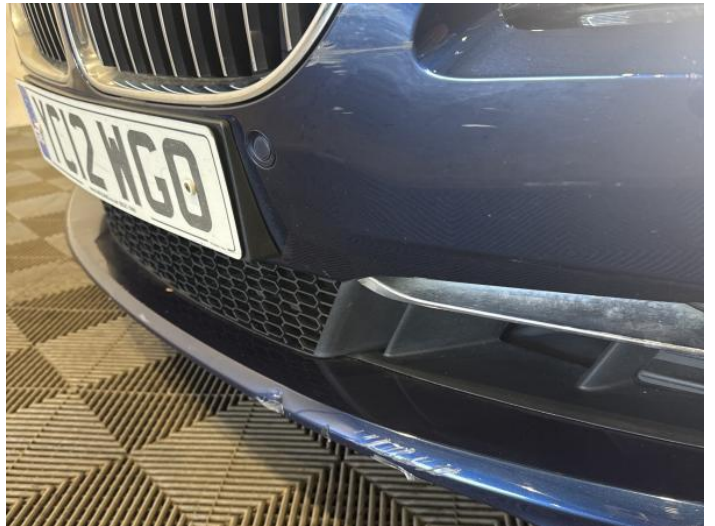
2: Bumper Front
Dented
With Paint Damage

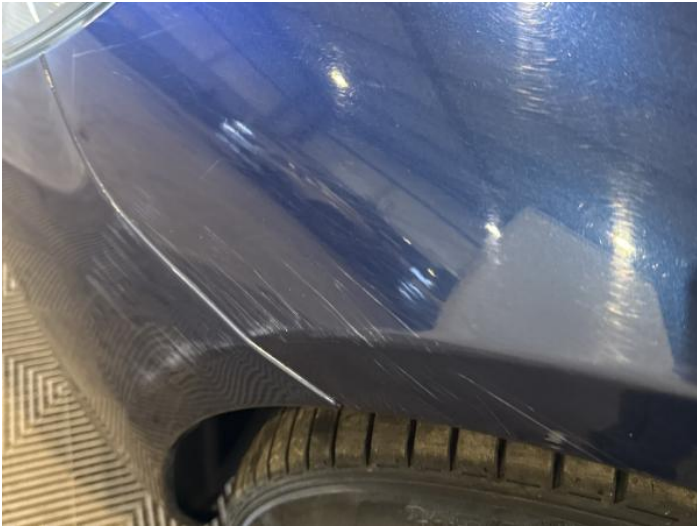
3: Wing nsf
Scratched
Over 25mm Thru Paint

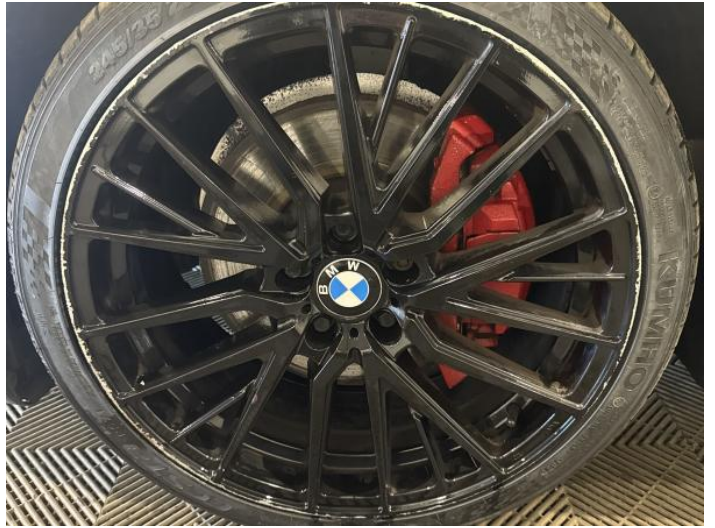
4: Wheel nsf
Dented
UpTo 30mm (Alloy)

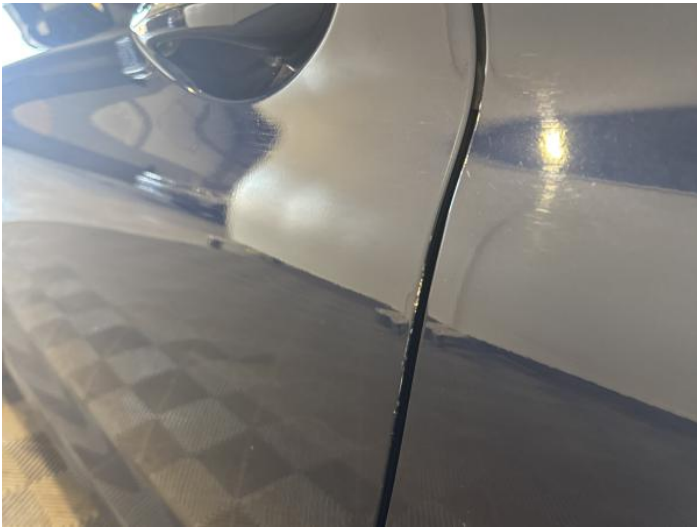
5: Door nsf
Chipped
Edge Chip

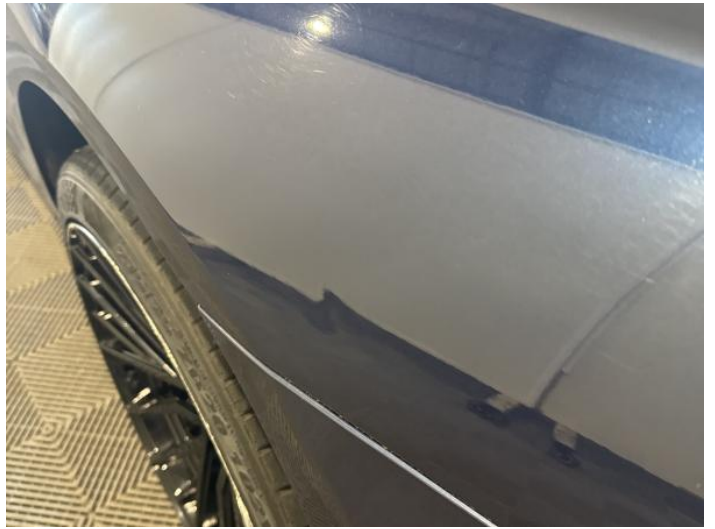
6: Qtr Panel nsr
Dented
Over 30mm

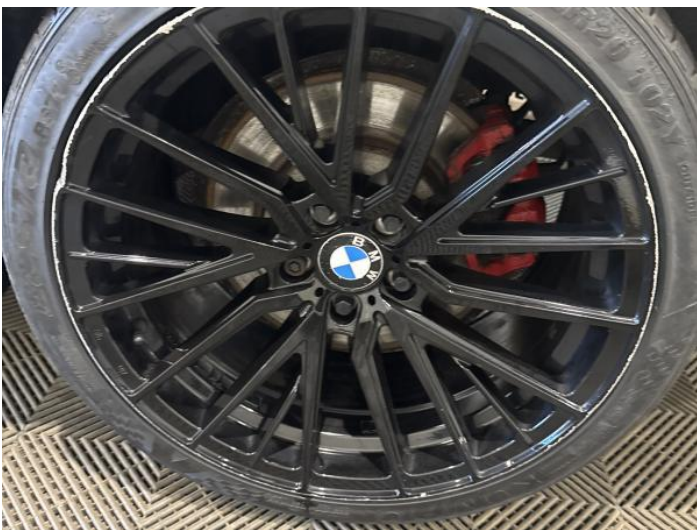
7: Wheel nsr
Dented
UpTo 30mm (Alloy)

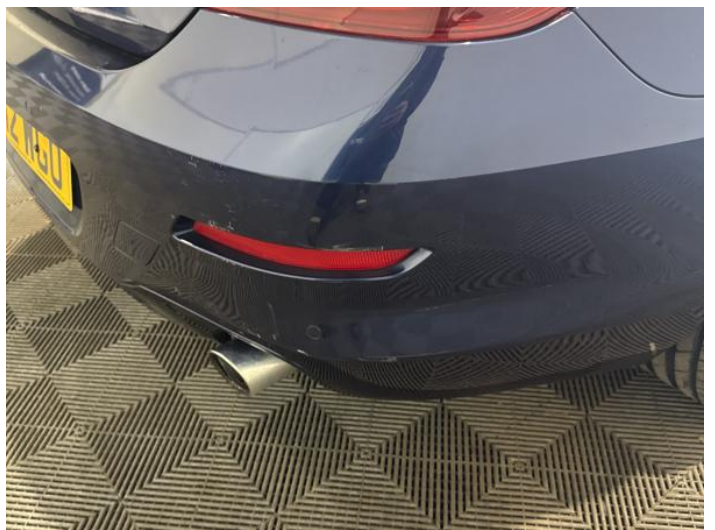
8: Bumper Rear
Scratched
Over 100mm Thru Paint

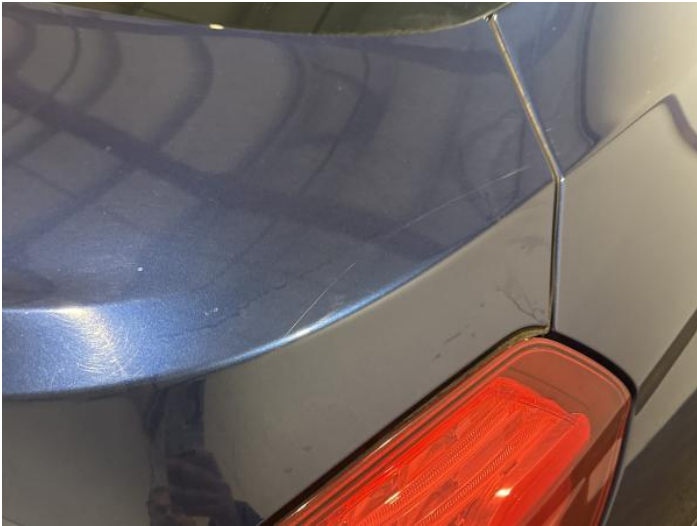
9: Boot Lid
Scratched
Over 25mm Thru Paint

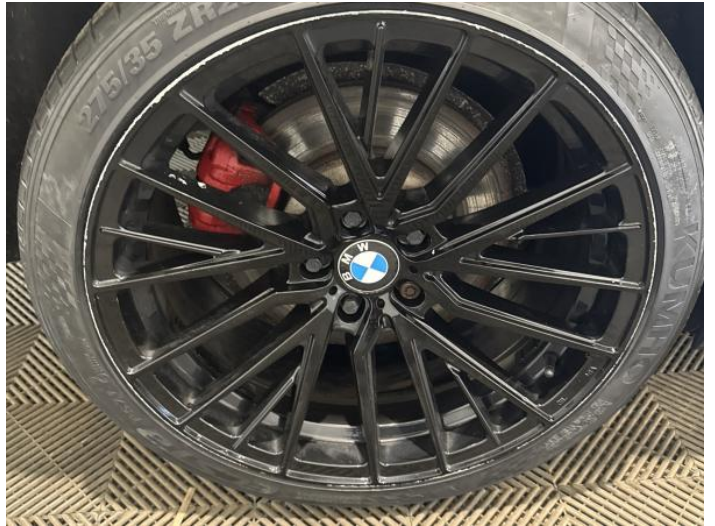
10: Wheel osr
Scratched
Over 50mm

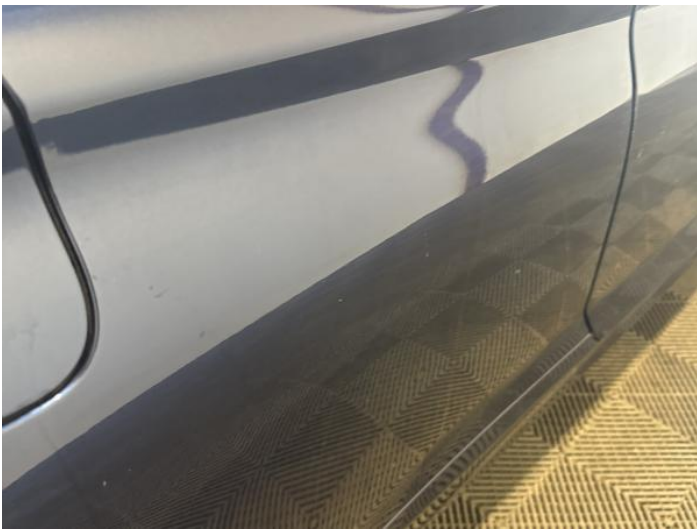
11: Qtr Panel osr
Dented
Over 30mm

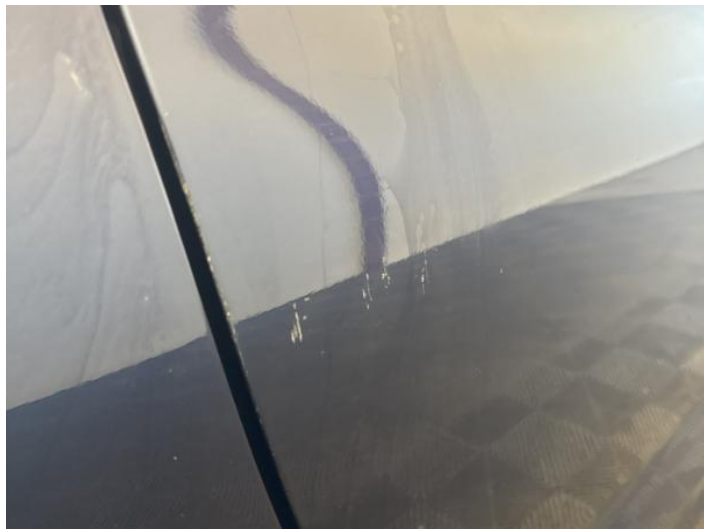
12: Door osf
Scratched
Over 25mm Thru Paint

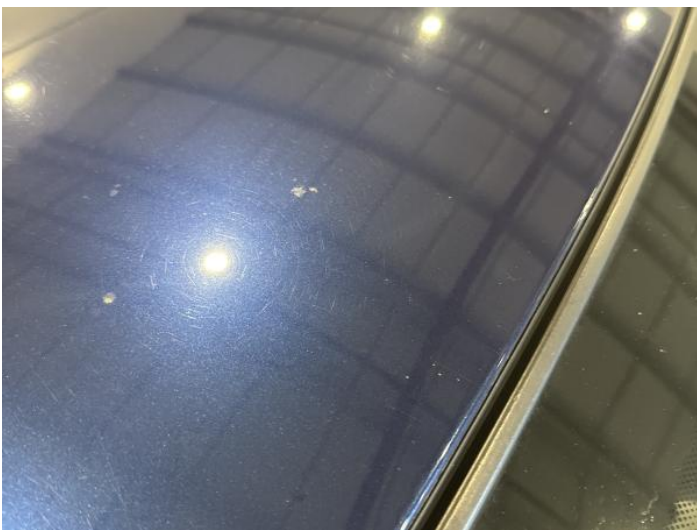
13: Roof
Chipped
1 To 5

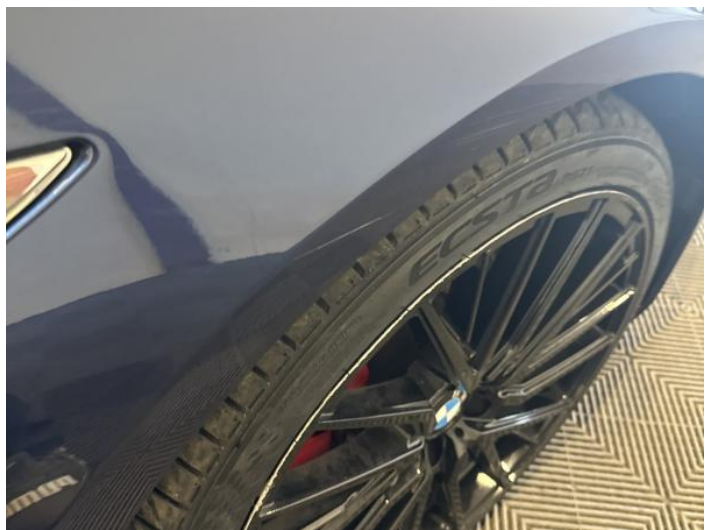
14: Wing osf
Scratched
Over 25mm Thru Paint

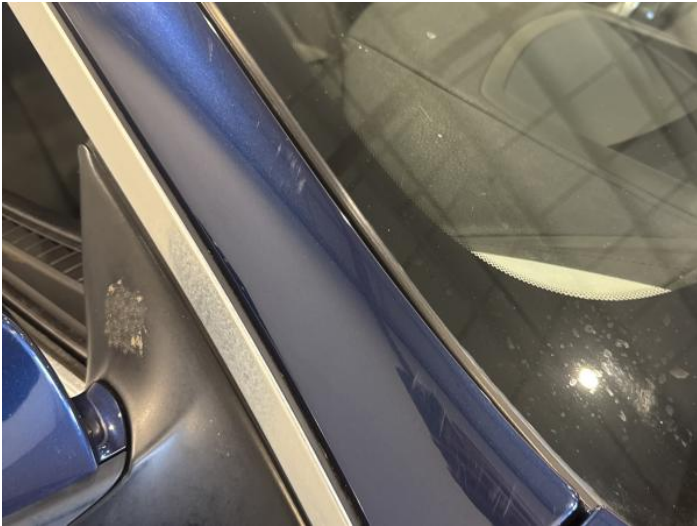
15: A Post os
 Scratched
 Over 25mm Thru Paint

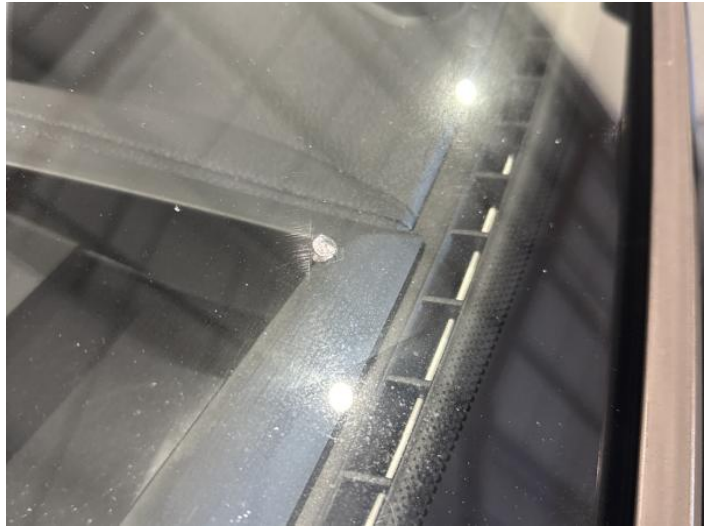
16: Screen Front
 Chipped
 Over 10mm

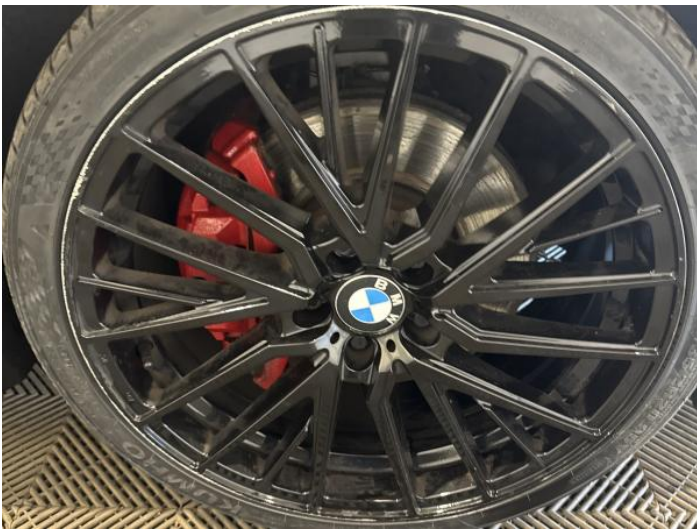
17: Wheel osf
 Scratched
 Over 50mm
