VEHICLE INSPECTION REPORT

LB21WMZ

Toyota C-Hr 1.8 Hybrid Design 5dr CVT

nama
GRADE
2

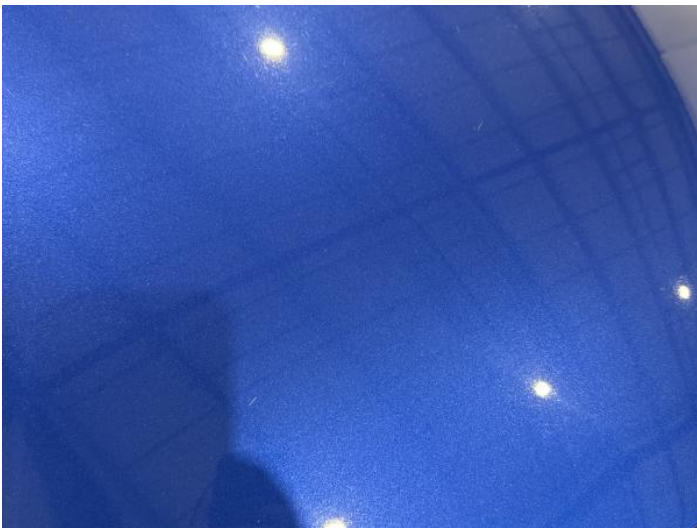
1: Bonnet
Chipped
1 To 5

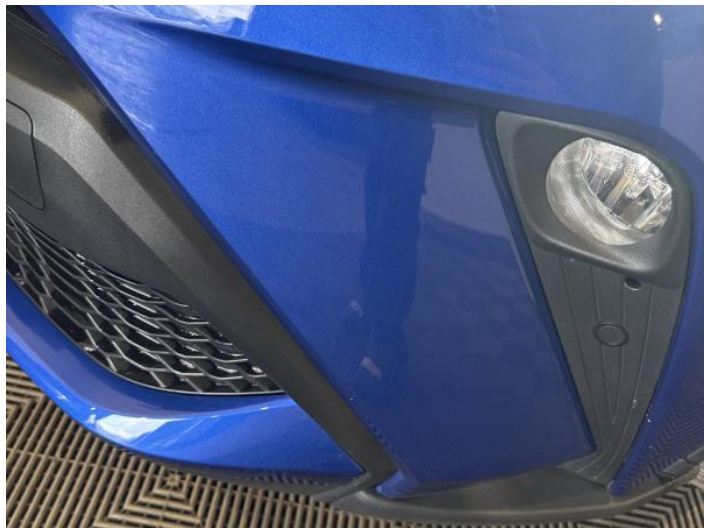
2: Bumper Front
Chipped
1 To 5

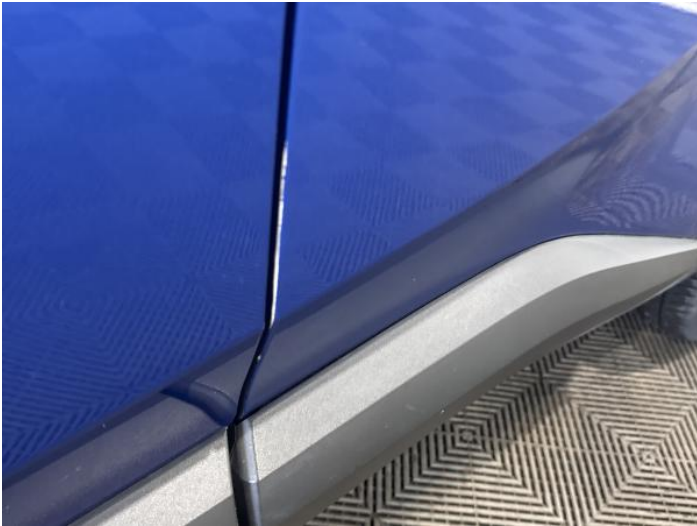
3: Door nsr
Scratched
Over 25mm Thru Paint

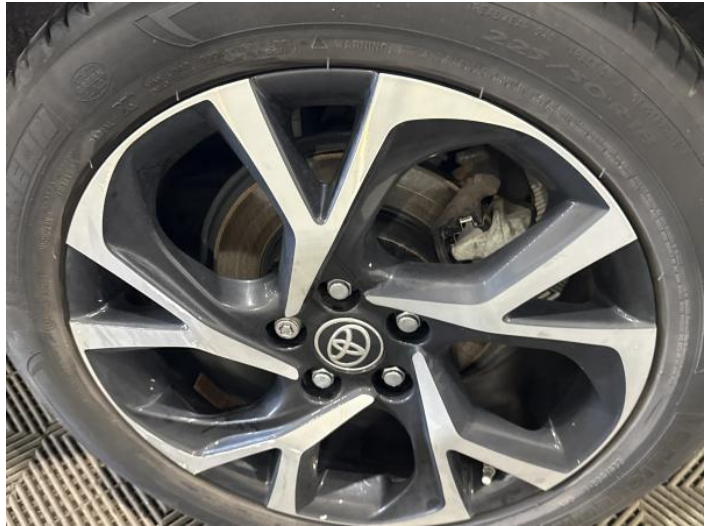
4: Wheel nsr
Scratched
Over 50mm

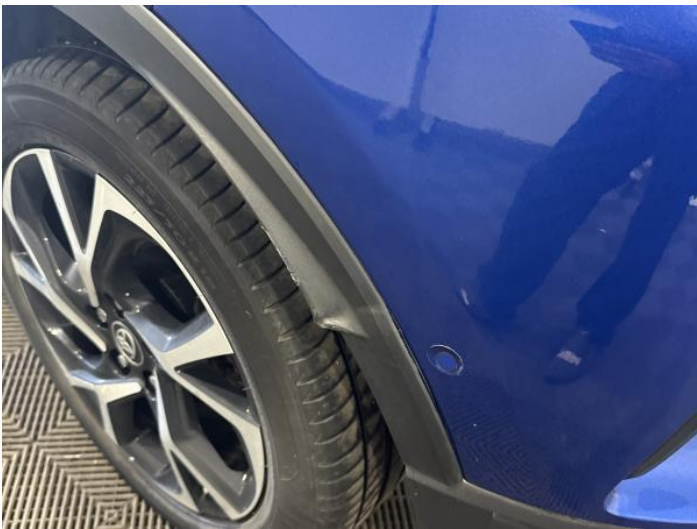
5: Qtr Panel Arch Extension ns
Scuffed (Unpainted)
Over 100mm

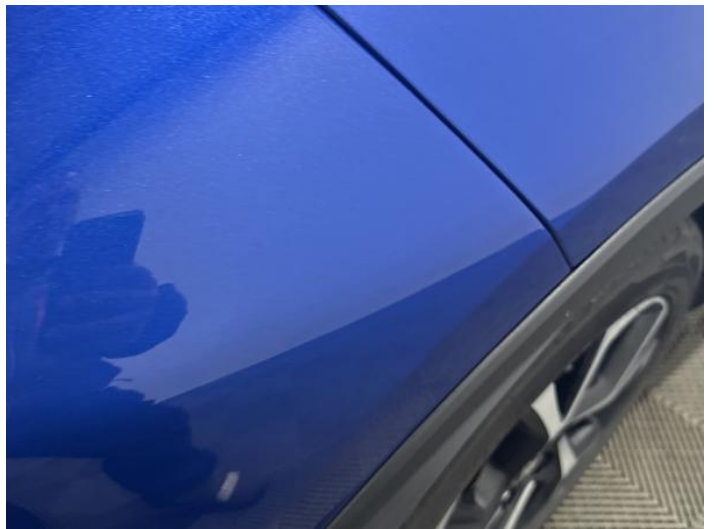
6: Bumper Rear
Scratched
Up To 25mm Thru Paint

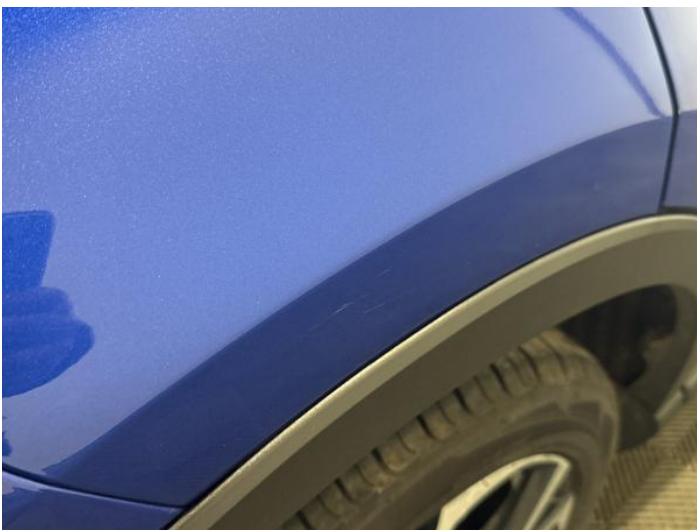
7: Qtr Panel osr
Scratched
Up To 25mm Thru Paint

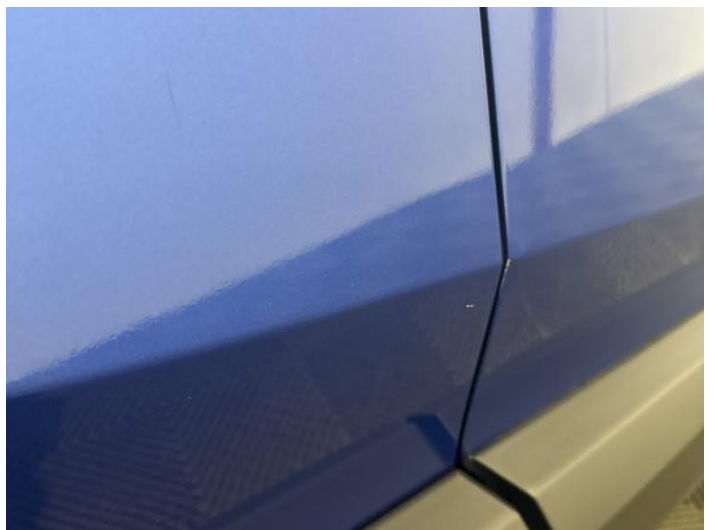
8: Door osr
Chipped
1 To 5

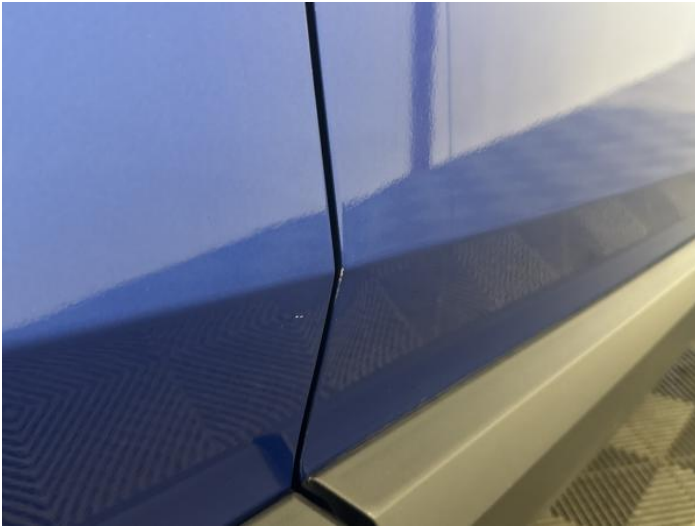
9: Door osf
Chipped
Edge Chip

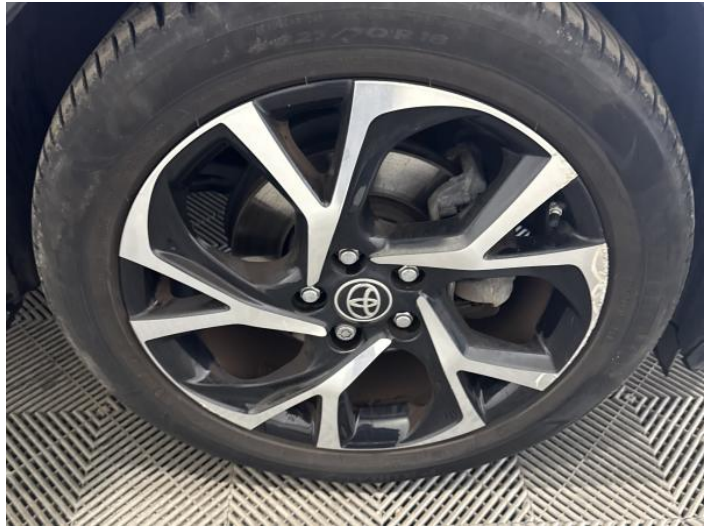
10: Wheel osf
Scratched
Over 50mm
