VEHICLE INSPECTION REPORT

RA21LMJ

Honda CR-V 2.0 i-MMD Hybrid EX 5dr eCVT

nama
GRADE
3

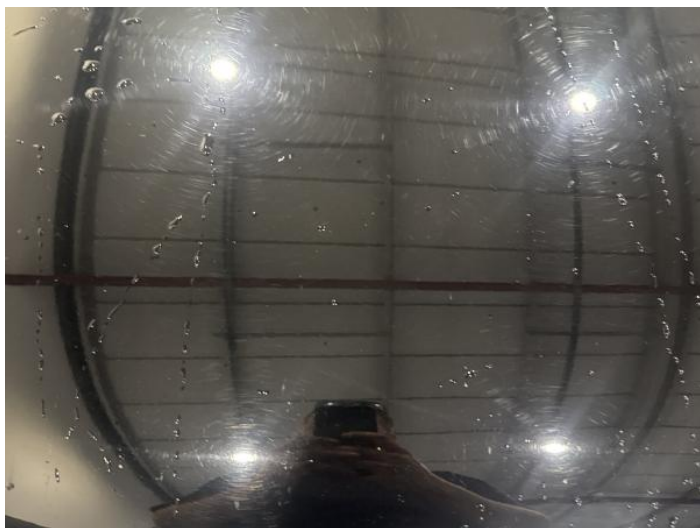
1: Bonnet
Chipped
1 To 5

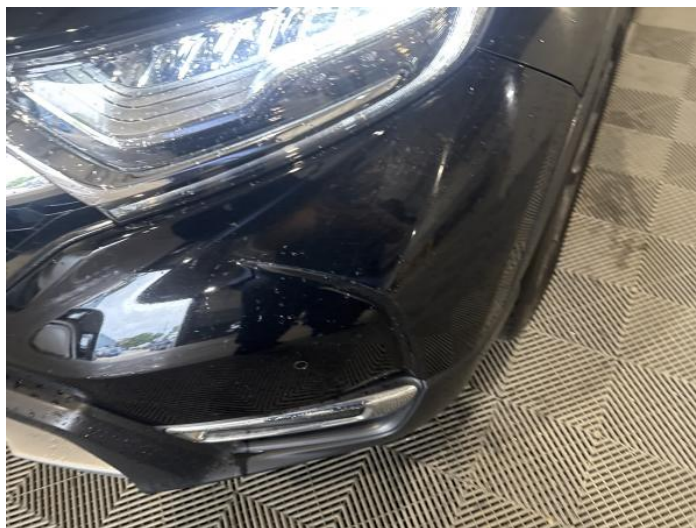
2: Bumper Front
Scratched
Over 25mm Not Thru Paint

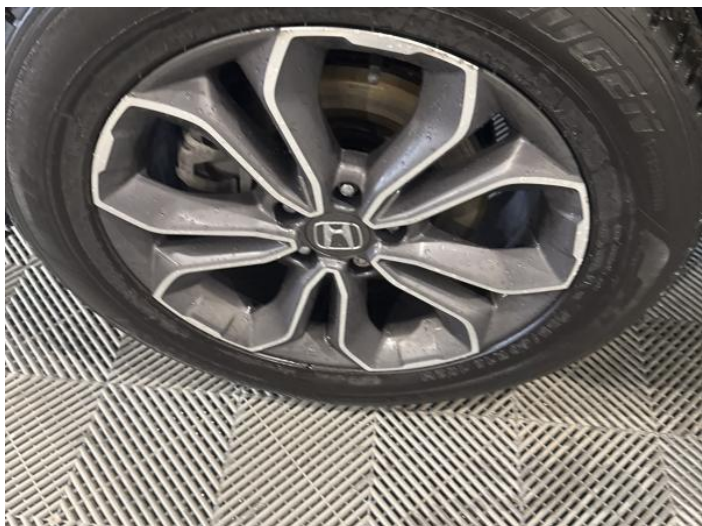
3: Wheel nsf
Scratched
Over 50mm

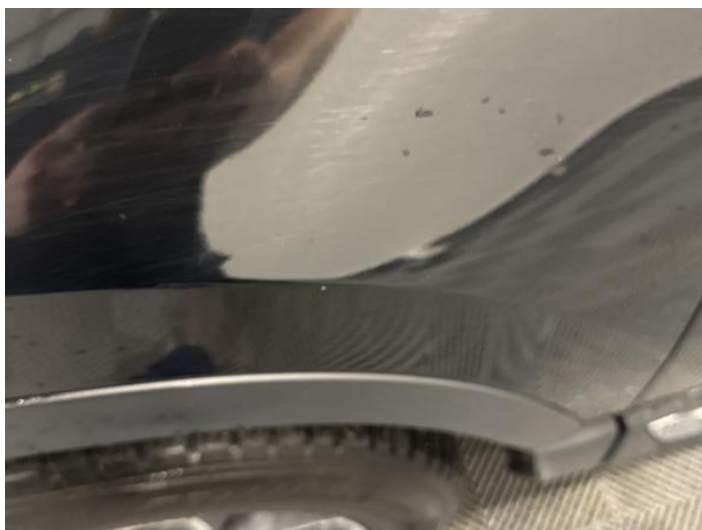
5: Wing nsf
Chipped
1 To 5

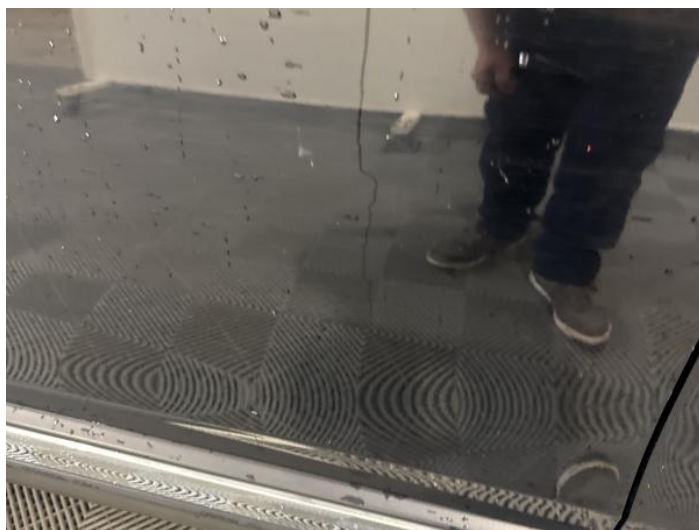
6: Door nsf
Chipped
1 To 5

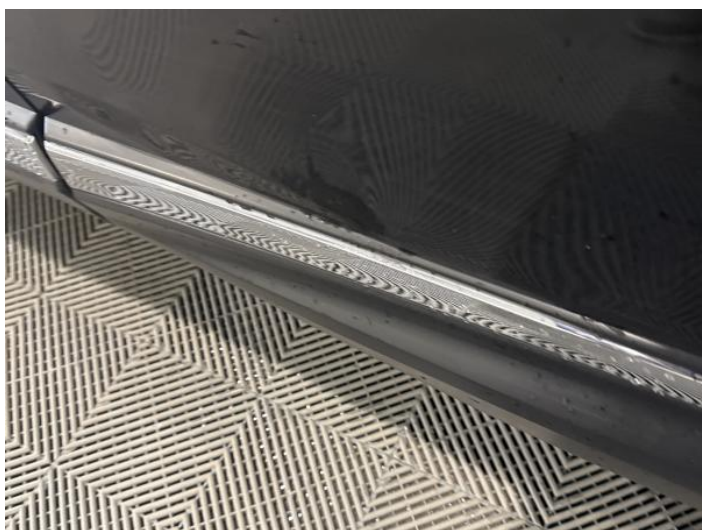
7: Door nsr
Dented
Over 30mm

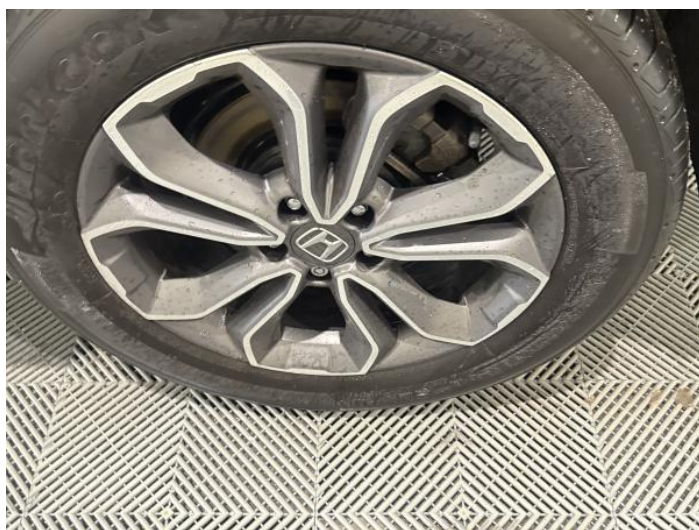
8: Wheel nsr
Scratched
Up To 50mm

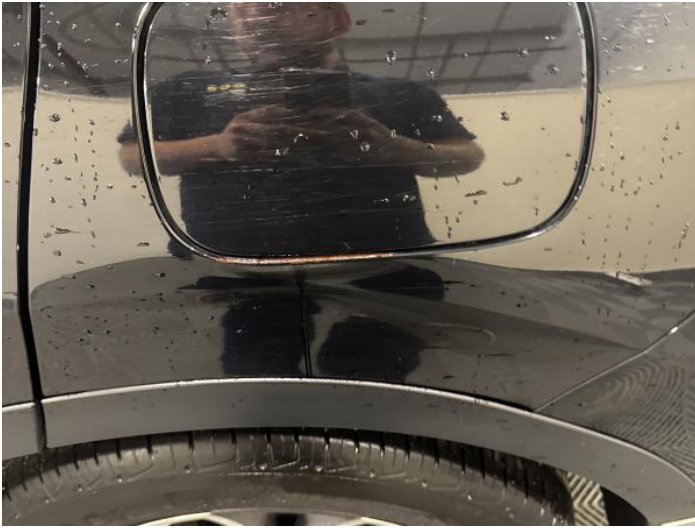
9: Qtr Panel nsr
Dented
With Paint Damage

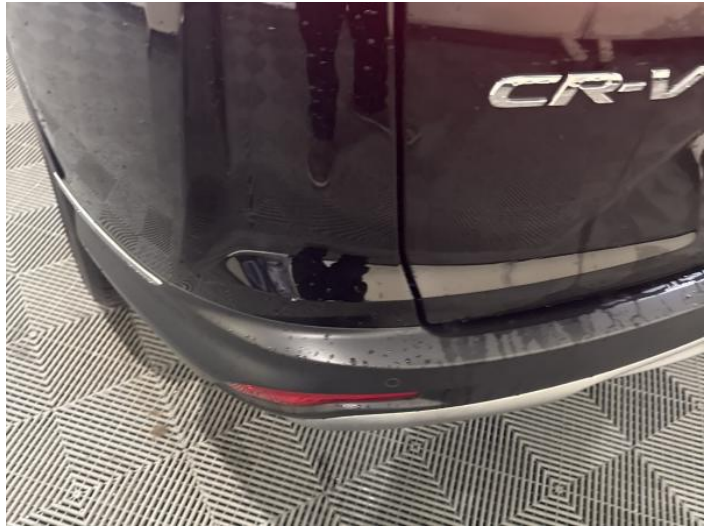
10: Bumper Rear
Scratched
25 to 100mm Thru Paint

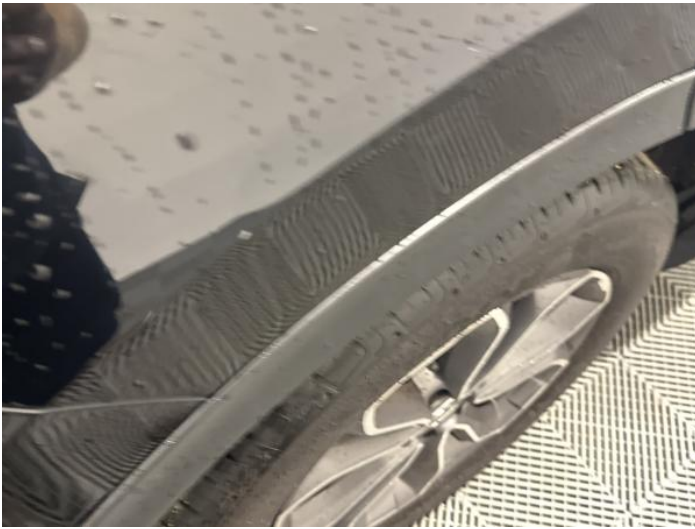
11: Qtr Panel osr
Dented
2 Or Less UpTo 10mm

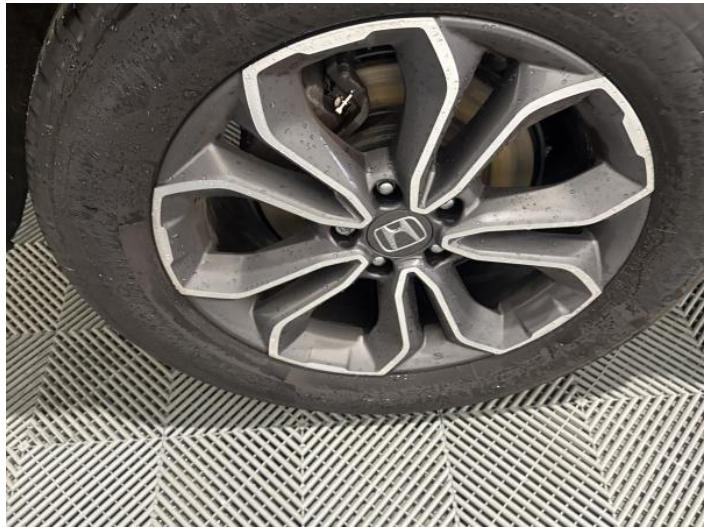
12: Wheel osr
Scratched
Up To 50mm
