# VEHICLE INSPECTION REPORT

**T66ATW**

## BMW 3 Series 320d SE 5dr Step Auto

nama  
 GRADE  
**3**

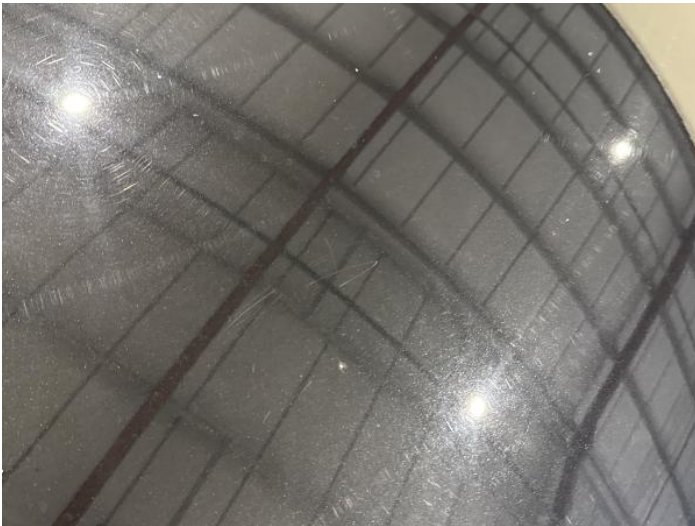
1: Bonnet  
Scratched  
Over 25mm Thru Paint

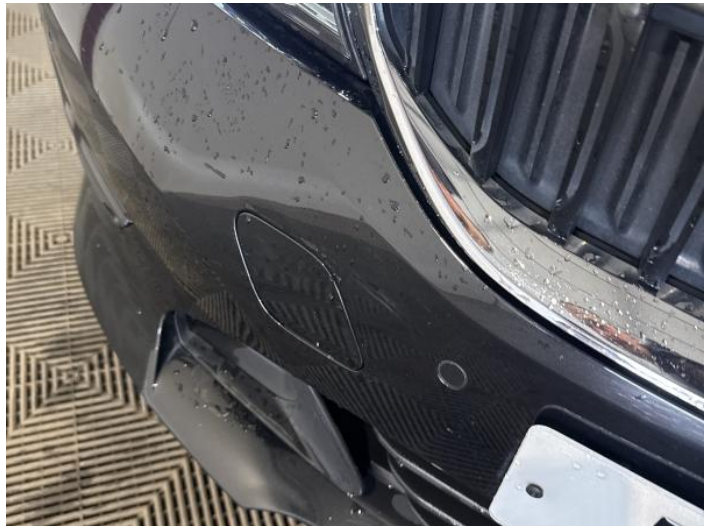
2: Bumper Front  
Scratched  
25 to 100mm Thru Paint

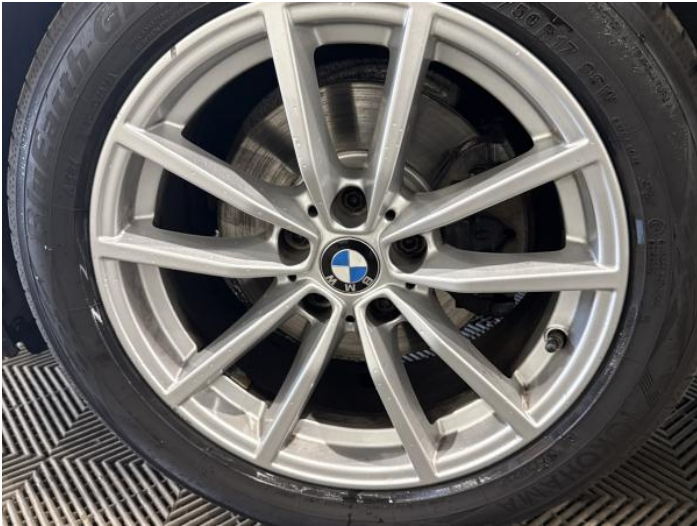
3: Wheel nsf  
Scratched  
Up To 50mm

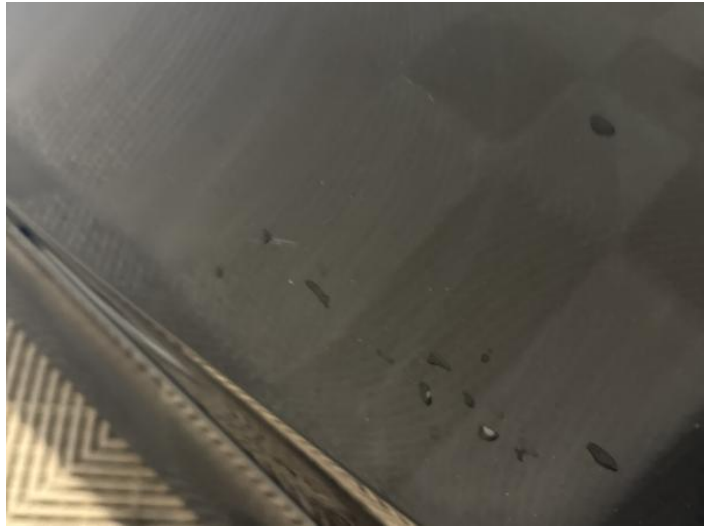
4: Door nsr  
Dented  
Between 10mm + 30mm

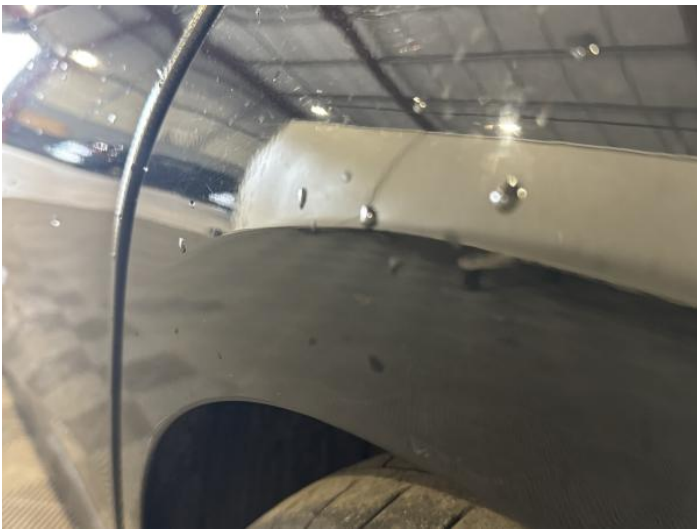
5: Qtr Panel nsr  
Dented  
Over 30mm

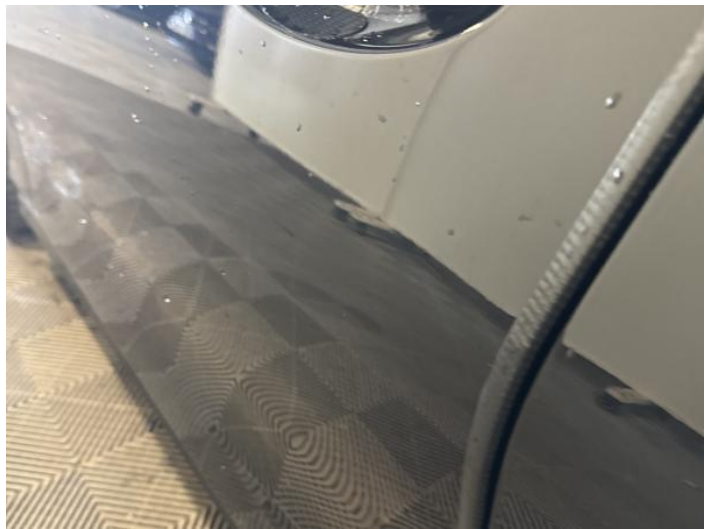
6: Door nsf  
Dented  
Between 10mm + 30mm

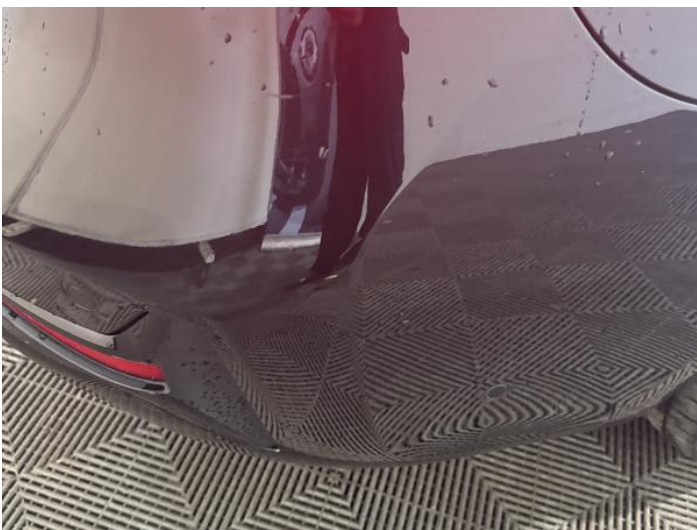
7: Bumper Rear  
Scratched  
25 to 100mm Thru Paint

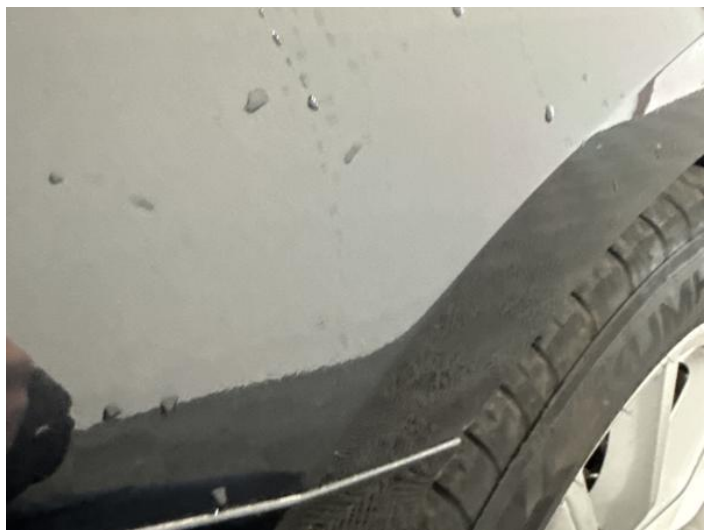
8: Qtr Panel osr  
Chipped  
1 To 5

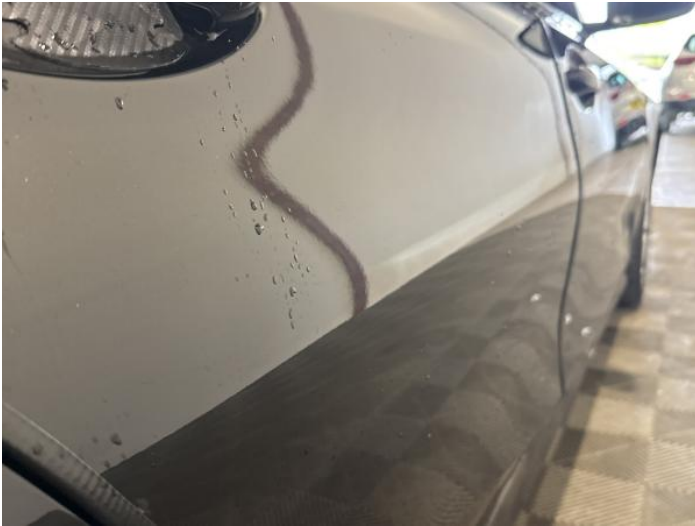
9: Door osr  
 Poor Previous Repair  
 Rippled UpTo 30%

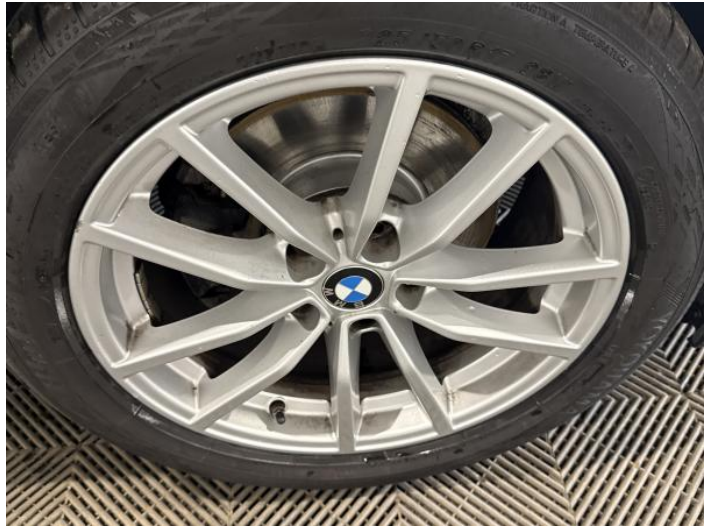
10: Wheel osf  
 Scratched  
 Up To 50mm
