VEHICLE INSPECTION REPORT

DV67VNP

Vauxhall Astra 1.4i 16V Design 5dr

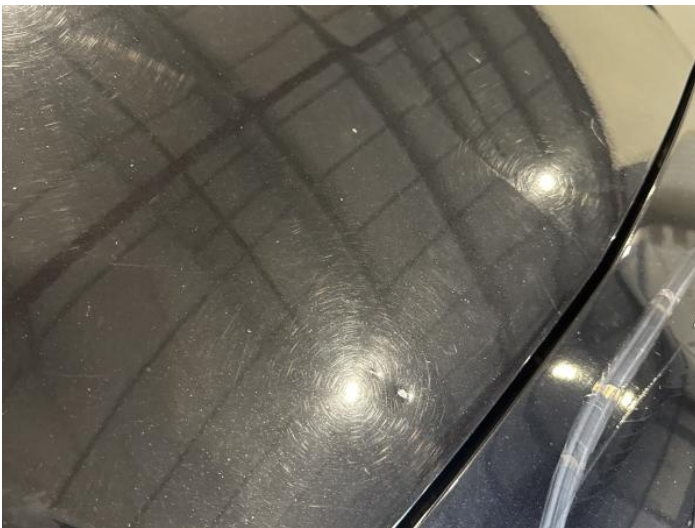
1: Bonnet
Dented
With Paint Damage

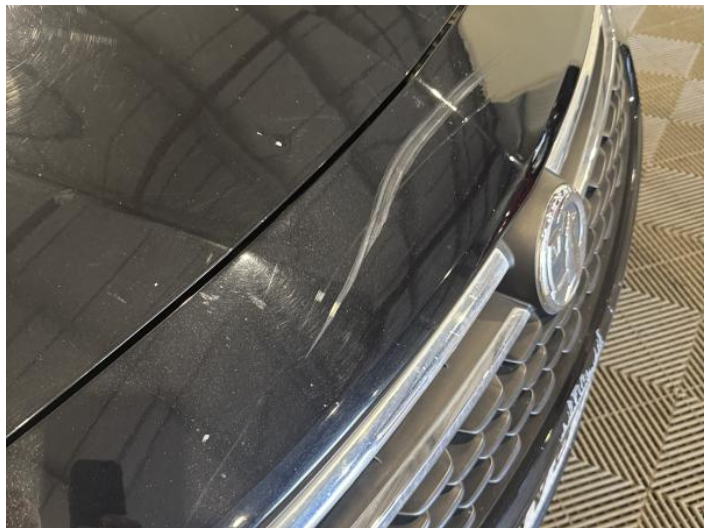
2: Bumper Front
Dented
With Paint Damage

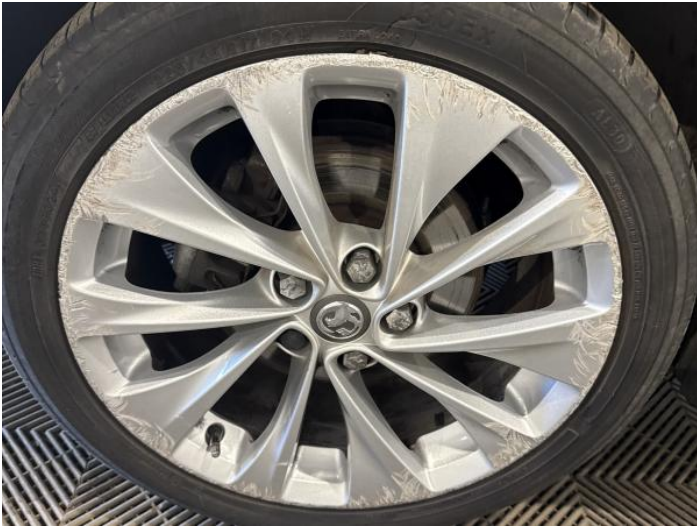
3: Wheel nsf
Scratched
Over 50mm

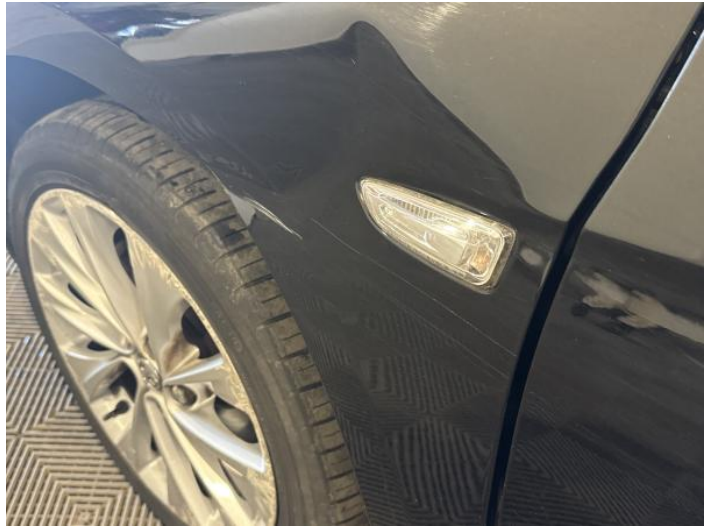
4: Wing nsf
Dented
With Paint Damage

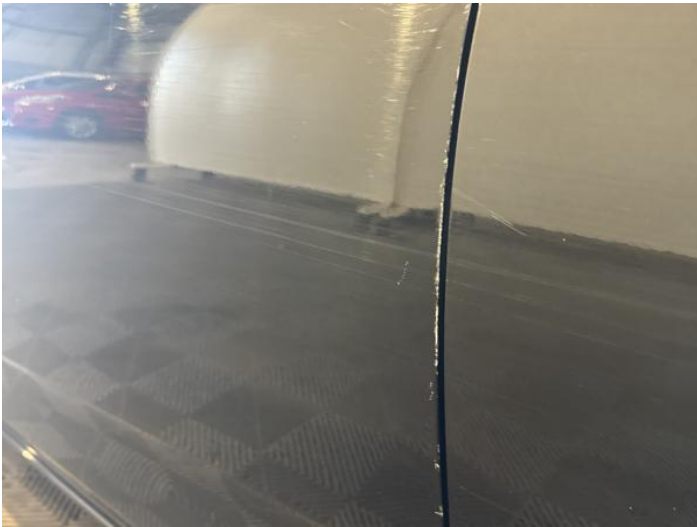
5: Door nsf
Chipped
Edge Chip

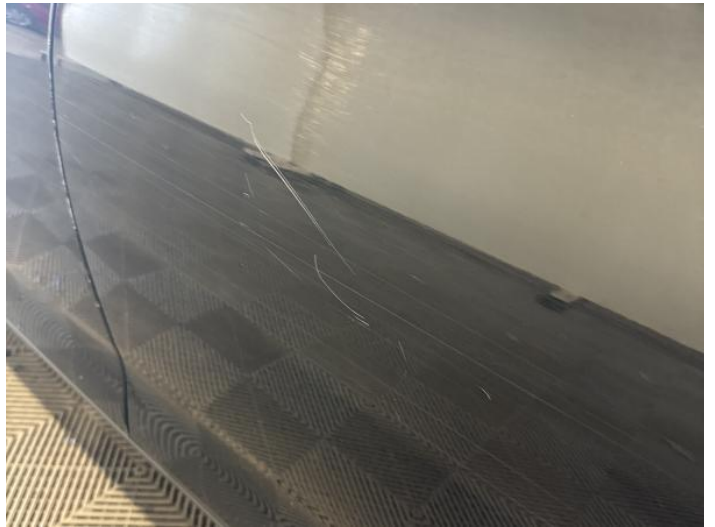
6: Door nsr
Scratched
Over 25mm Thru Paint

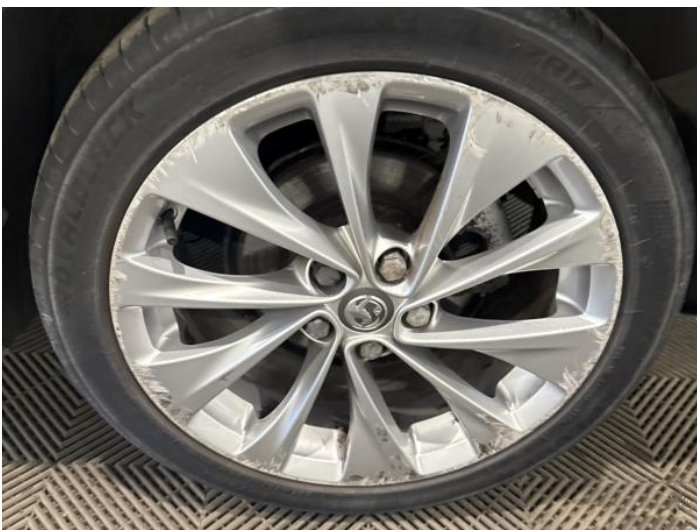
7: Wheel nsr
Scratched
Over 50mm

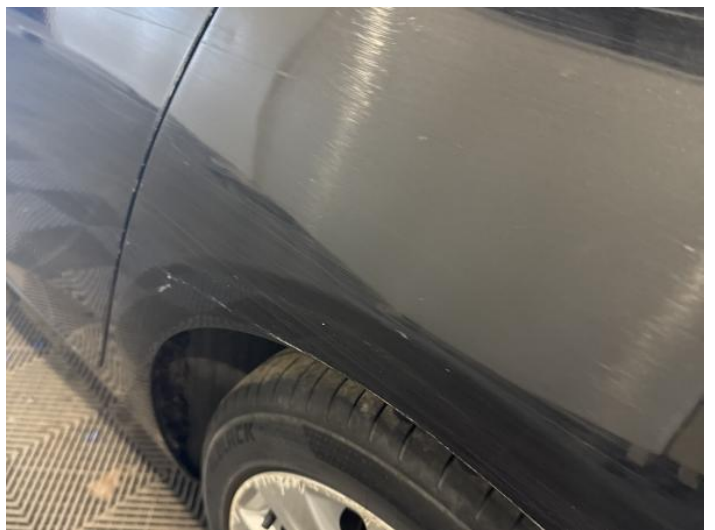
8: Qtr Panel nsr
Dented
With Paint Damage

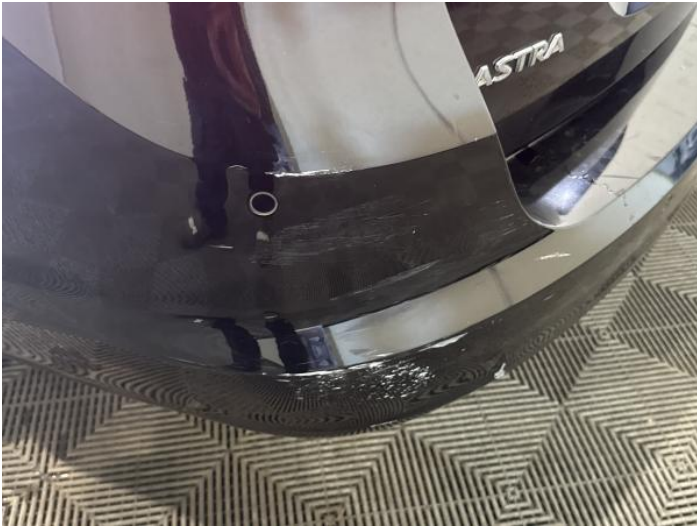
9: Bumper Rear
Scratched
Over 100mm Thru Paint

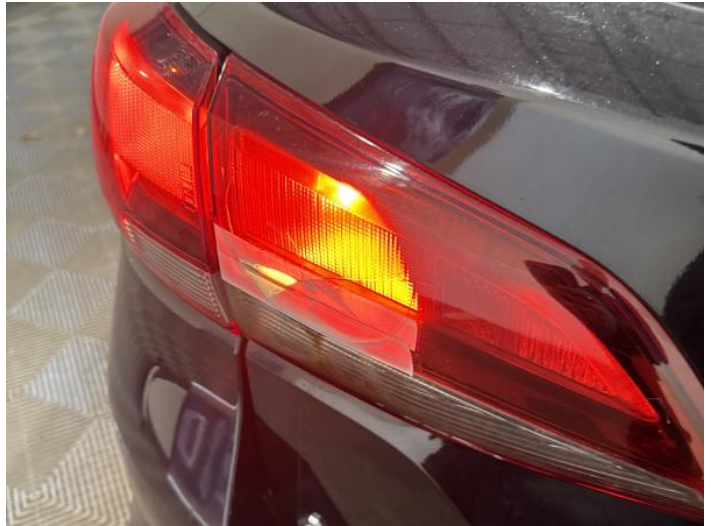
10: Lamp nsr
Broken
Replace

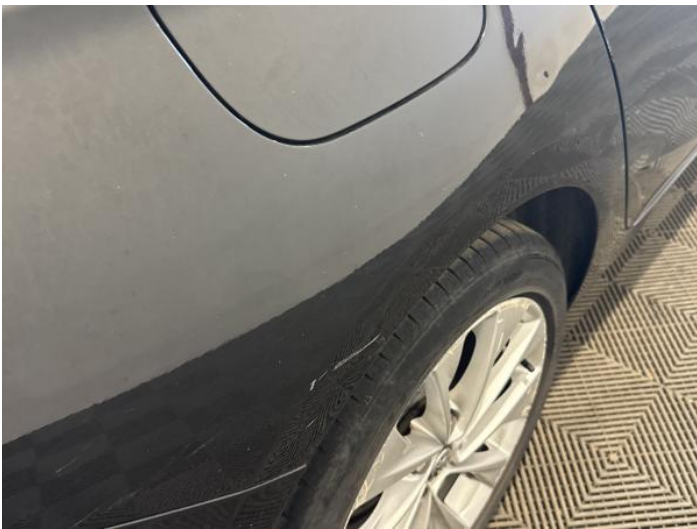
11: Qtr Panel osr
Dented
With Paint Damage

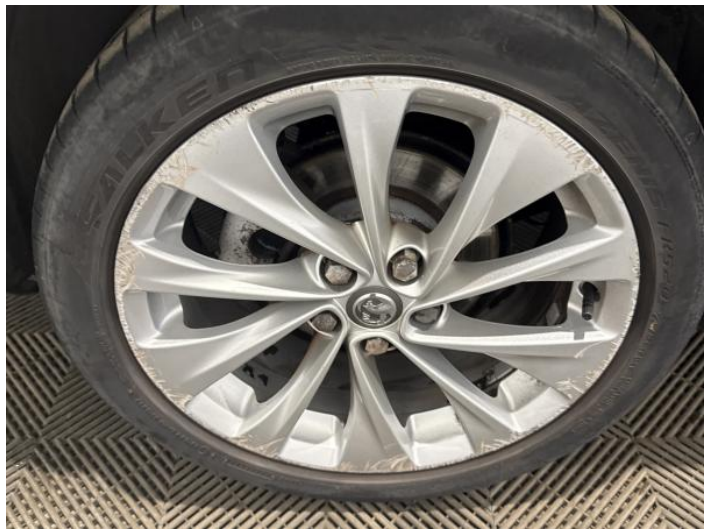
12: Wheel osr
Scratched
Over 50mm

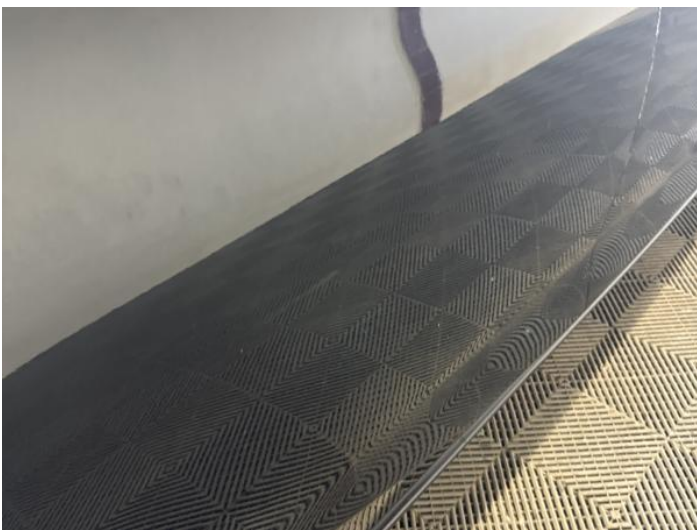
13: Door osr
Scratched
Over 25mm Thru Paint

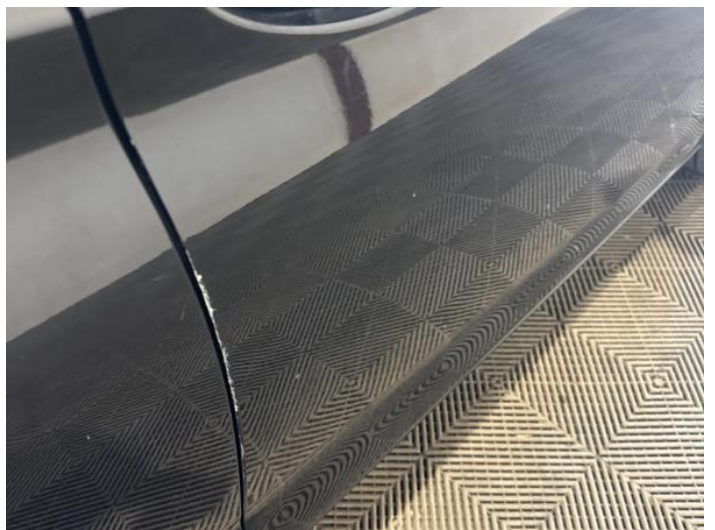
14: Door osf
Dented
With Paint Damage

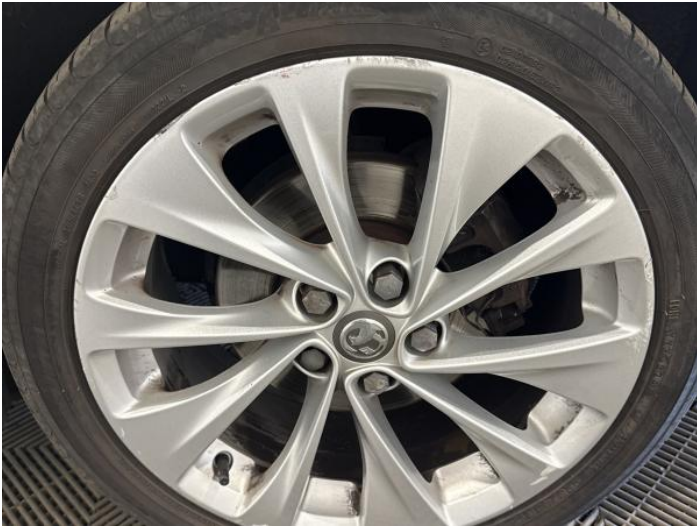
15: Wheel ofsf
Scratched
Over 50mm

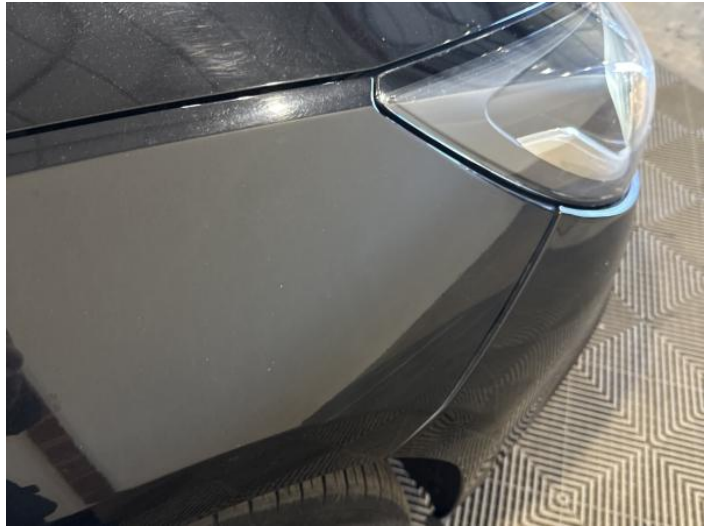
16: Wing ofsf
Chipped
1 To 5

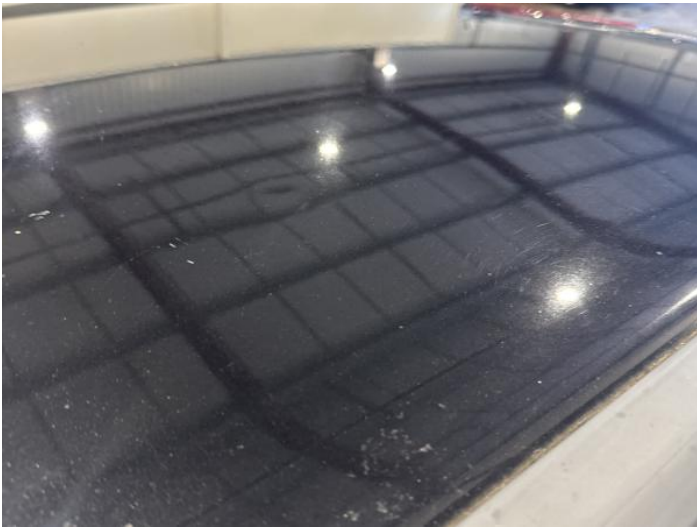
17: Roof
Dented
Between 10mm + 30mm
