VEHICLE INSPECTION REPORT

KW67YEB

Suzuki Swift 1.0 Boosterjet SHVS SZ5 5dr

nama
GRADE
4

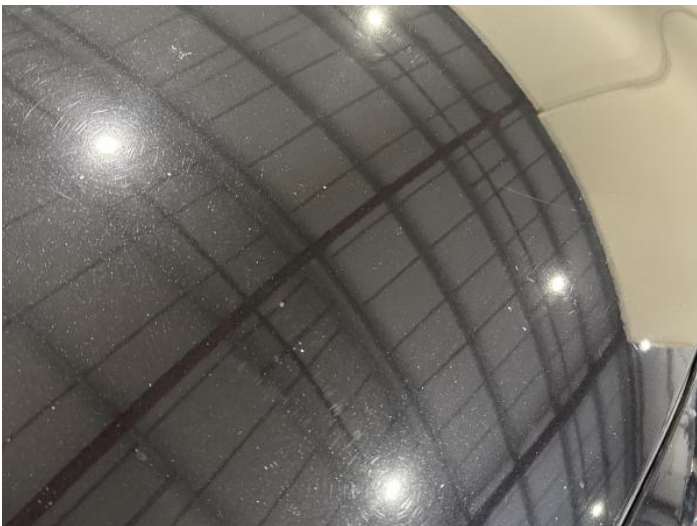
1: Bonnet
Chipped
Multiple Chips

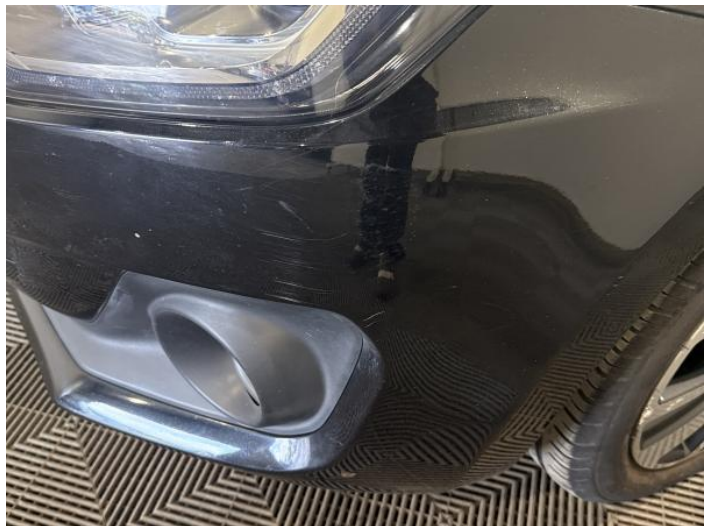
2: Bumper Front
Scratched
25 to 100mm Thru Paint

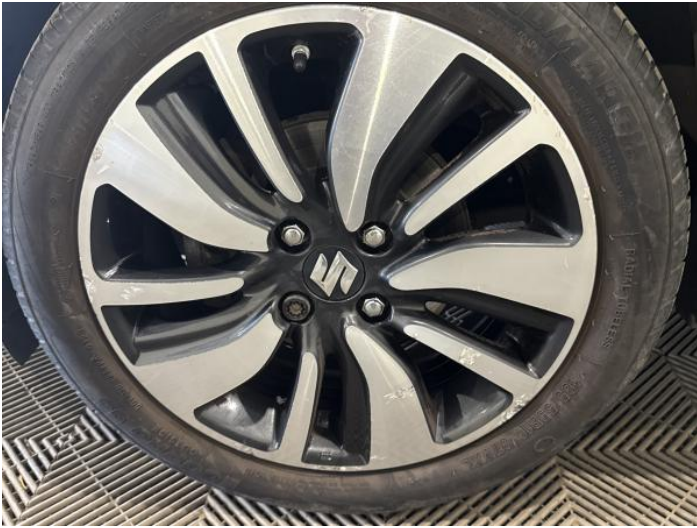
3: Wheel nsf
Scratched
Over 50mm

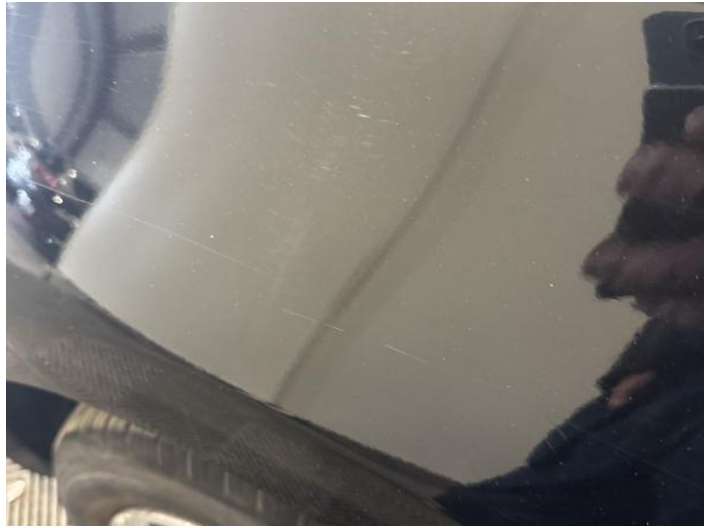
4: Wing nsf
Scratched
Over 25mm Thru Paint

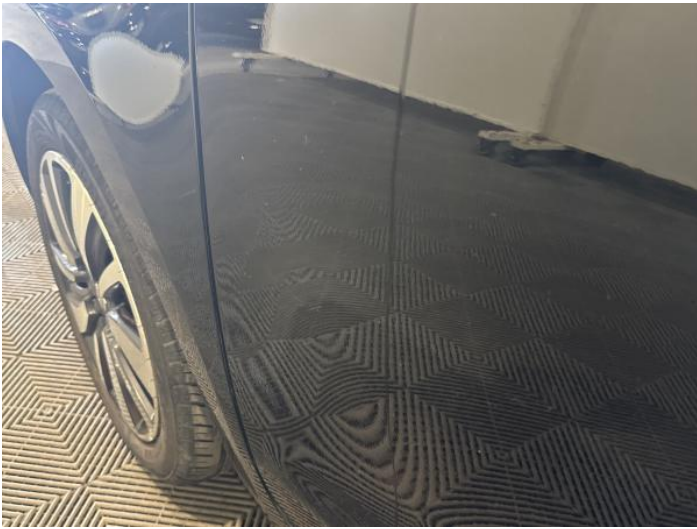
5: Door nsf
Scratched
Over 25mm Thru Paint

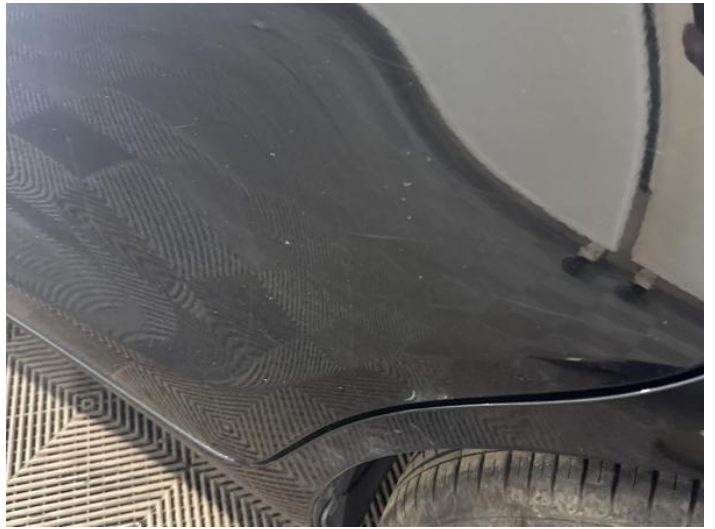
6: Door nsr
Scratched
UpTo 25mm Thru Paint

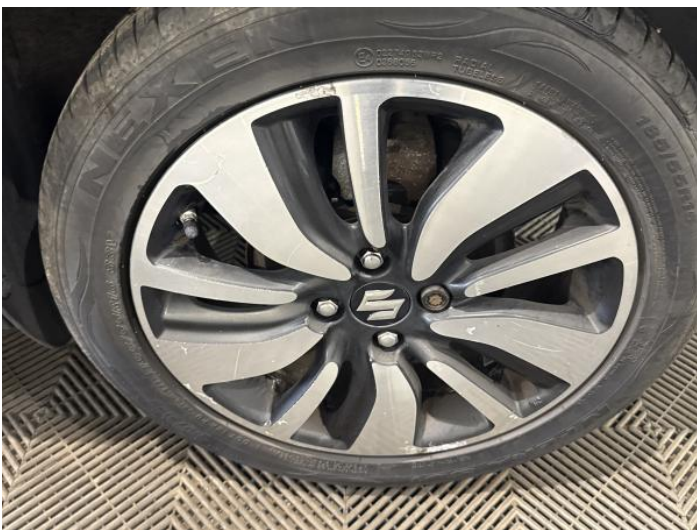
7: Wheel nsr
Scratched
Over 50mm

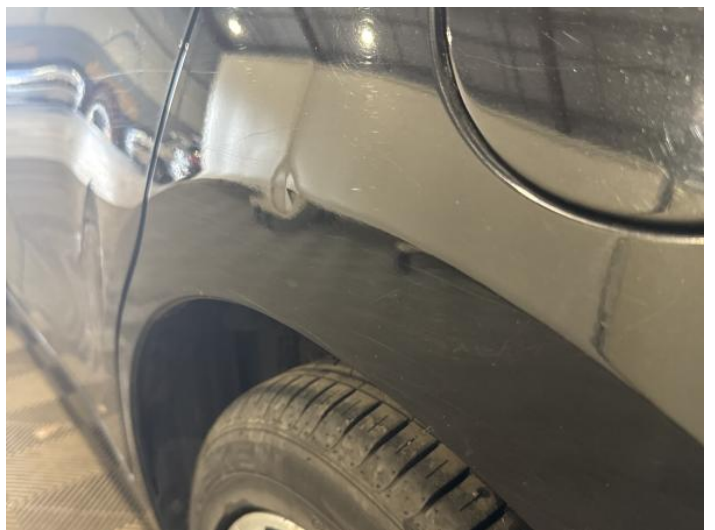
8: Qtr Panel nsr
Dented
Over 30mm

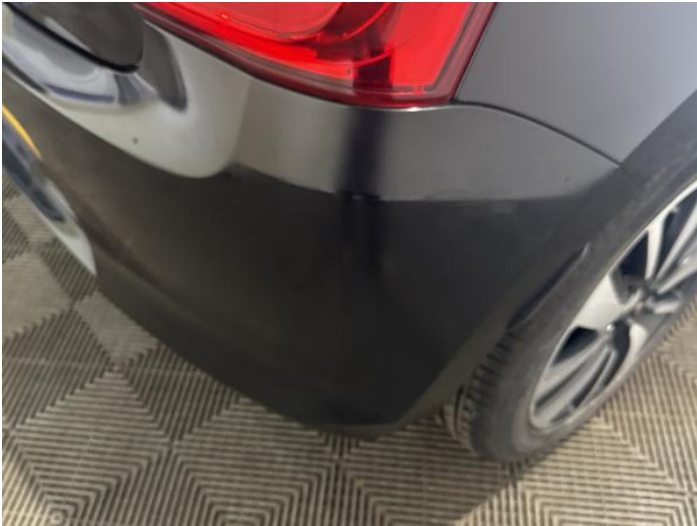
9: Bumper Rear
Poor Previous Repair
Poor Paint

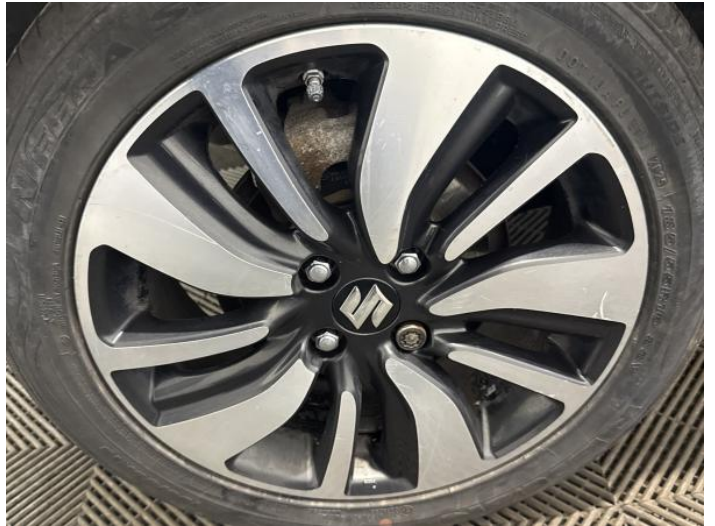
10: Wheel osr
Scratched
Up To 50mm

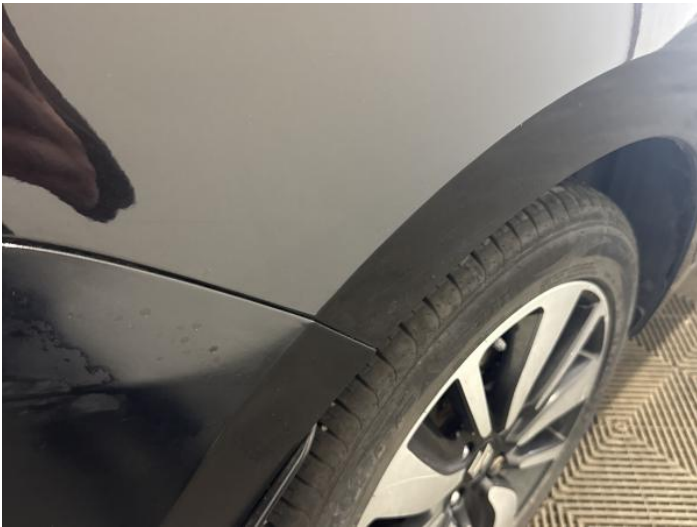
11: Qtr Panel osr
Scratched
Over 25mm Thru Paint

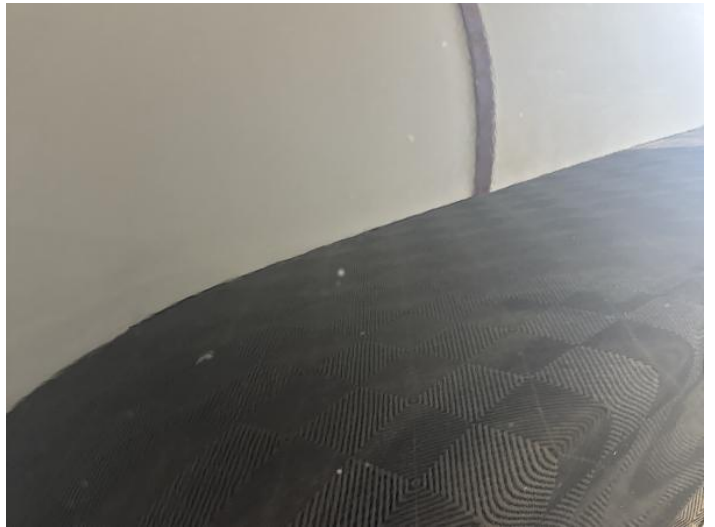
12: Door osr
Dented
2 Or Less UpTo 10mm

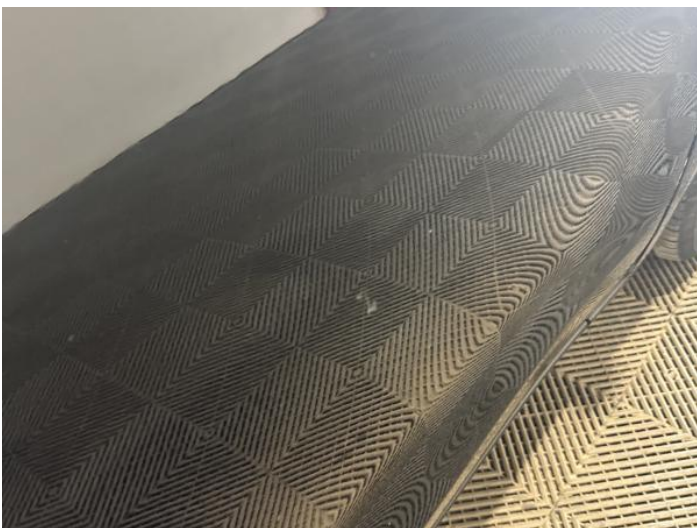
13: Door osf
Scratched
UpTo 25mm Thru Paint

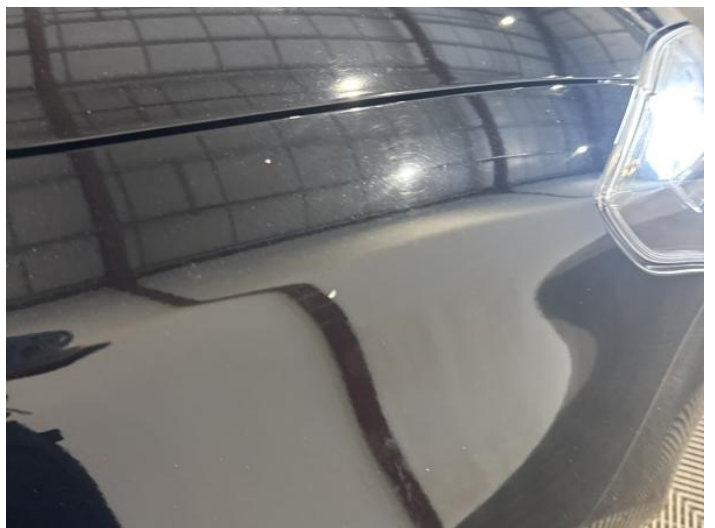
14: Wing osf
Chipped
1 To 5

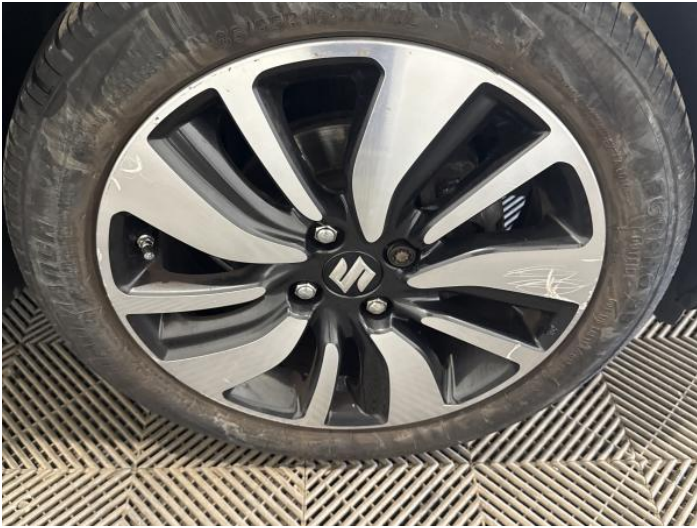
15: Wheel of
Scratched
Over 50mm
