VEHICLE INSPECTION REPORT

GU72WWH

Toyota C-Hr 1.8 Hybrid Design 5dr CVT

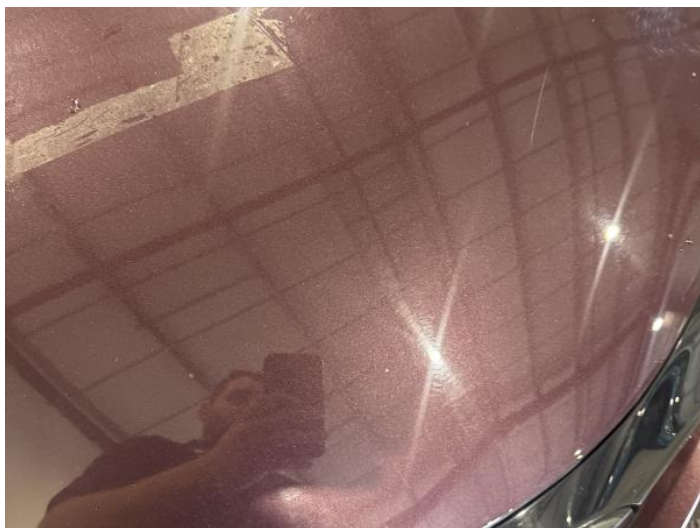
1: Bonnet
Chipped
1 To 5

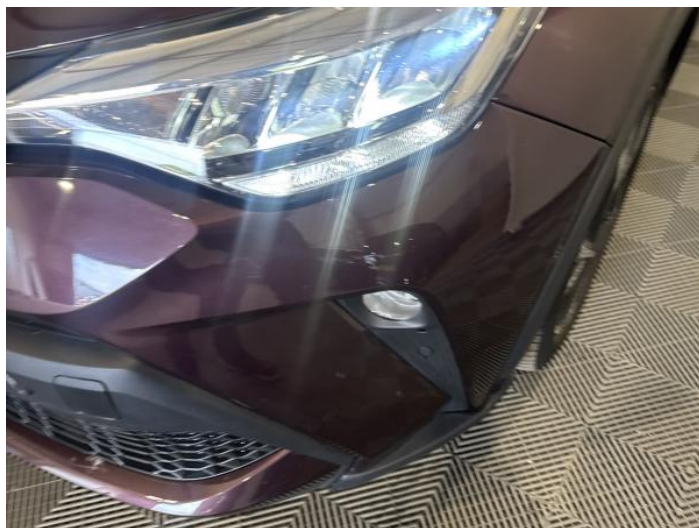
2: Bumper Front
Chipped
Multiple Chips

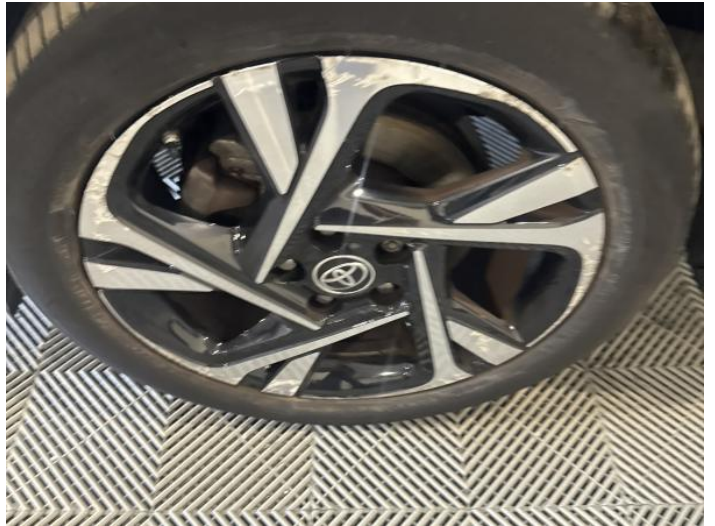
4: Wheel nsf
Corroded
Light

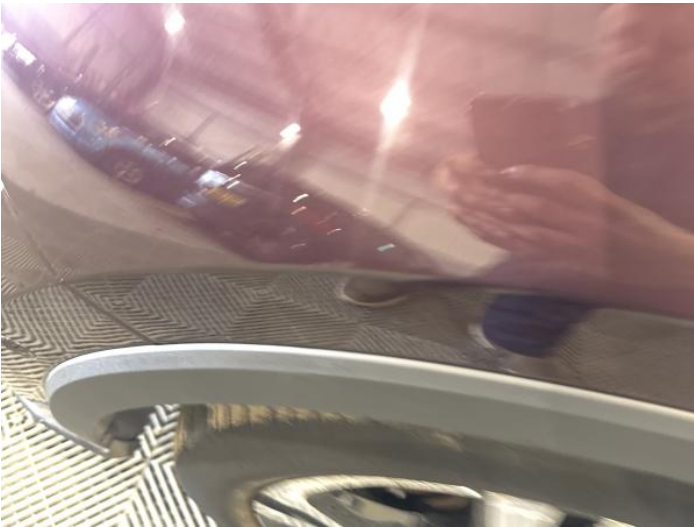
5: Wing nsf
Dented
Over 2 UpTo 10mm

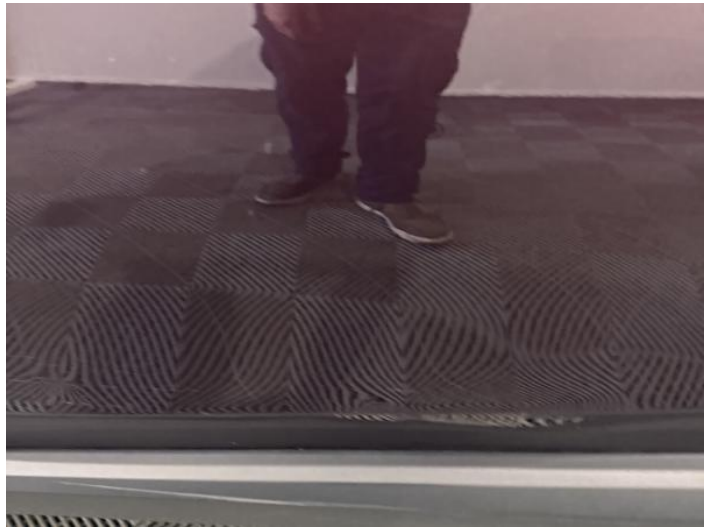
6: Door nsf
Dented
With Paint Damage

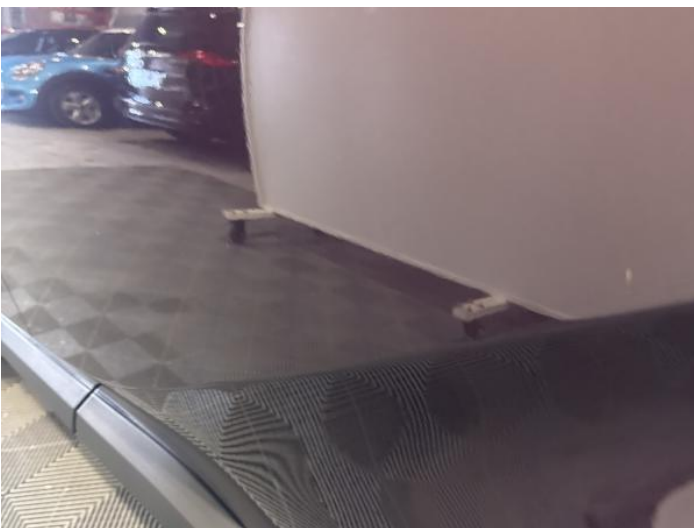
7: Door nsr
Chipped
1 To 5

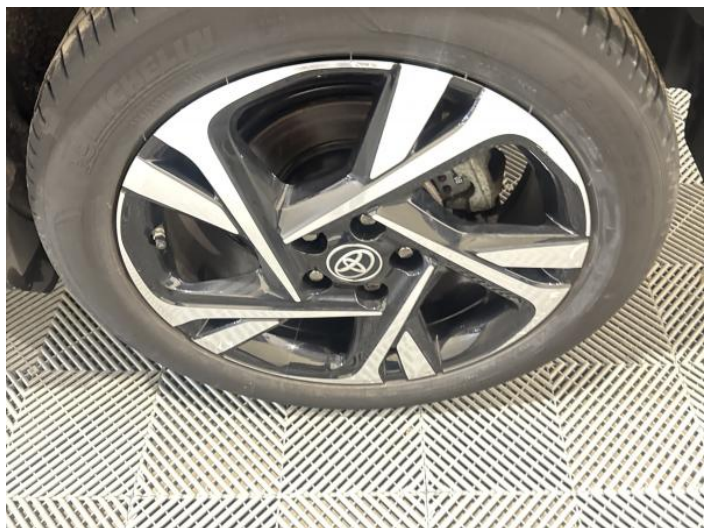
8: Wheel nsr
Scratched
Up To 50mm

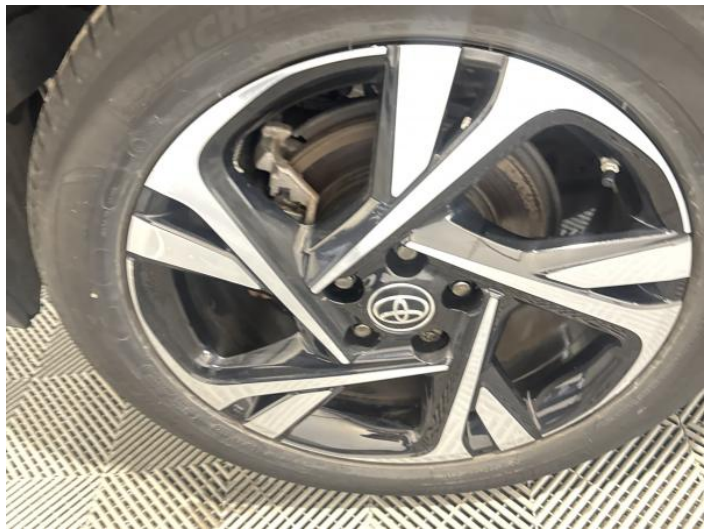
12: Wheel osr
Scratched
Over 50mm

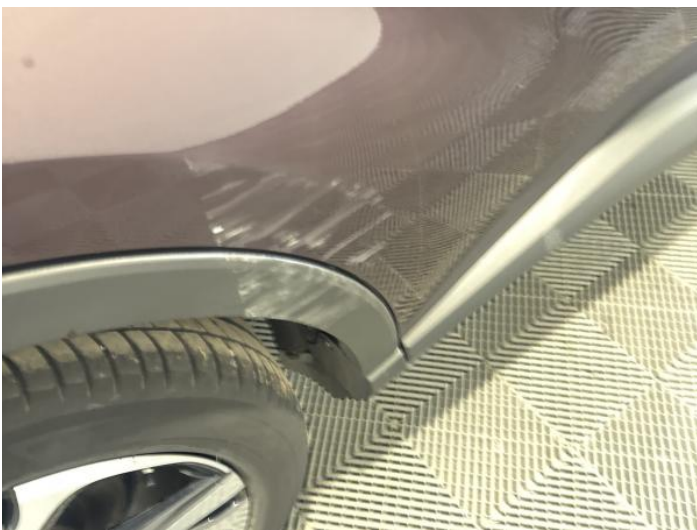
13: Door osr
Dented
With Paint Damage

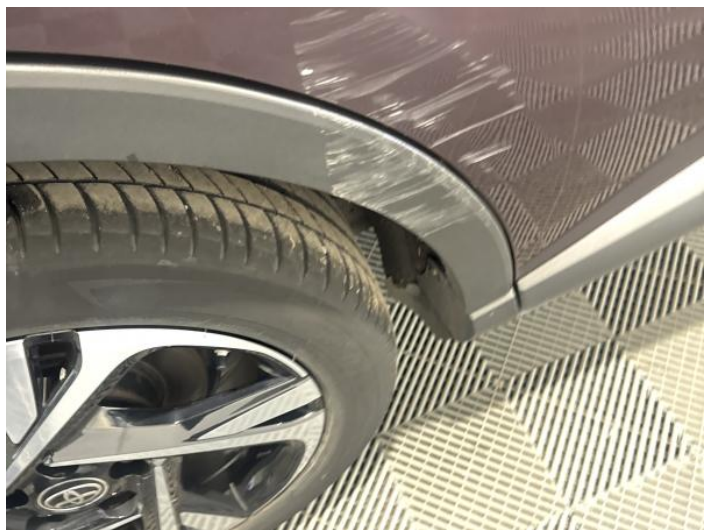
14: Qtr Panel Trim os
Scuffed
Over 25mm

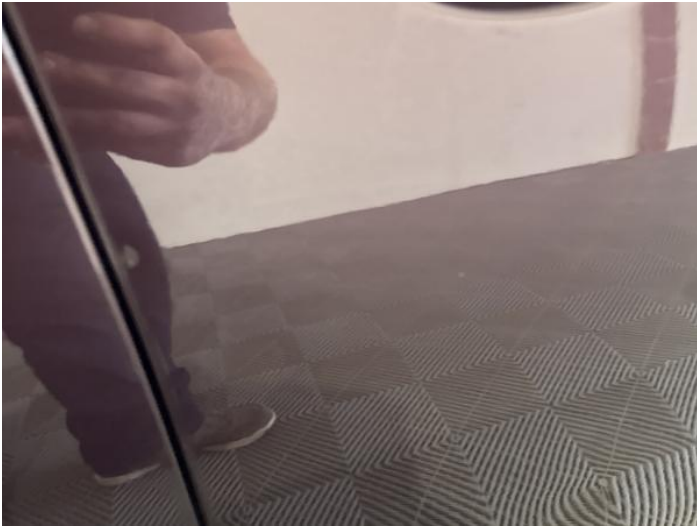
15: Door osf
Dented
Over 2 UpTo 10mm

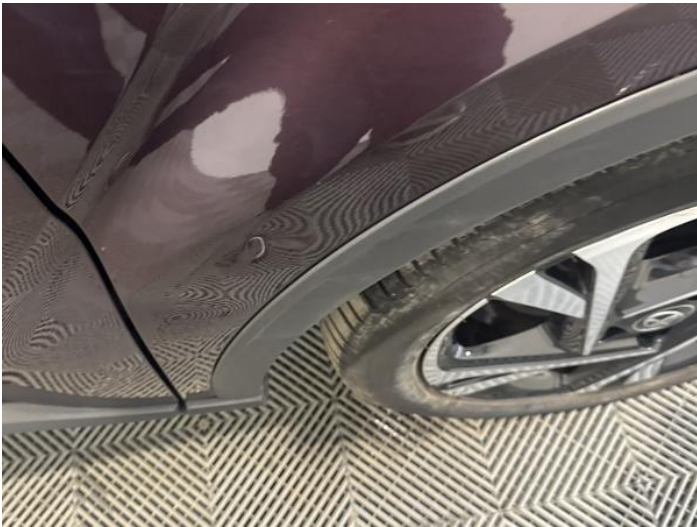
17: Wing osf
Dented
Over 30mm

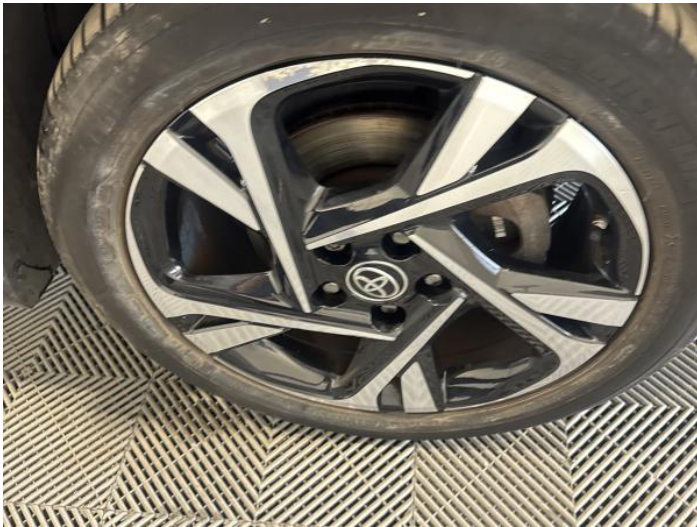
18: Wheel osf
Scratched
Over 50mm
