VEHICLE INSPECTION REPORT

GY09OKM

Volvo XC60 D5 [205] SE Lux Premium 5dr AWD Geartronic

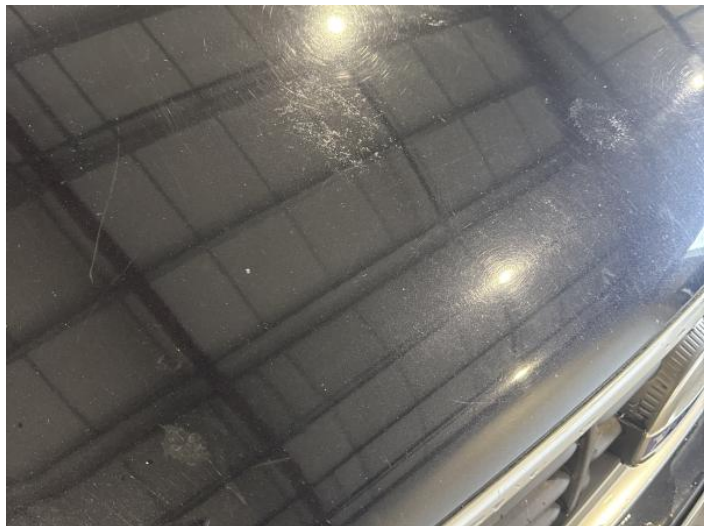
2: Bonnet
Scratched
Over 25mm Thru Paint

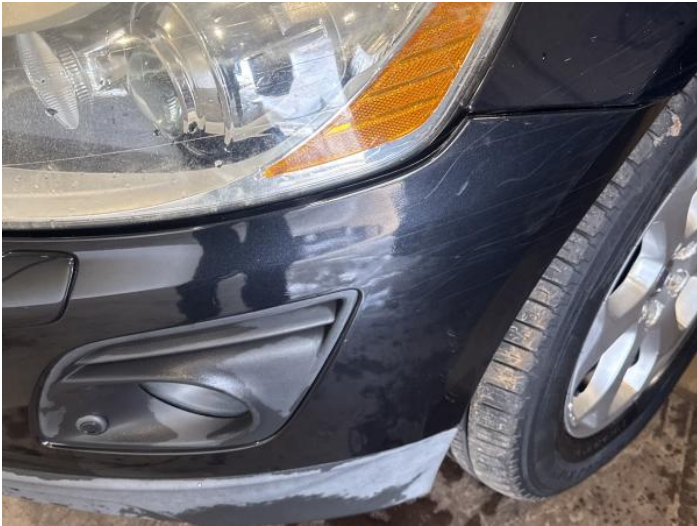
3: Bumper Front
Scratched
Over 100mm Thru Paint

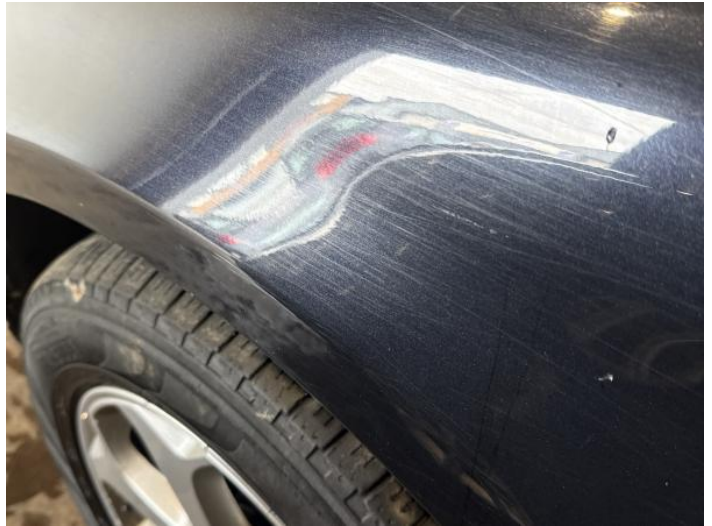
4: Wing nsf
Scratched
Over 25mm Thru Paint

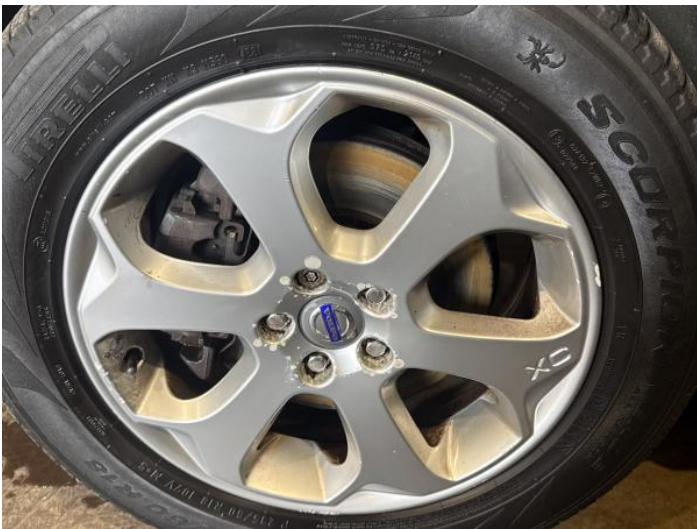
5: Wheel nsf
Scratched
Up To 50mm

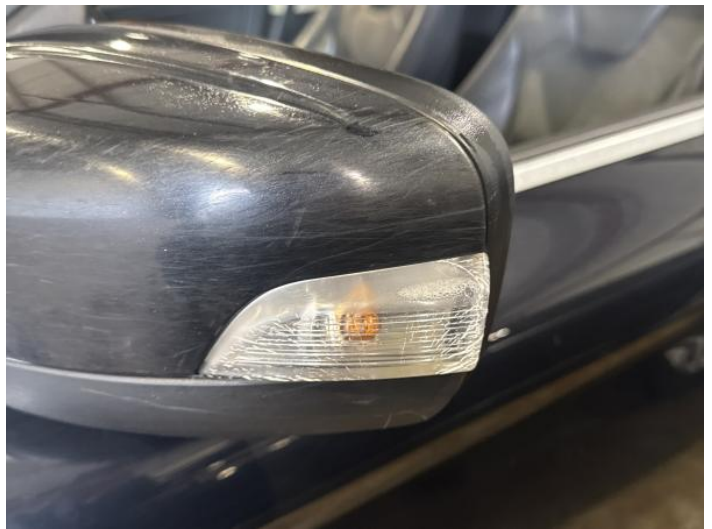
6: Flasher Side Repeater ns
Broken
Replace

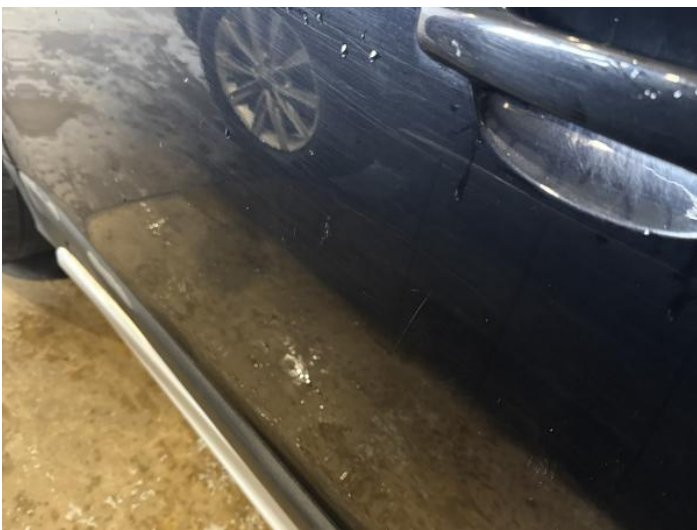
7: Door nsf
Scratched
Over 25mm Thru Paint

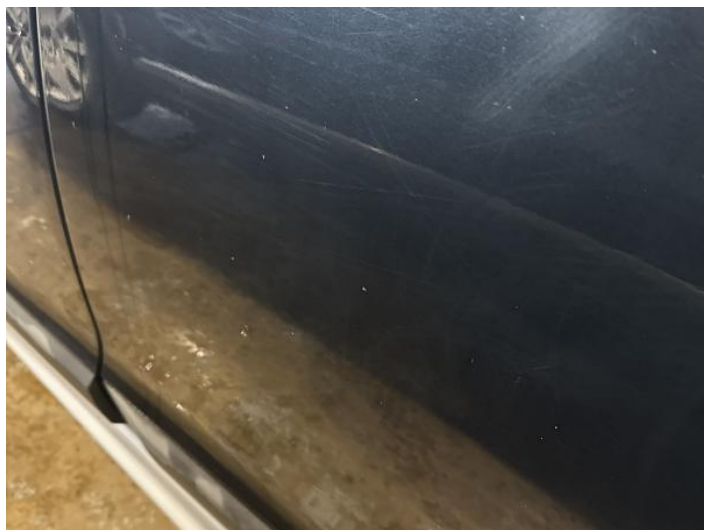
8: Door nsr
Chipped
Multiple Chips

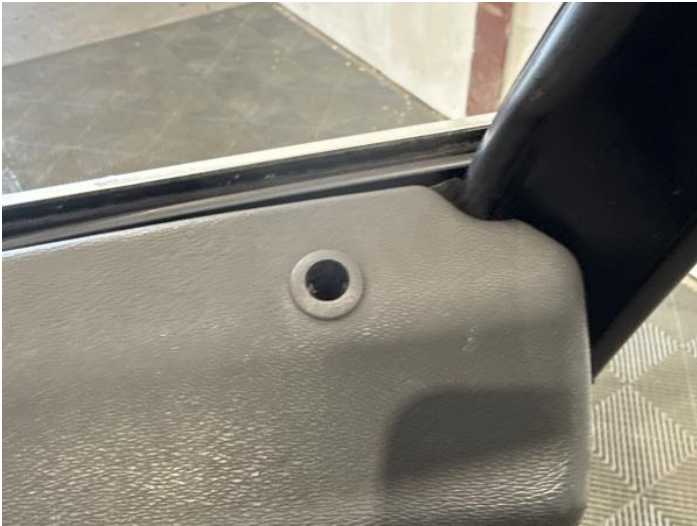
9: Switches And Controls
Missing
Replace

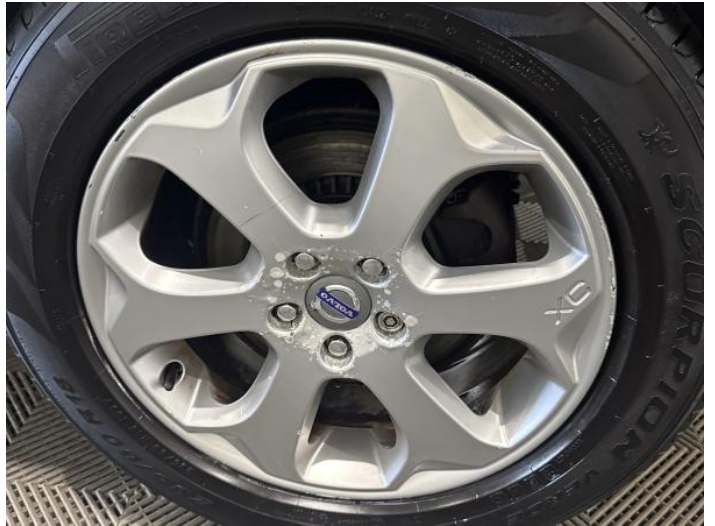
10: Wheel nsr
Scratched
Over 50mm

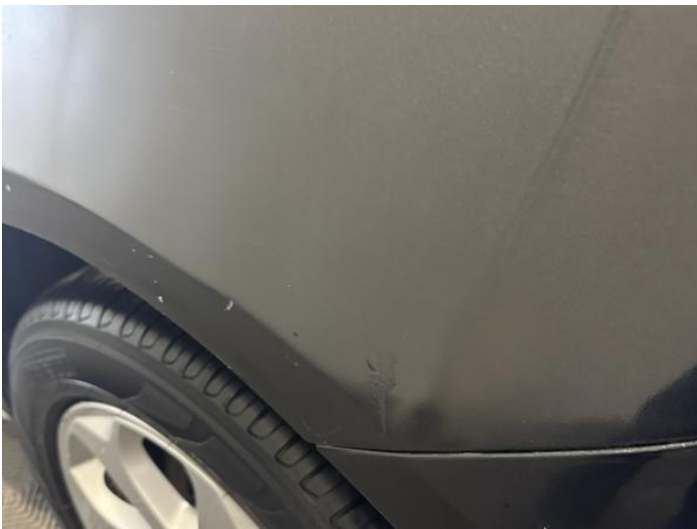
11: Qtr Panel nsr
Poor Previous Repair
Poor Paint

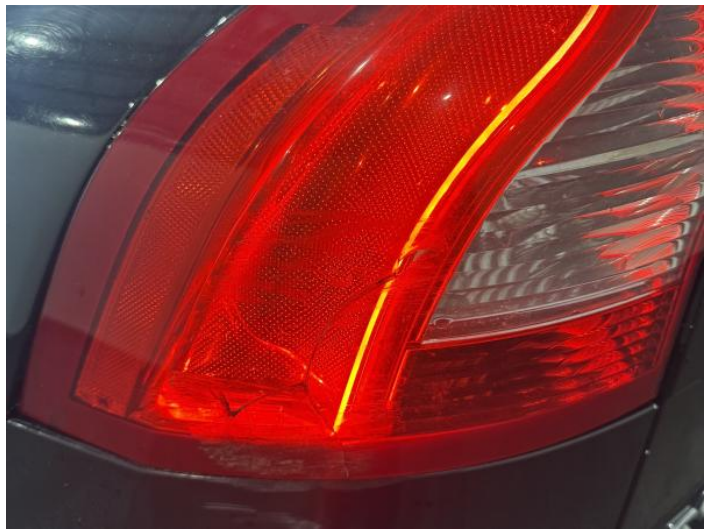
12: Lamp nsr
Broken
Replace

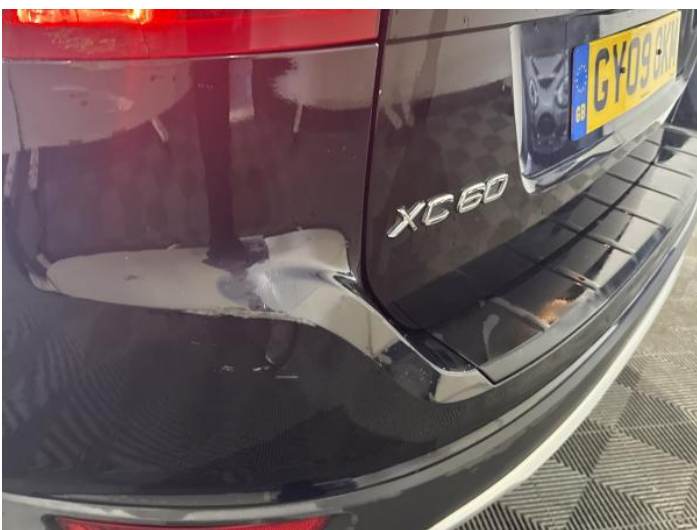
13: Bumper Rear
Scratched
25 to 100mm Thru Paint

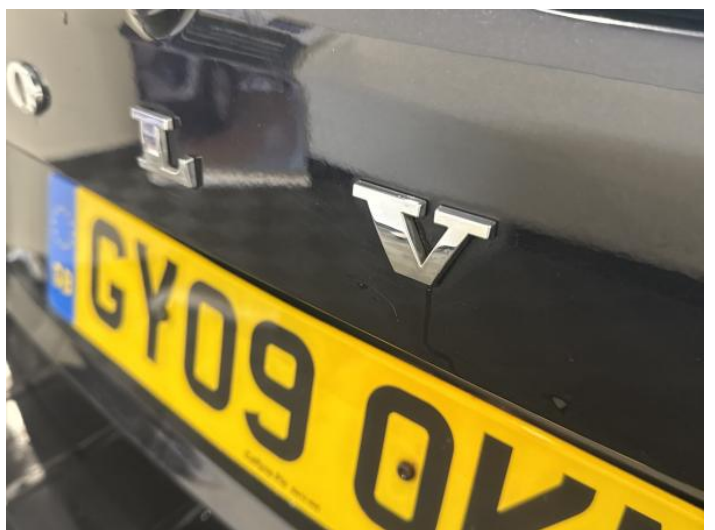
14: Tailgate
Scratched
UpTo 25mm Thru Paint

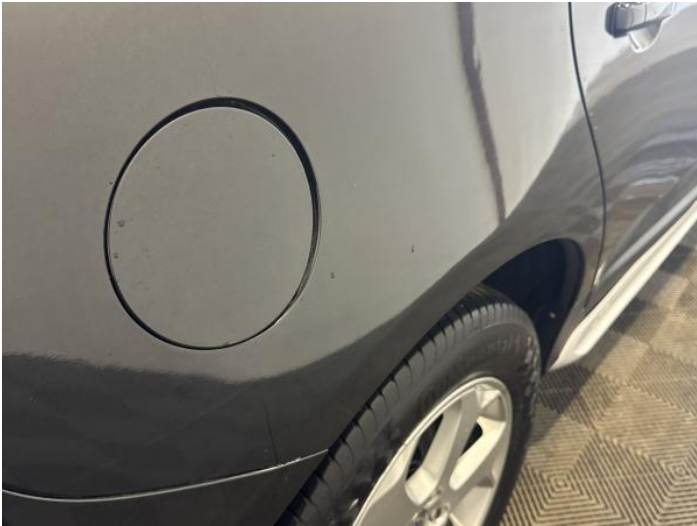
15: Qtr Panel osf
Scratched
Over 25mm Thru Paint

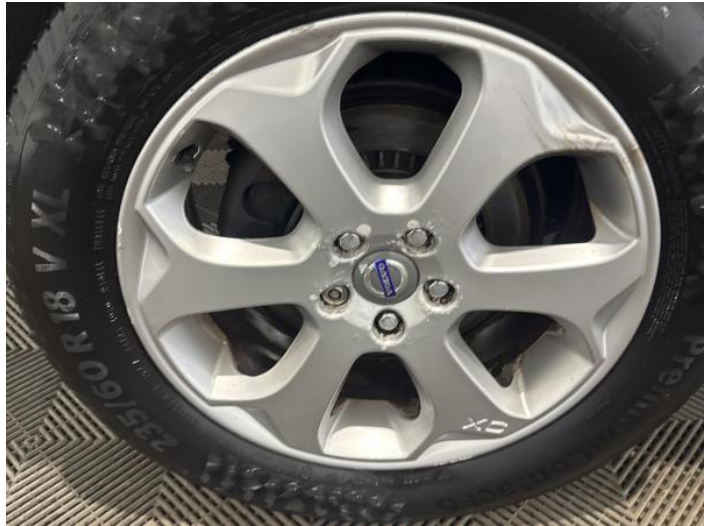
16: Wheel osf
Scratched
Over 50mm

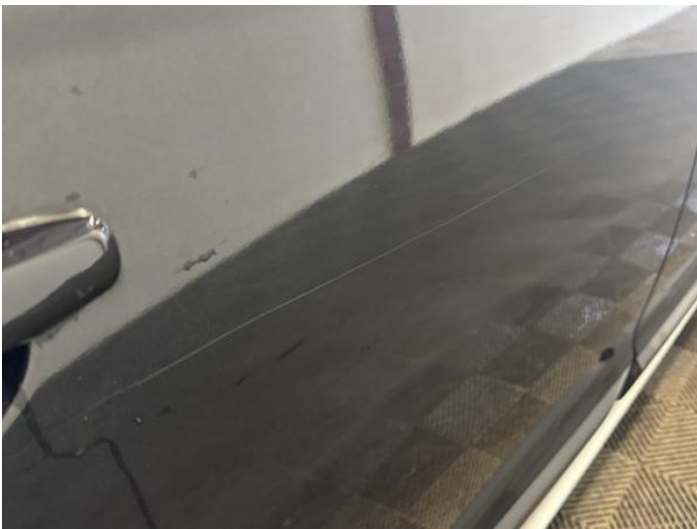
17: Door osf
Scratched
Over 25mm Thru Paint

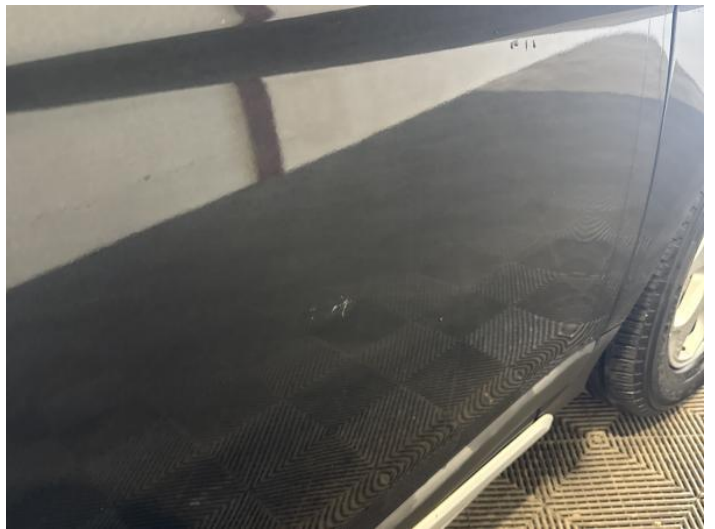
18: Door osf
Scratched
Over 25mm Thru Paint

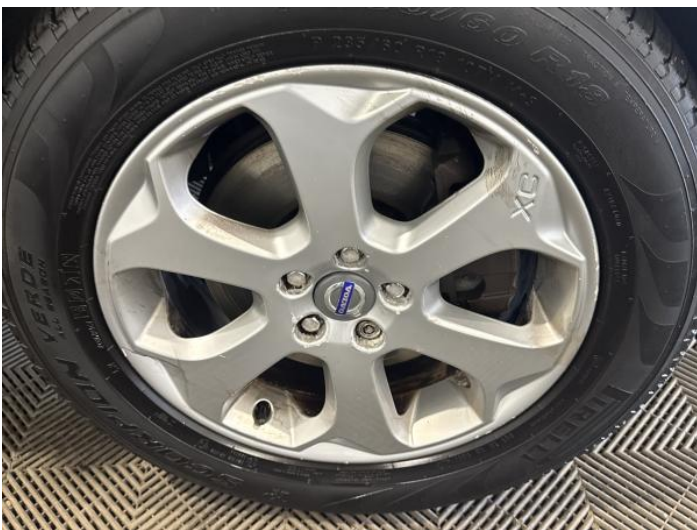
19: Wheel osf
Scratched
Over 50mm

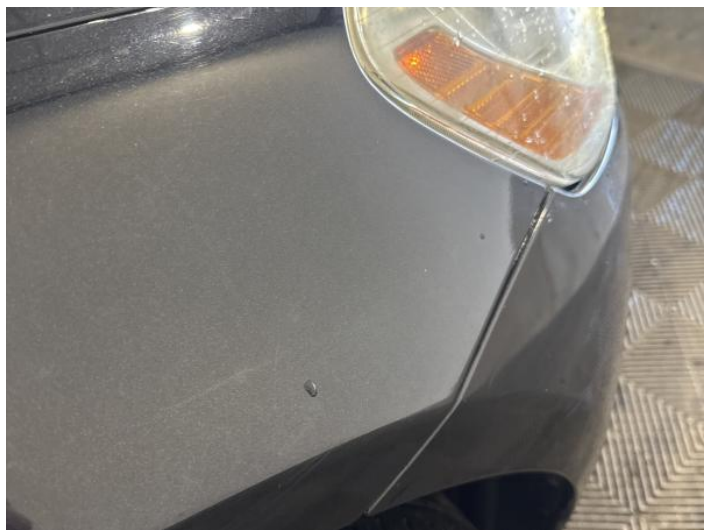
20: Wing osf
Chipped
1 To 5

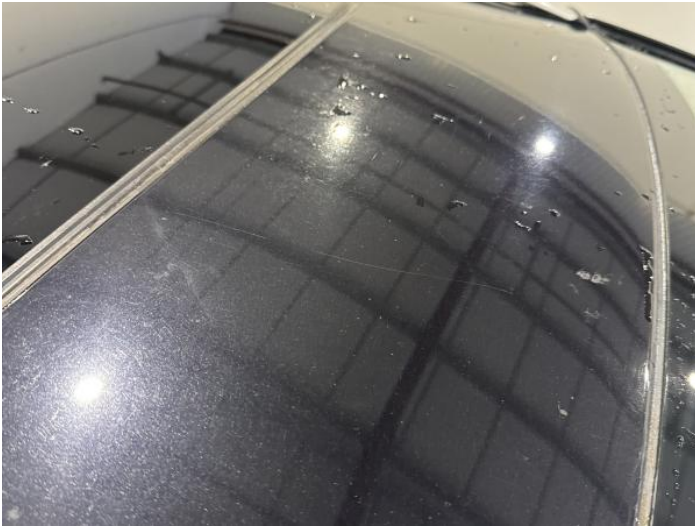
21: Roof
 Scratched
 Over 25mm Thru Paint
