# VEHICLE INSPECTION REPORT

**RV13PXP**

## Ford Fiesta 1.0 EcoBoost Zetec 5dr

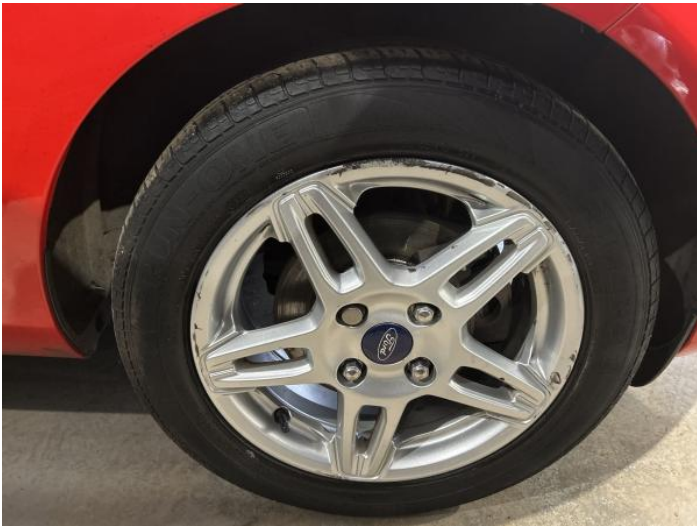
1: Wheel of  
Scratched  
Over 50mm

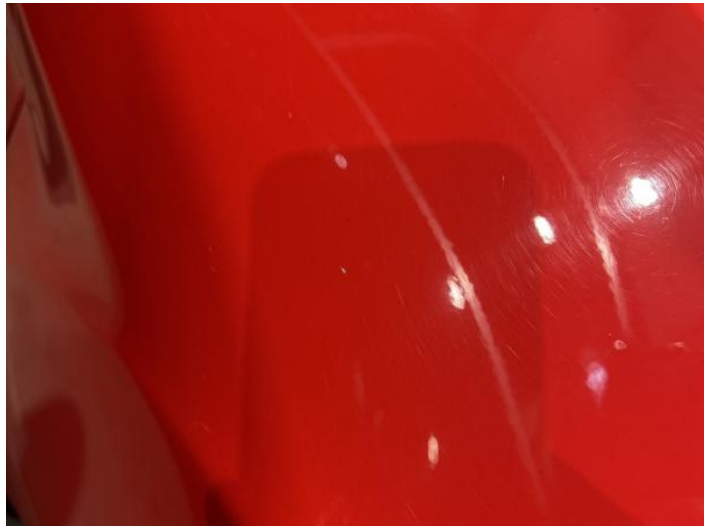
2: Wing of  
Chipped  
1 To 5

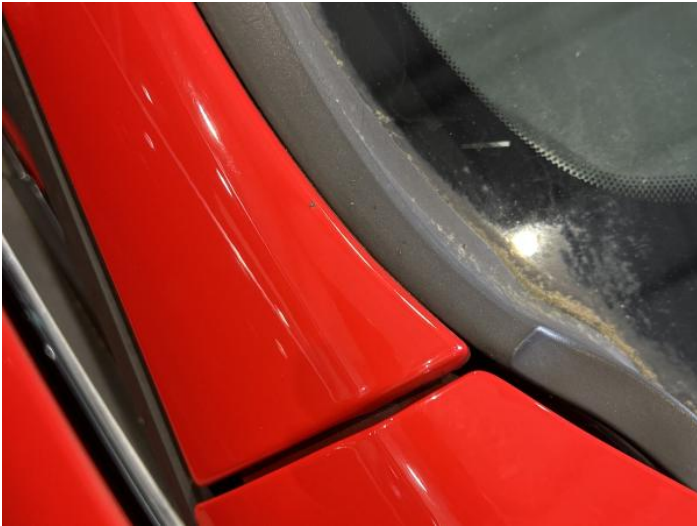
3: A Post os  
Chipped  
1 To 5

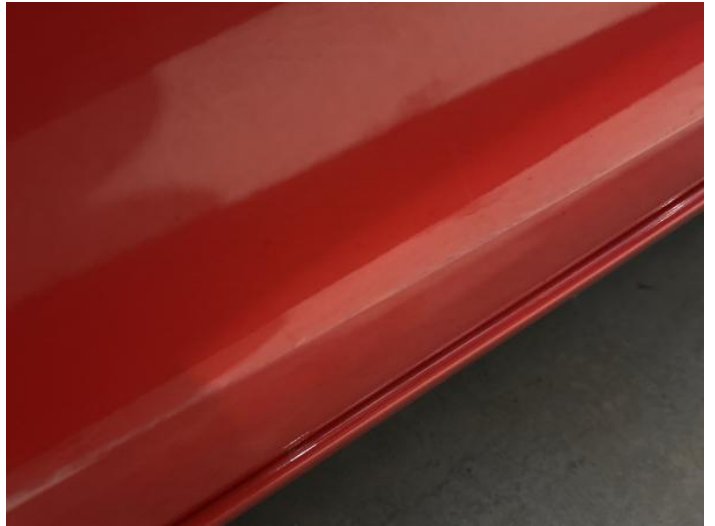
4: Door osf  
Scratched  
Over 25mm Thru Paint

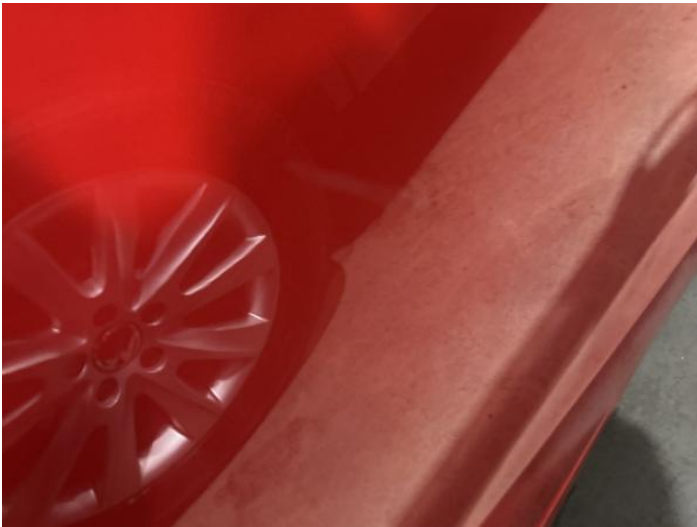
5: Door osr  
Scratched  
Over 25mm Thru Paint

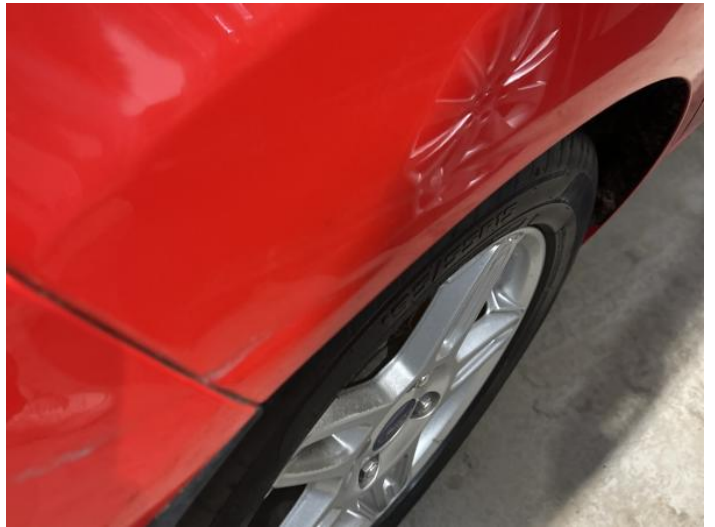
6: Qtr Panel osr  
Dented  
With Paint Damage

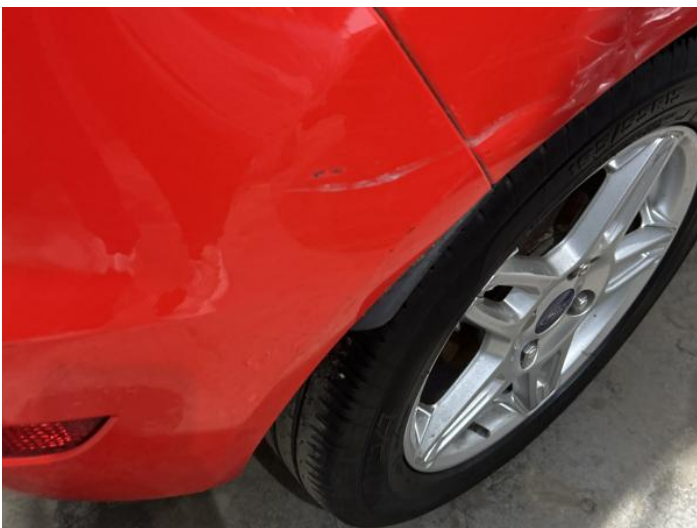
7: Bumper Rear  
Scratched  
25 to 100mm Thru Paint

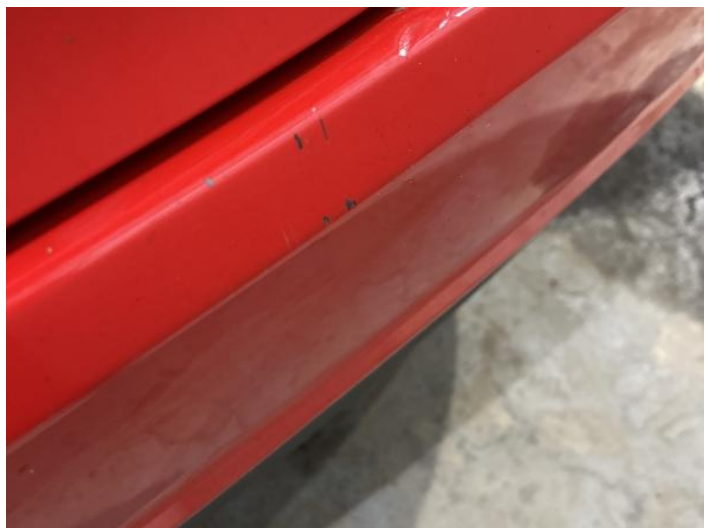
8: Bumper Rear  
Chipped  
Multiple Chips

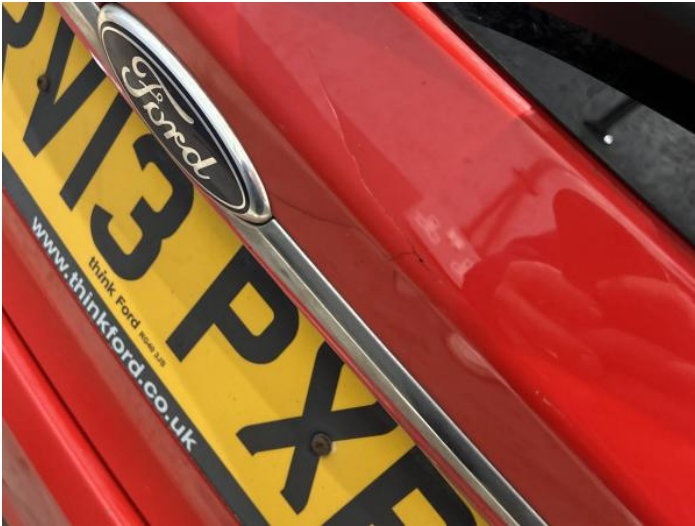
9: Tailgate  
Poor Previous Repair  
Poor Paint

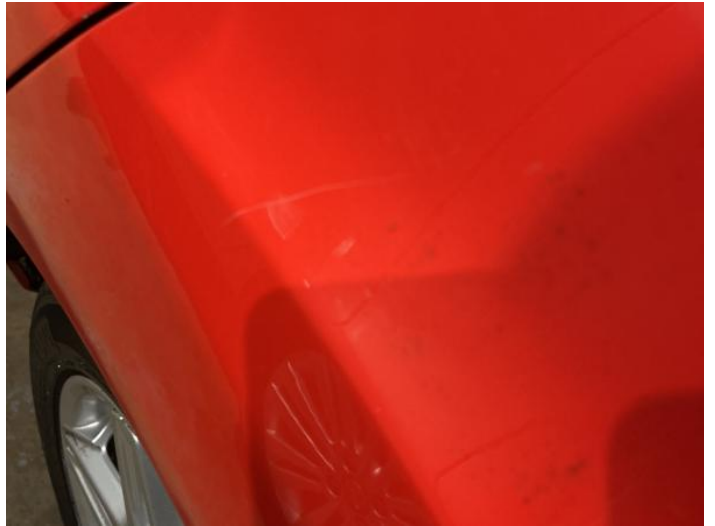
10: Qtr Panel nsr  
Scratched  
Over 25mm Not Thru Paint

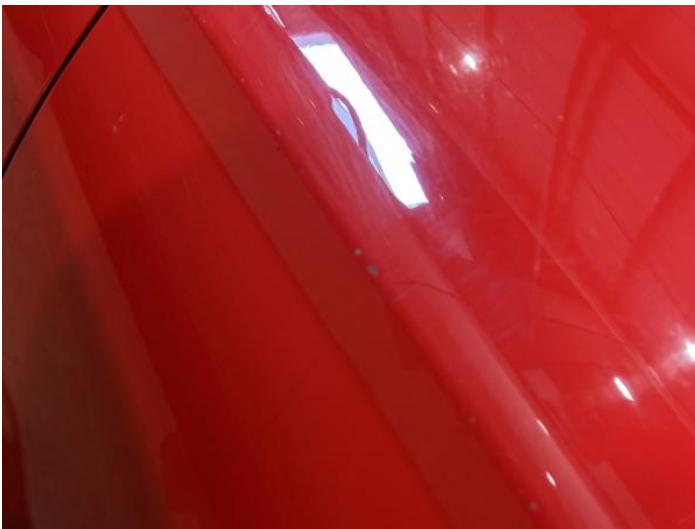
11: Door nsr  
Chipped  
Multiple Chips

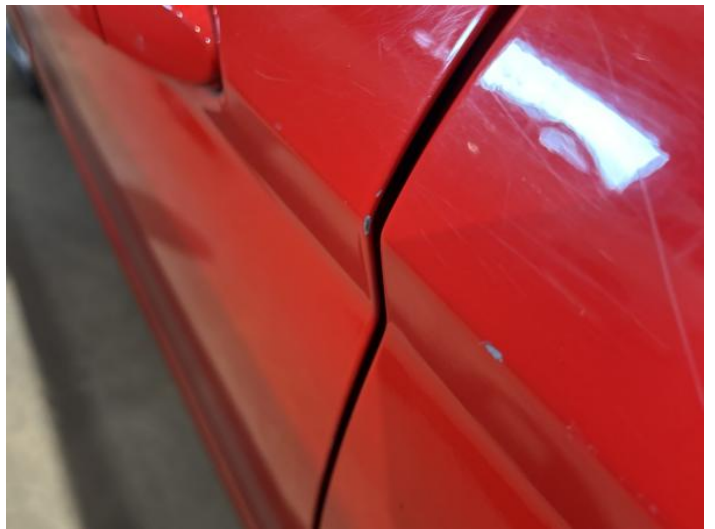
12: Door nsf  
Chipped  
Edge Chip

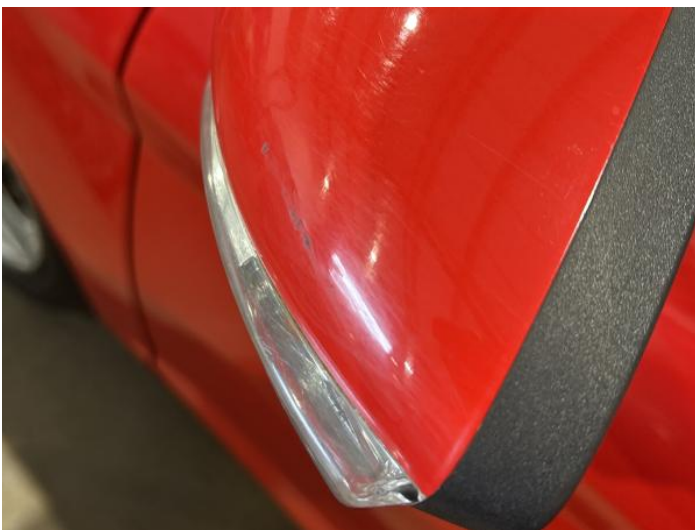
13: Door Mirror Assy nsf  
Scratched (Painted)  
Up To 25mm Thru Paint

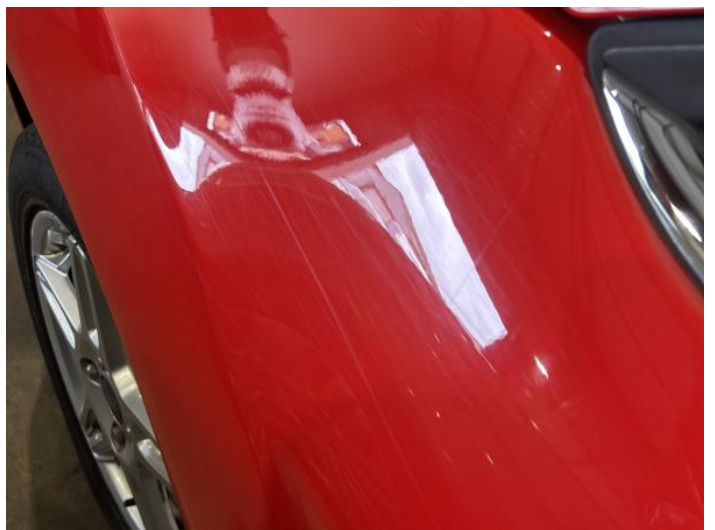
14: Wing nsf  
Scratched  
Over 25mm Not Thru Paint

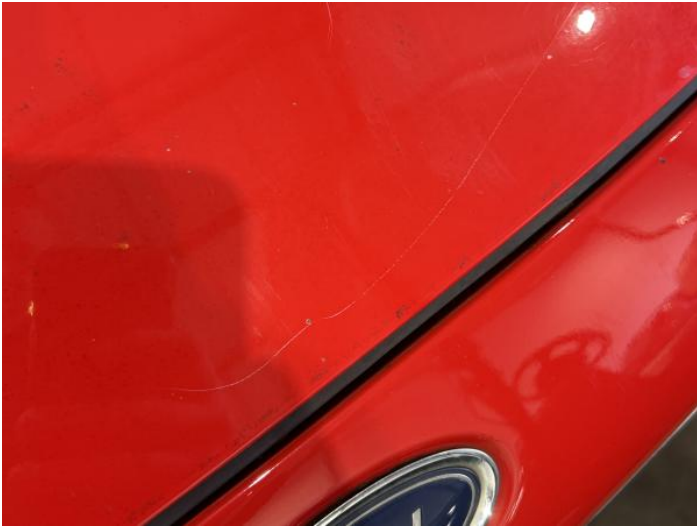
15: Bonnet  
Scratched  
Over 25mm Thru Paint

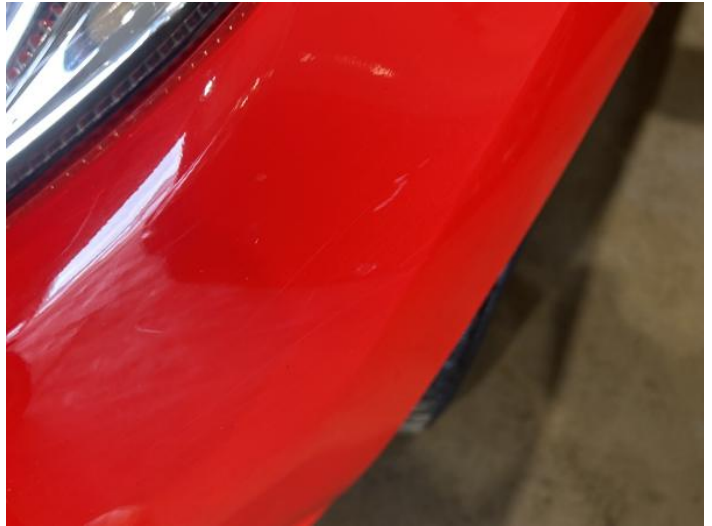
16: Bumper Front  
Scratched  
Over 25mm Not Thru Paint

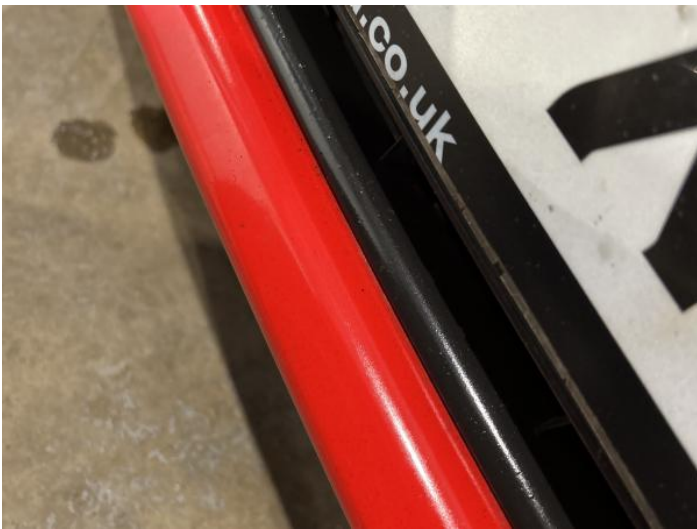
17: Bumper Front  
Chipped  
Multiple Chips

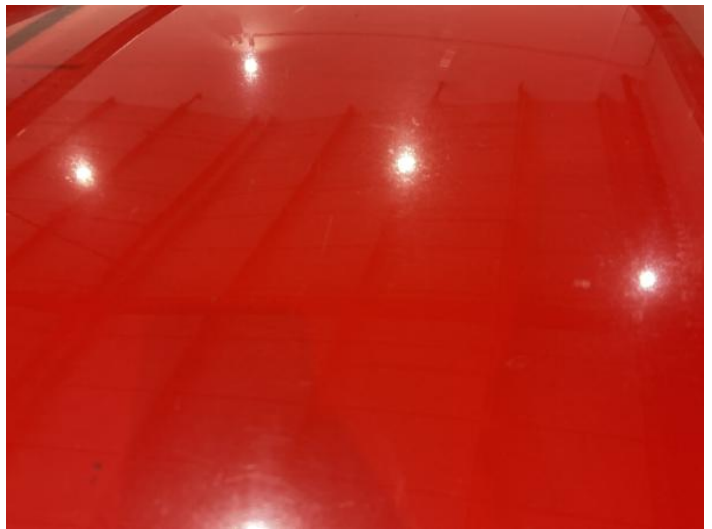
18: Roof  
Scratched  
Over 25mm Not Thru Paint

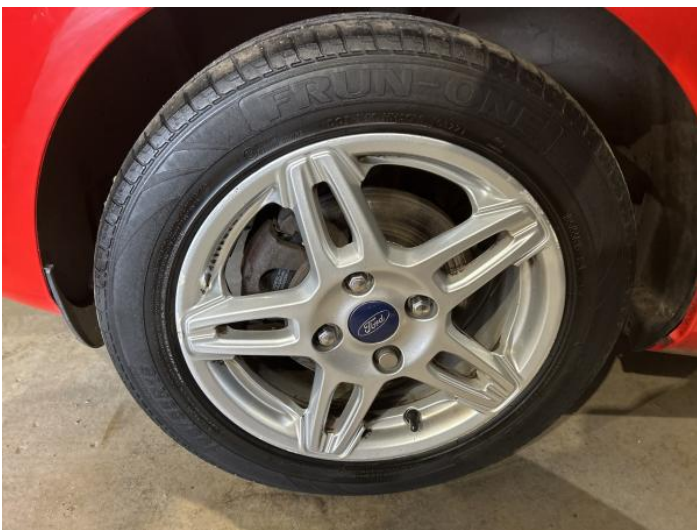
19: Wheel nsf  
Scratched  
Over 50mm
