VEHICLE INSPECTION REPORT

FH660TR

Fiat Tipo 1.4 Easy Plus 5dr

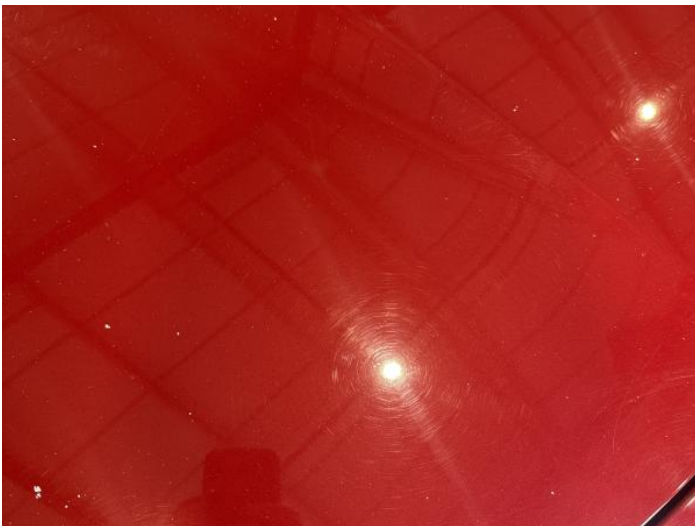
1: Bonnet
Chipped
Multiple Chips

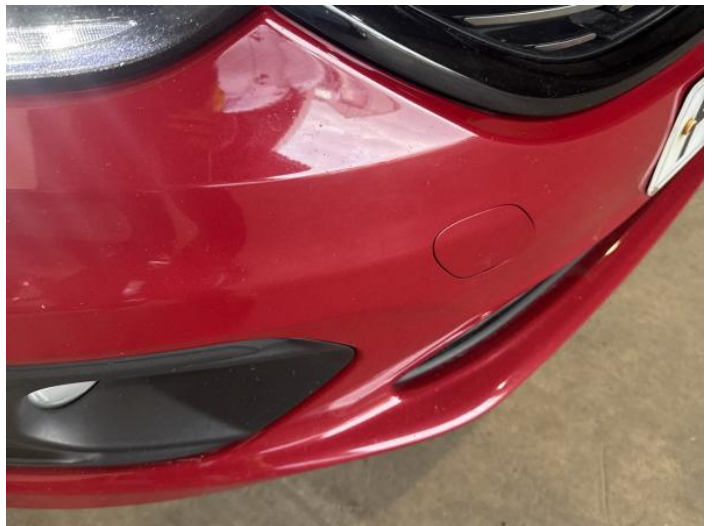
2: Bumper Front
Chipped
Multiple Chips

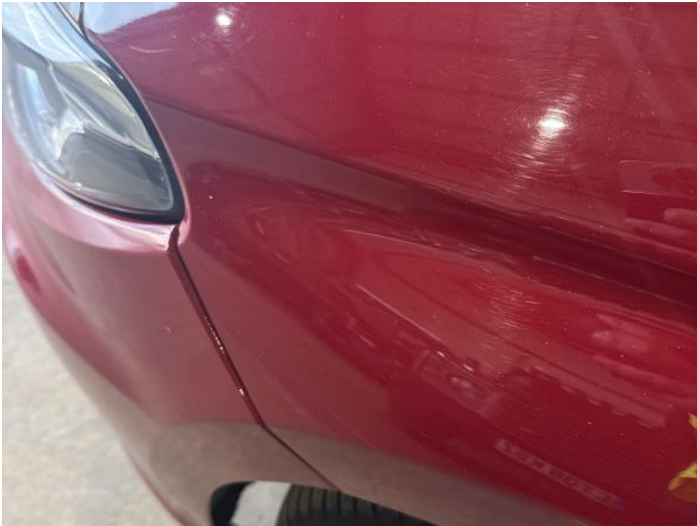
3: Wing nsf
Scratched
Over 25mm Thru Paint

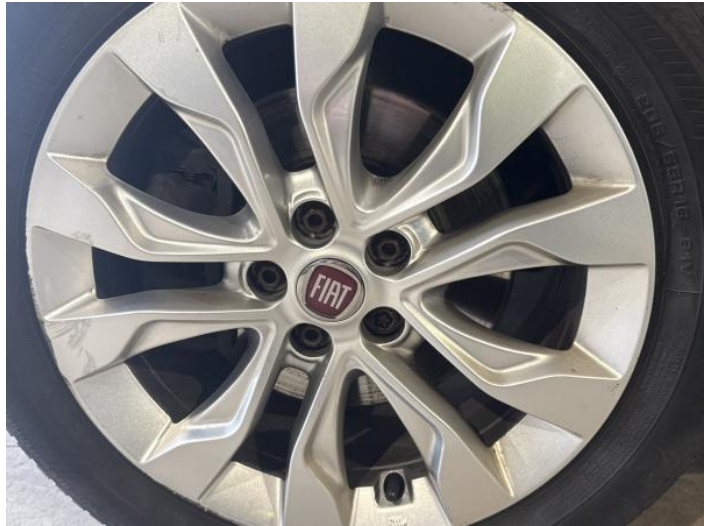
4: Wheel nsf
Scratched
Over 50mm

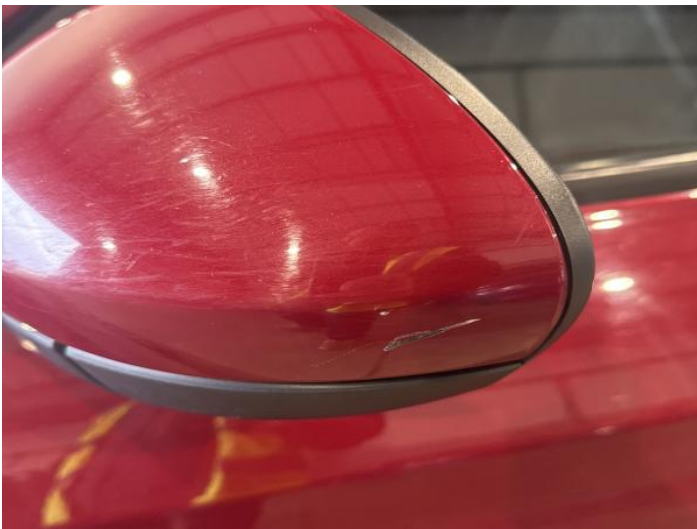
5: Door Mirror Assy nsf
Scratched (Painted)
Over 25mm Thru Paint

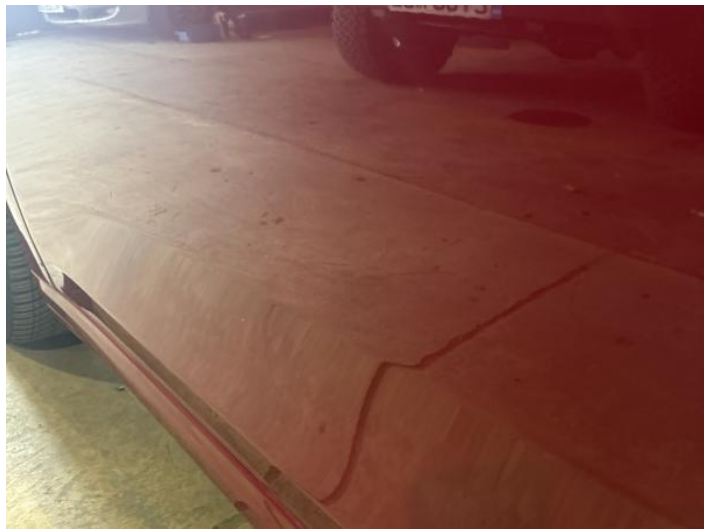
6: Door nsf
Dented
Between 10mm + 30mm

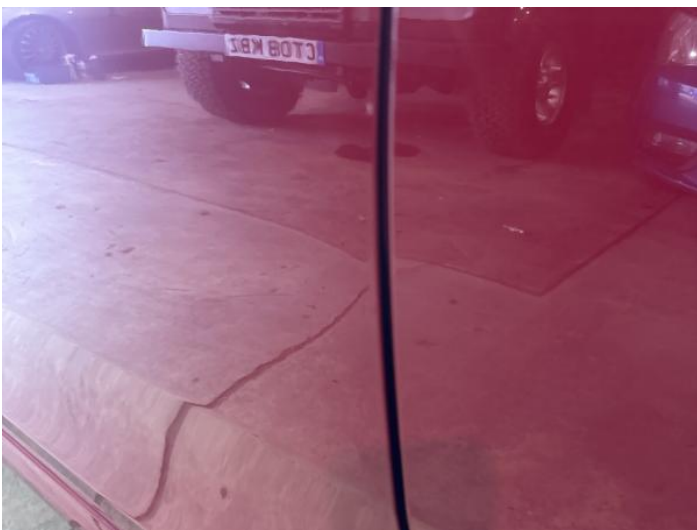
7: Door nsf
Chipped
Edge Chip

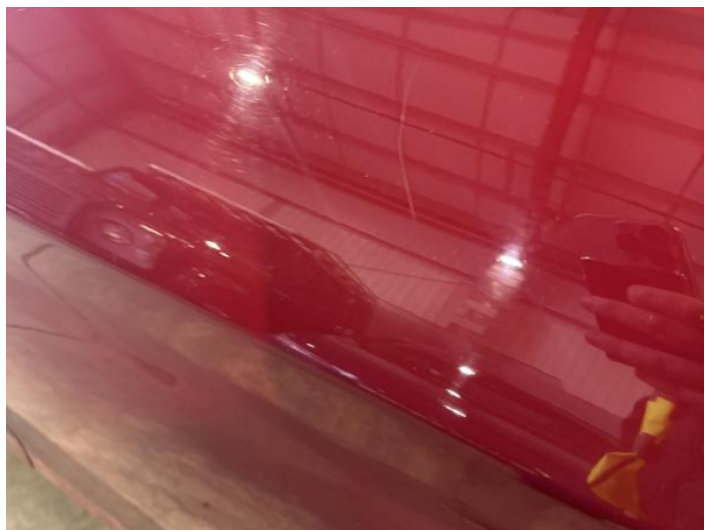
8: Door nsr
Scratched
Over 25mm Thru Paint

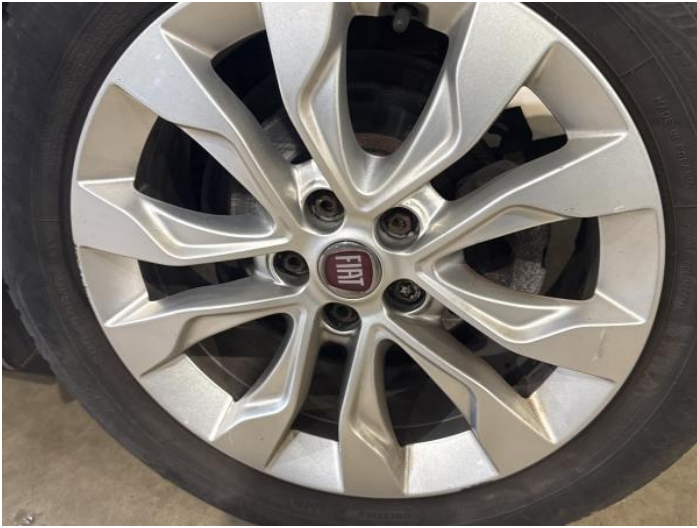
9: Wheel nsr
Scratched
Over 50mm

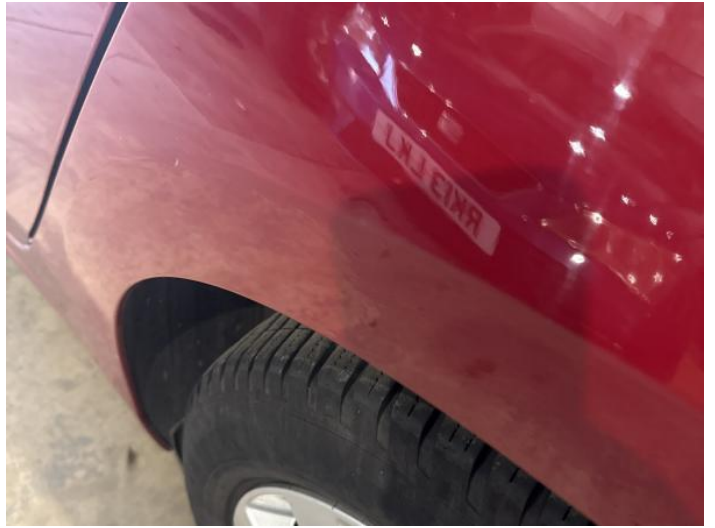
10: Qtr Panel nsr
Dented
Between 10mm + 30mm

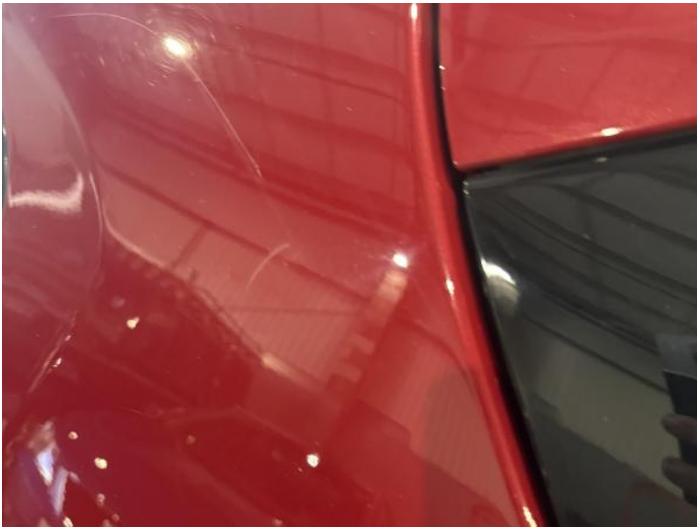
11: Qtr Panel nsr
Scratched
Over 25mm Thru Paint

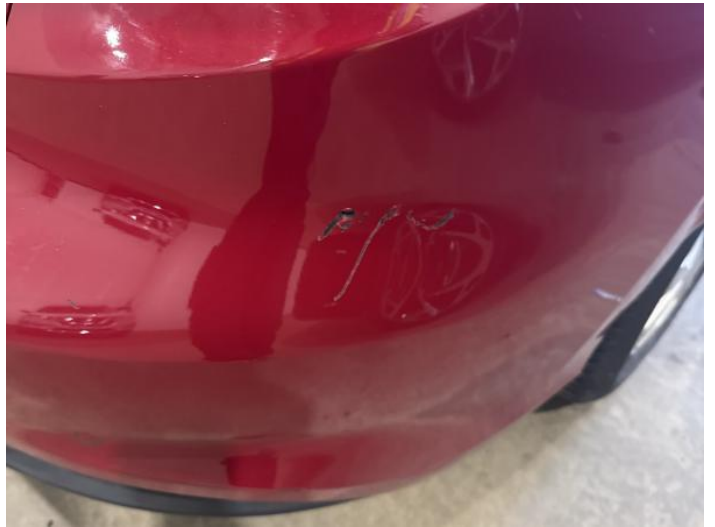
12: Bumper Rear
Dented
With Paint Damage

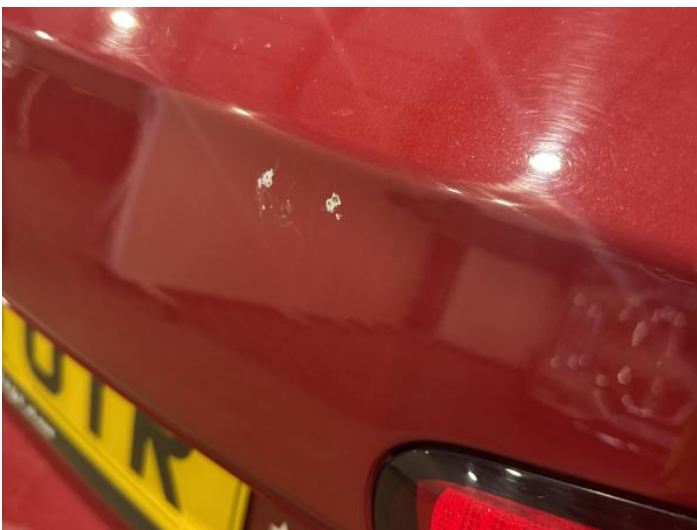
13: Tailgate
Scratched
Over 25mm Thru Paint

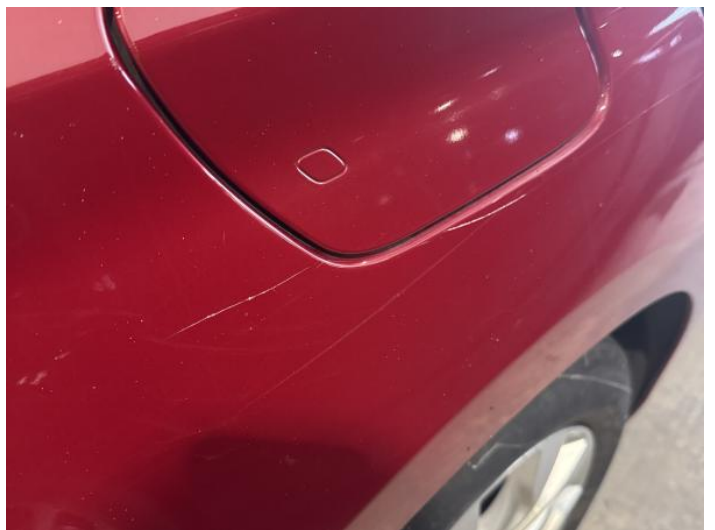
14: Qtr Panel osr
Scratched
Over 25mm Thru Paint

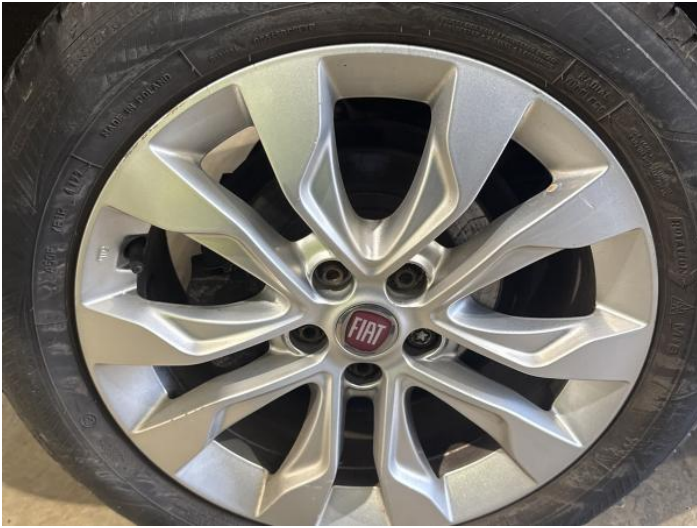
15: Wheel osr
Scratched
Up To 50mm

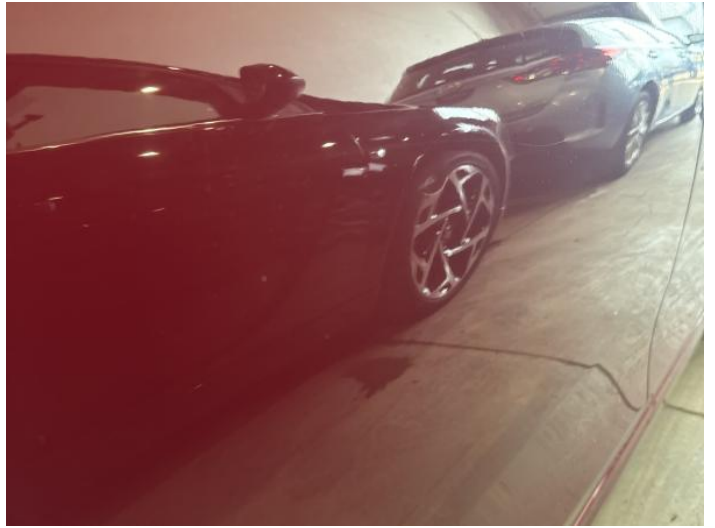
16: Door osr
Dented
With Paint Damage

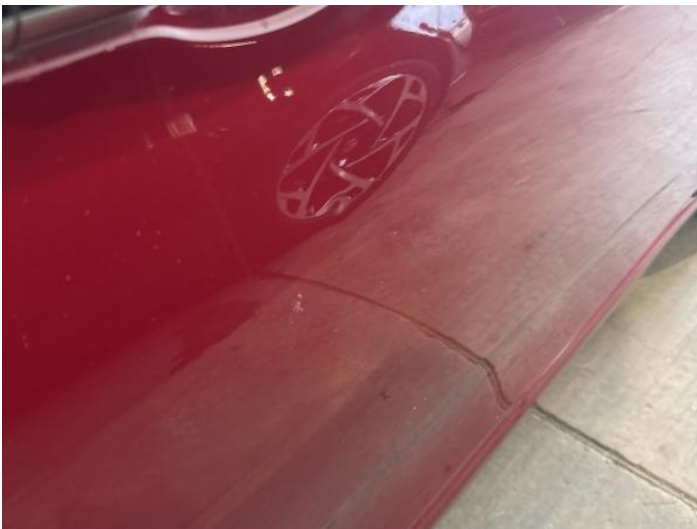
17: Door osf
Dented
Over 30mm

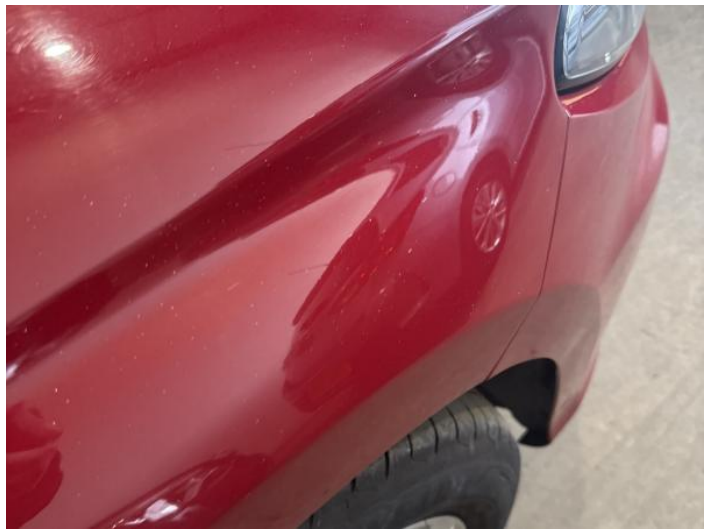
18: Wing osf
Chipped
Multiple Chips

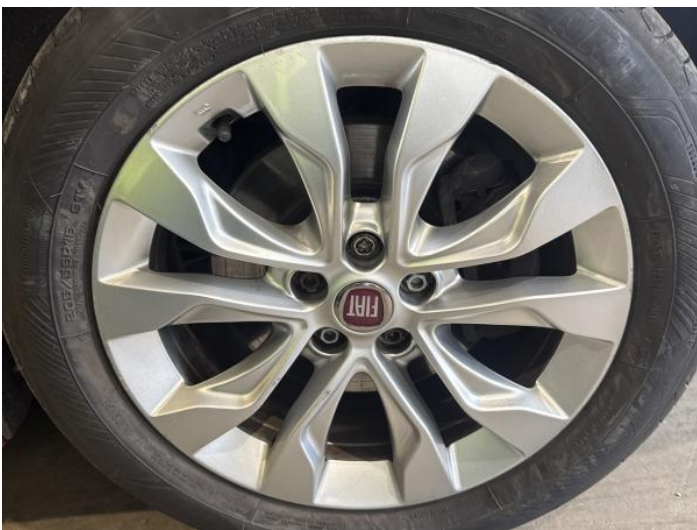
19: Wheel osf
Scratched
Over 50mm

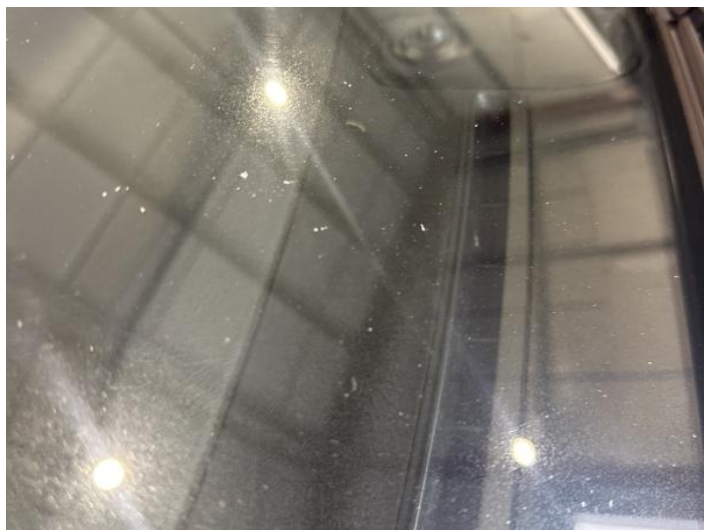
20: Screen Front
Chipped
UpTo 10mm

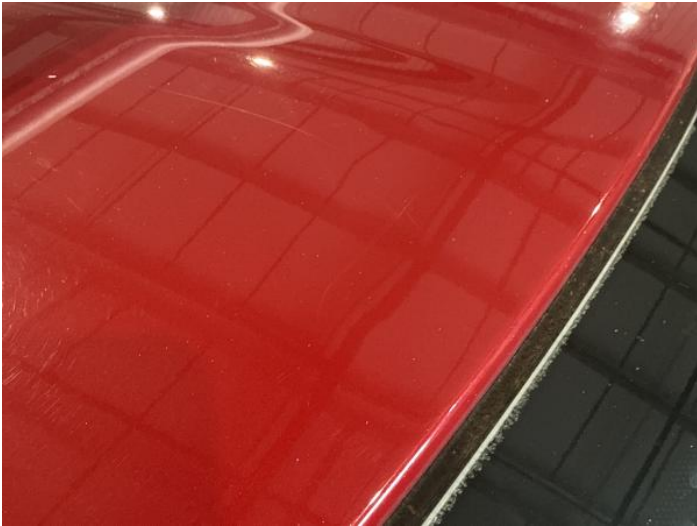
21: Roof
Dented
Over 30mm
