## VEHICLE INSPECTION REPORT

**SJ14LTA**

### Nissan Qashqai 1.2 DiG-T Acenta Premium 5dr

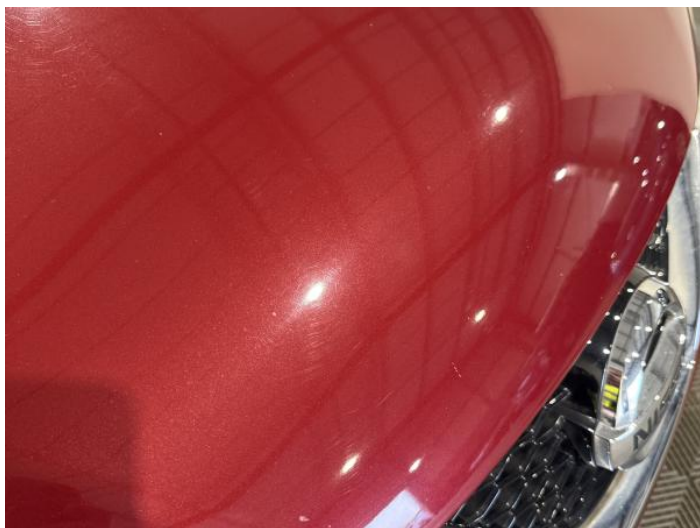
1: Bonnet  
Chipped  
Multiple Chips

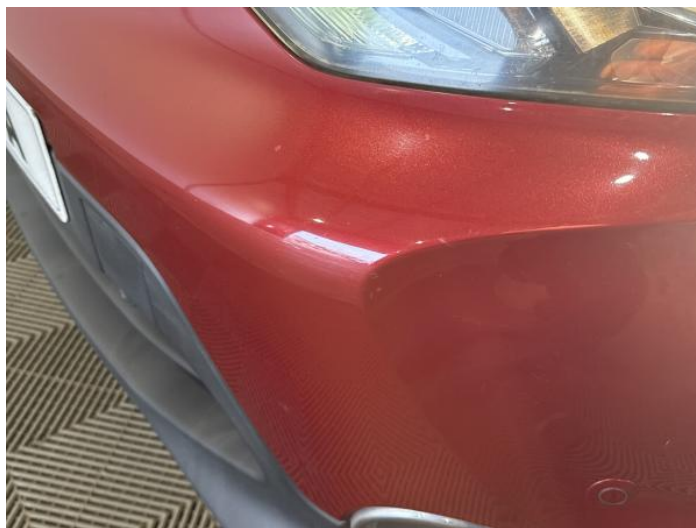
2: Bumper Front  
Chipped  
Multiple Chips

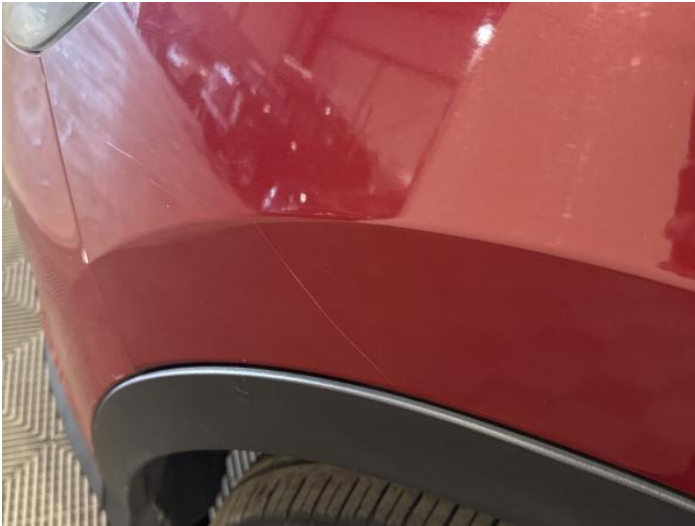
3: Wing nsf  
Scratched  
Over 25mm Thru Paint

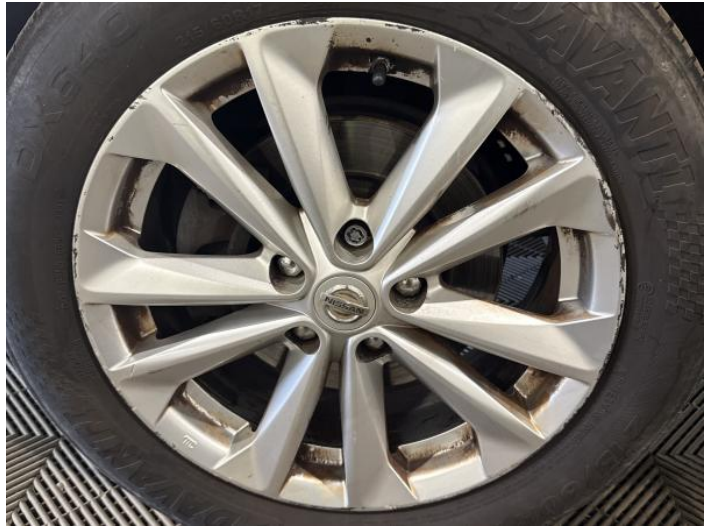
4: Wheel nsf  
Scratched  
Over 50mm

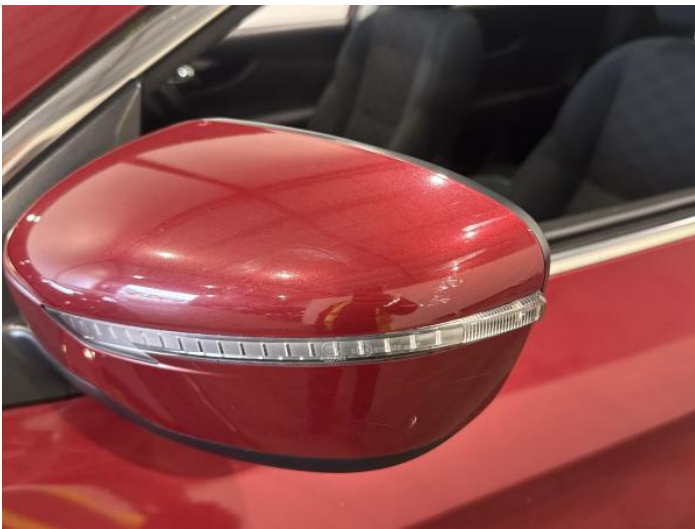
5: Door Mirror Assy nsf  
Scratched (Painted)  
UpTo 25mm Thru Paint

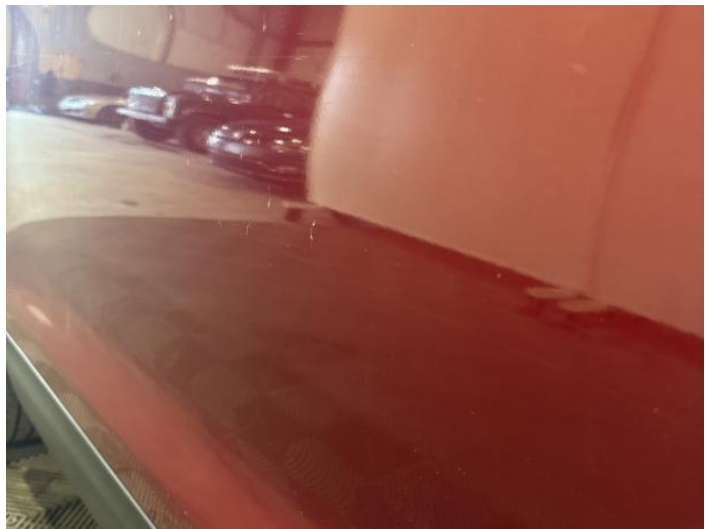
6: Door nsf  
Scratched  
Over 25mm Thru Paint

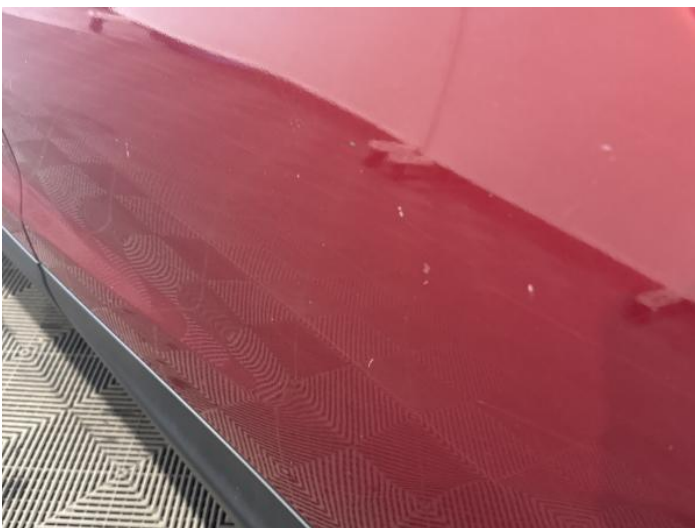
7: Door nsr  
Scratched  
Over 25mm Thru Paint

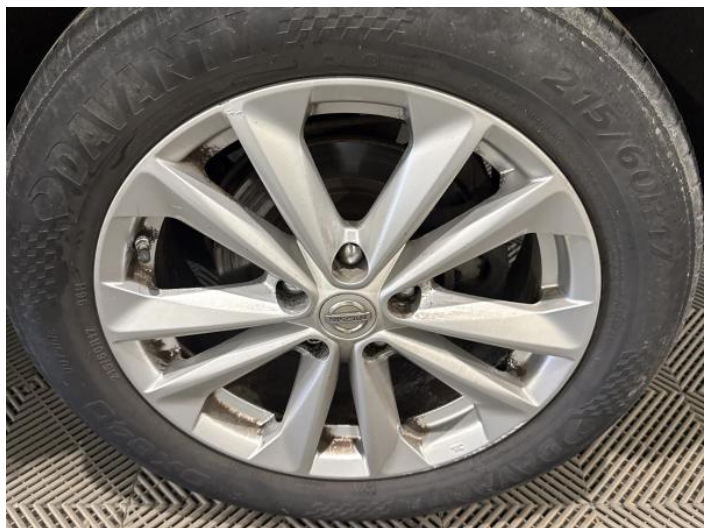
8: Wheel nsr  
Corroded  
Light

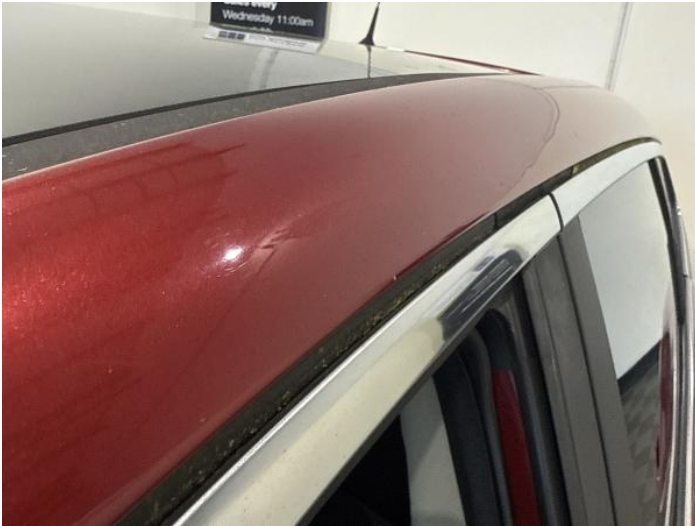
9: A Post ns  
Dented  
2 Or Less UpTo 10mm

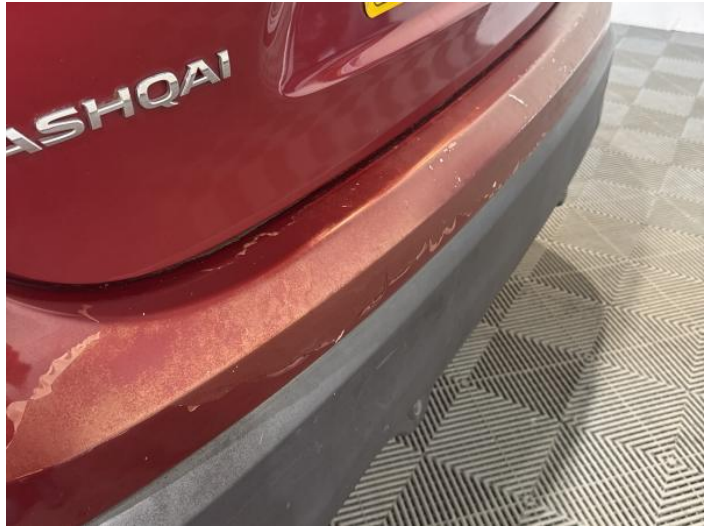
10: Bumper Rear  
Poor Previous Repair  
Paint Flake

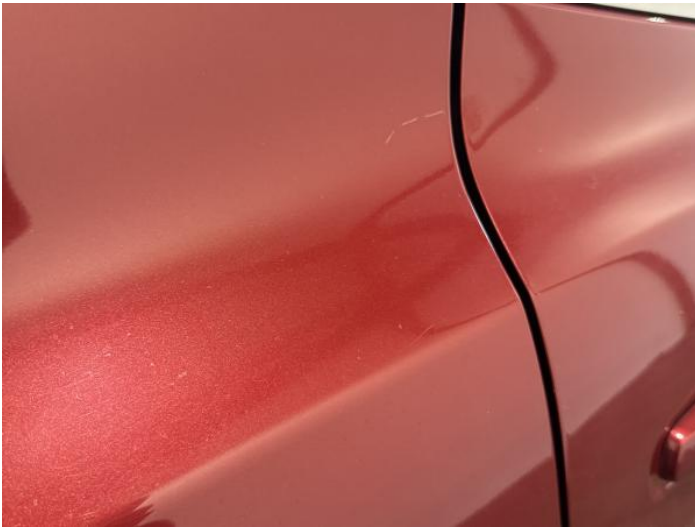
11: Qtr Panel osr  
Scratched  
Over 25mm Thru Paint

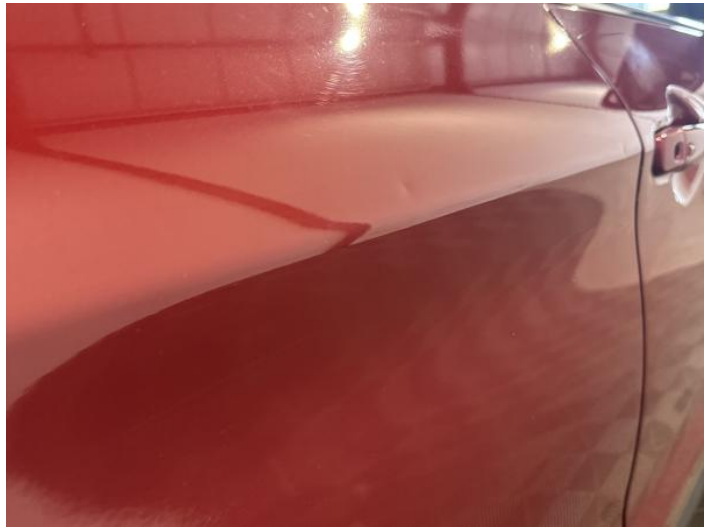
12: Door osr  
Dented  
Between 10mm + 30mm

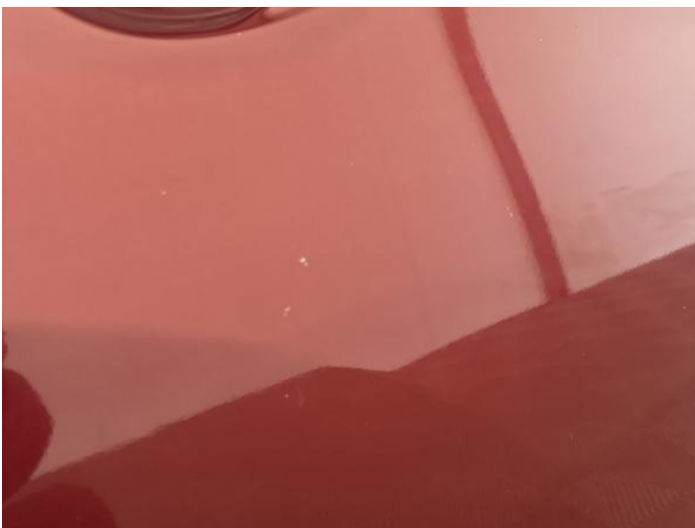
13: Door osr  
Chipped  
1 To 5

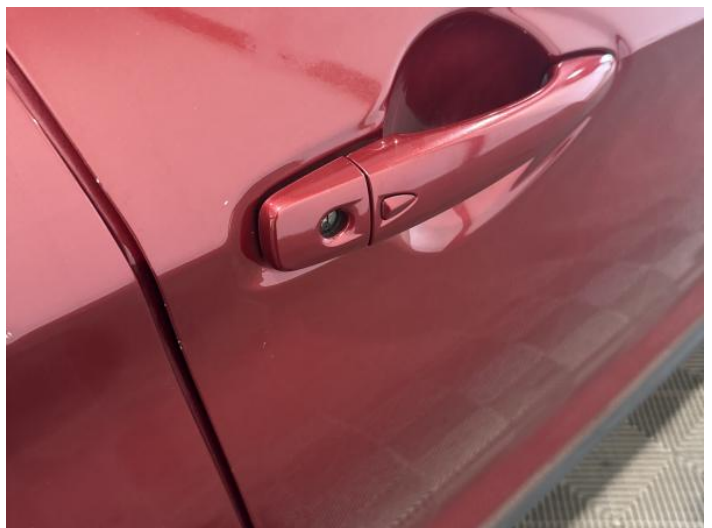
14: Door osf  
Chipped  
1 To 5

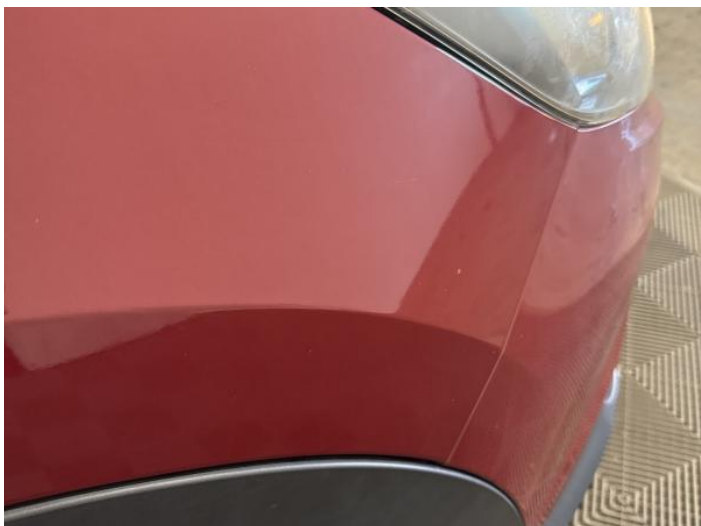
15: Wing osf  
Scratched  
UpTo 25mm Thru Paint

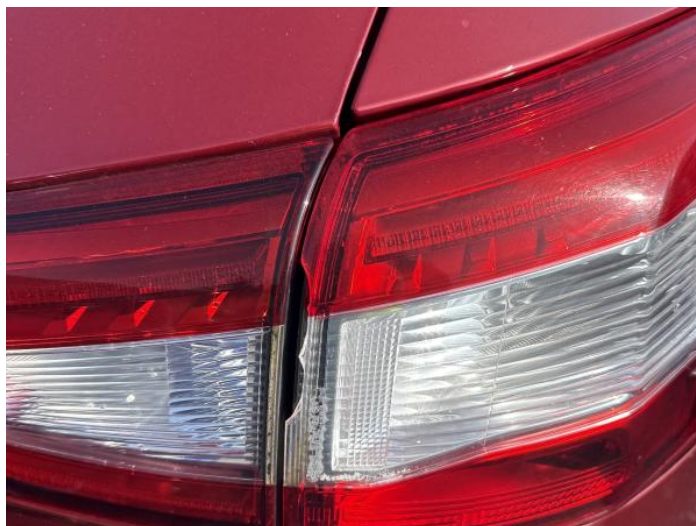
16: Lamp osr  
Broken  
Replace
