# VEHICLE INSPECTION REPORT

**FW13ENE**

## Volkswagen Passat 1.6 TDI Bluemotion Tech S 5dr

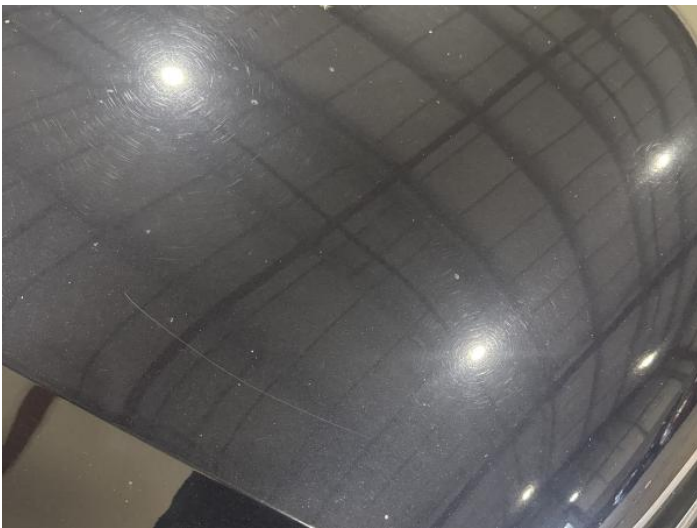
1: Bonnet  
Scratched  
Over 25mm Thru Paint

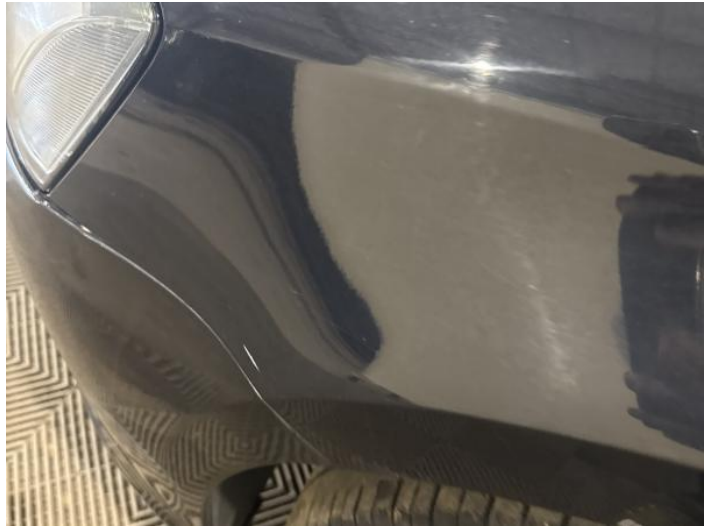
4: Wing nsf  
Scratched  
UpTo 25mm Thru Paint

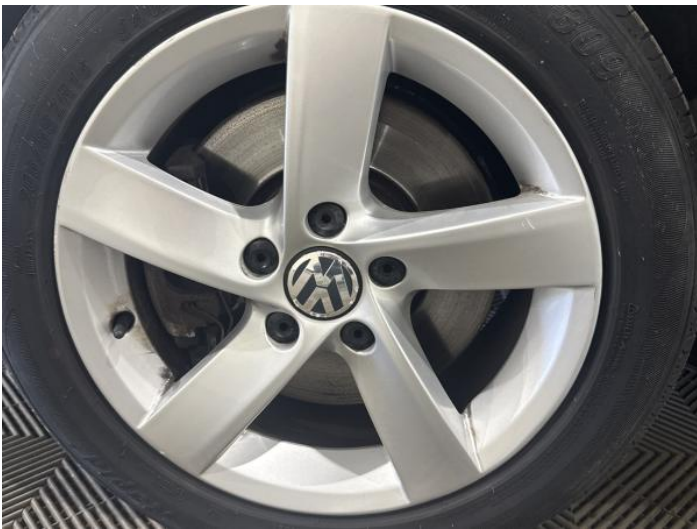
5: Wheel nsf  
Scratched  
Over 50mm

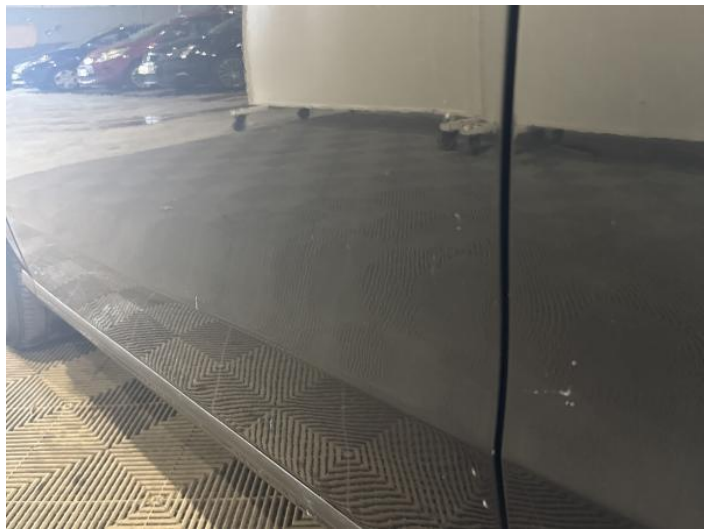
6: Door nsf  
Scratched  
Over 25mm Thru Paint

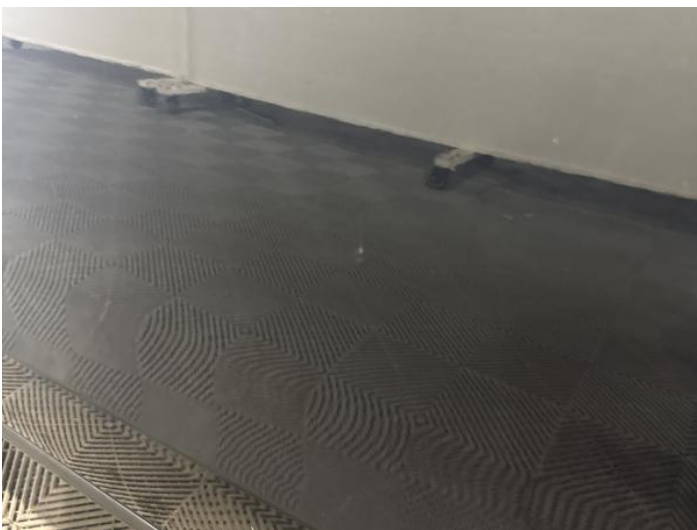
7: Door nsr  
Scratched  
UpTo 25mm Thru Paint

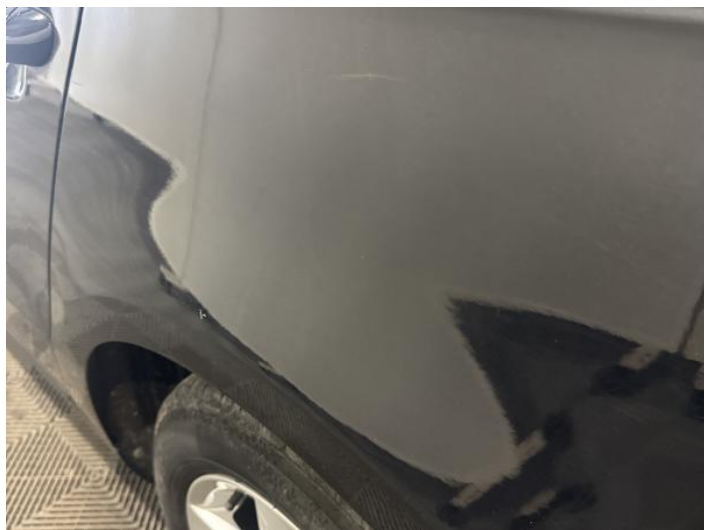
8: Qtr Panel nsr  
Scratched  
Over 25mm Thru Paint

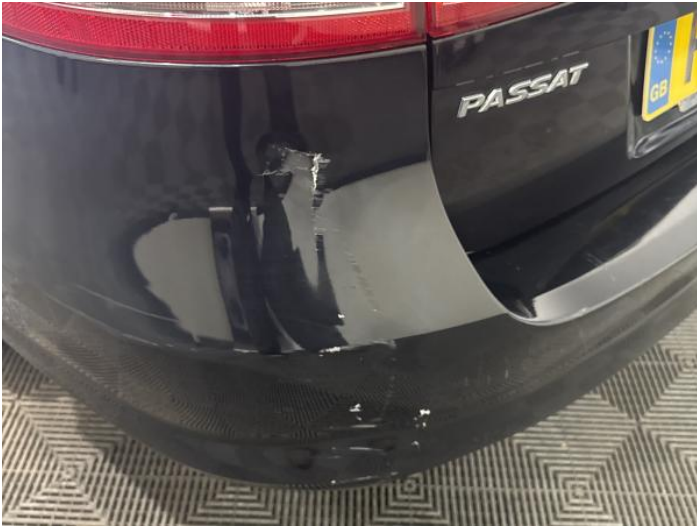
9: Bumper Rear  
Cracked  
UpTo 25mm

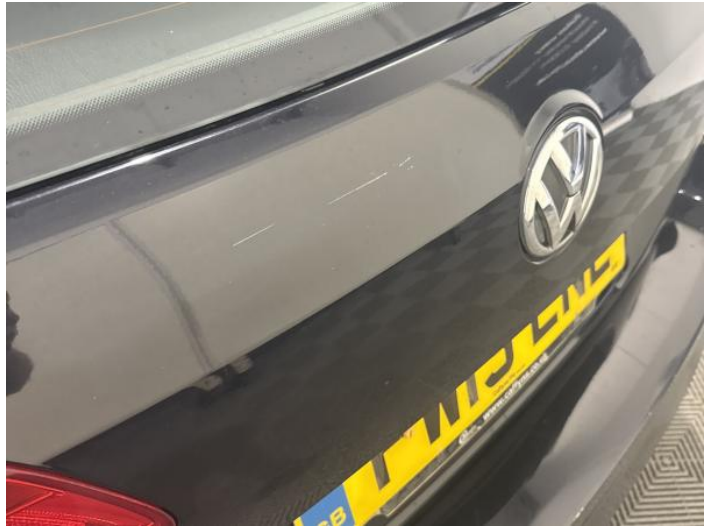
10: Tailgate  
Scratched  
Over 25mm Thru Paint

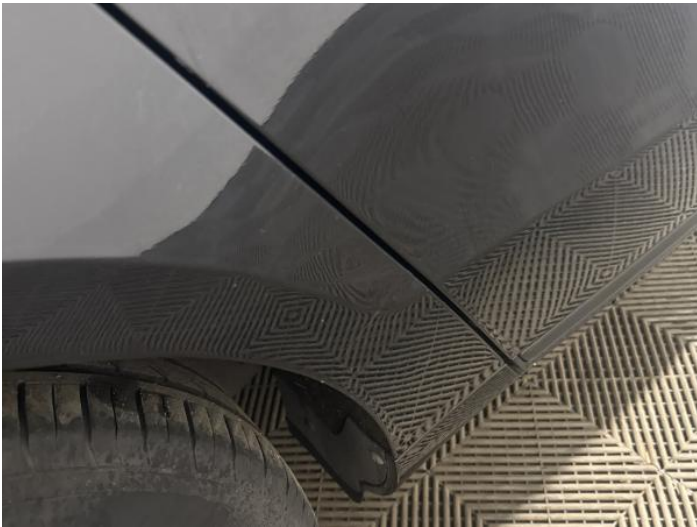
11: Qtr Panel osf  
Scratched  
Over 25mm Thru Paint

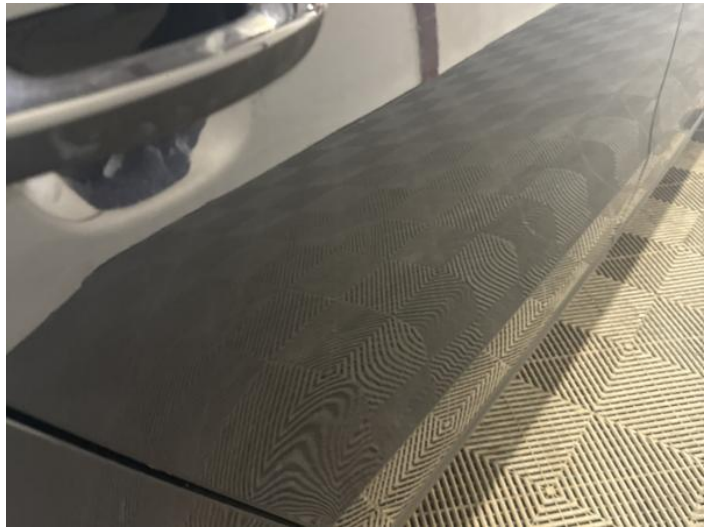
12: Door osf  
Dented  
Over 30mm

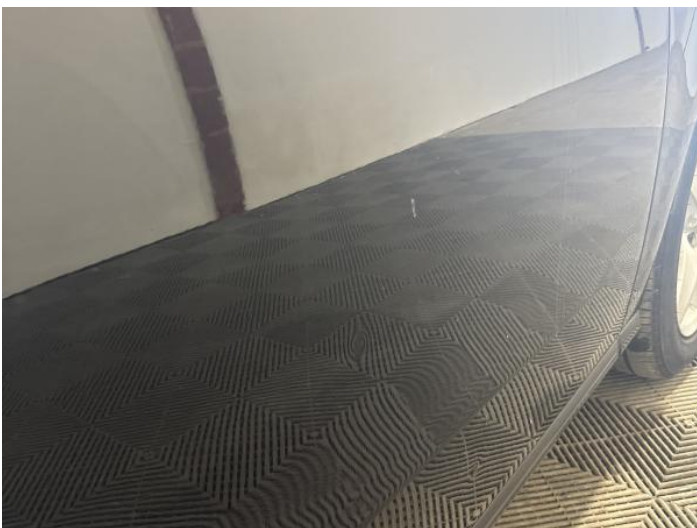
13: Door osf  
Chipped  
Multiple Chips

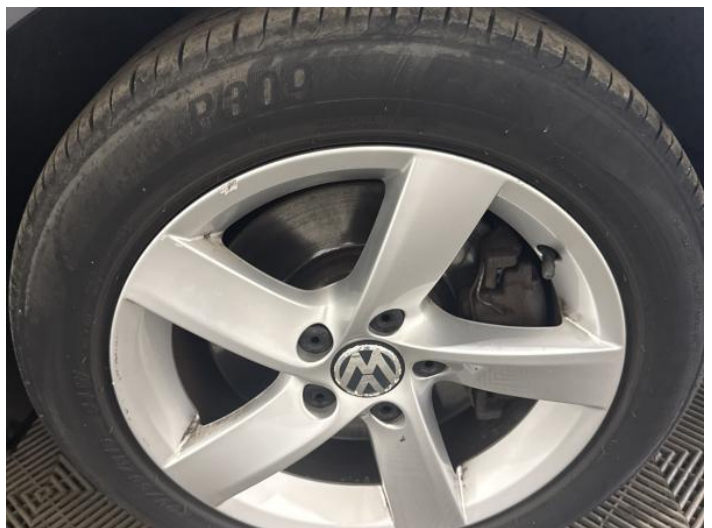
14: Wheel osf  
Scratched  
Over 50mm

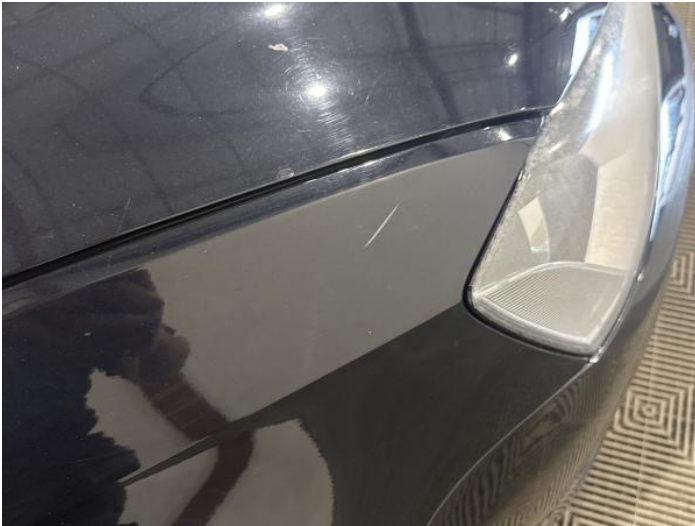
15: Wing osf  
Scratched  
Over 25mm Thru Paint

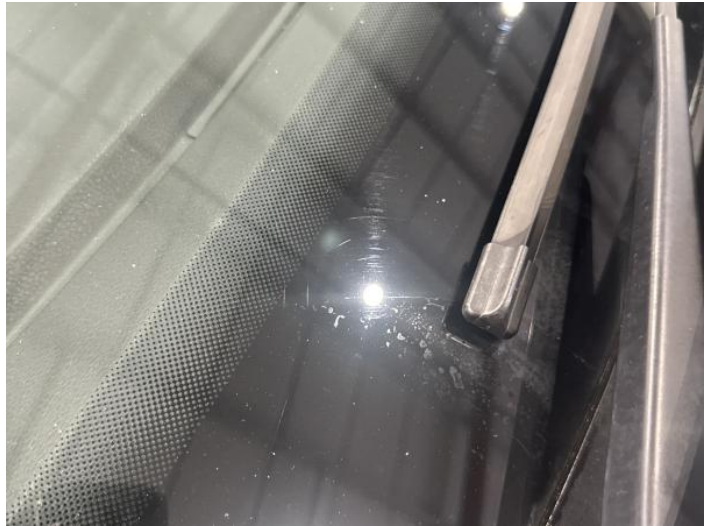
16: Screen Front  
Chipped  
UpTo 10mm

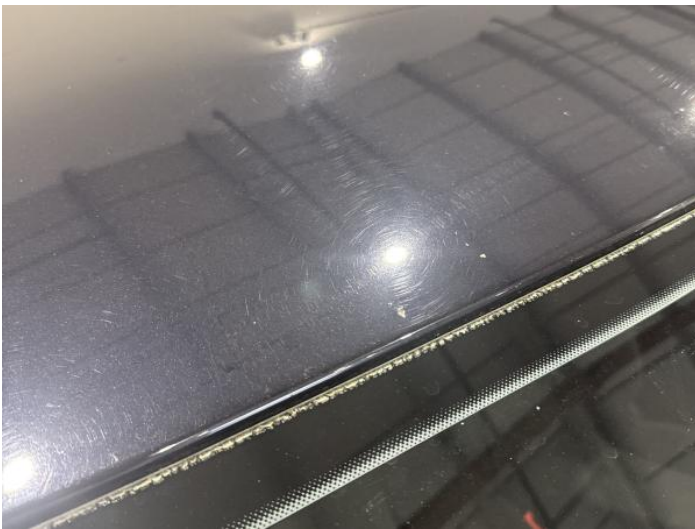
17: Roof  
Chipped  
1 To 5
