VEHICLE INSPECTION REPORT

ML14ZYE

Peugeot 308 1.6 e-HDi 115 Feline 5dr

nama
GRADE
4

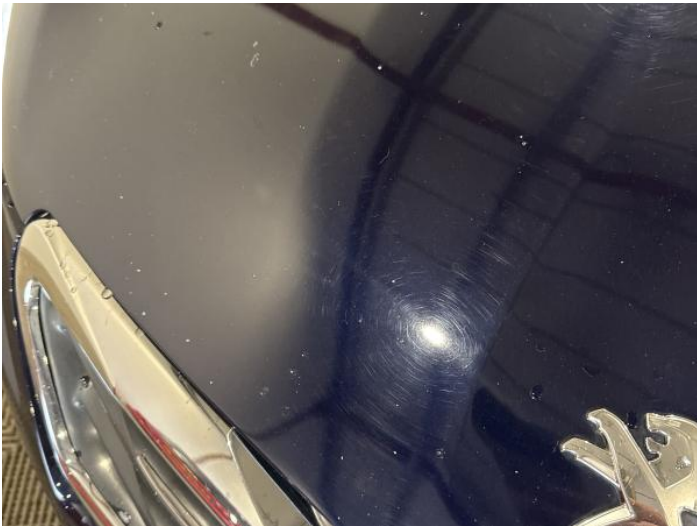
1: Bonnet
Chipped
Multiple Chips

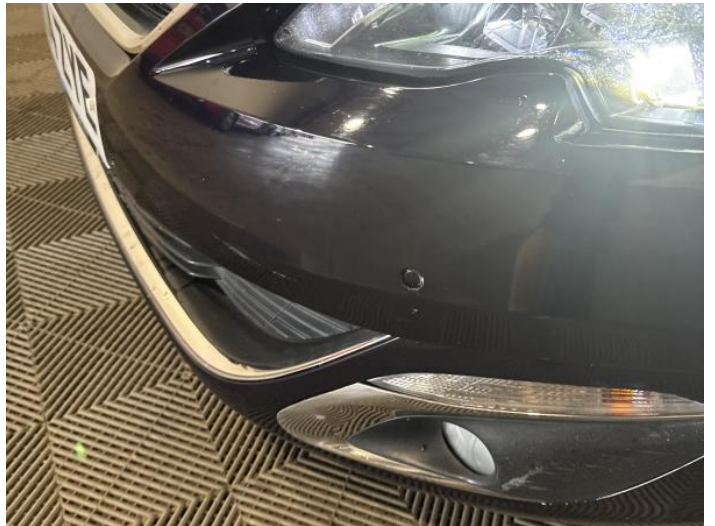
2: Bumper Front
Scratched
Over 100mm Thru Paint

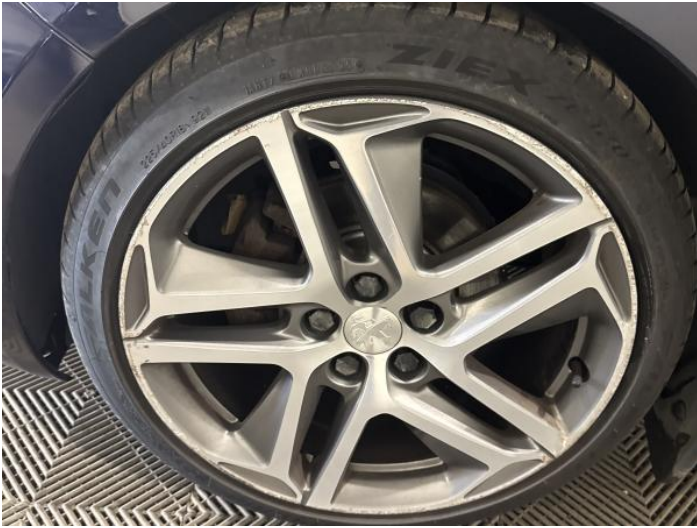
3: Wheel nsf
Scratched
Over 50mm

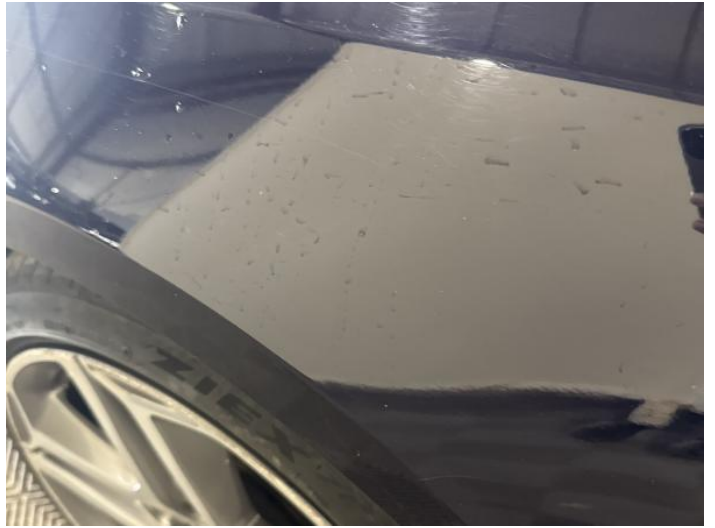
4: Wing nsf
Scratched
UpTo 25mm Thru Paint

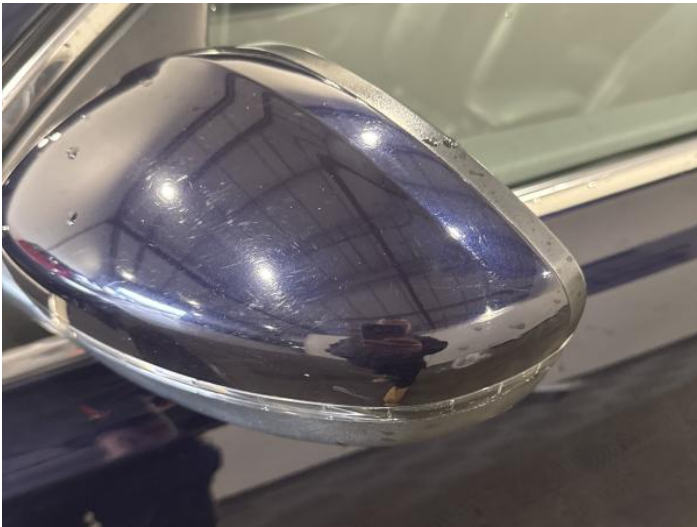
5: Door Mirror Assy nsf
Scratched (Painted)
UpTo 25mm Thru Paint

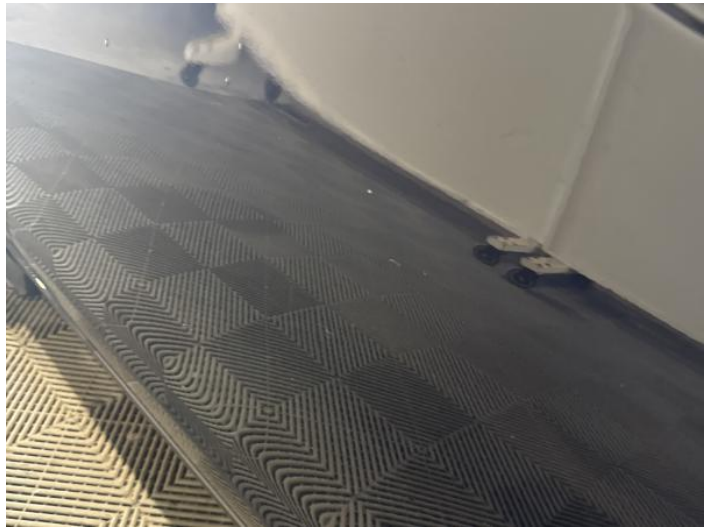
6: Door nsf
Chipped
Multiple Chips

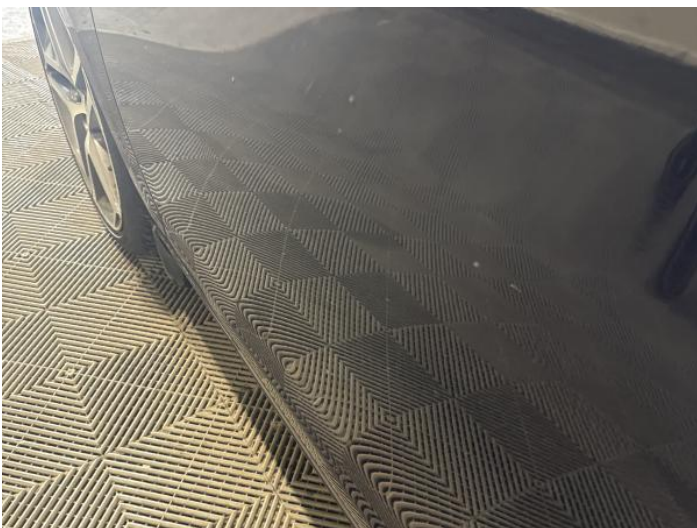
7: Door nsf
Dented
Between 10mm + 30mm

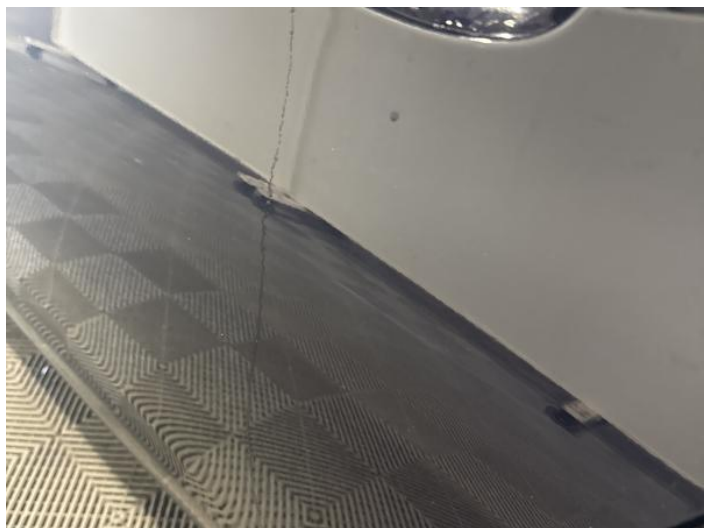
8: Door nsr
Scratched
Over 25mm Thru Paint

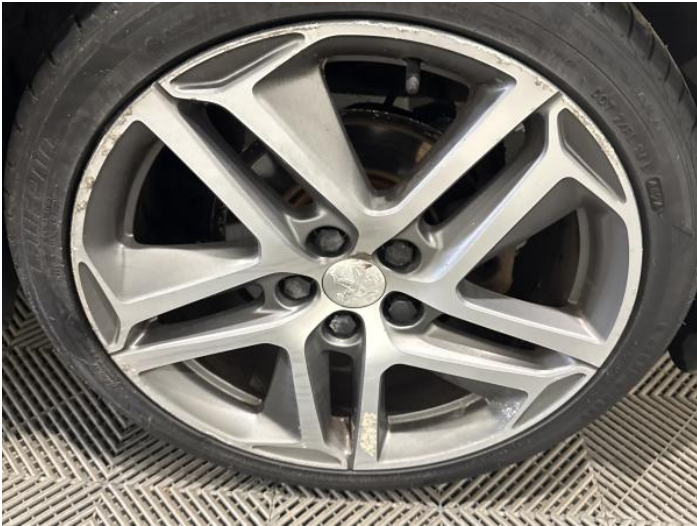
9: Wheel nsr
Scratched
Over 50mm

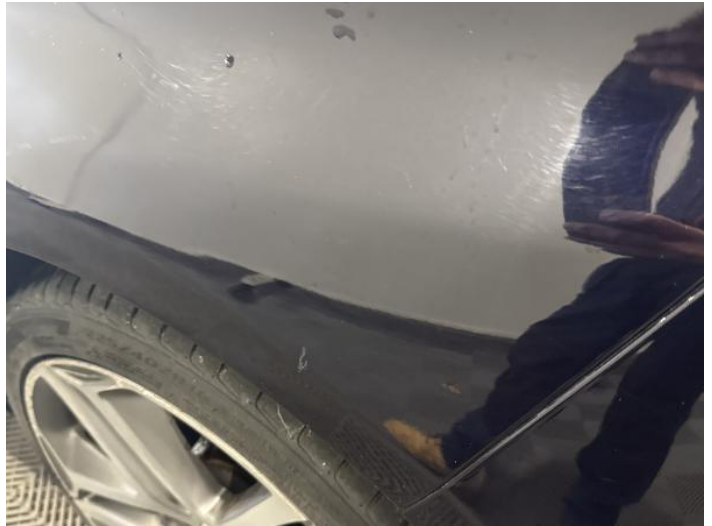
10: Qtr Panel nsr
Scratched
UpTo 25mm Thru Paint

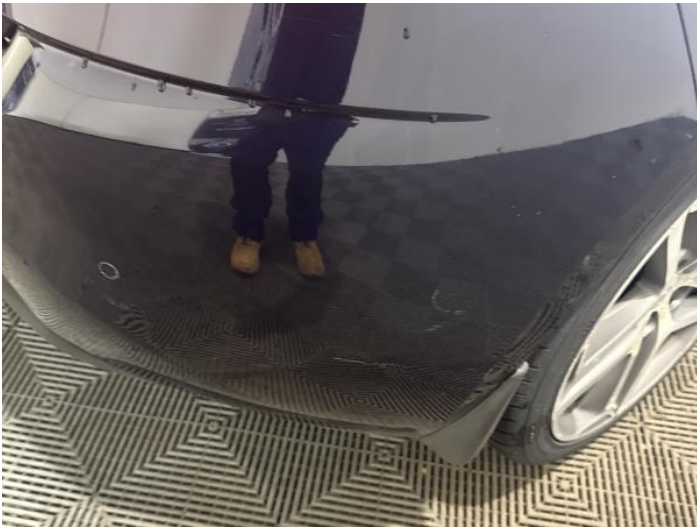
11: Bumper Rear
Scratched
Over 100mm Thru Paint

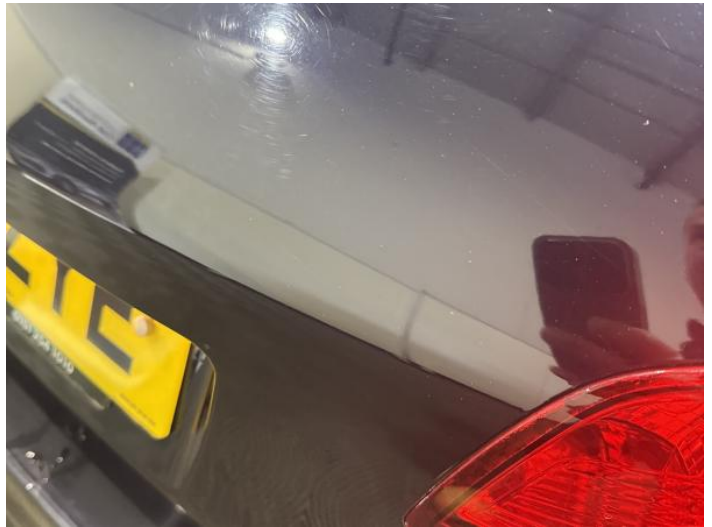
12: Tailgate
Scratched
UpTo 25mm Thru Paint

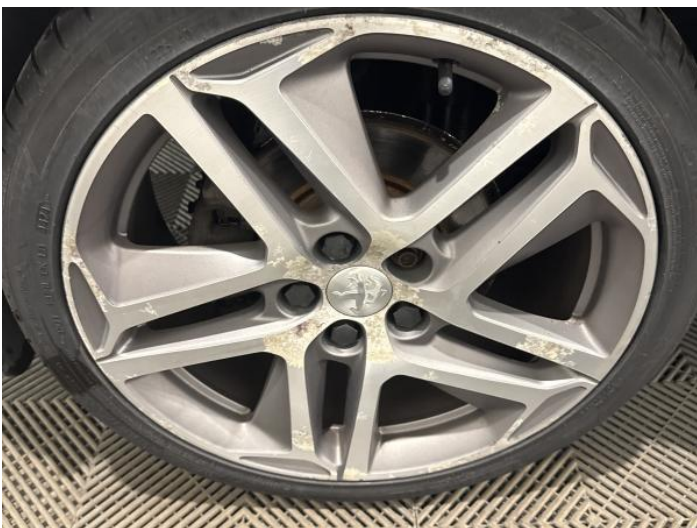
13: Wheel osr
Scratched
Over 50mm

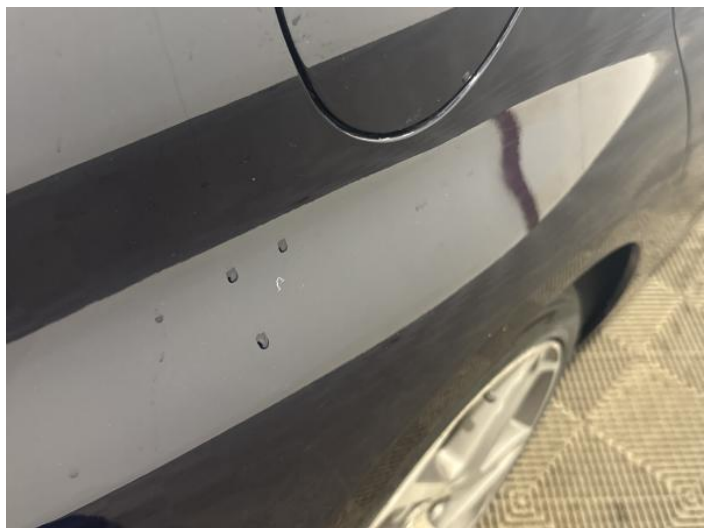
14: Qtr Panel osr
Chipped
1 To 5

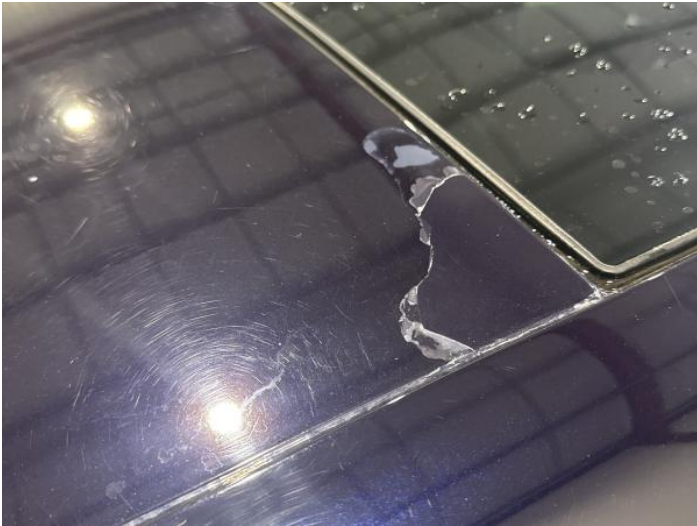
15: Roof
Poor Previous Repair
Paint Flake

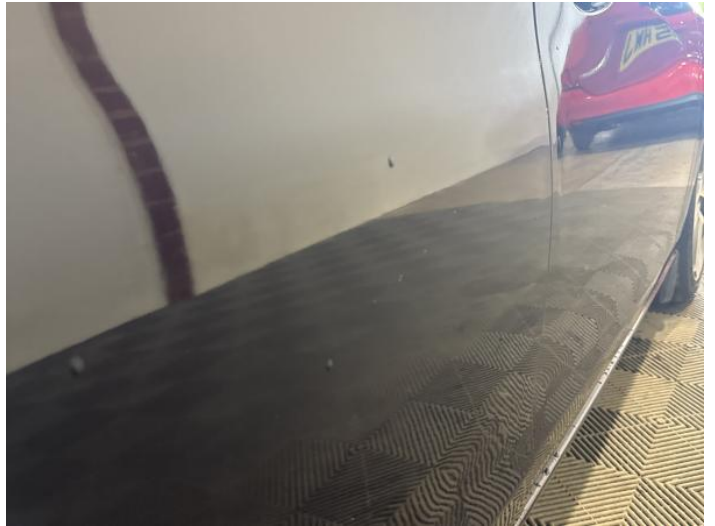
16: Door osr
Poor Previous Repair
Rippled Up To 30%

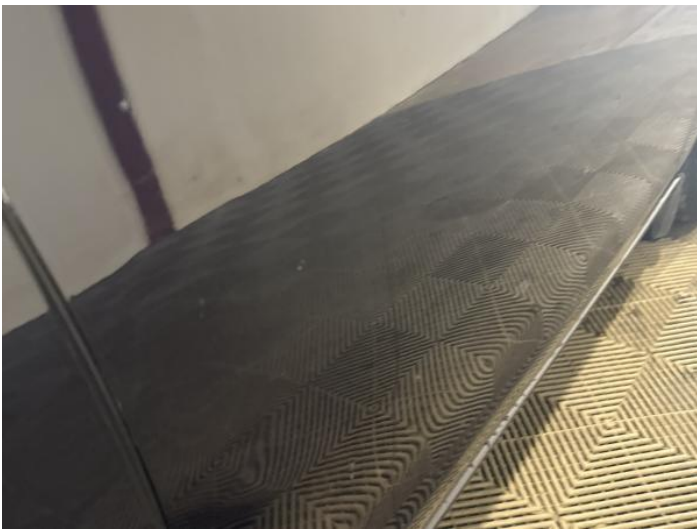
17: Door osf
Dented
With Paint Damage

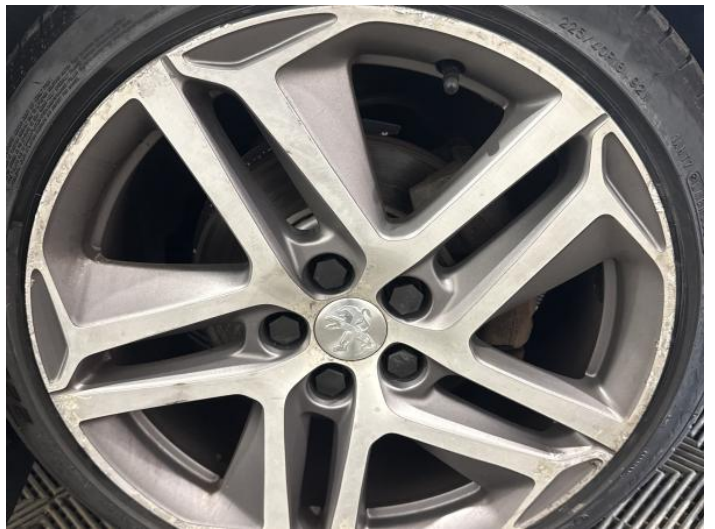
18: Wheel osf
Scratched
Over 50mm

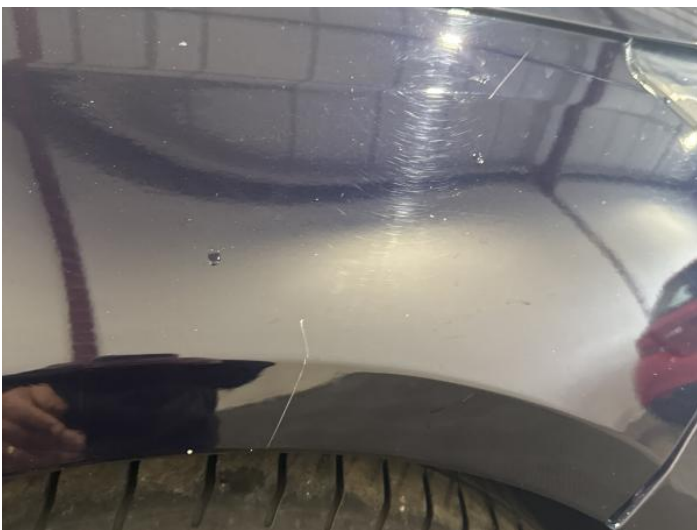
19: Wing osf
Scratched
Over 25mm Thru Paint
