VEHICLE INSPECTION REPORT

LR13NDO

Mazda 6 2.2d [175] Sport Nav 5dr

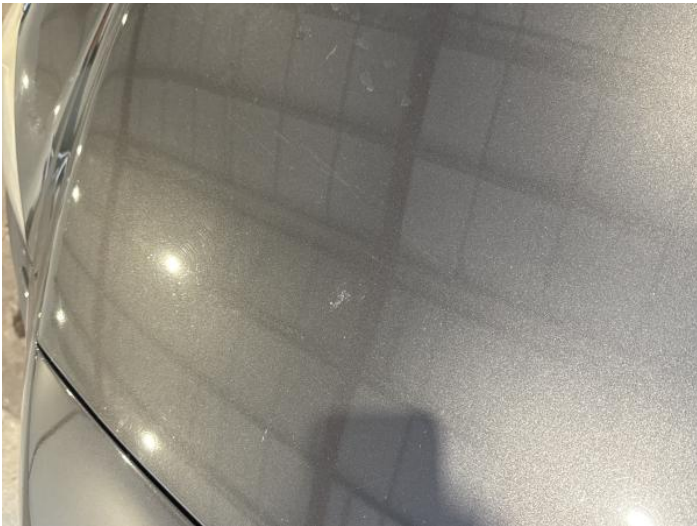
1: Bonnet
Dented
With Paint Damage

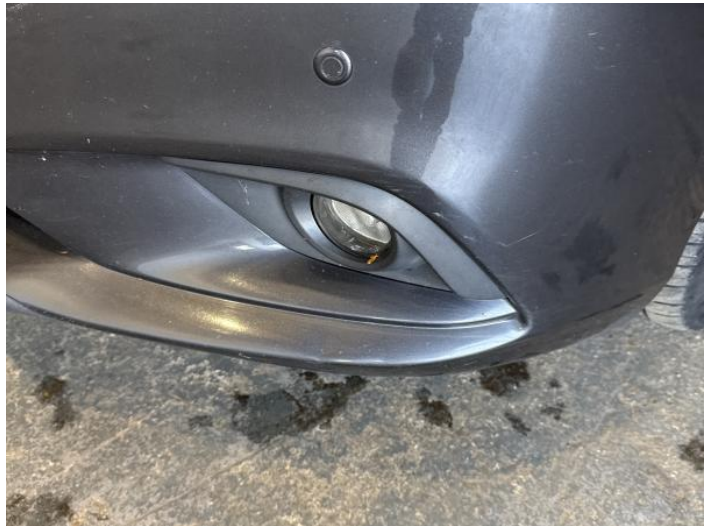
2: Bumper Front
Dented
With Paint Damage

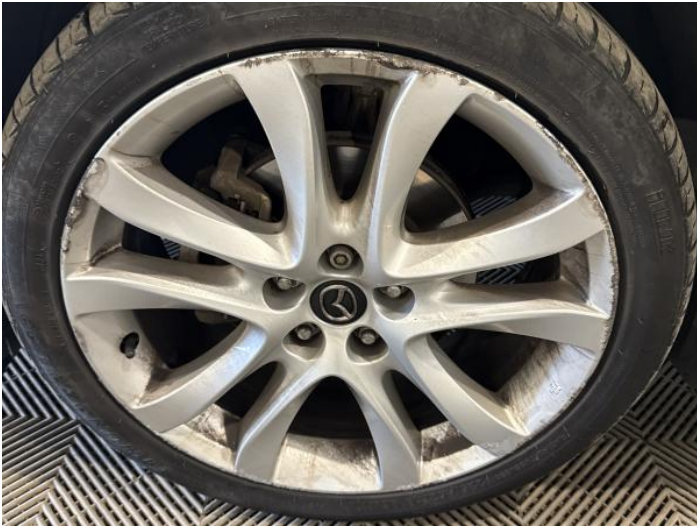
3: Wheel nsf
Scratched
Over 50mm

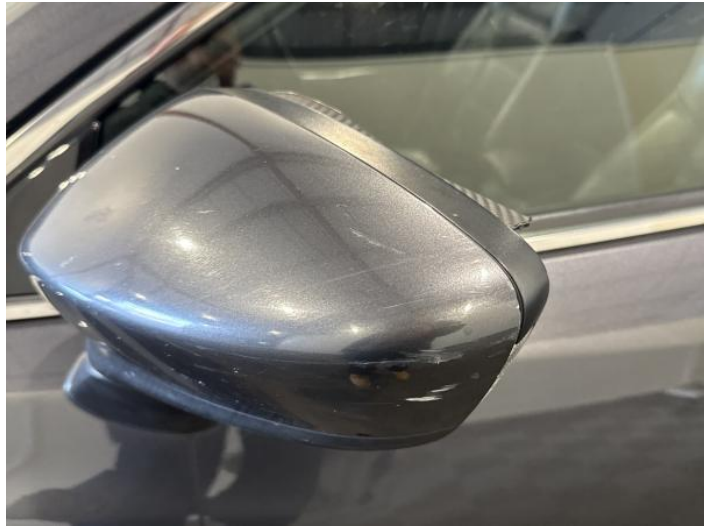
4: Door Mirror Assy nsf
Scratched (Painted)
UpTo 25mm Thru Paint

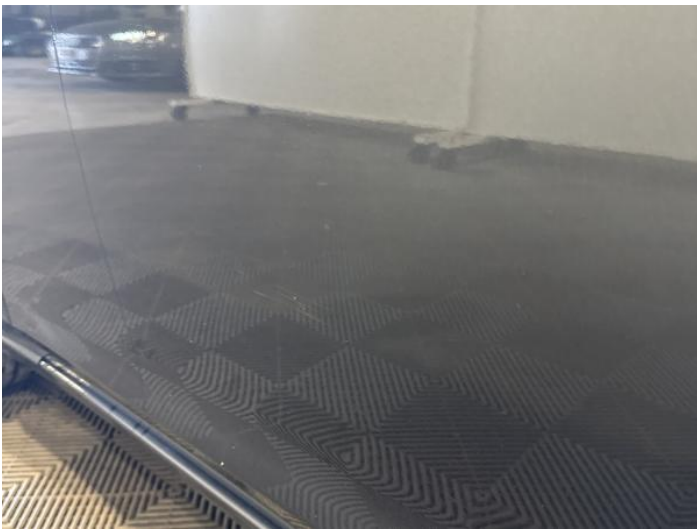
5: Door nsf
Scratched
Over 25mm Thru Paint

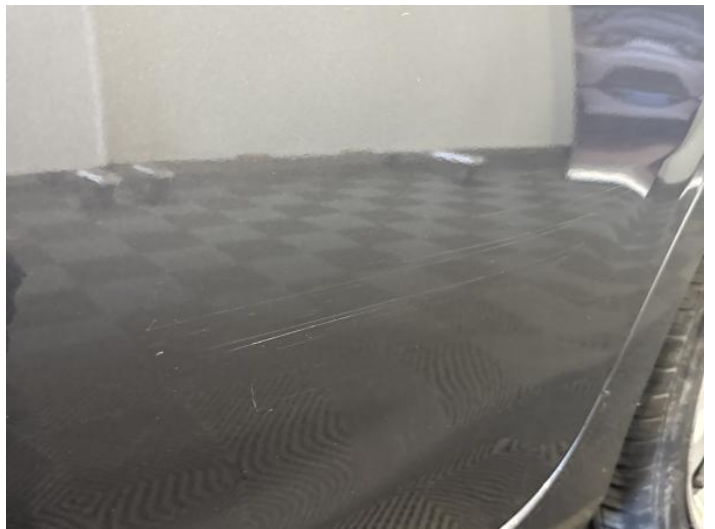
6: Door nsr
Dented
With Paint Damage

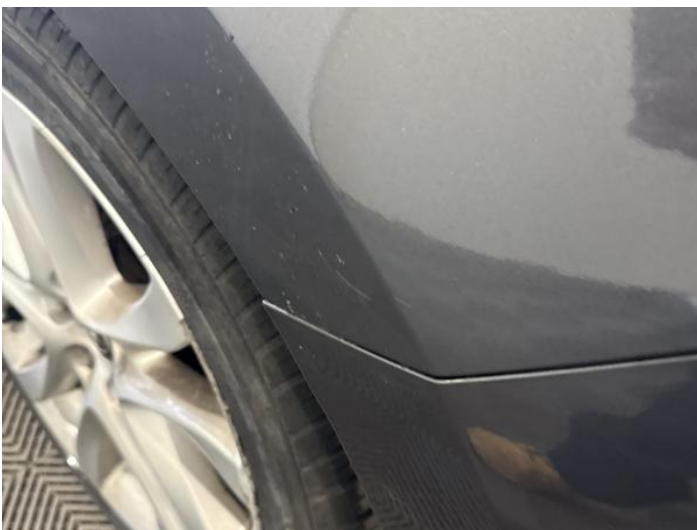
7: Qtr Panel nsr
Scratched
UpTo 25mm Thru Paint

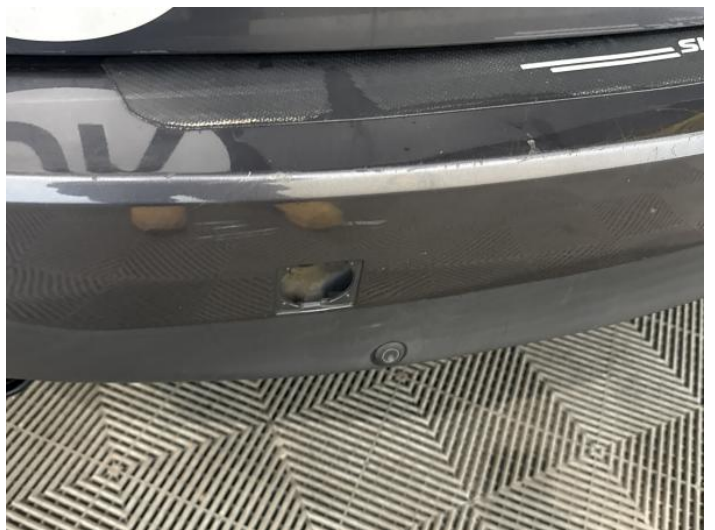
8: Rear TowEye Cvr
Missing
Replace

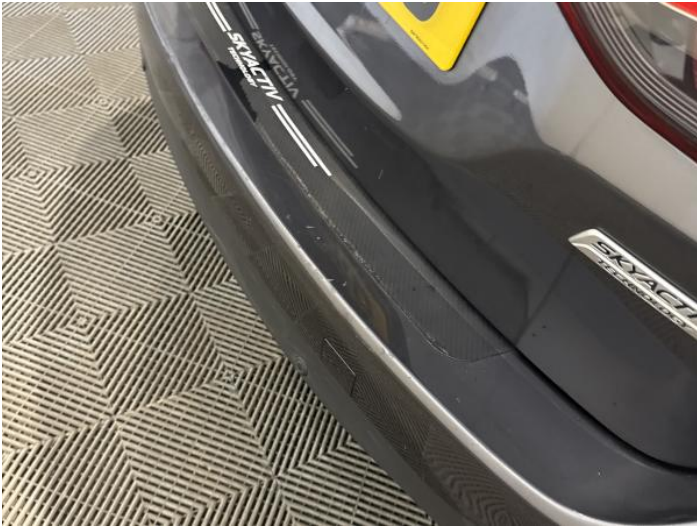
9: Bumper Rear
Scratched
25 to 100mm Thru Paint

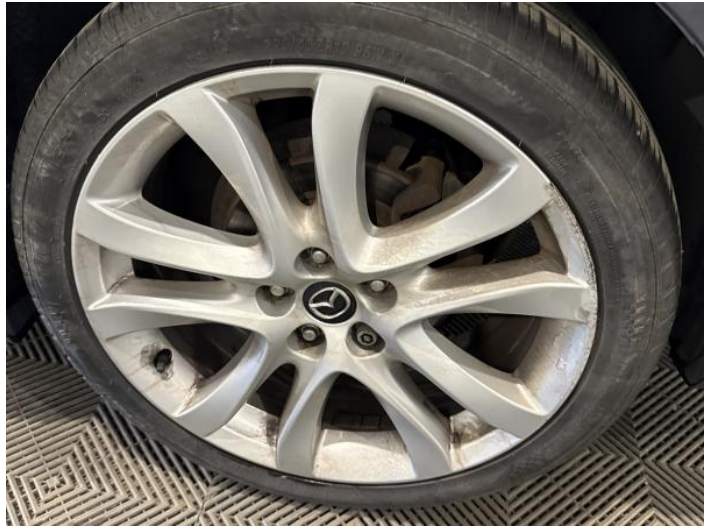
10: Wheel nsr
Scratched
Over 50mm

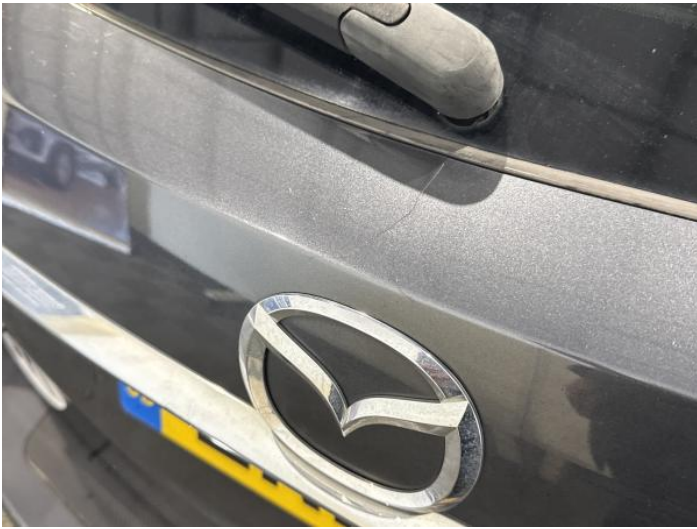
11: Tailgate
Cracked
Replace

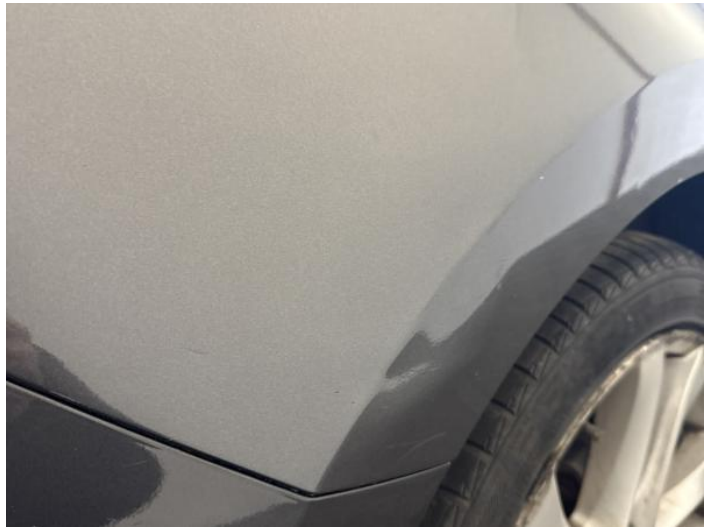
12: Qtr Panel osr
Dented
Over 30mm

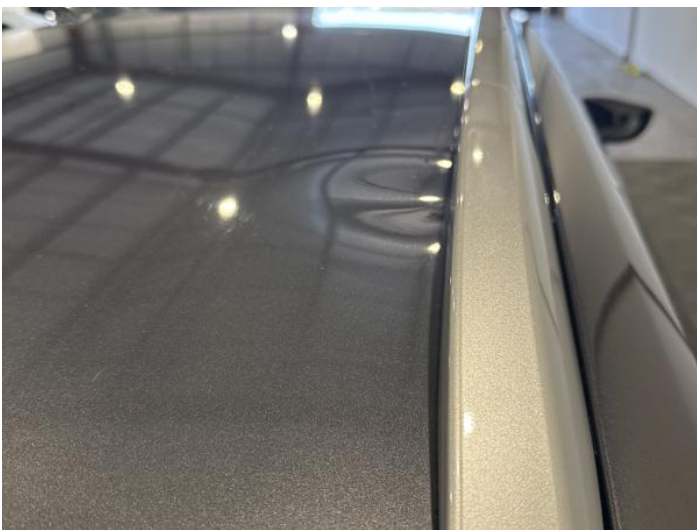
13: Roof
Dented
Over 30mm

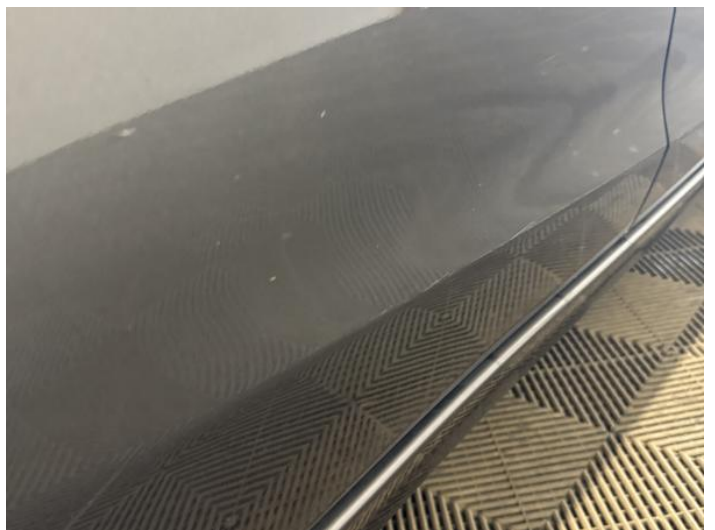
14: Door osr
Dented
With Paint Damage

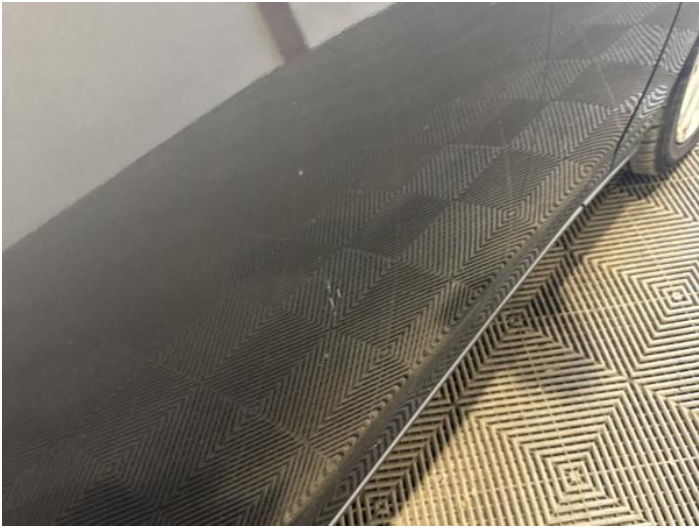
15: Door osf
Dented
With Paint Damage

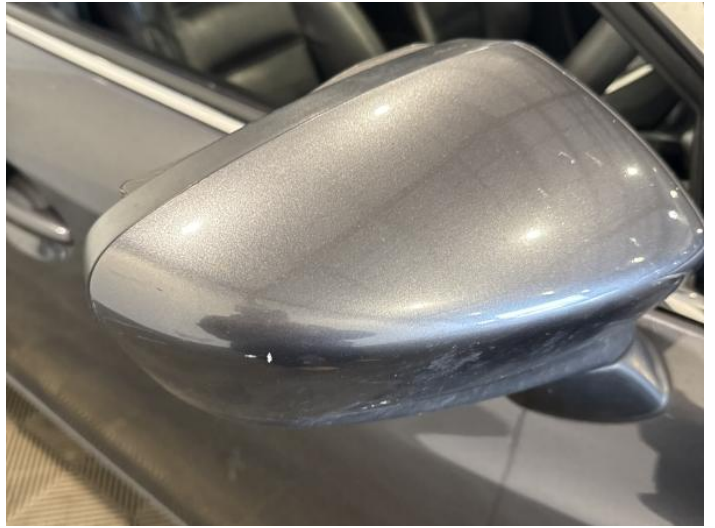
16: Door Mirror Assy osf
Scratched (Painted)
UpTo 25mm Thru Paint

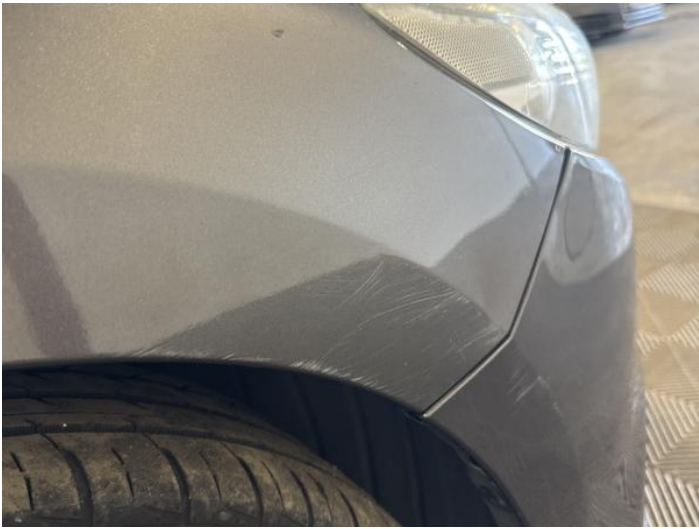
17: Wing osf
Dented
With Paint Damage

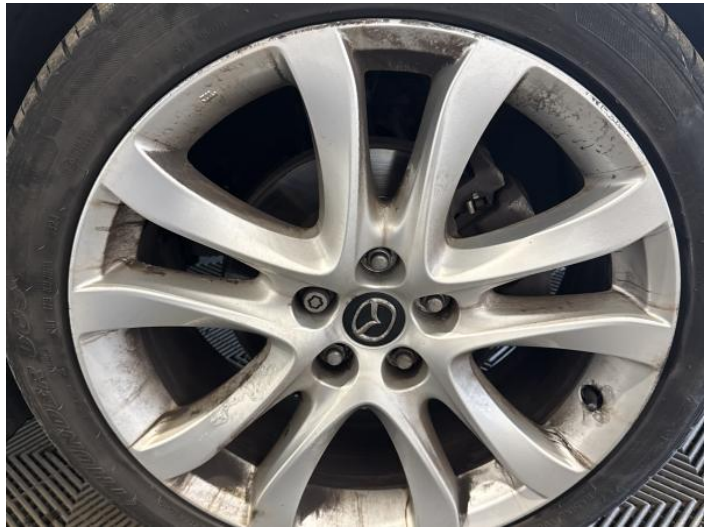
18: Wheel osf
Scratched
Over 50mm

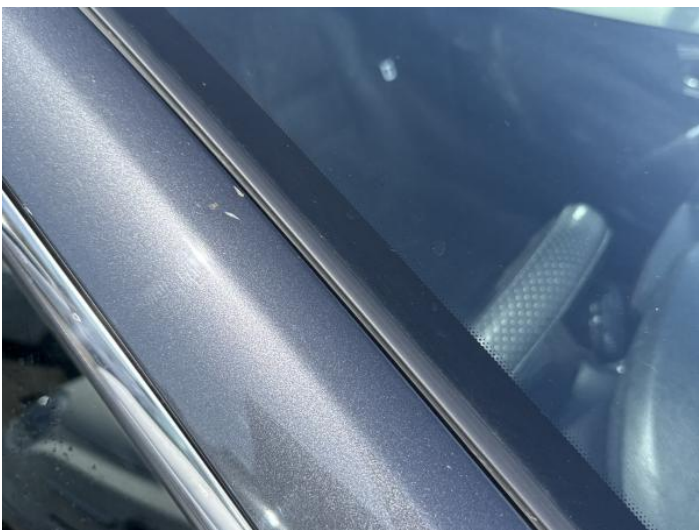
19: A Post os
Chipped
1 To 5
