# VEHICLE INSPECTION REPORT

**RE16UJW**

## Vauxhall Corsa 1.4 [75] ecoFLEX Energy 3dr [AC]

nama  
GRADE  
**4**

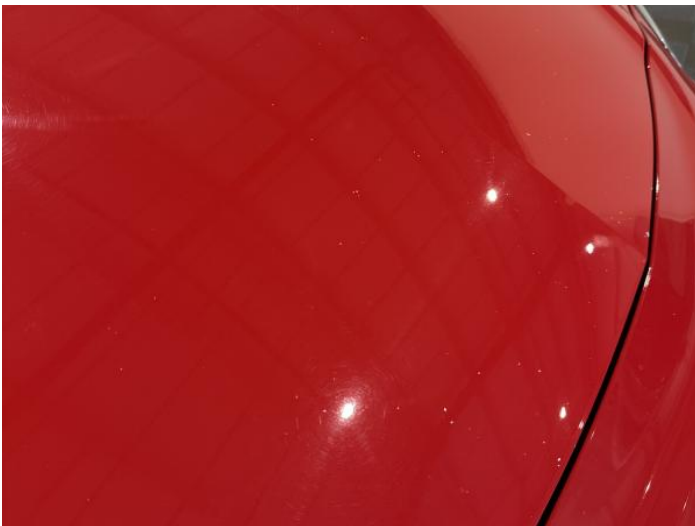
1: Bonnet  
Chipped  
Multiple Chips

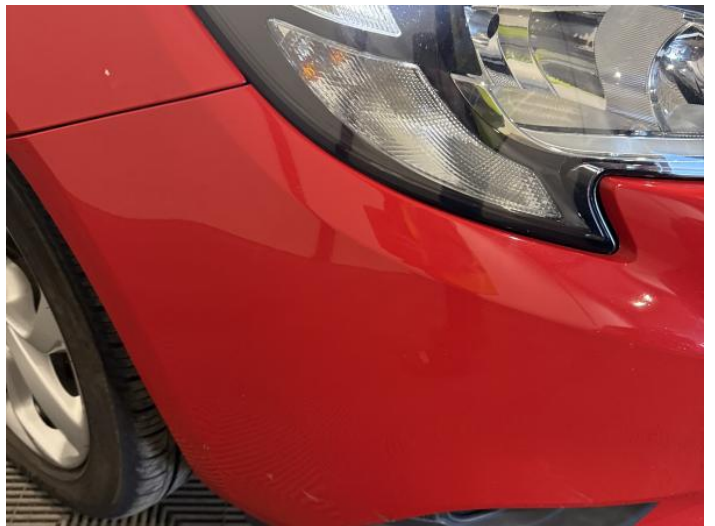
2: Bumper Front  
Scratched  
25 to 100mm Thru Paint

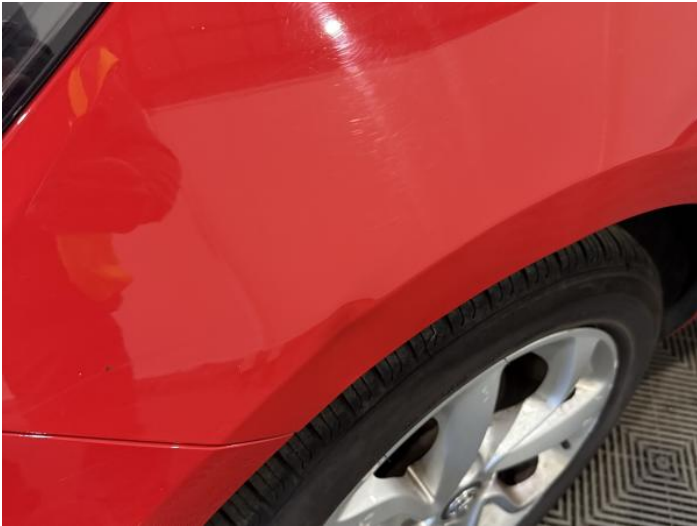
3: Wing nsf  
Dented  
Over 30mm

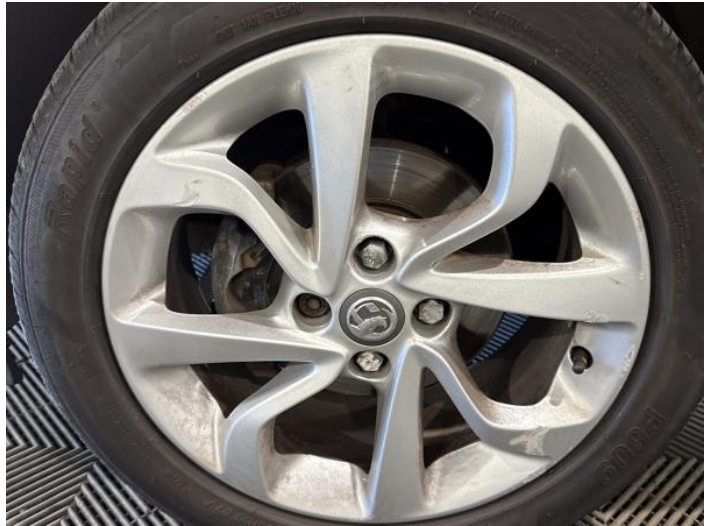
4: Wheel nsf  
Scratched  
Over 50mm

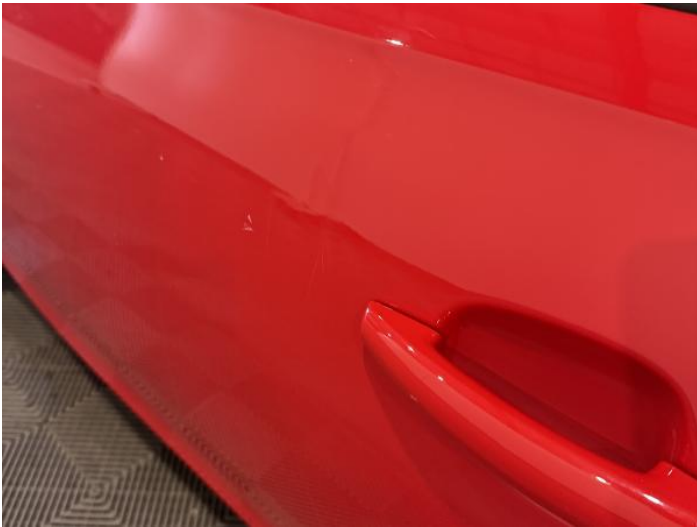
5: Door nsf  
Dented  
With Paint Damage

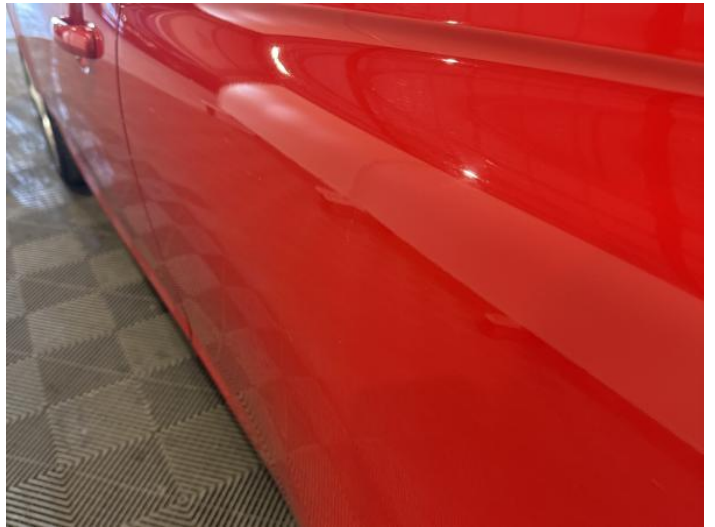
6: Qtr Panel nsr  
Dented  
With Paint Damage

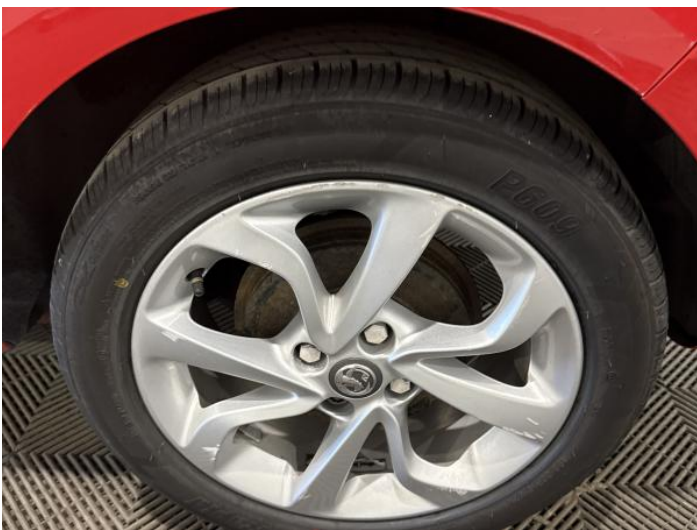
7: Wheel nsr  
Scratched  
Over 50mm

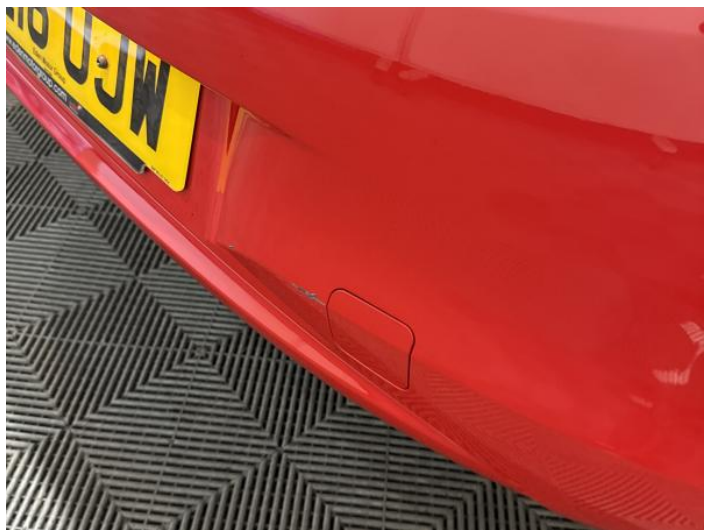
8: Bumper Rear  
Scratched  
25 to 100mm Thru Paint

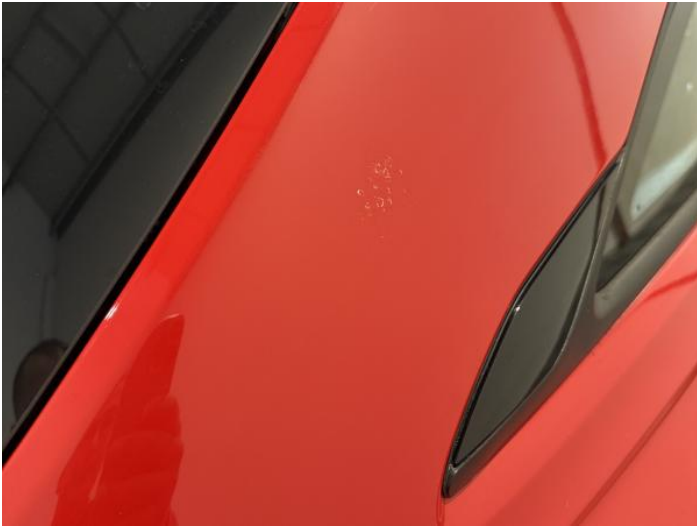
9: Qtr Panel osf  
Scratched  
Over 25mm Thru Paint

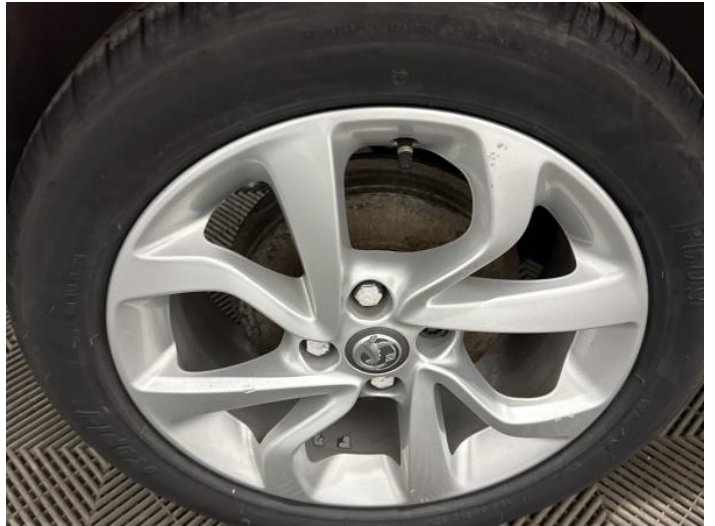
10: Wheel osf  
Scratched  
Up To 50mm

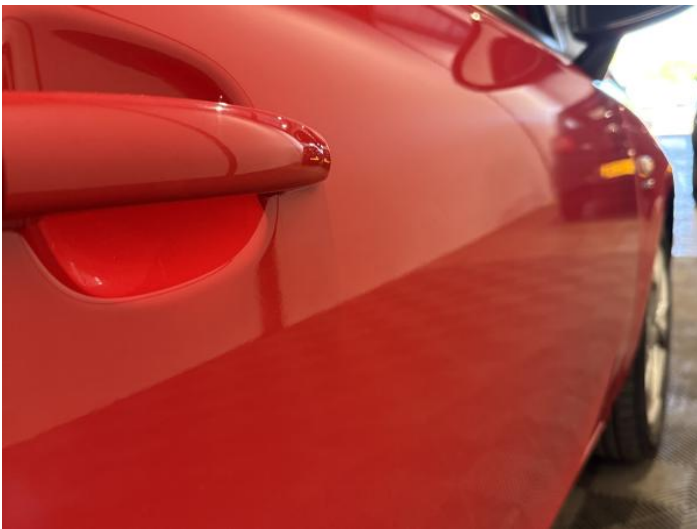
11: Door osf  
Dented  
Over 30mm

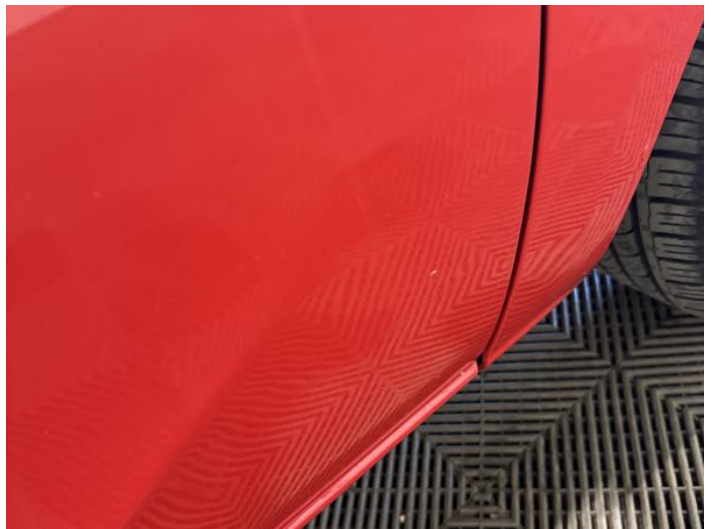
12: Door osf  
Chipped  
1 To 5

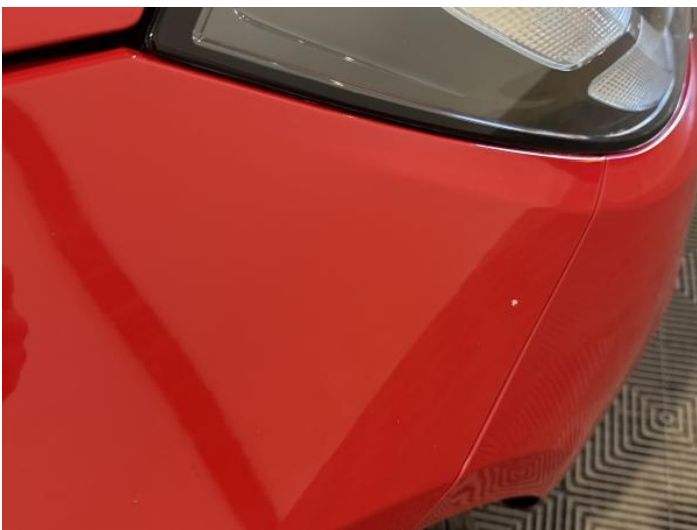
13: Wing osf  
Chipped  
1 To 5

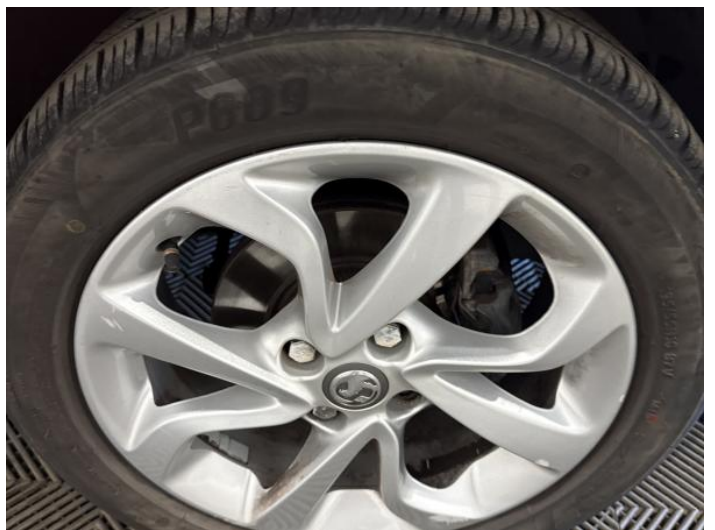
14: Wheel osf  
Scratched  
Over 50mm

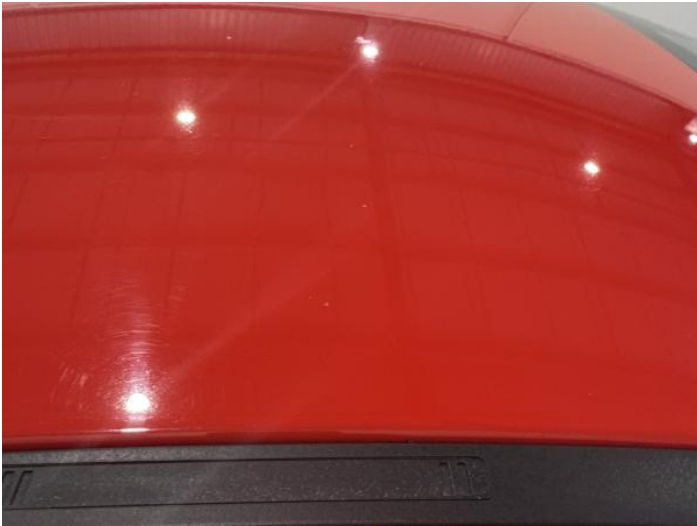
15: Roof  
Dented  
Between 10mm + 30mm
