VEHICLE INSPECTION REPORT

YF09SVW

BMW 3 Series 318d M Sport 4dr Step Auto

nama
 GRADE
3

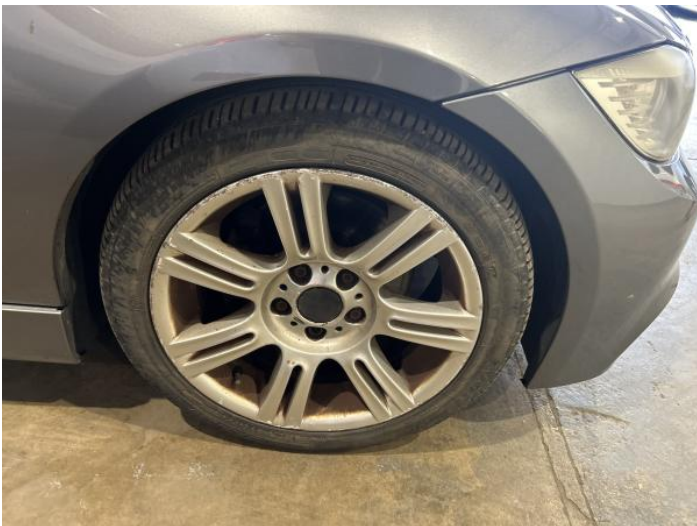
1: Wheel of
Scratched
Over 50mm

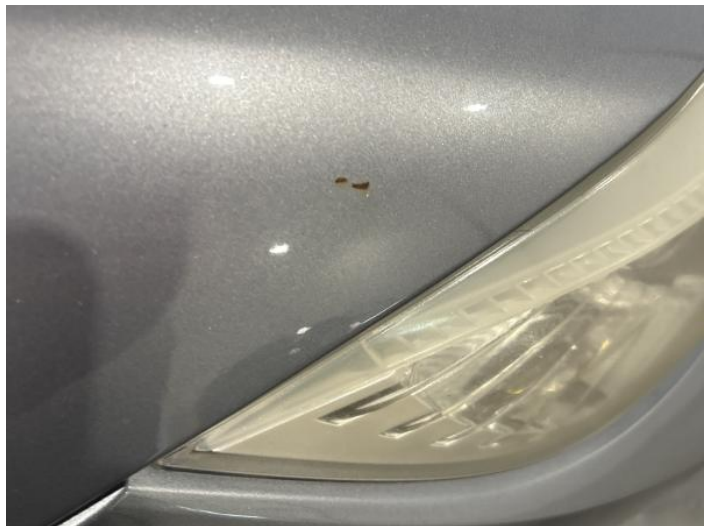
2: Wing of
Chipped
1 To 5

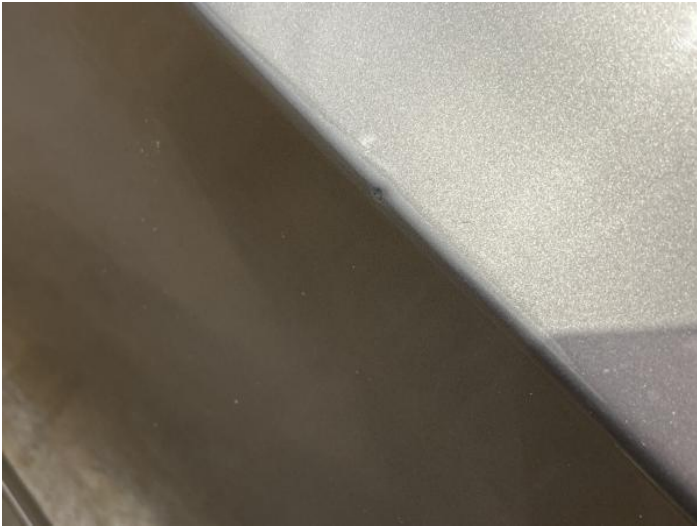
3: Door osf
Chipped
1 To 5

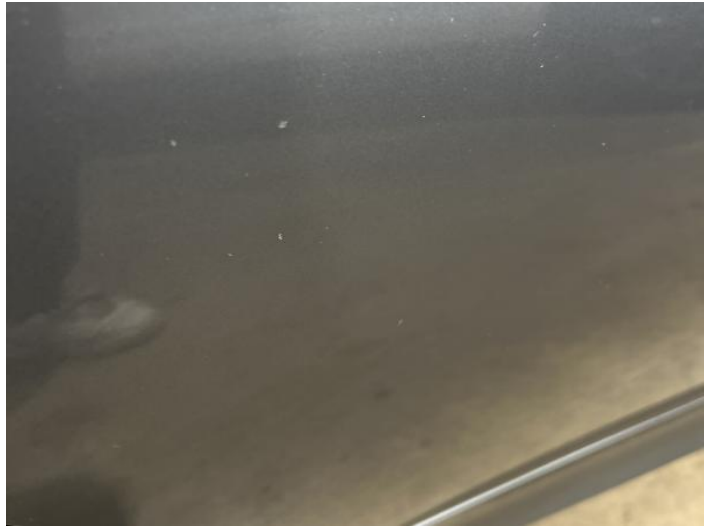
4: Door osr
Chipped
1 To 5

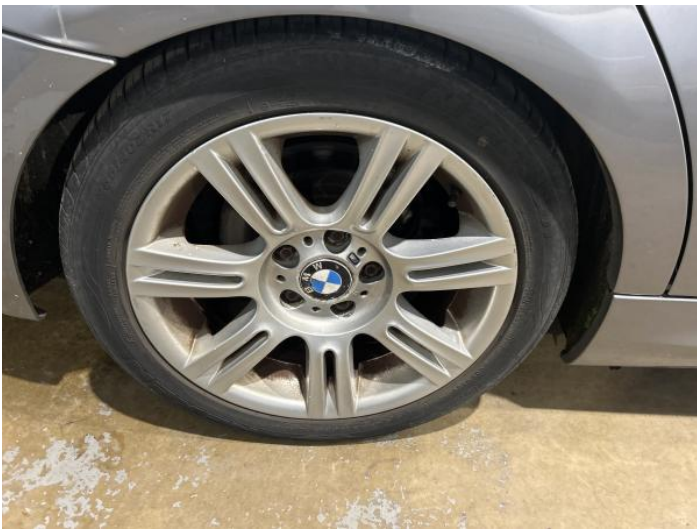
5: Wheel osr
Scratched
Up To 50mm

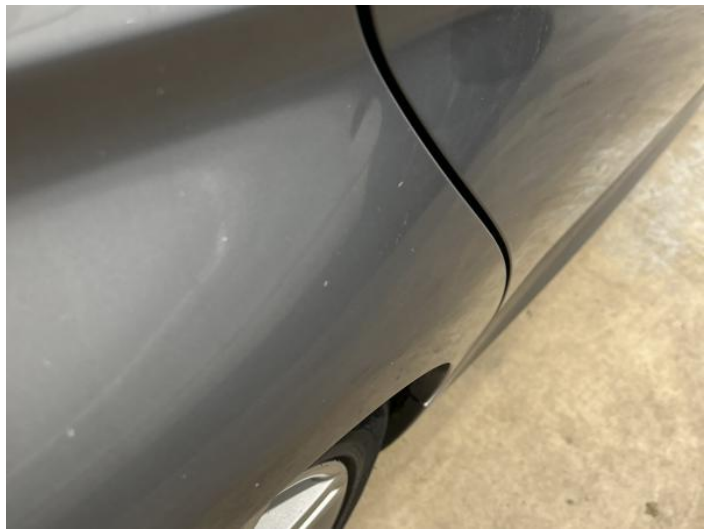
6: Qtr Panel osr
Dented
Between 10mm + 30mm

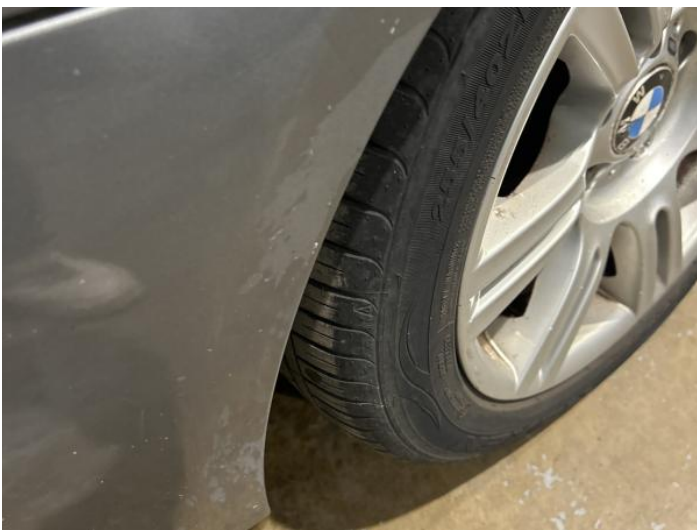
7: Bumper Rear
Poor Previous Repair
Paint Flake

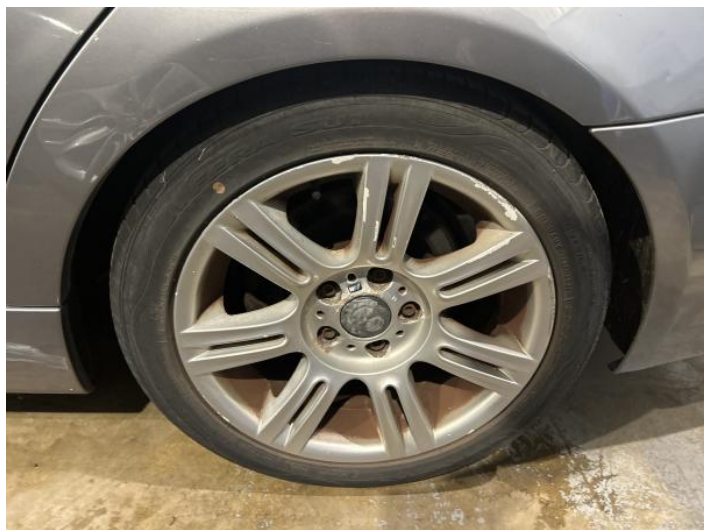
8: Wheel nsr
Scratched
Over 50mm

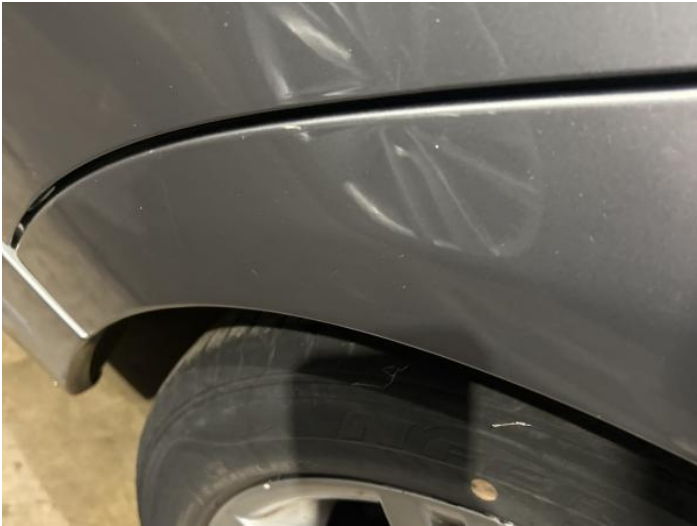
9: Qtr Panel nsf
Chipped
1 To 5

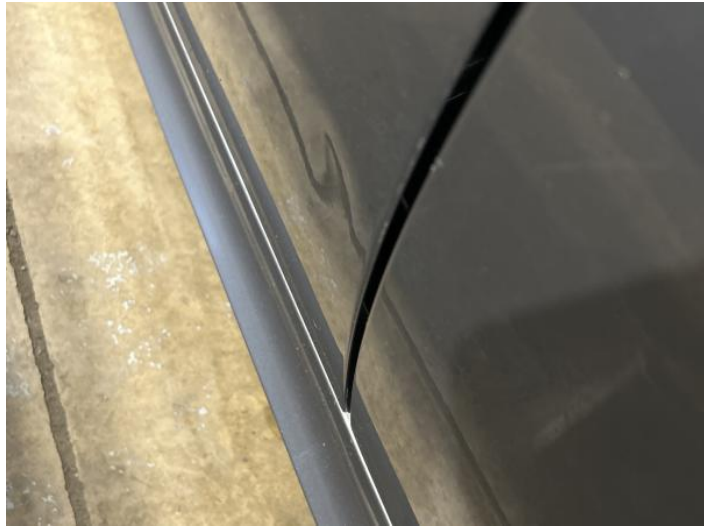
10: Door nsf
Dented
Between 10mm + 30mm

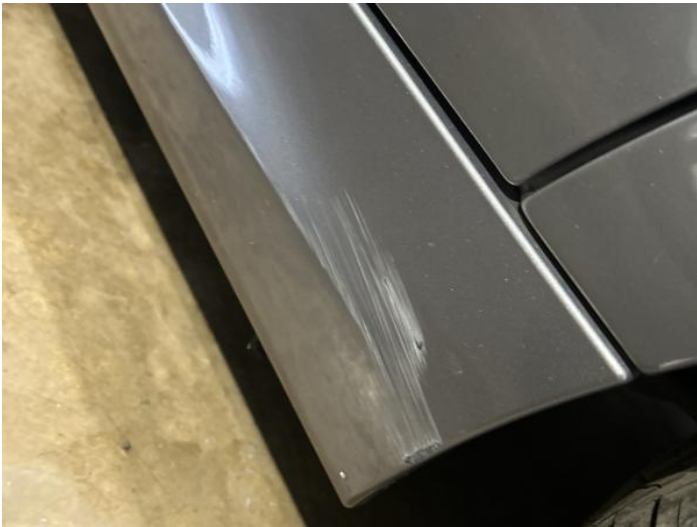
11: Sill Panel Trim ns
Scratched (Painted)
Over 25mm Thru Paint

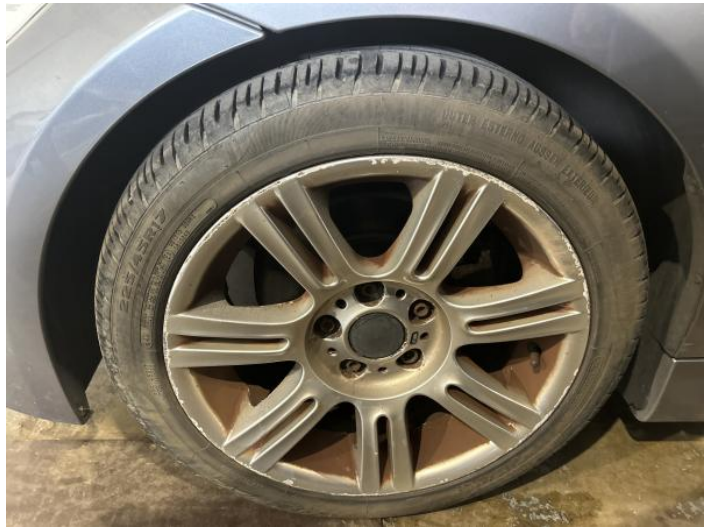
12: Wheel nsf
Scratched
Over 50mm

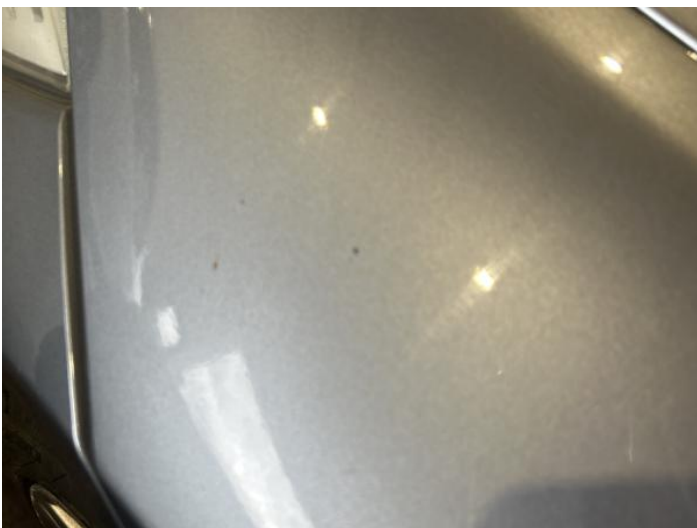
13: Wing nsf
Chipped
1 To 5

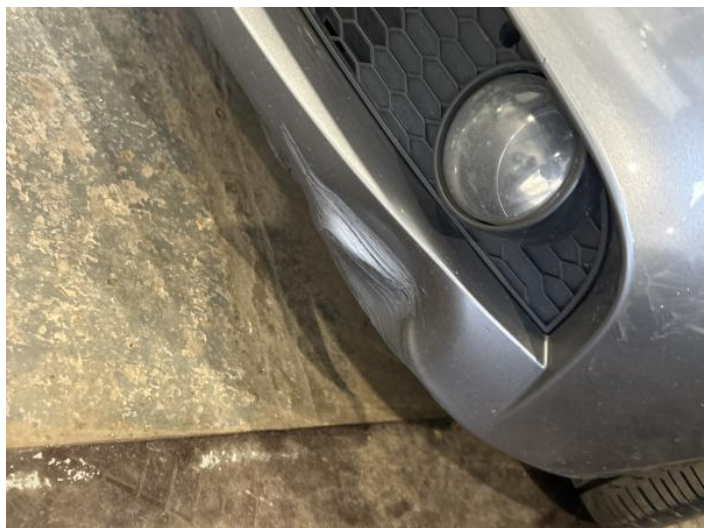
14: Bumper Front
Dented
With Paint Damage

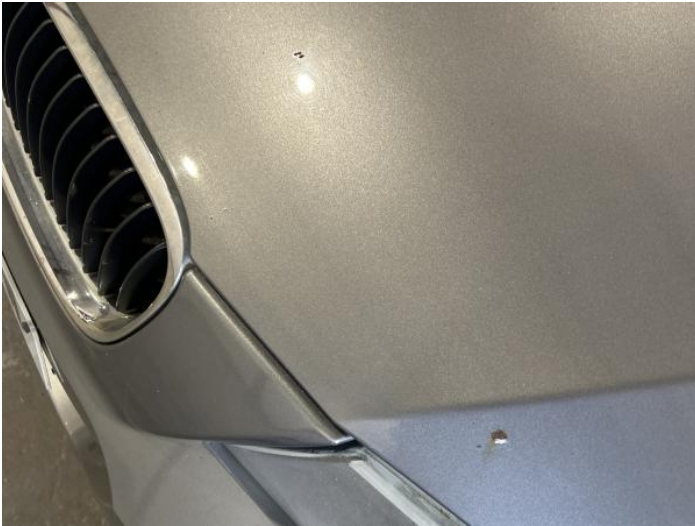
15: Bonnet
Chipped
Multiple Chips

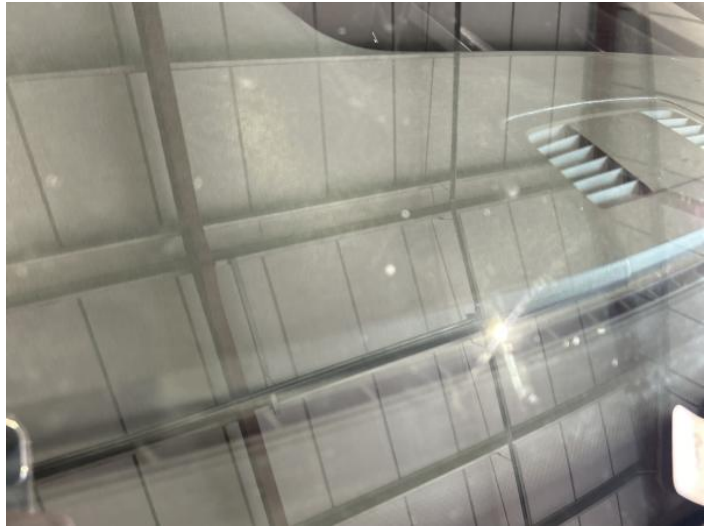
16: Screen Front
Chipped
UpTo 10mm

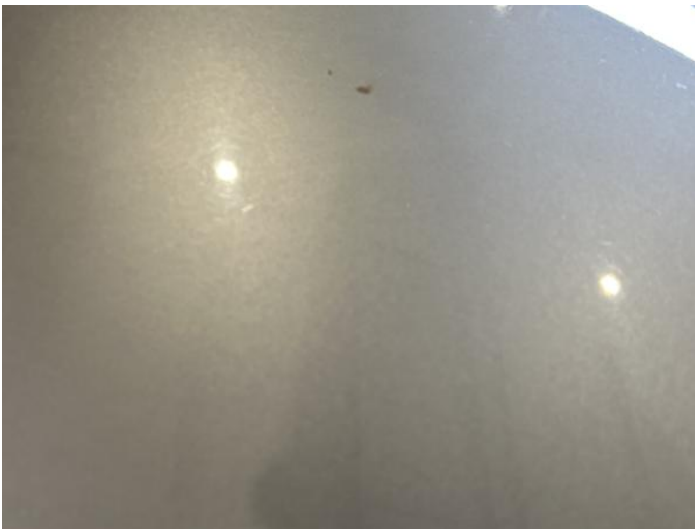
17: Roof
Chipped
1 To 5
