VEHICLE INSPECTION REPORT

GU64TLJ

Honda Jazz 1.4 i-VTEC ES Plus 5dr

nama
GRADE
4

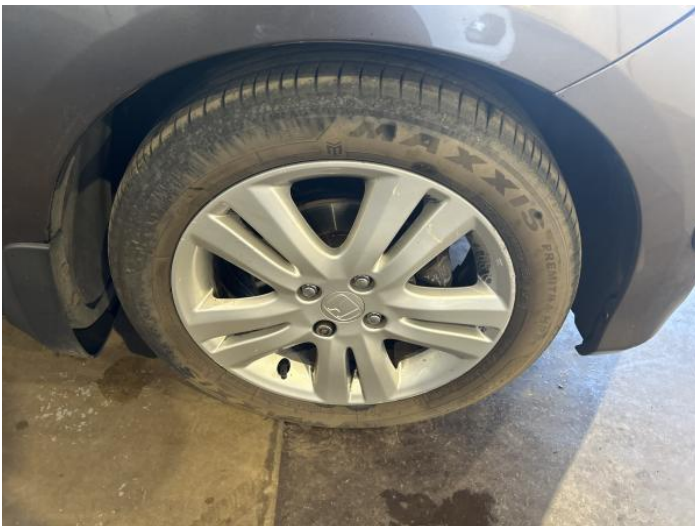
1: Wheel osf
Scratched
Over 50mm

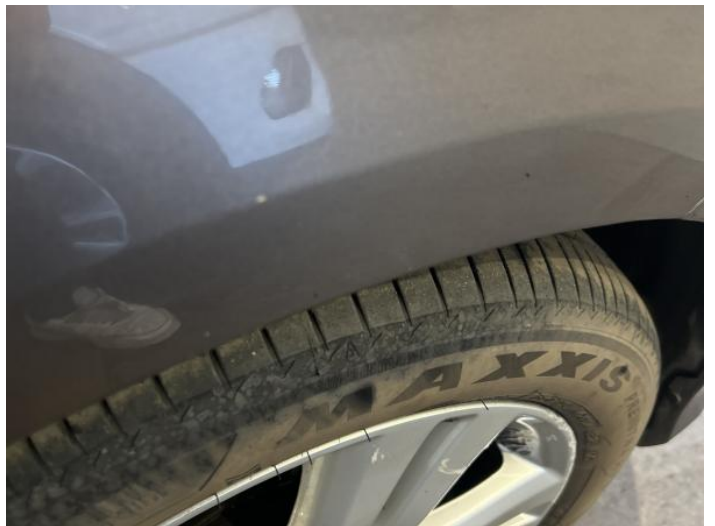
2: Wing osf
Chipped
1 To 5

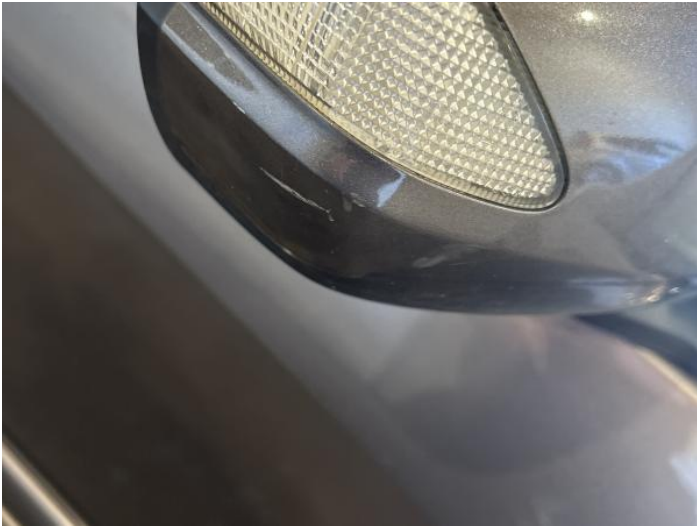
3: Door Mirror Assy osf
Scratched (Painted)
UpTo 25mm Thru Paint

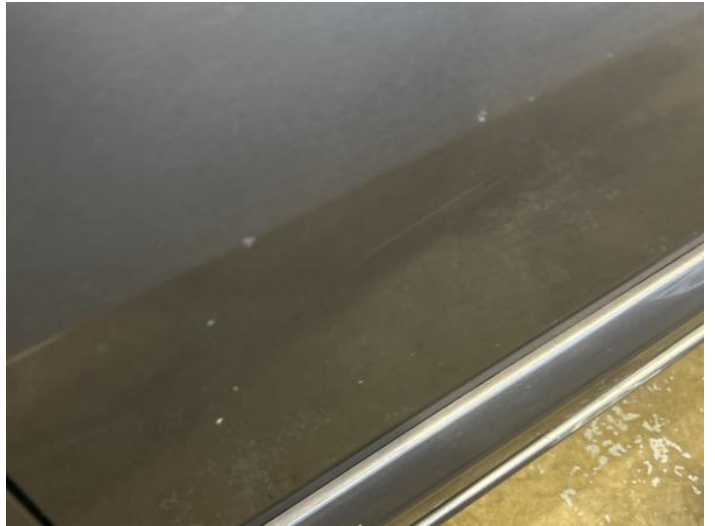
4: Door osf
Chipped
Multiple Chips

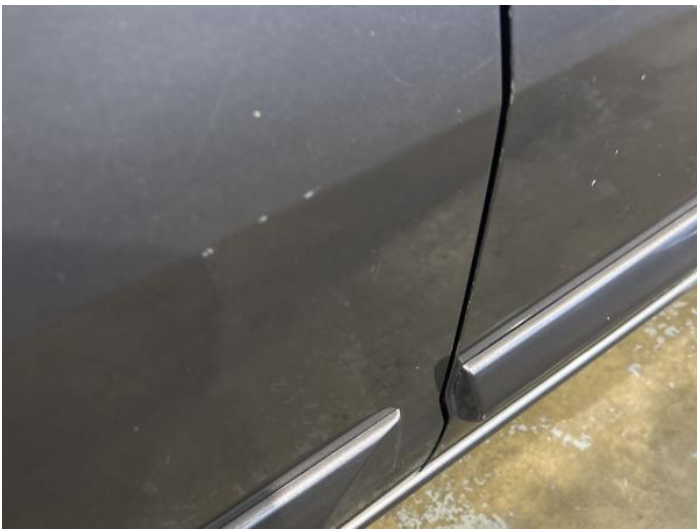
5: Door osr
Chipped
1 To 5

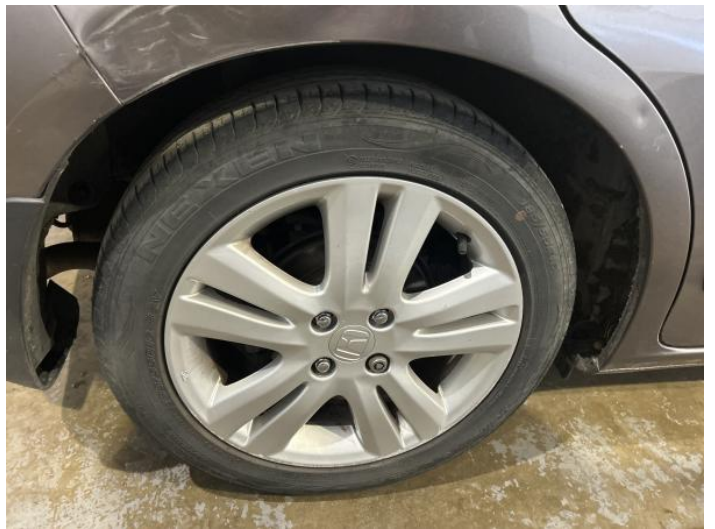
6: Wheel osr
Scratched
Over 50mm

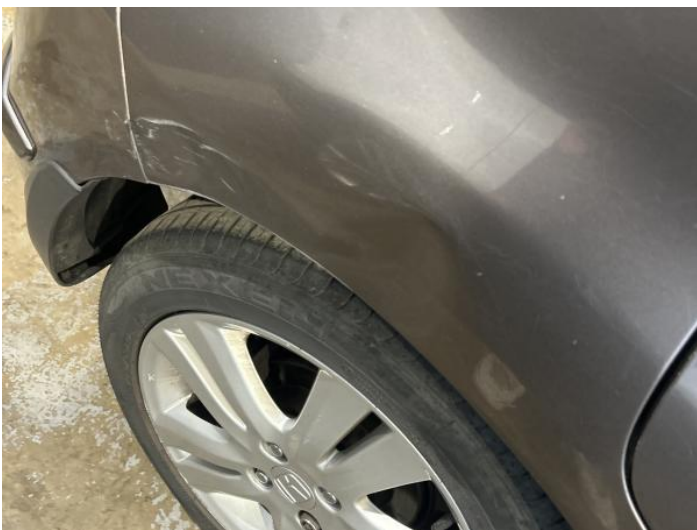
7: Qtr Panel osr
Dented
With Paint Damage

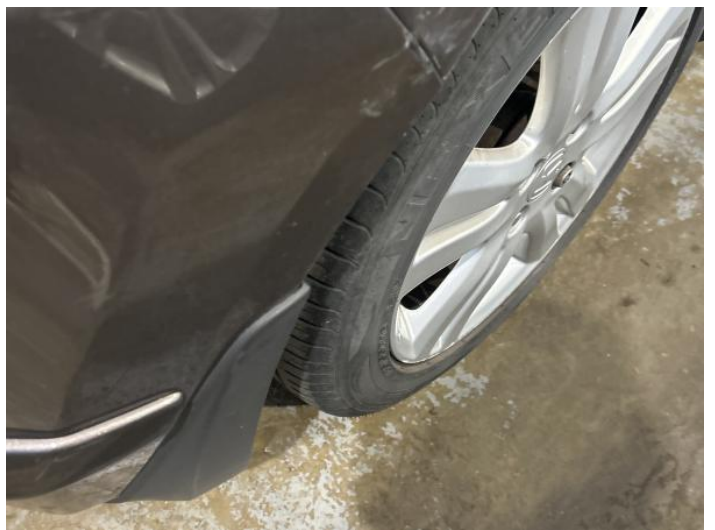
8: Bumper Rear
Scratched
Over 100mm Thru Paint

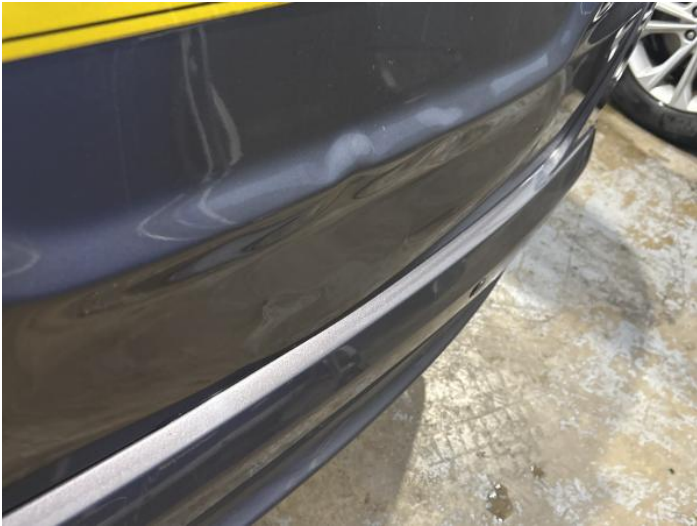
9: Tailgate
Dented
With Paint Damage

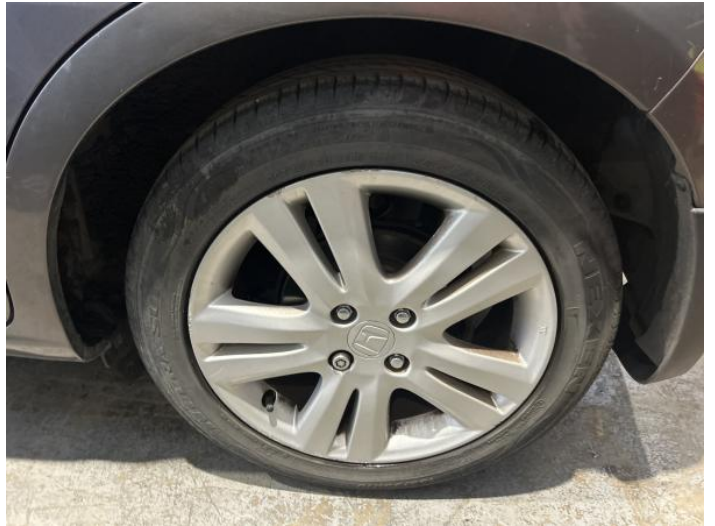
10: Wheel nsr
Scratched
Over 50mm

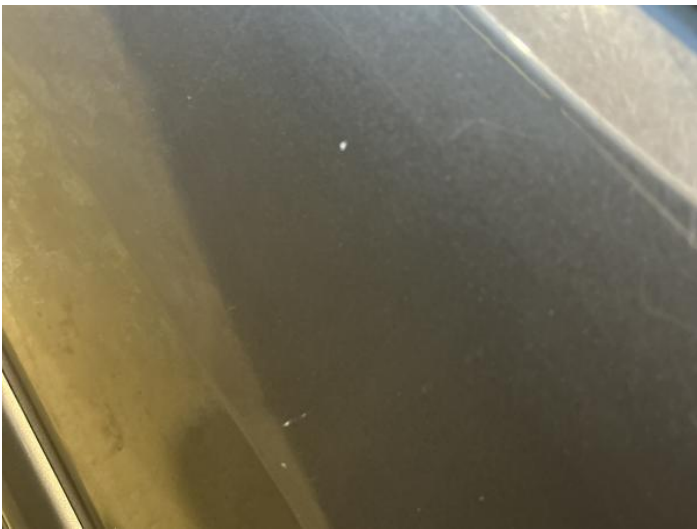
11: Door nsf
Chipped
1 To 5

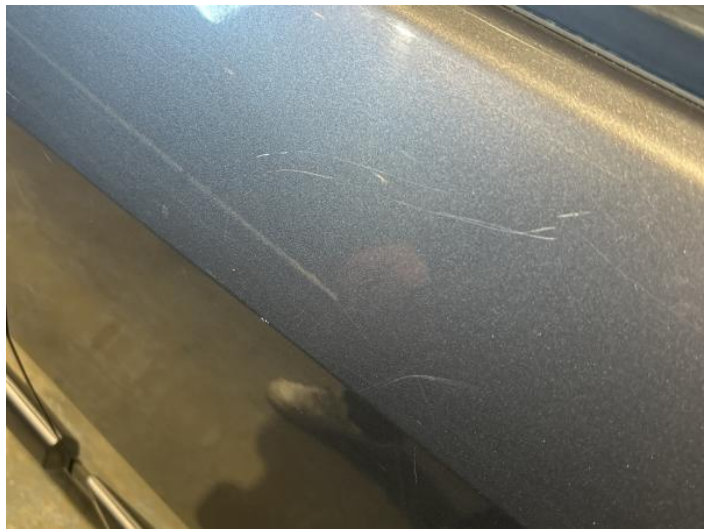
12: Door nsr
Scratched
Over 25mm Thru Paint

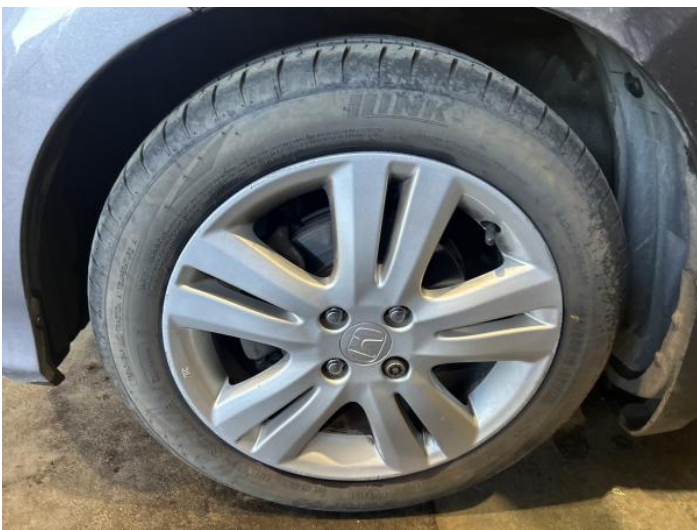
13: Wheel nsf
Scratched
Over 50mm

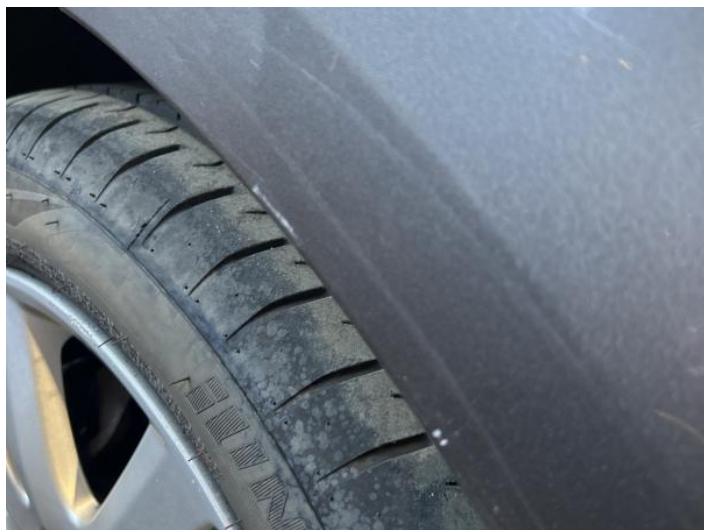
14: Wing nsf
Chipped
1 To 5

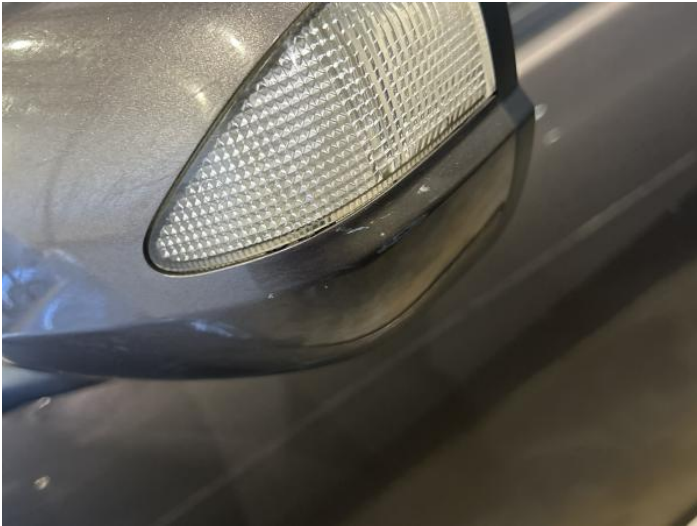
15: Door Mirror Assy nsf
Scratched (Painted)
UpTo 25mm Thru Paint

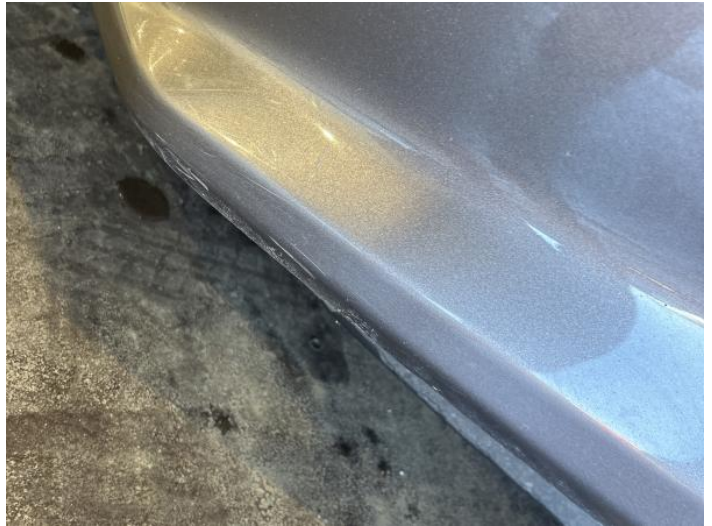
16: Bumper Front
Scratched
Over 100mm Thru Paint

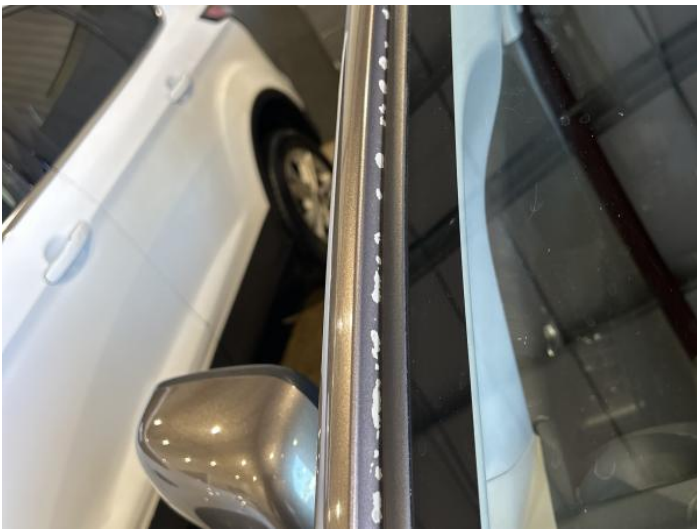
17: A Post os
Chipped
Edge Chip

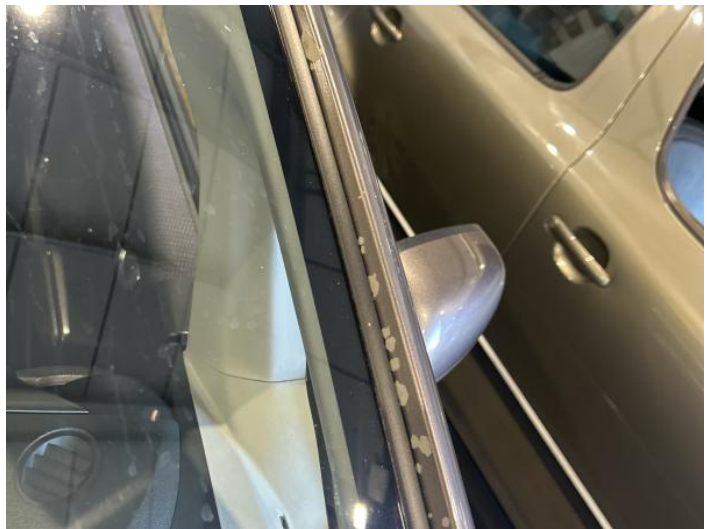
18: A Post ns
Chipped
Edge Chip

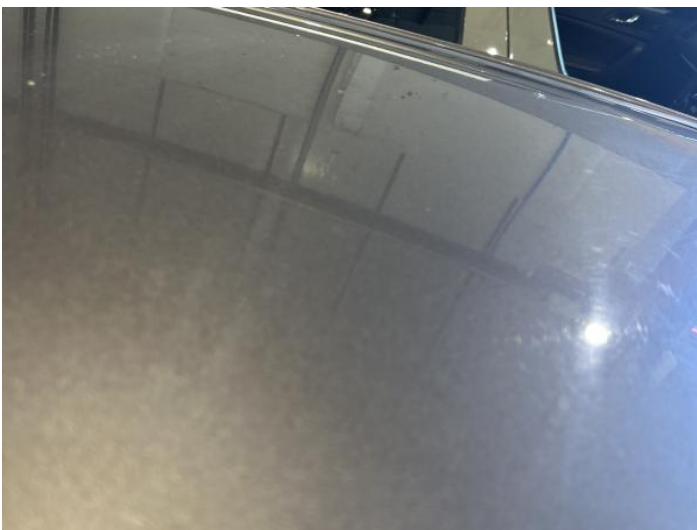
19: Roof
Dented
Between 10mm + 30mm

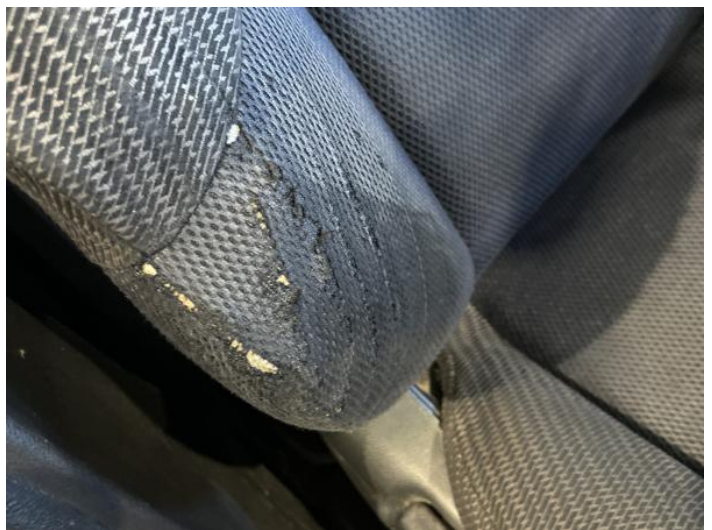
20: Seat Back Cover osf
Torn
Over 3mm
