# VEHICLE INSPECTION REPORT

**LL64YRW**

## Ford C-Max 2.0 TDCi Titanium 5dr Powershift

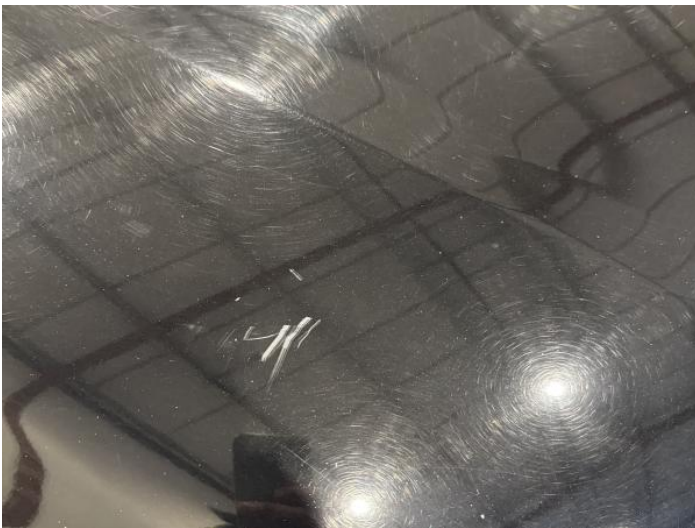
1: Bonnet  
Scratched  
Over 25mm Thru Paint

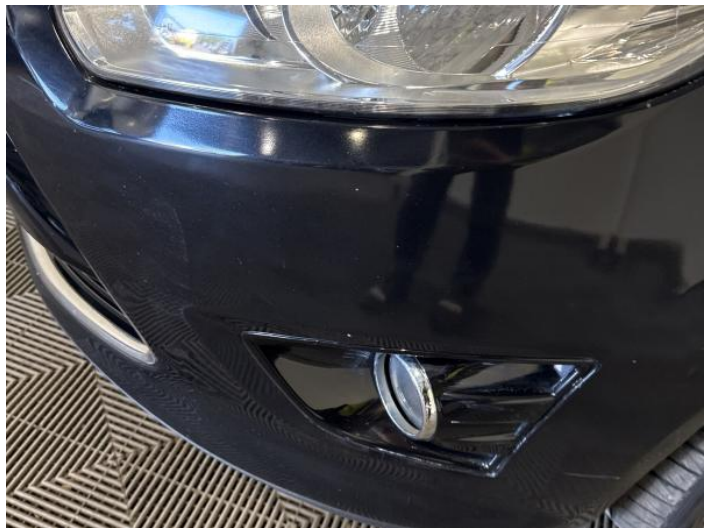
2: Bumper Front  
Scratched  
Over 100mm Thru Paint

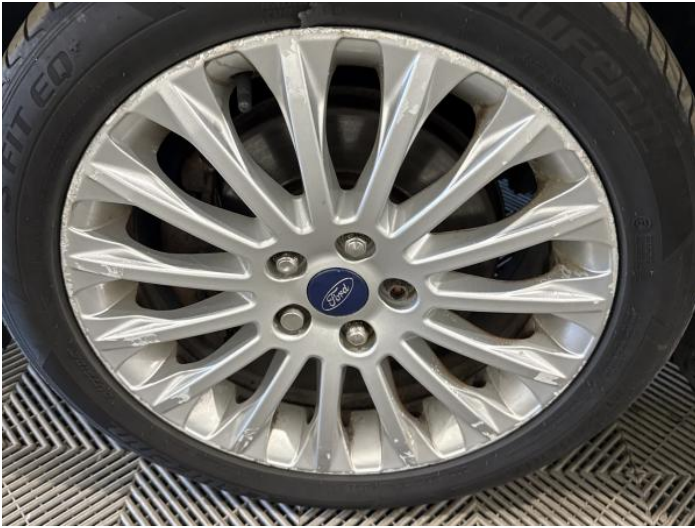
3: Wheel nsf  
Scratched  
Over 50mm

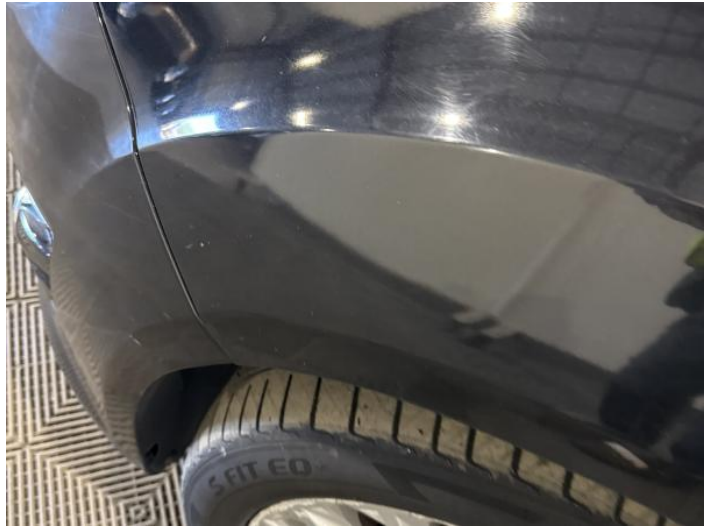
4: Wing nsf  
Scratched  
Over 25mm Thru Paint

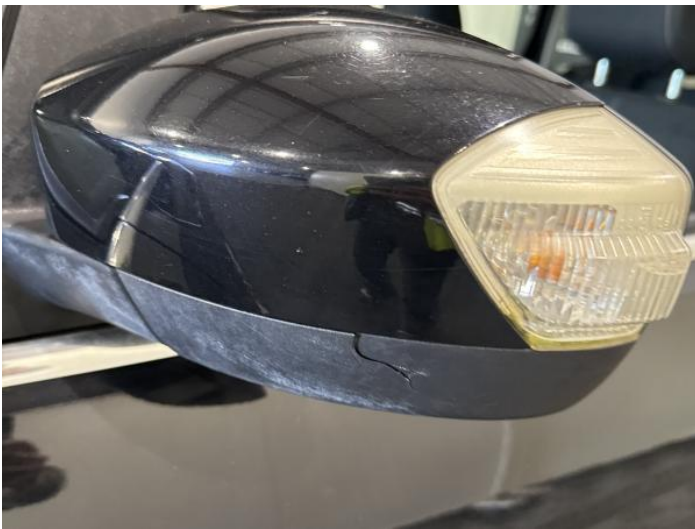
5: Door Mirror Assy nsf  
Broken  
Replace

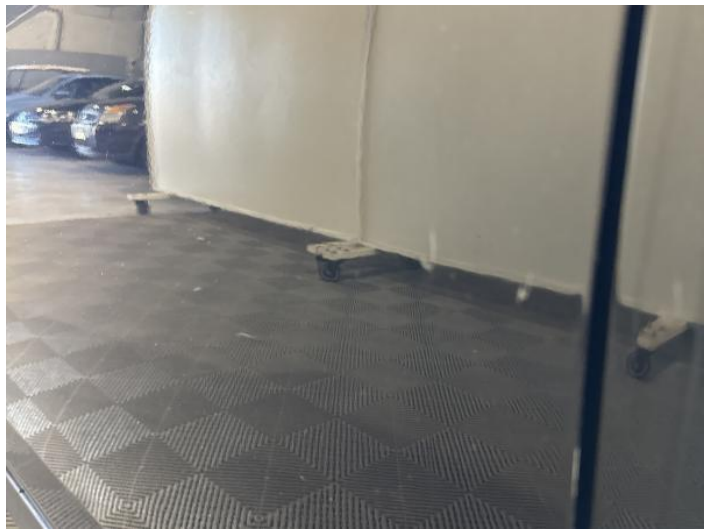
6: Door nsf  
Scratched  
Up To 25mm Thru Paint

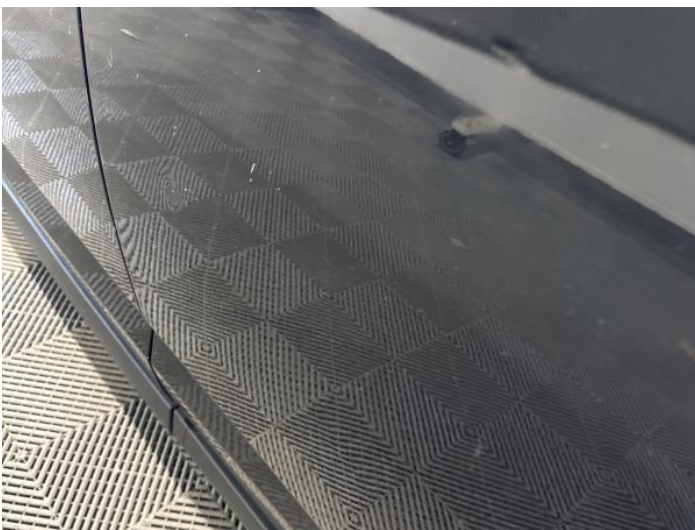
7: Door nsr  
Scratched  
Over 25mm Thru Paint

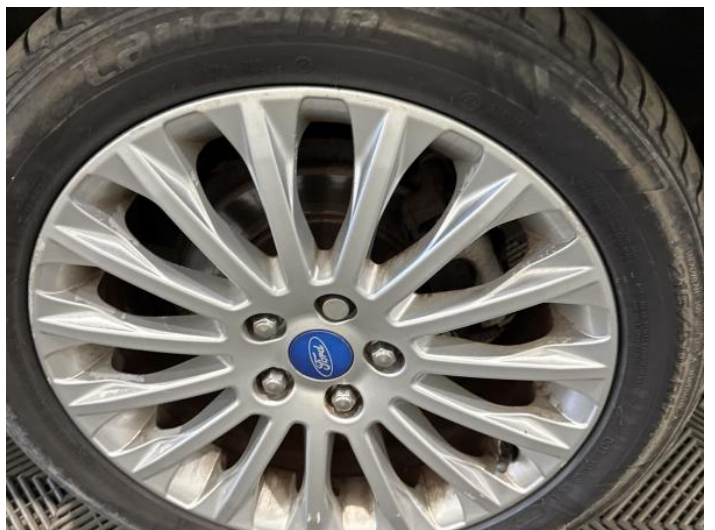
8: Wheel nsr  
Scratched  
Over 50mm

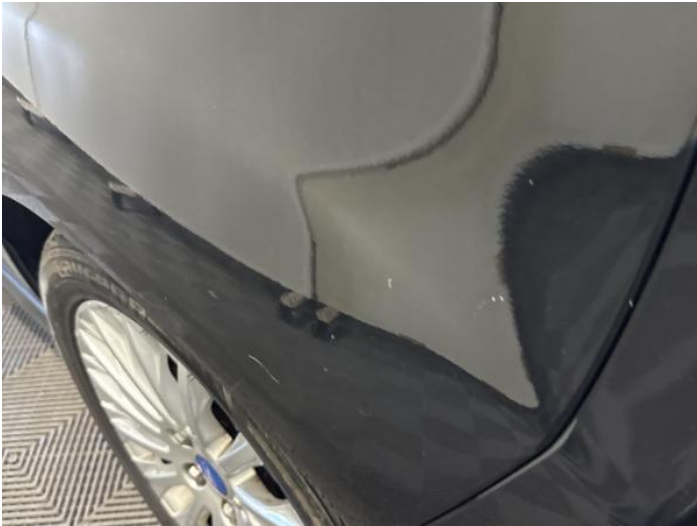
9: Qtr Panel nsr  
Dented  
With Paint Damage

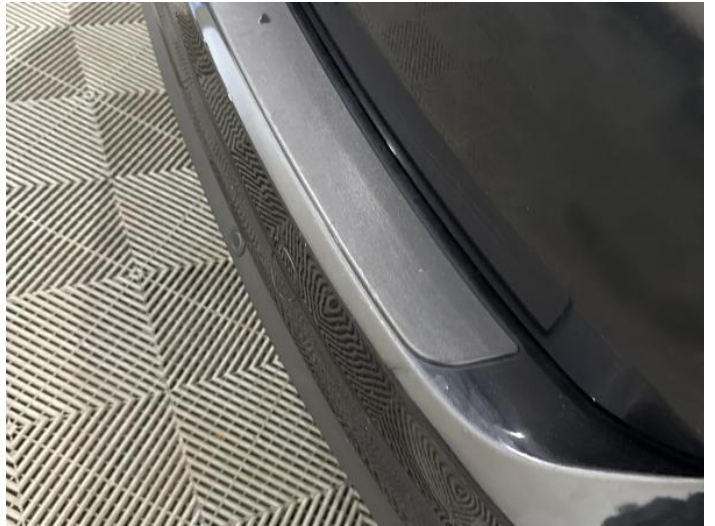
10: Bumper Rear  
Scratched  
25 to 100mm Thru Paint

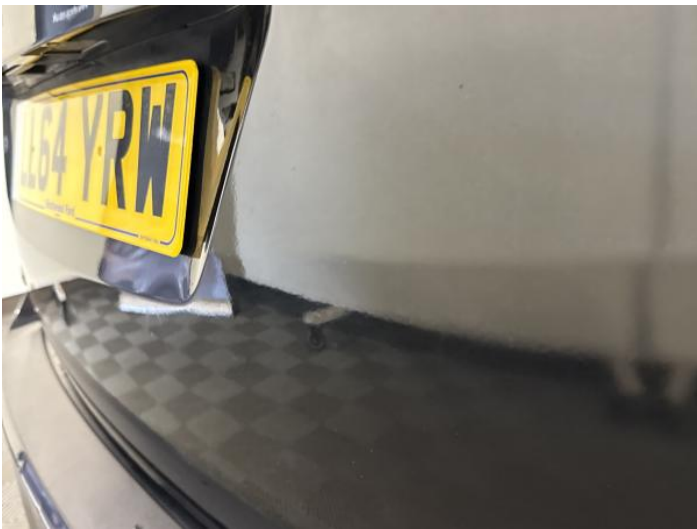
11: Tailgate  
Poor Previous Repair  
Poor Paint

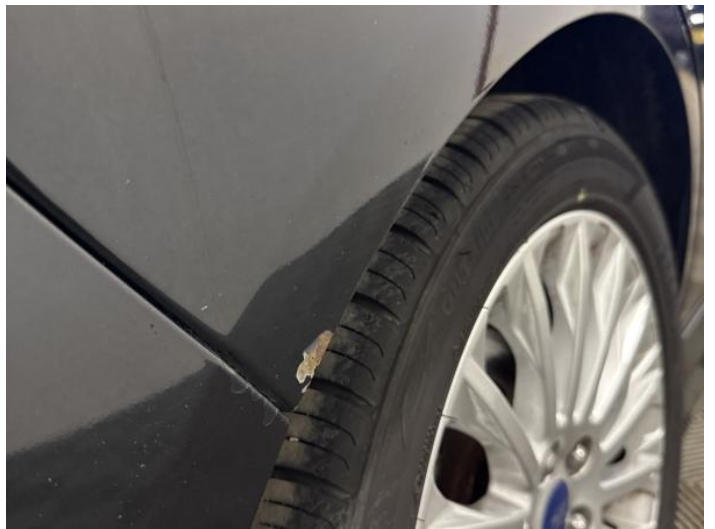
12: Qtr Panel osr  
Scratched  
Rusted

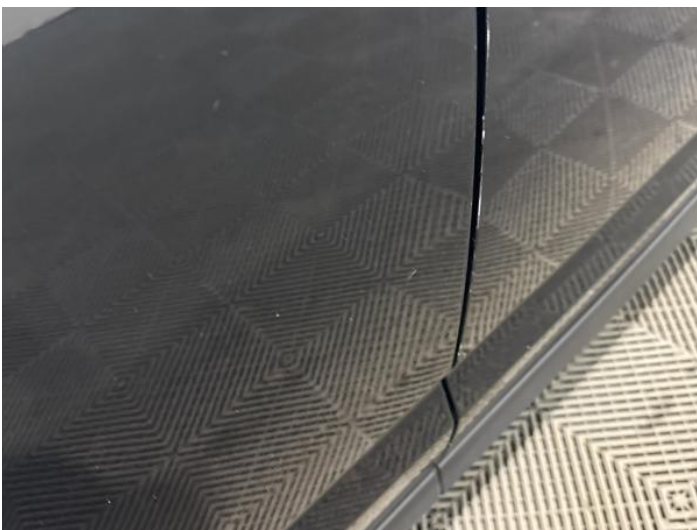
13: Door osr  
Scratched  
Up To 25mm Thru Paint

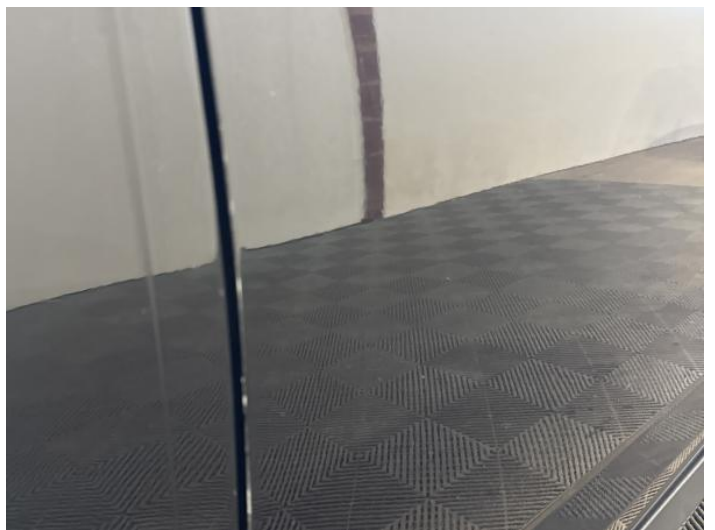
14: Door osf  
Chipped  
Edge Chip

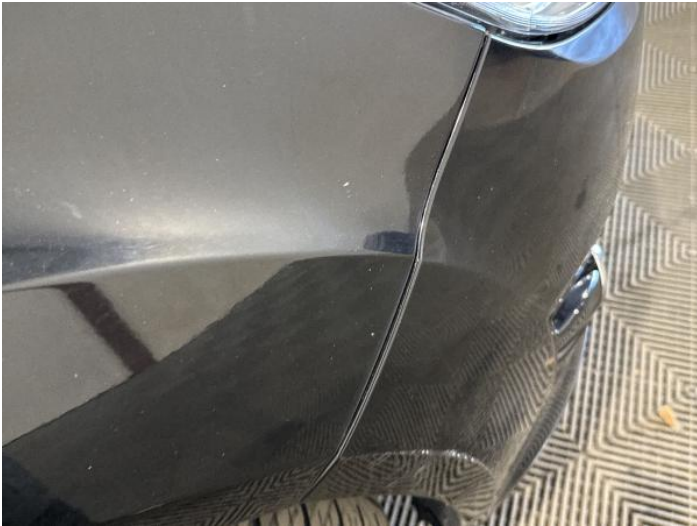
15: Wing osf  
Chipped  
1 To 5

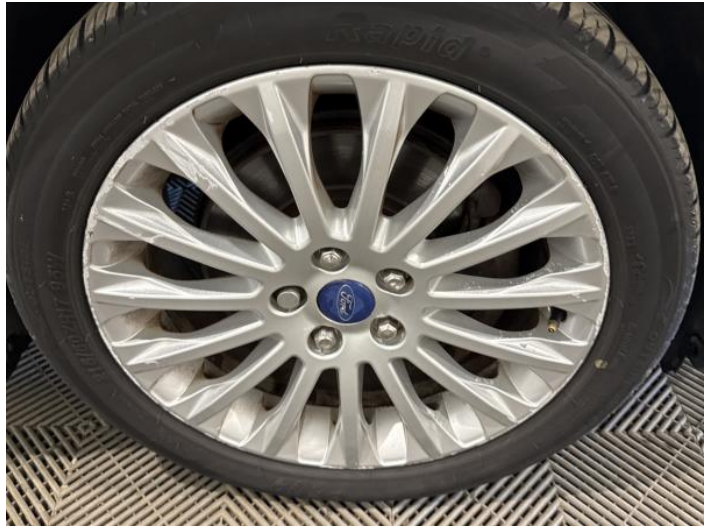
16: Wheel osf  
Scratched  
Over 50mm

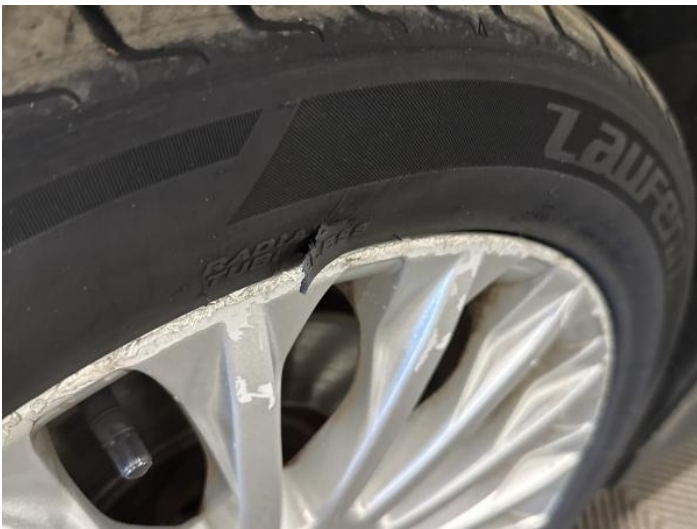
NSF	LAUFENN	Damaged
NSR	LAUFENN	3.0mm
OSF	RAPID	5.0mm
OSR	RAPID	5.0mm
Spare

17: Tyre nsf  
Damaged  
Replace
