VEHICLE INSPECTION REPORT

LL16YNV

BMW X3 xDrive20d M Sport 5dr Step Auto

nama
GRADE
4

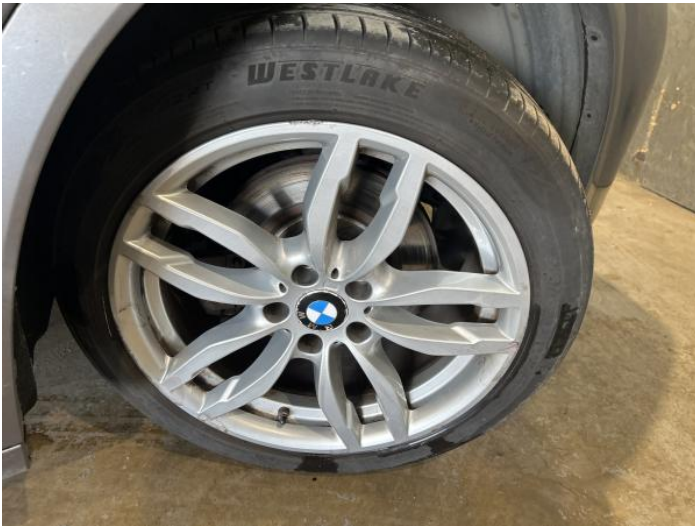
1: Wheel osf
Scratched
Over 50mm

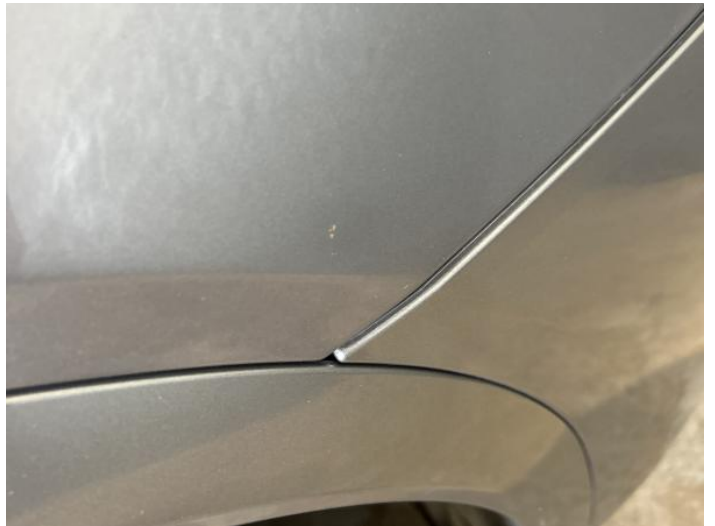
2: Wing osf
Chipped
1 To 5

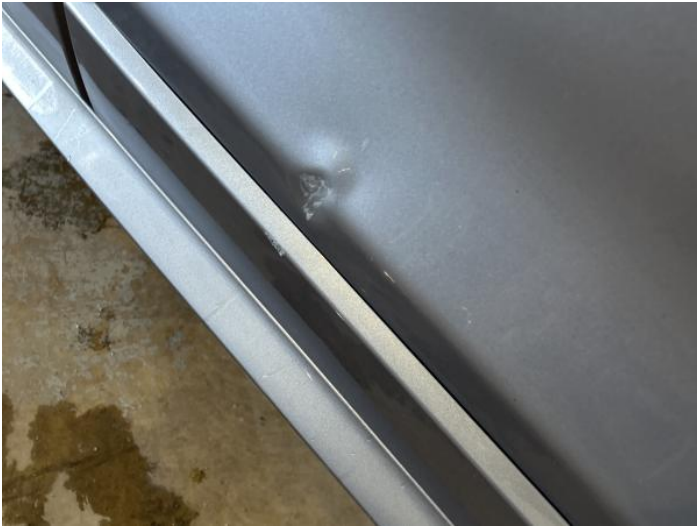
3: Door osf
Dented
With Paint Damage

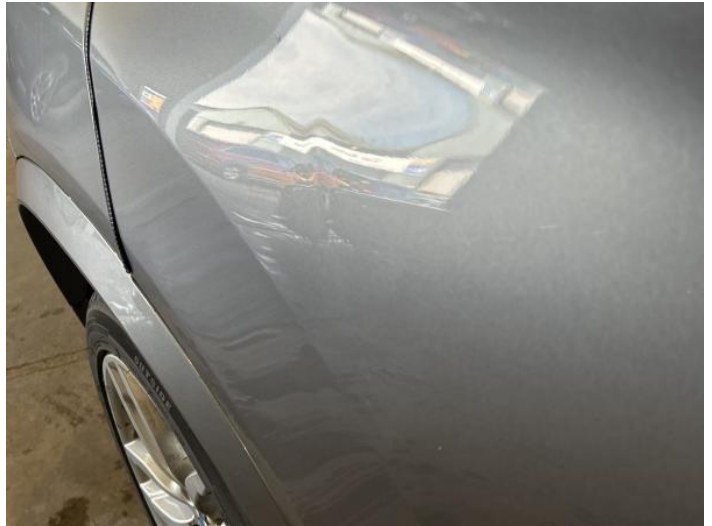
4: Door osr
Dented
Over 30mm

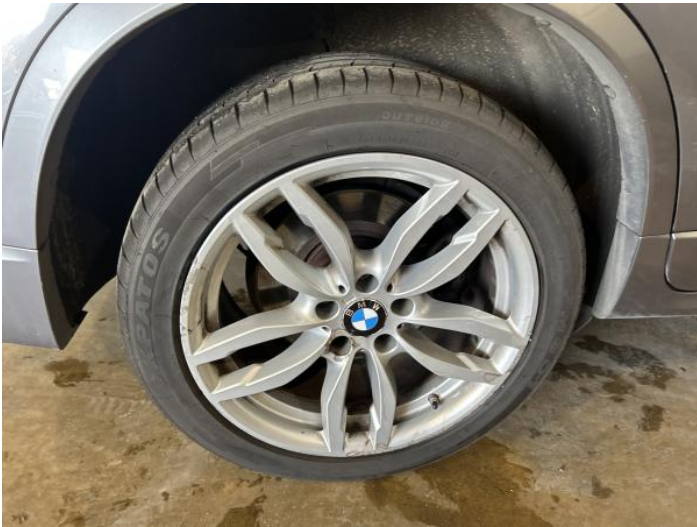
5: Wheel osr
Scratched
Over 50mm

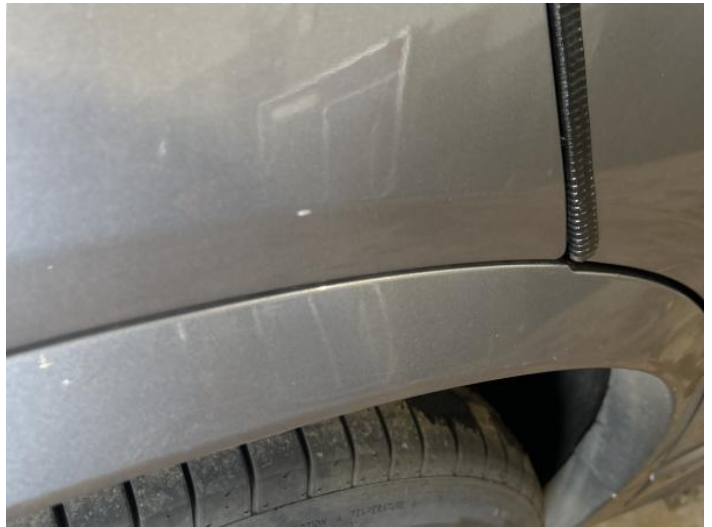
6: Qtr Panel osr
Chipped
1 To 5

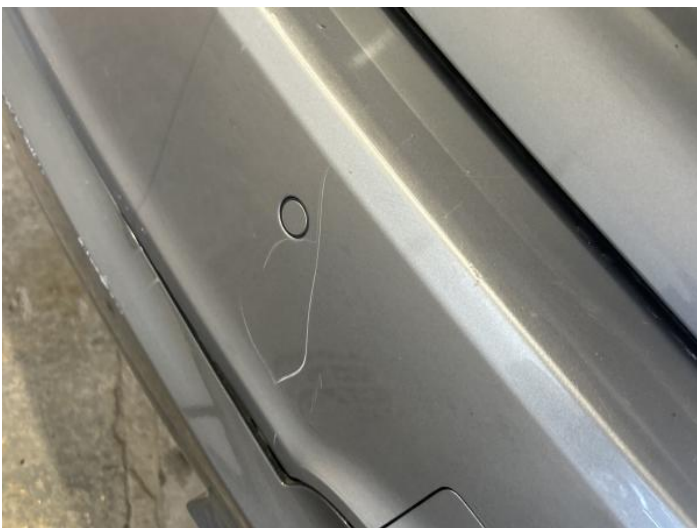
7: Bumper Rear
Scratched
Over 100mm Thru Paint

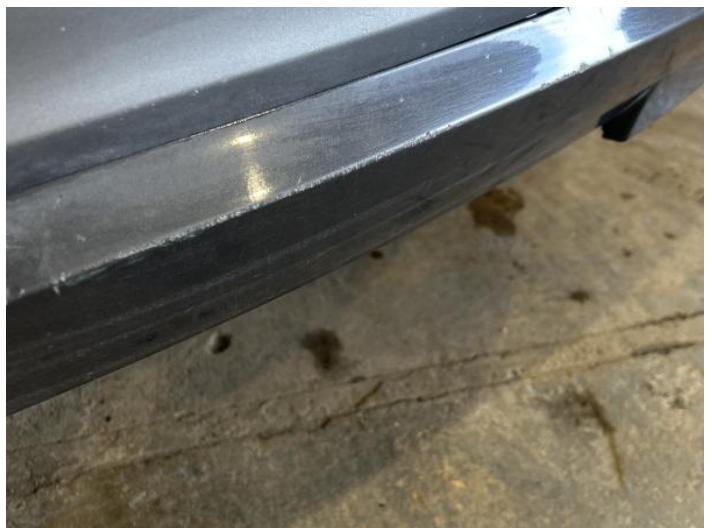
8: Bumper Rear Moulding
Scratched (Painted)
Over 25mm Thru Paint

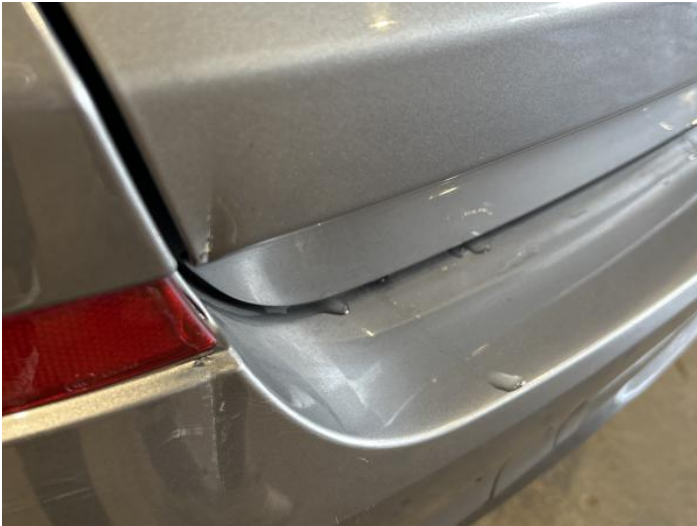
9: Tailgate
Dented
With Paint Damage

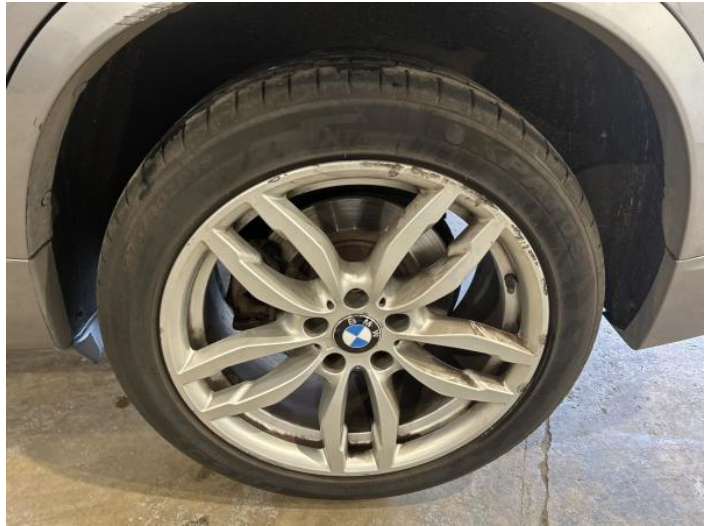
10: Wheel nsr
Scratched
Over 50mm

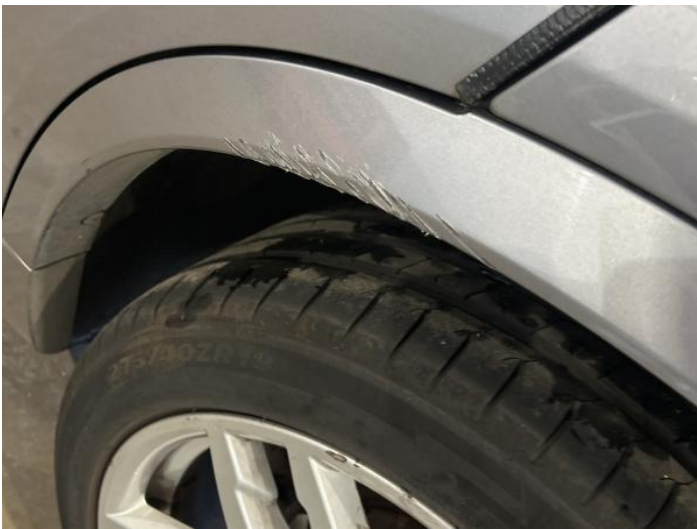
11: Qtr Panel Moulding ns
Scratched (Painted)
Over 25mm Thru Paint

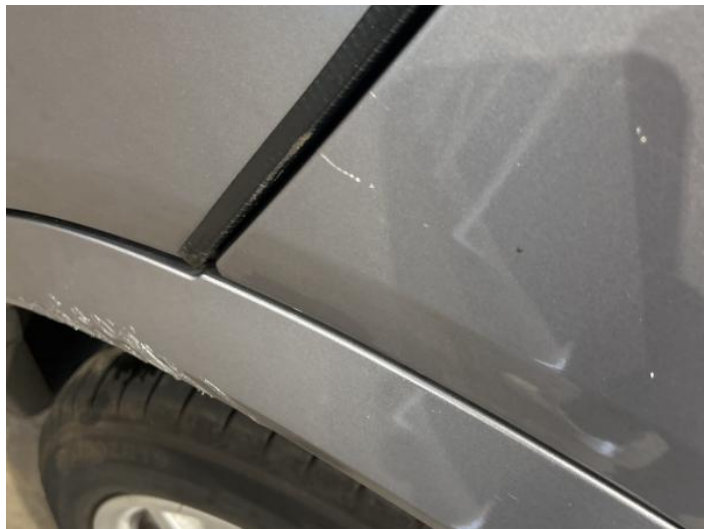
12: Qtr Panel nsr
Scratched
UpTo 25mm Thru Paint

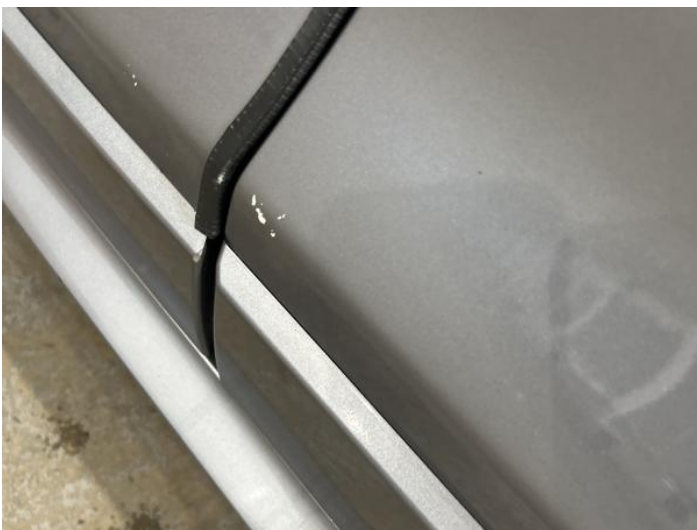
13: Door nsr
Chipped
1 To 5

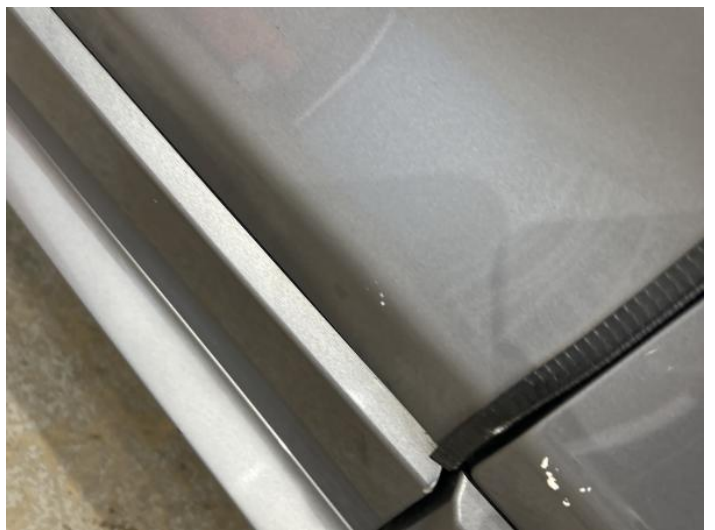
14: Door nsf
Chipped
1 To 5

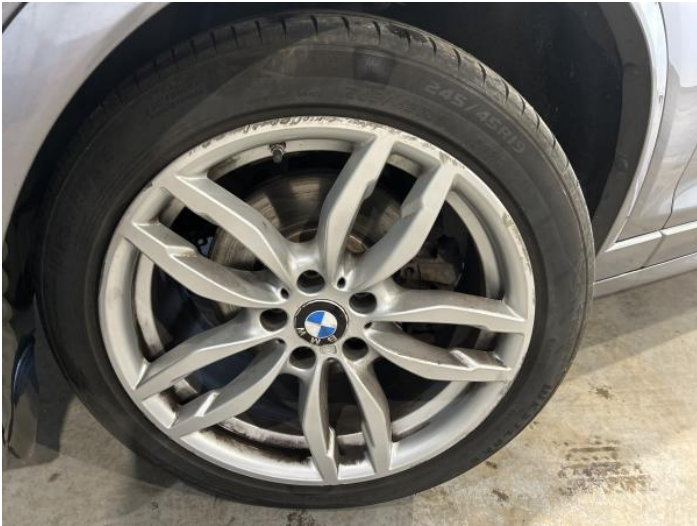
15: Wheel nsf
Scratched
Over 50mm

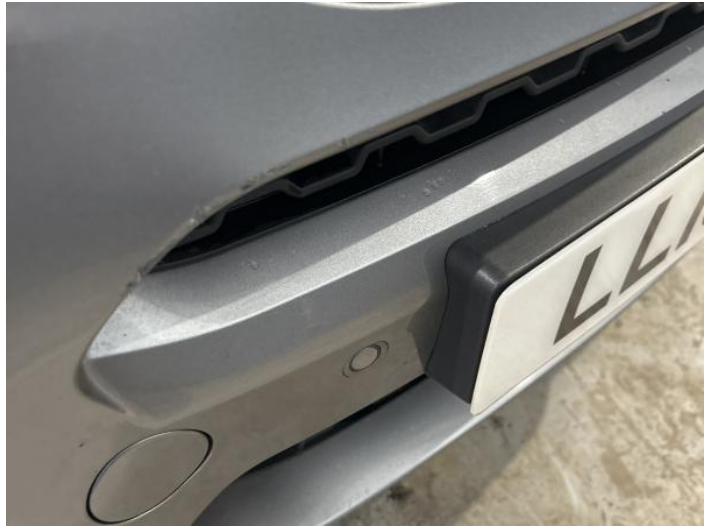
16: Bumper Front
Scratched
25 to 100mm Thru Paint

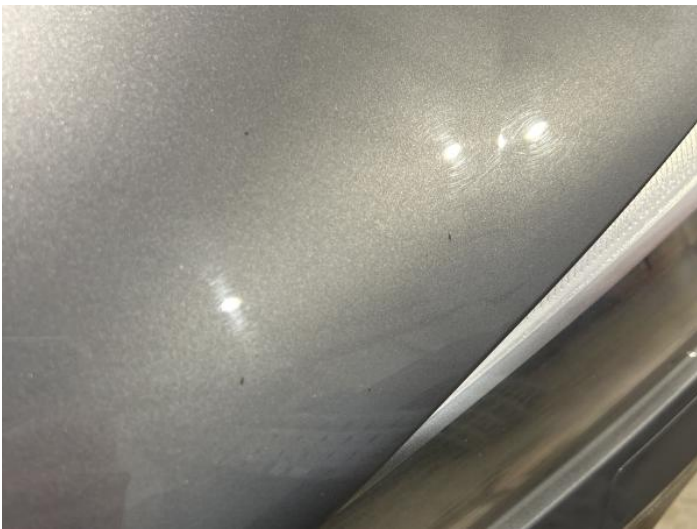
17: Bonnet
Chipped
1 To 5
