**WN12BYK**

## Seat Leon 1.6 TDI CR SE Copa 5dr DSG

nama  
GRADE  
**4**

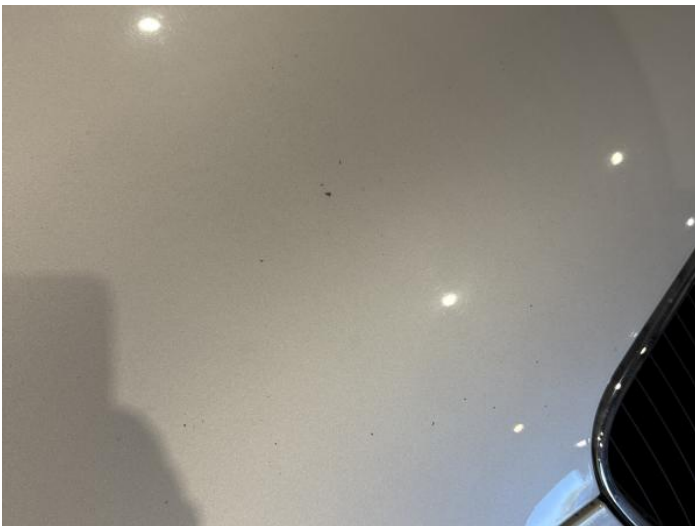
1: Bonnet  
Chipped  
Multiple Chips

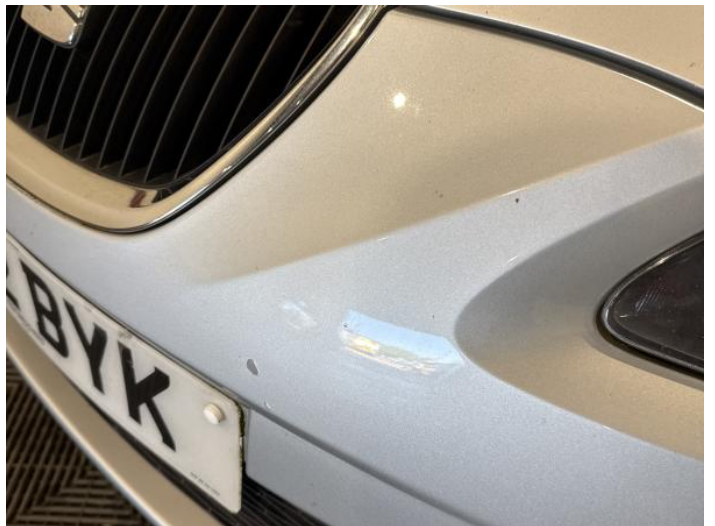
2: Bumper Front  
Poor Previous Repair  
Paint Flake

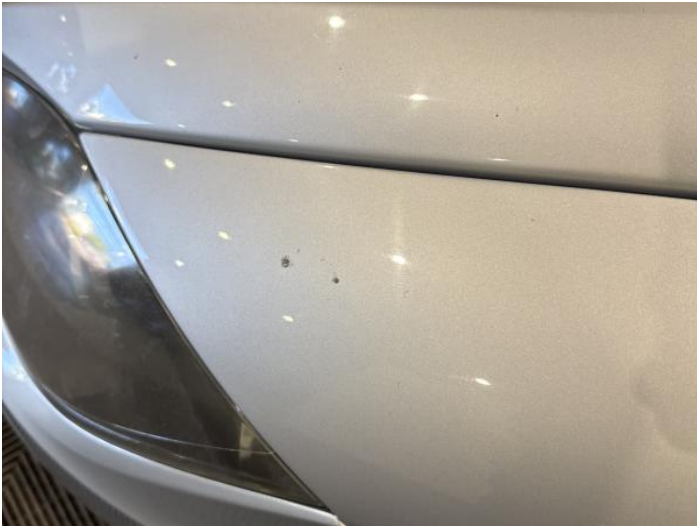
3: Wing nsf  
Chipped  
Over 5mm

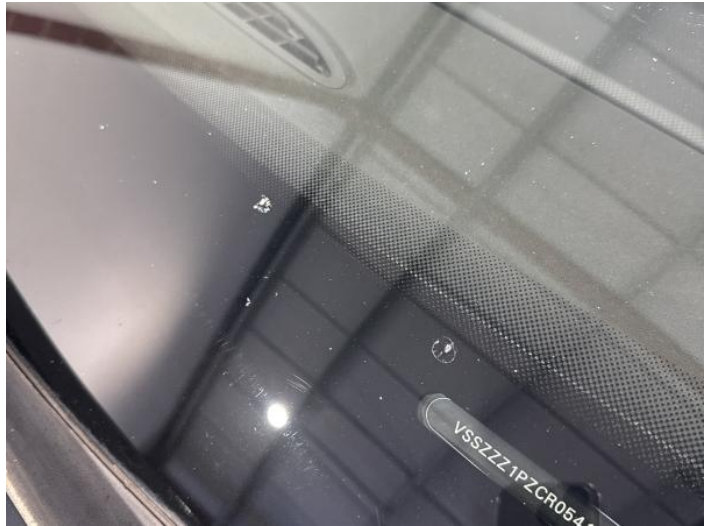
4: Screen Front  
Cracked  
Replace

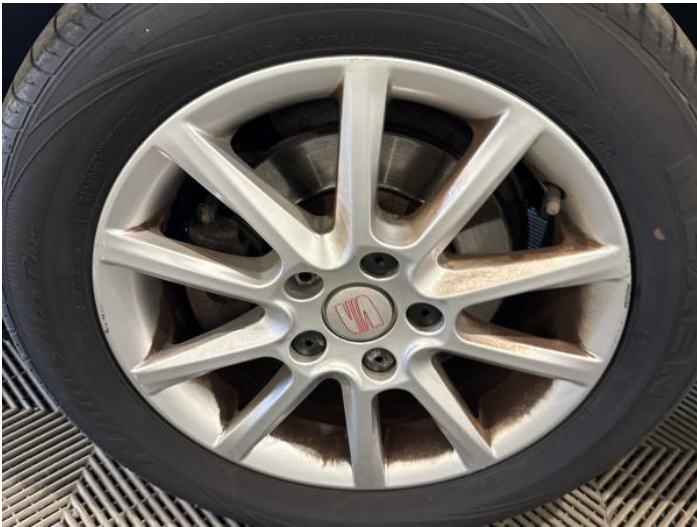
5: Wheel nsf  
Scratched  
Over 50mm

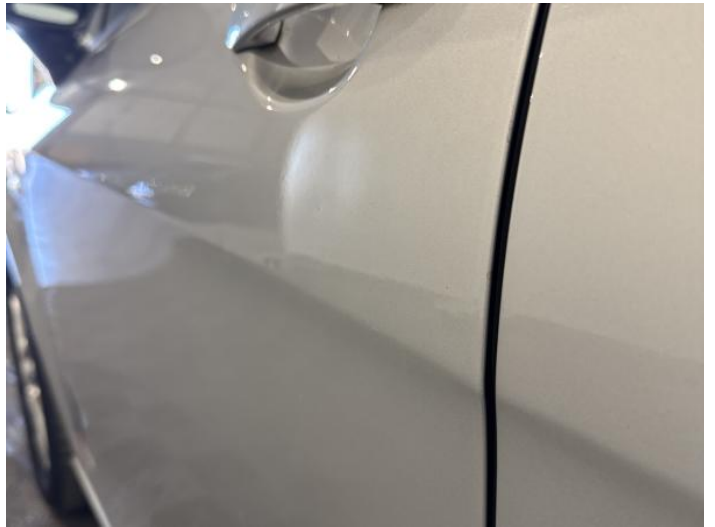
6: Door nsf  
Dented  
Over 30mm

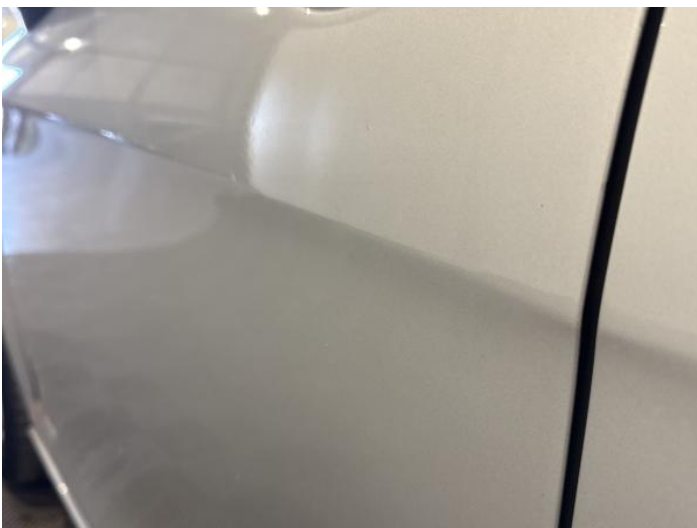
7: Door nsf  
Chipped  
1 To 5

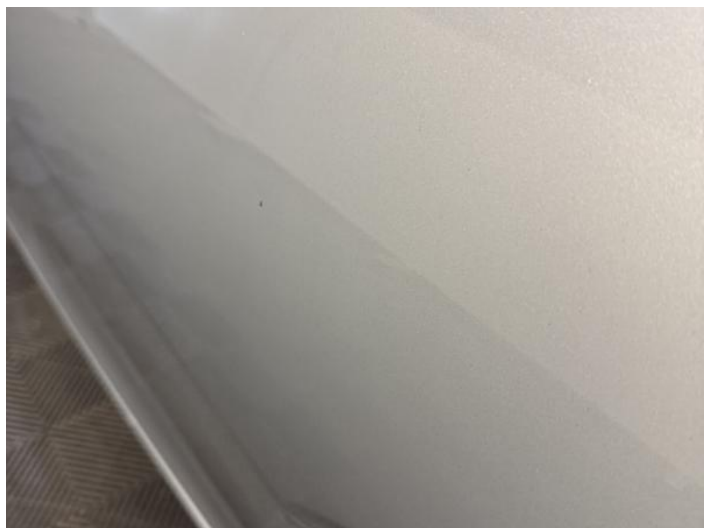
8: Door nsr  
Dented  
2 Or Less UpTo 10mm

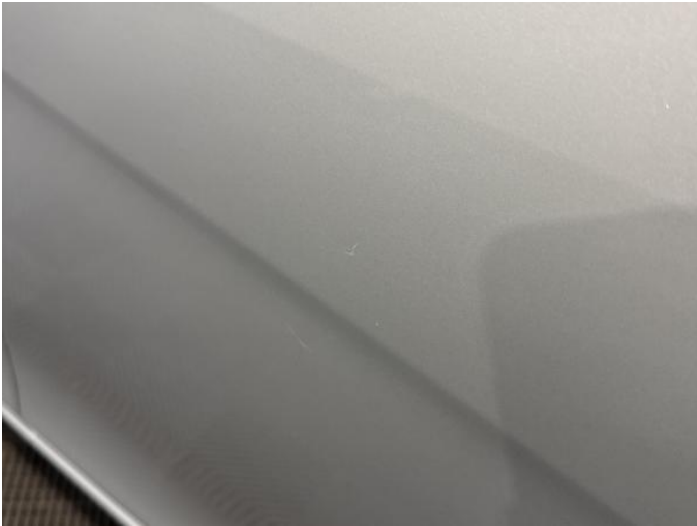
9: Door nsr  
Scratched  
UpTo 25mm Thru Paint

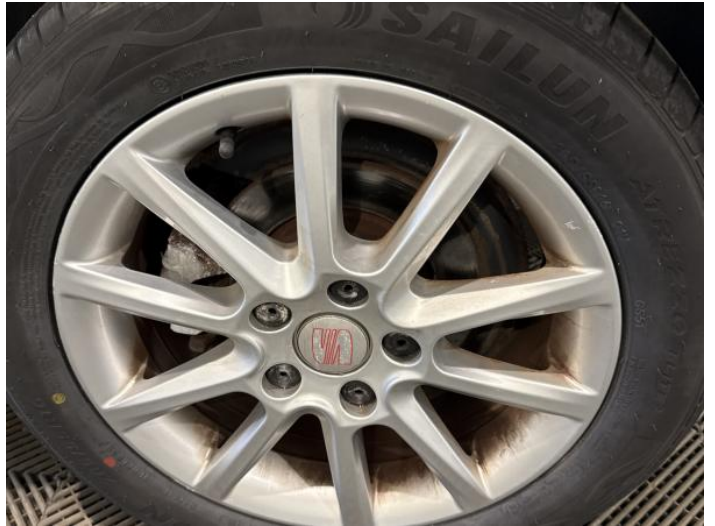
10: Wheel nsr  
Scratched  
Over 50mm

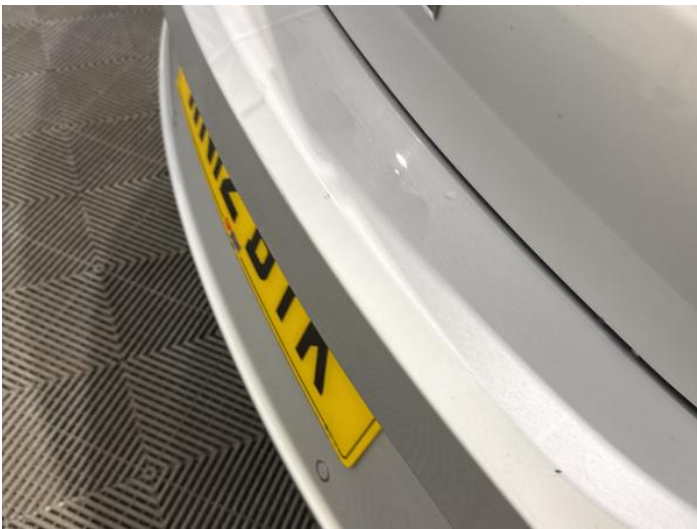
11: Bumper Rear  
Scratched  
25 to 100mm Thru Paint

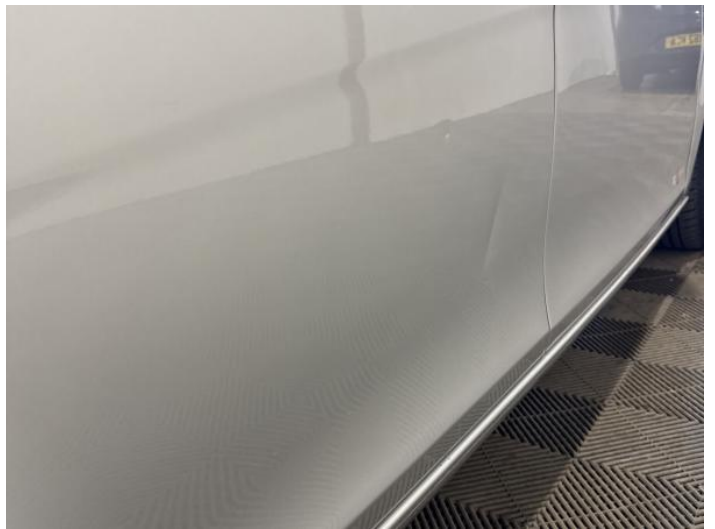
12: Door osr  
Dented  
Over 30mm

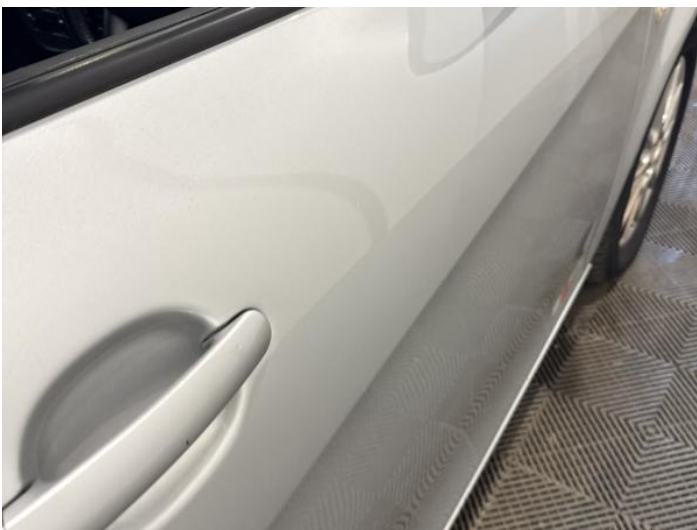
13: Door osf  
Dented  
Between 10mm + 30mm

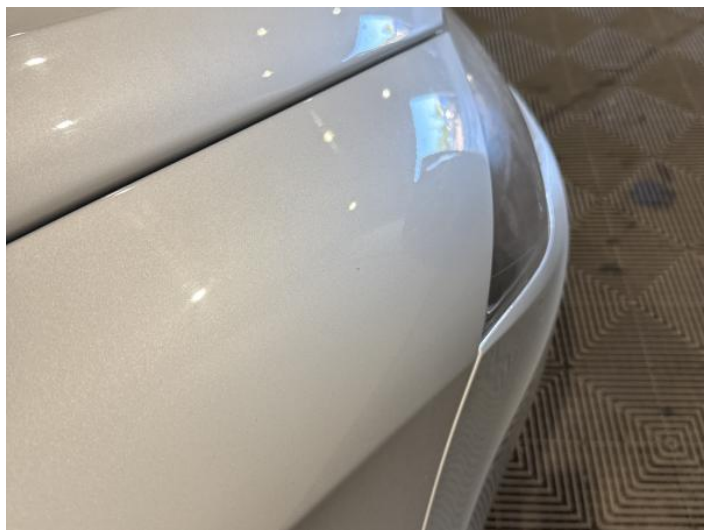
14: Wing osf  
Chipped  
1 To 5
