VEHICLE INSPECTION REPORT

GK60WZD

Volvo XC60 D5 [205] S 5dr AWD Geartronic

nama
GRADE
4

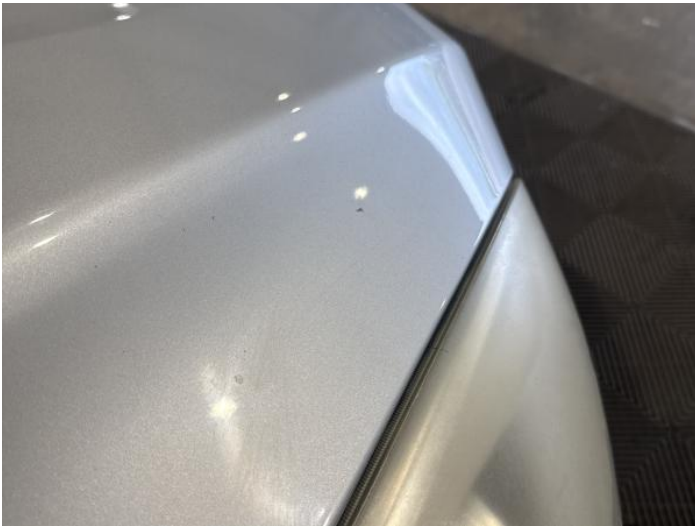
1: Bonnet
Scratched
Over 25mm Thru Paint

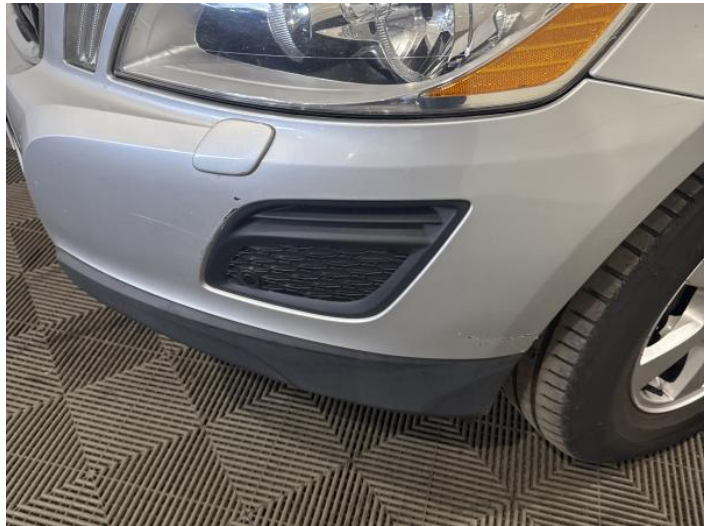
2: Bumper Front
Scratched
Over 100mm Thru Paint

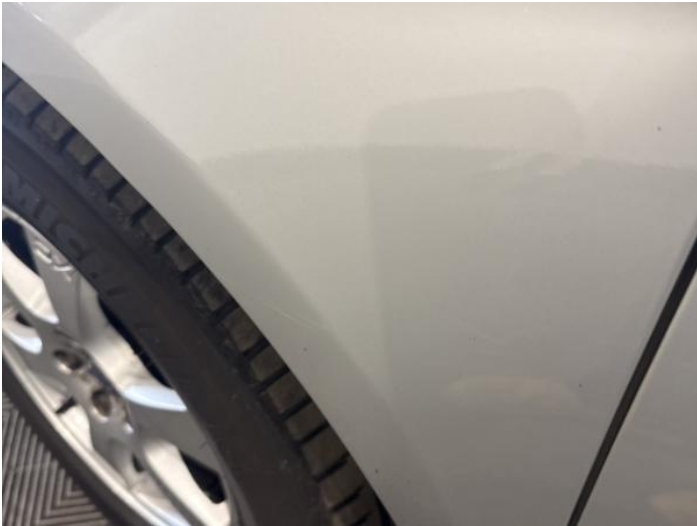
3: Wing nsf
Scratched
Over 25mm Thru Paint

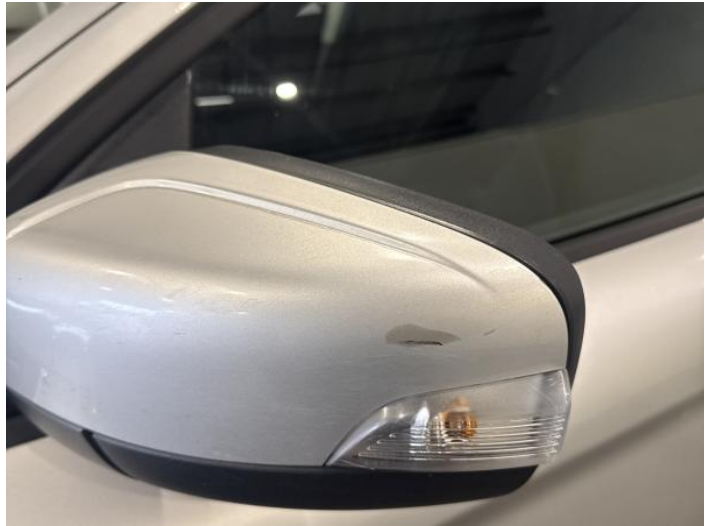
4: Door Mirror Assy nsf
Scratched (Painted)
UpTo 25mm Thru Paint

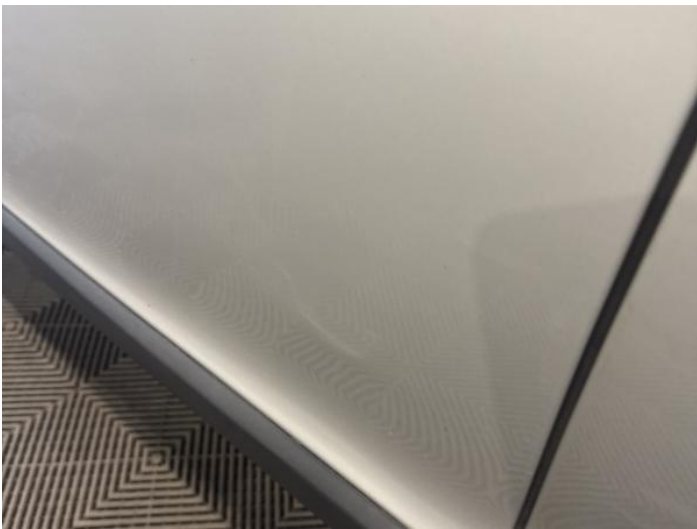
5: Door nsf
Dented
Over 30mm

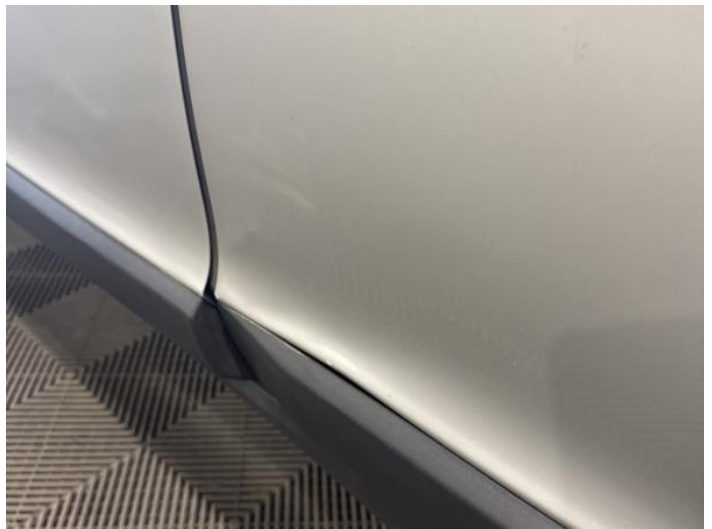
6: Door nsr
Dented
With Paint Damage

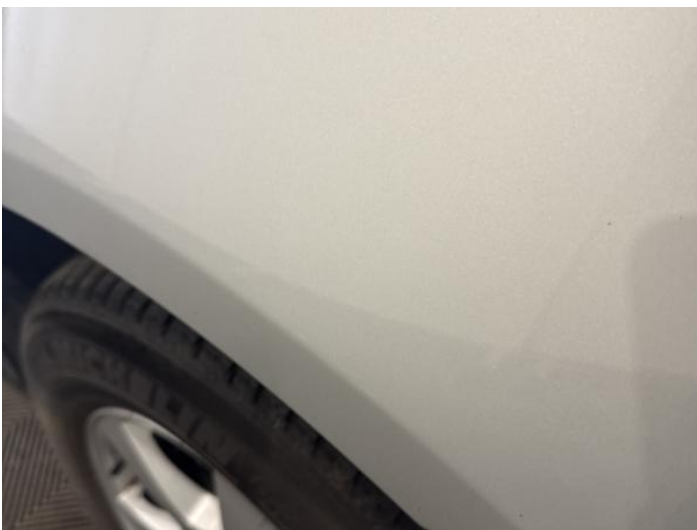
7: Qtr Panel nsr
Scratched
UpTo 25mm Thru Paint

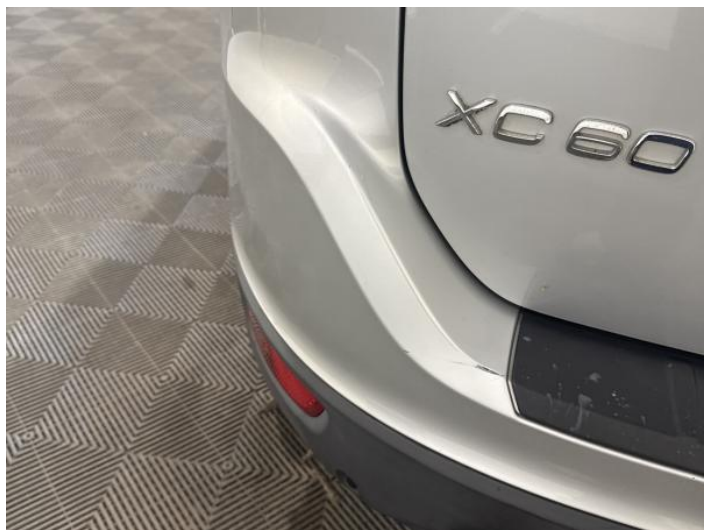
8: Bumper Rear
Scratched
25 to 100mm Thru Paint

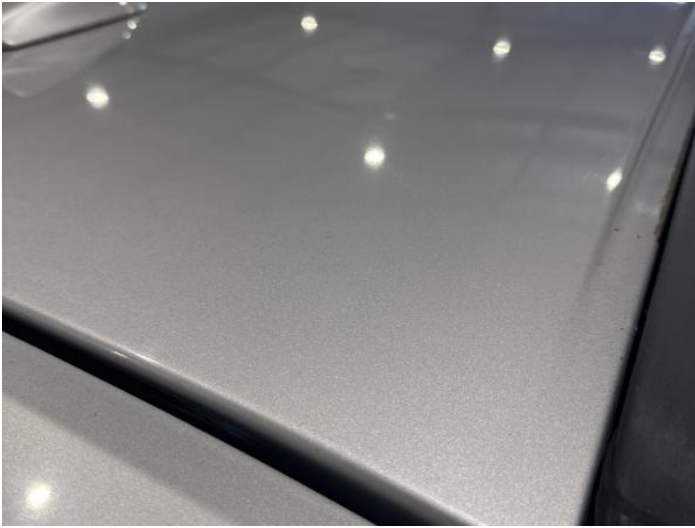
9: Roof
Dented
Over 30mm

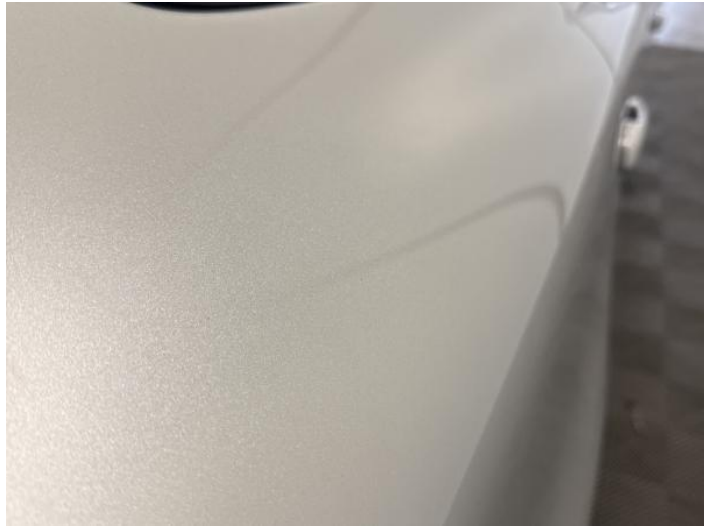
10: Qtr Panel osr
Dented
Between 10mm + 30mm

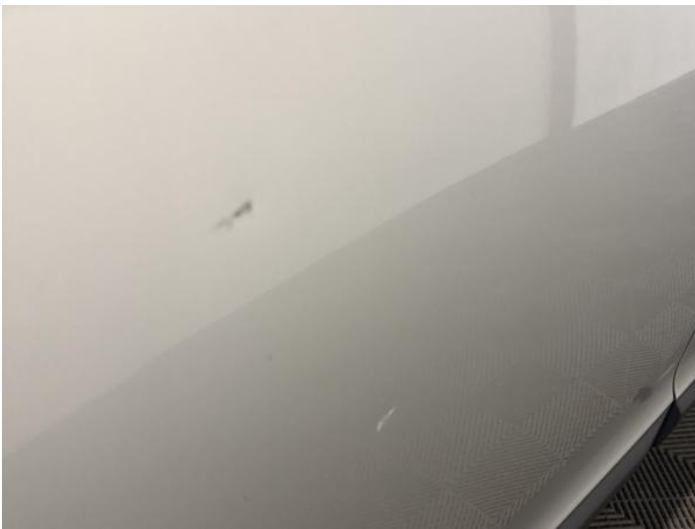
11: Door osr
Scratched
Over 25mm Thru Paint

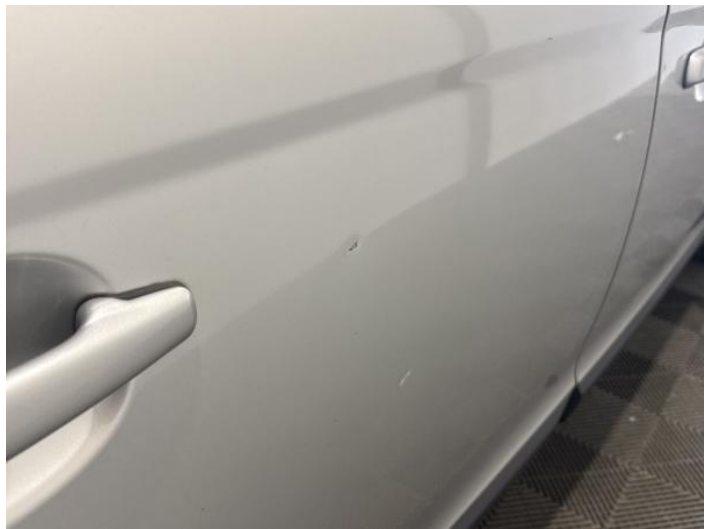
12: Door osr
Dented
Between 10mm + 30mm

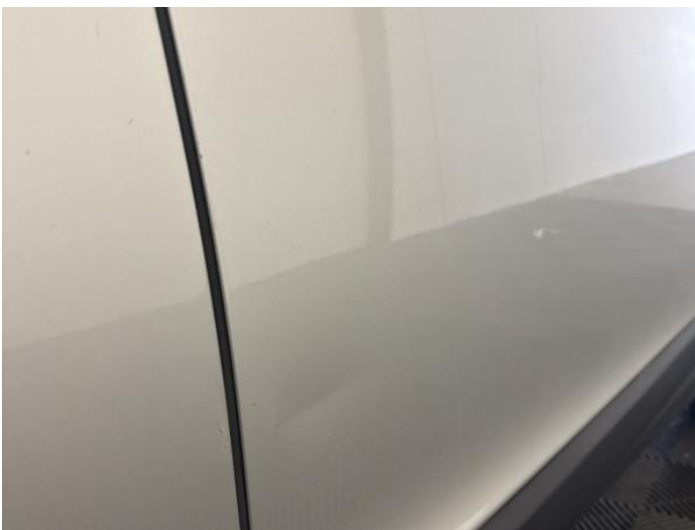
13: Door osf
Dented
Over 30mm
