# VEHICLE INSPECTION REPORT

**GY10CWN**

## Ford Fusion 1.6 Zetec 5dr [Climate]

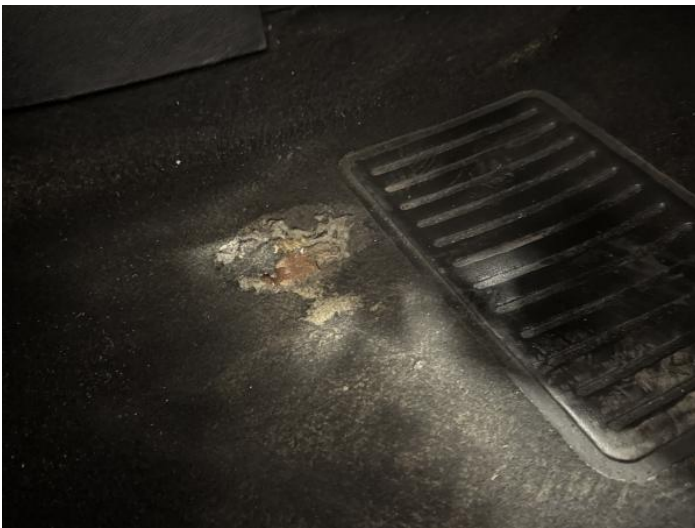
1: Carpets Front  
Holed  
Over 3mm

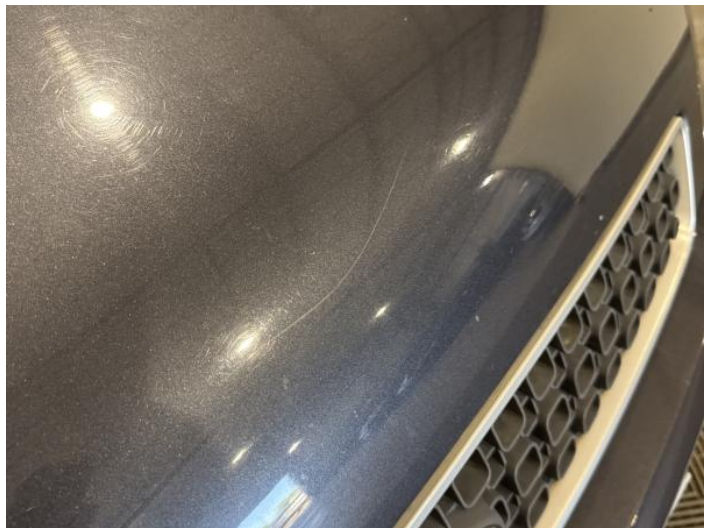
2: Bonnet  
Scratched  
Over 25mm Thru Paint

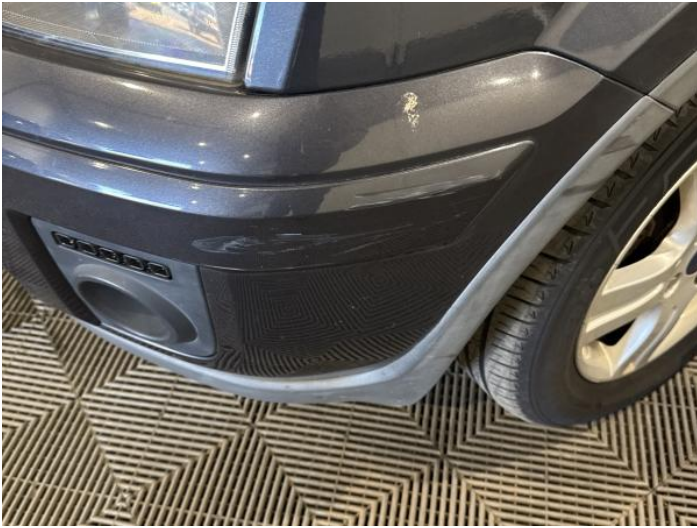
3: Bumper Front  
Scratched  
25 to 100mm Thru Paint

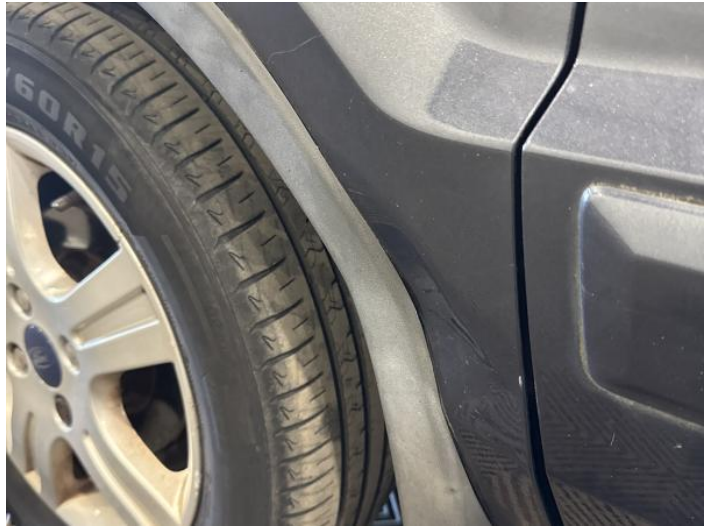
4: Wing nsf  
Dented  
Over 30mm

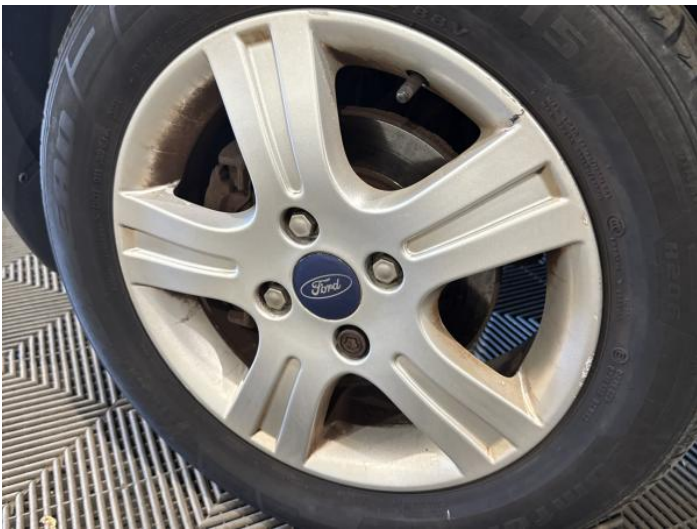
5: Wheel nsf  
Scratched  
Over 50mm

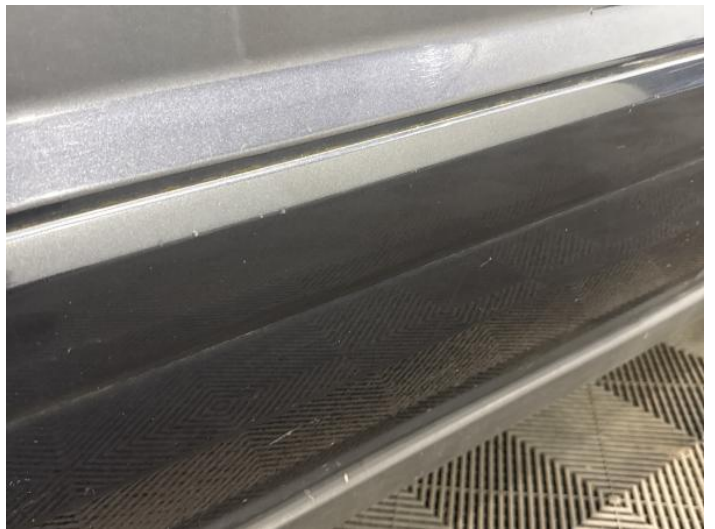
6: Door nsf  
Chipped  
Multiple Chips

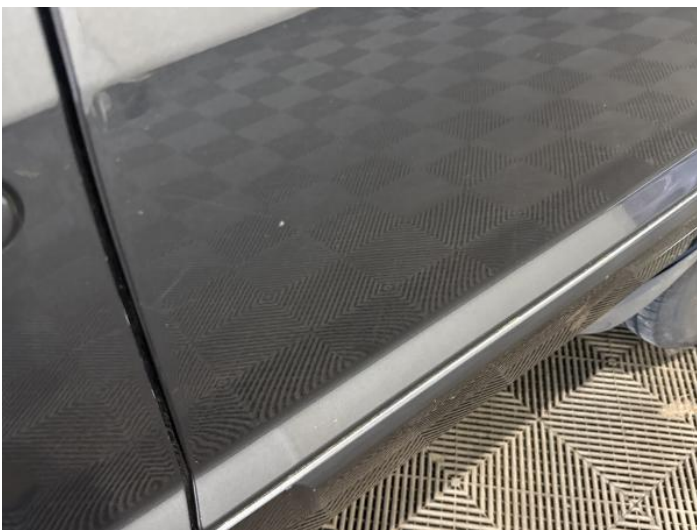
7: Door nsr  
Scratched  
Over 25mm Thru Paint

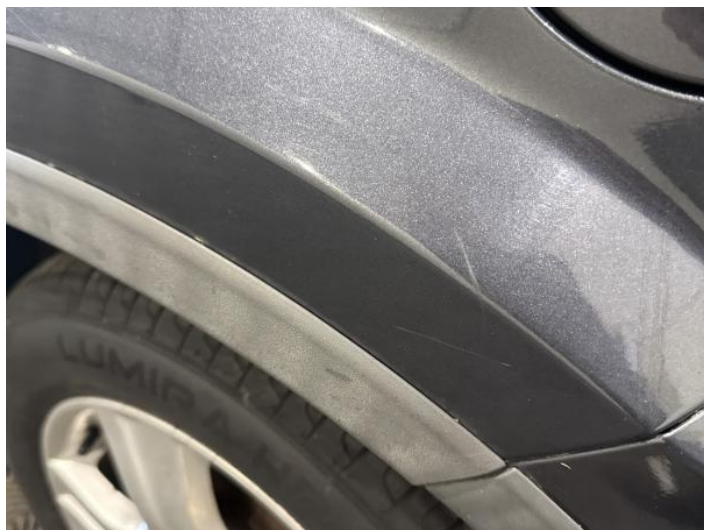
8: Qtr Panel nsr  
Scratched  
Over 25mm Thru Paint

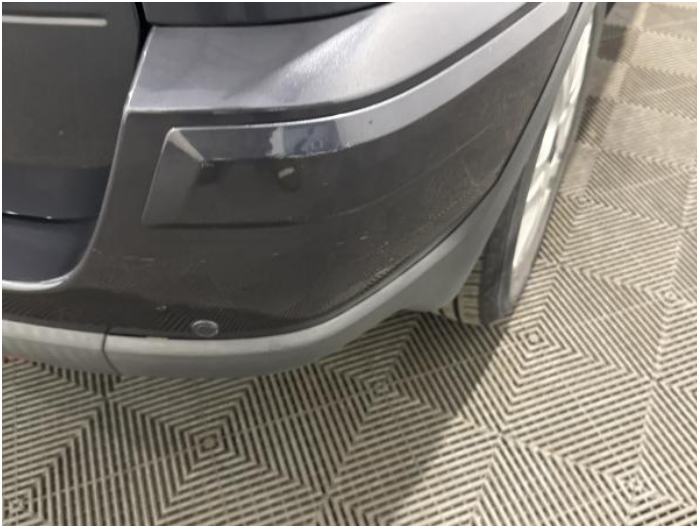
9: Bumper Rear  
Scratched  
Over 100mm Thru Paint

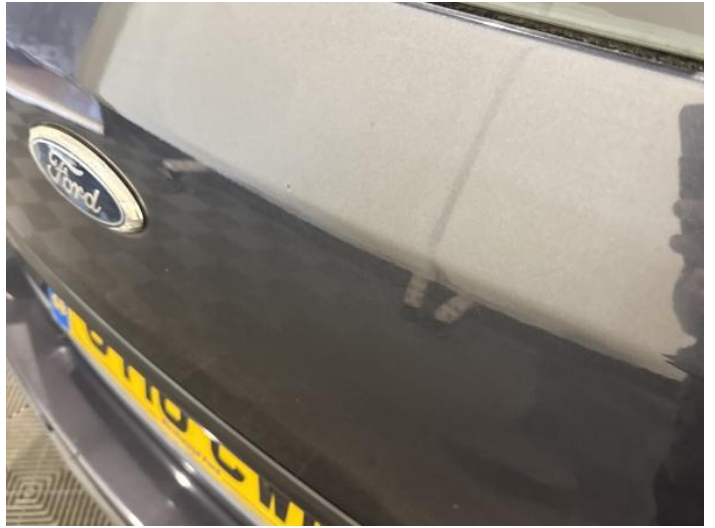
10: Tailgate  
Chipped  
1 To 5

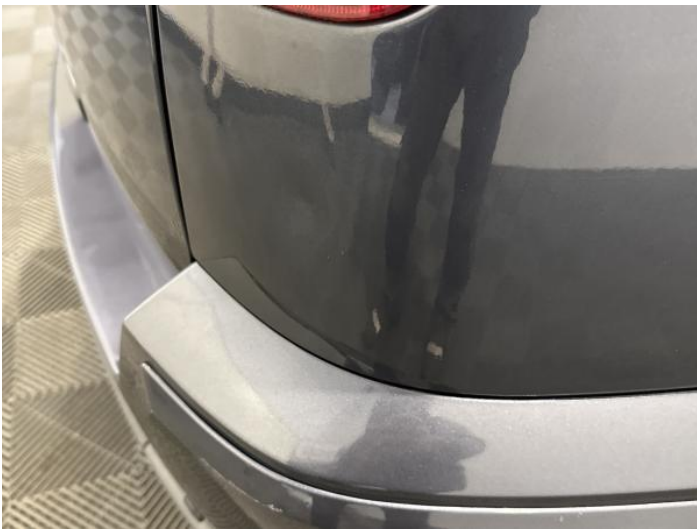
11: Qtr Panel osr  
Dented  
Over 30mm

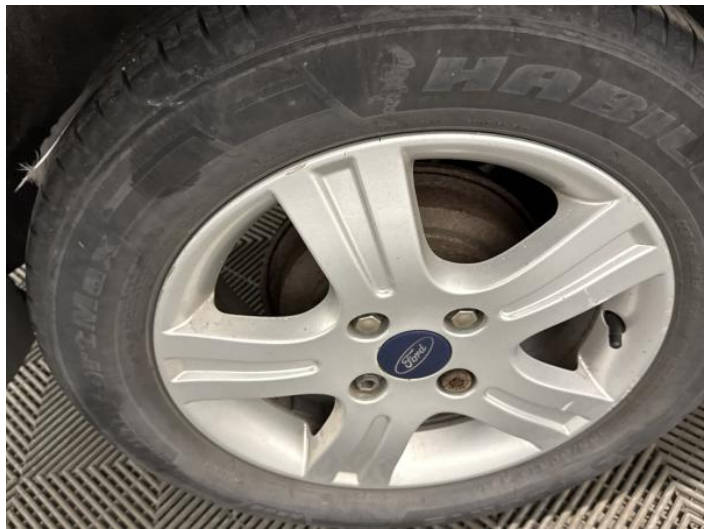
12: Wheel osr  
Scratched  
Over 50mm

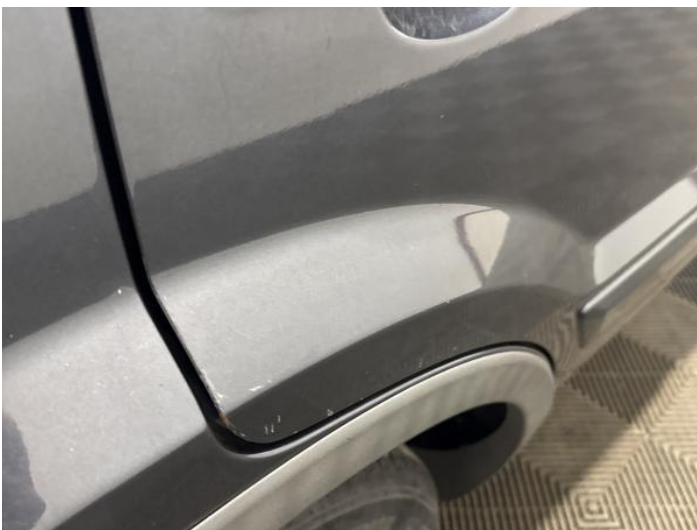
13: Door osr  
Scratched  
Over 25mm Thru Paint

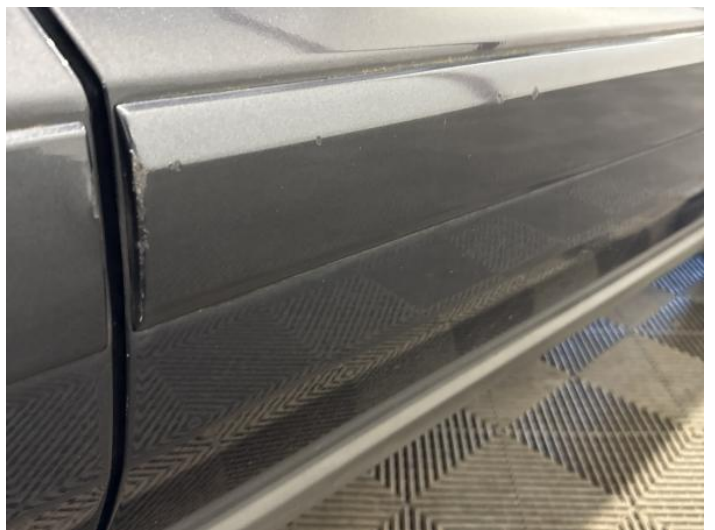
14: Door Moulding osf  
Scratched (Painted)  
Over 25mm Thru Paint

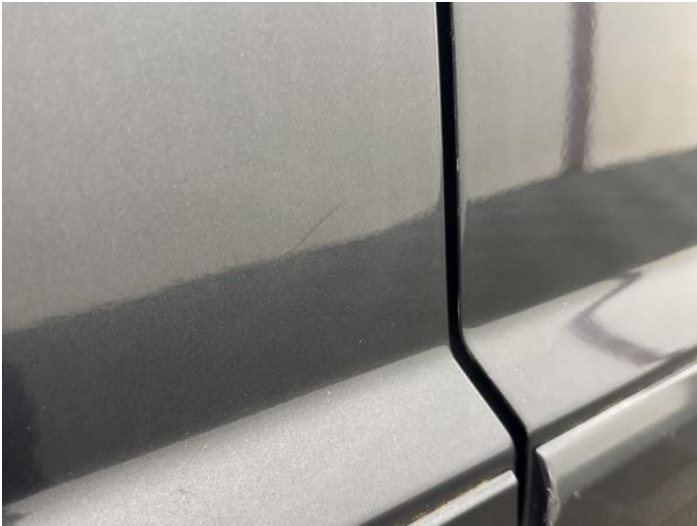
15: Door osr  
Dented  
Between 10mm + 30mm

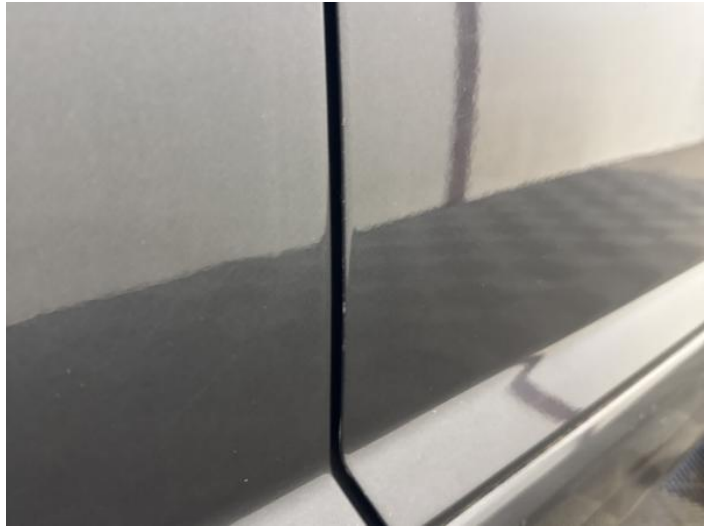
16: Door osf  
Chipped  
Edge Chip

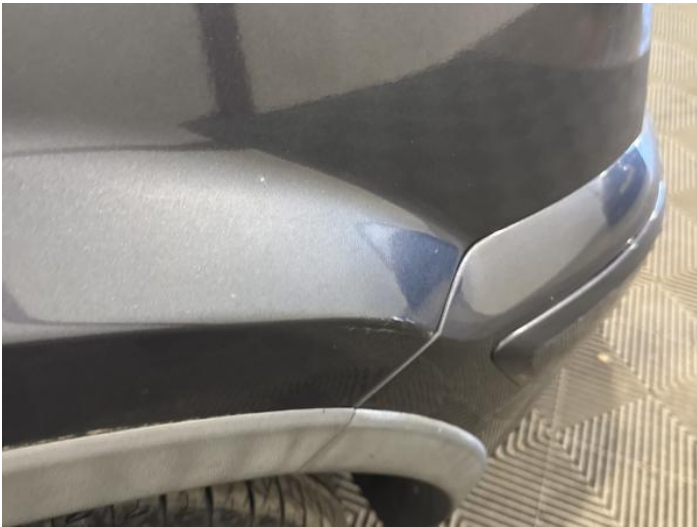
17: Wing osf  
Scratched  
Over 25mm Thru Paint

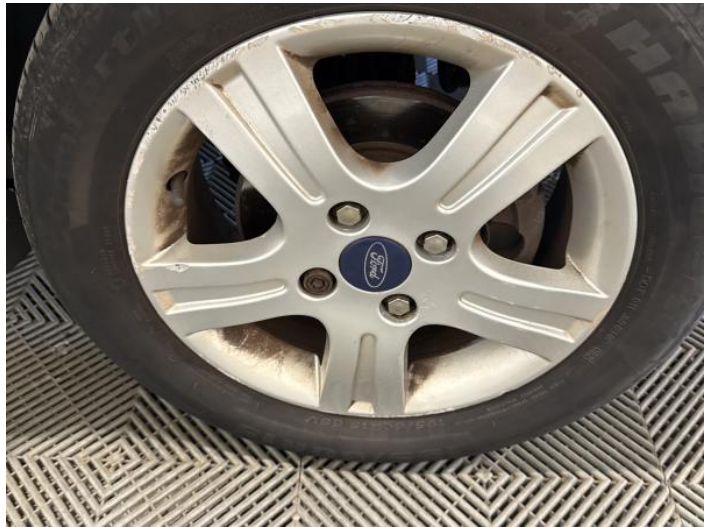
18: Wheel osf  
Scratched  
Over 50mm

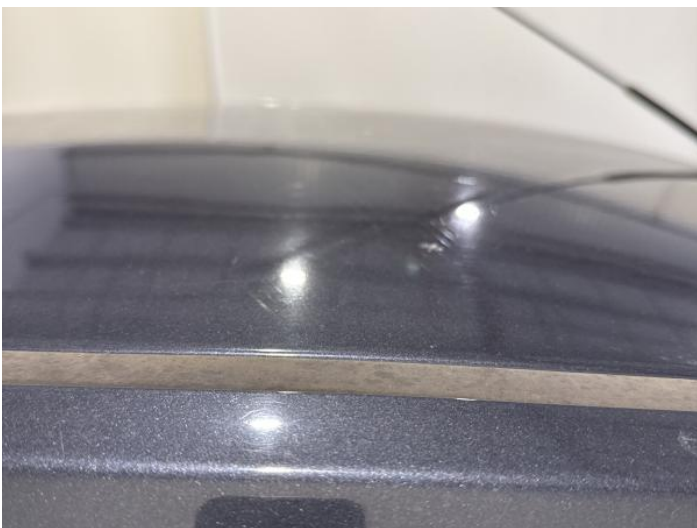
19: Roof  
Dented  
Over 30mm

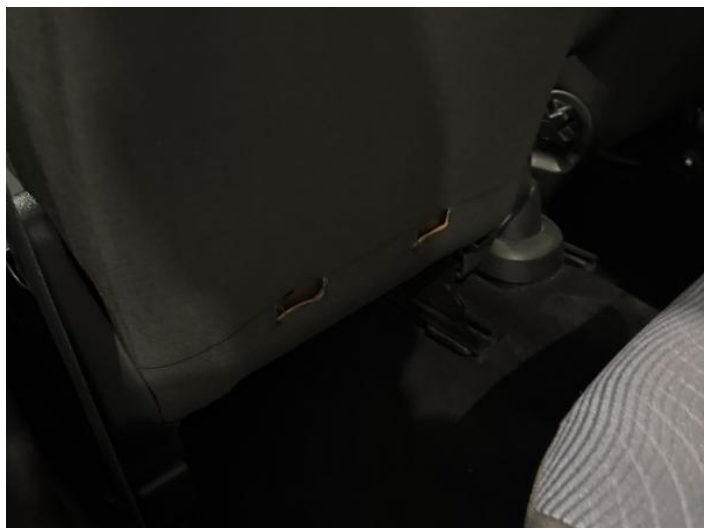
20: Seat Back Cover nsf  
Scuffed  
Over 25mm
