# VEHICLE INSPECTION REPORT

**DU66UKK**

## Vauxhall Mokka 1.4T SE 5dr

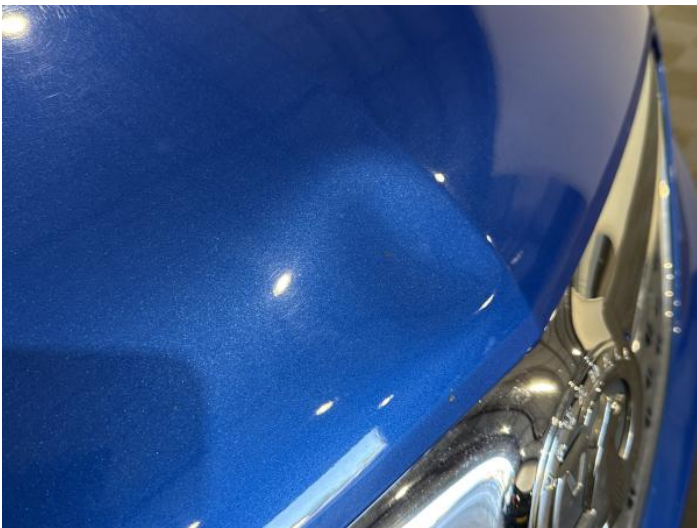
1: Bonnet  
Dented  
Over 30mm

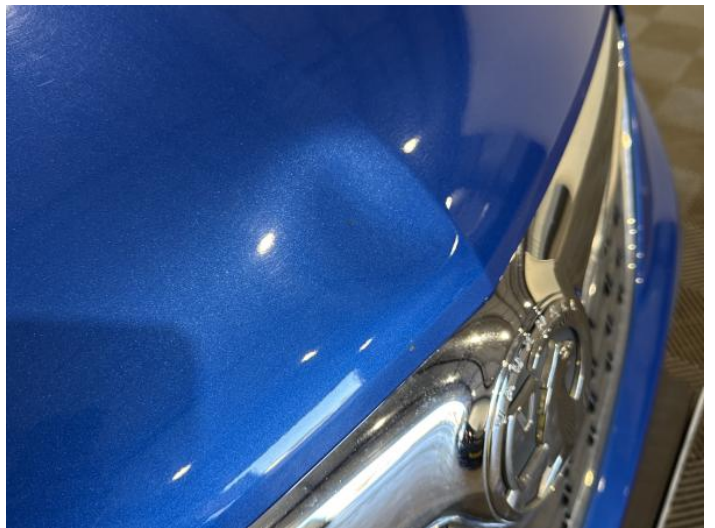
2: Bonnet  
Chipped  
1 To 5

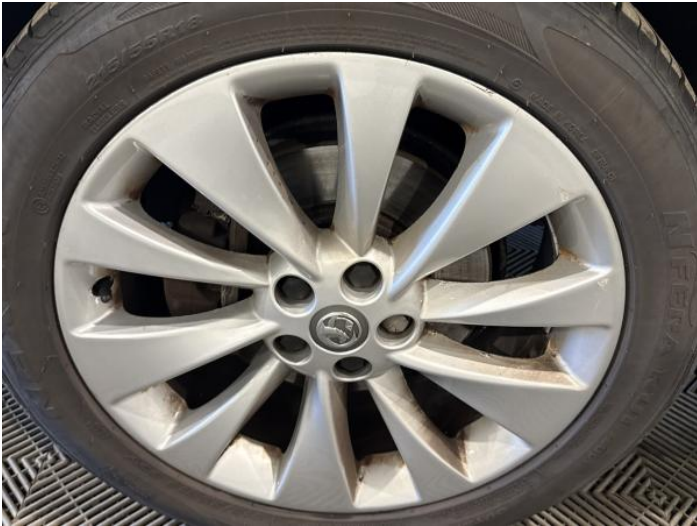
3: Wheel nsf  
Scratched  
Over 50mm

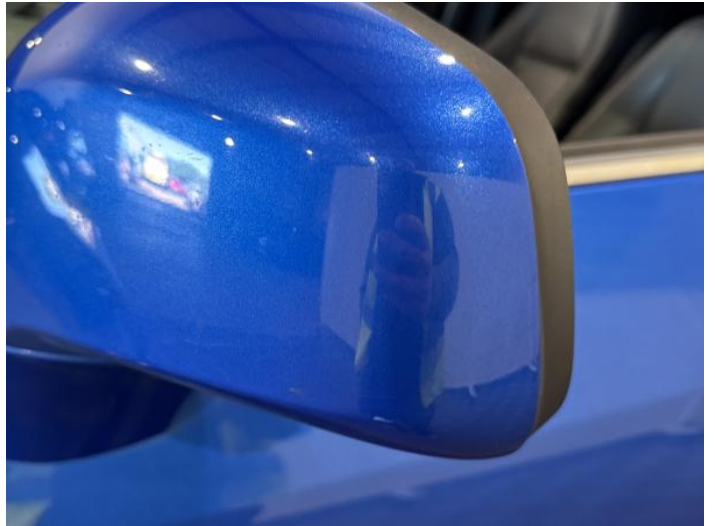
4: Door Mirror Assy nsf  
Scratched (Painted)  
UpTo 25mm Thru Paint

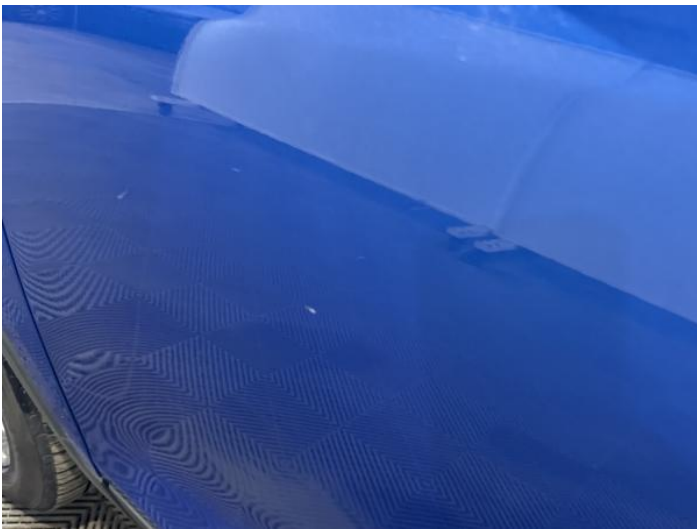
5: Door nsf  
Scratched  
UpTo 25mm Thru Paint

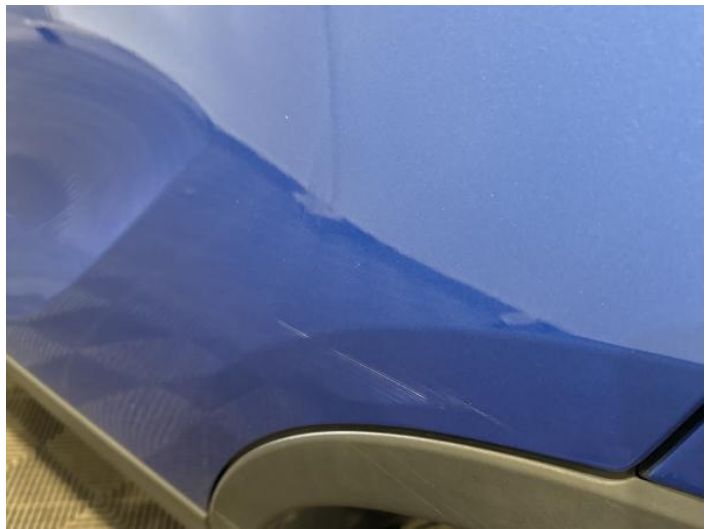
6: Door nsr  
Dented  
With Paint Damage

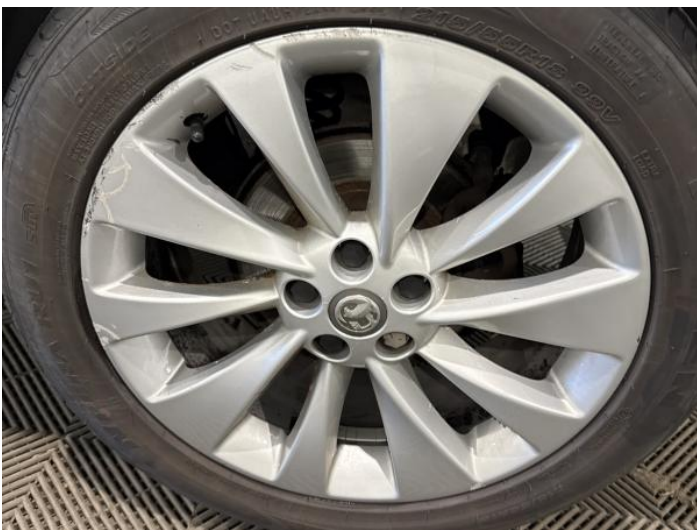
7: Wheel nsr  
Scratched  
Over 50mm

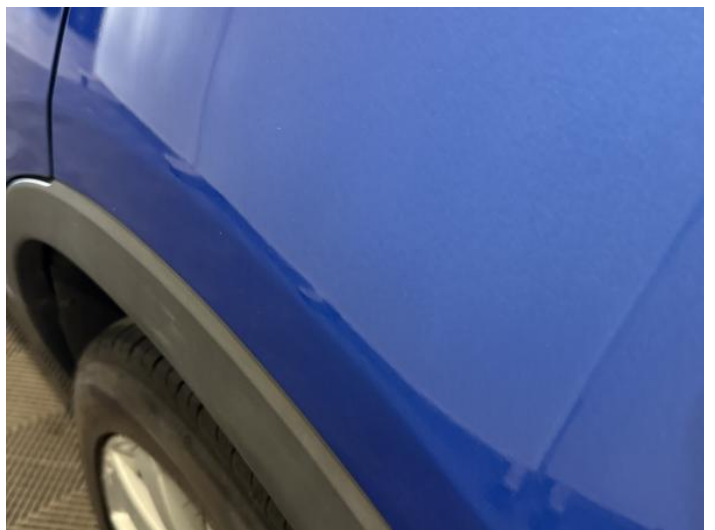
8: Qtr Panel nsr  
Dented  
Between 10mm + 30mm

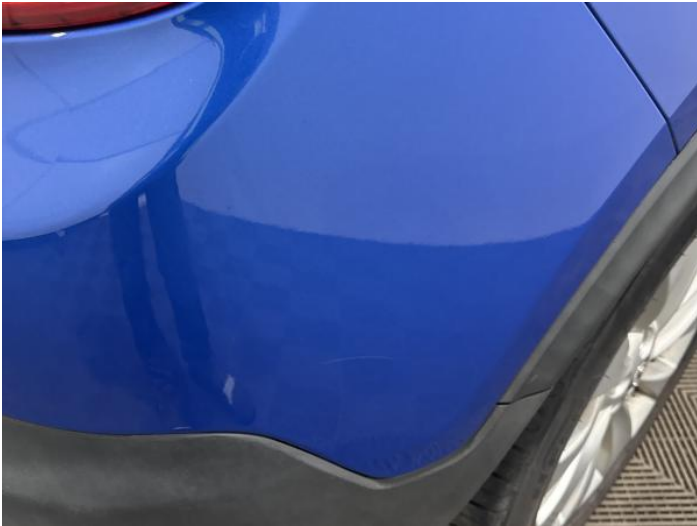
9: Bumper Rear  
Scratched  
25 to 100mm Thru Paint

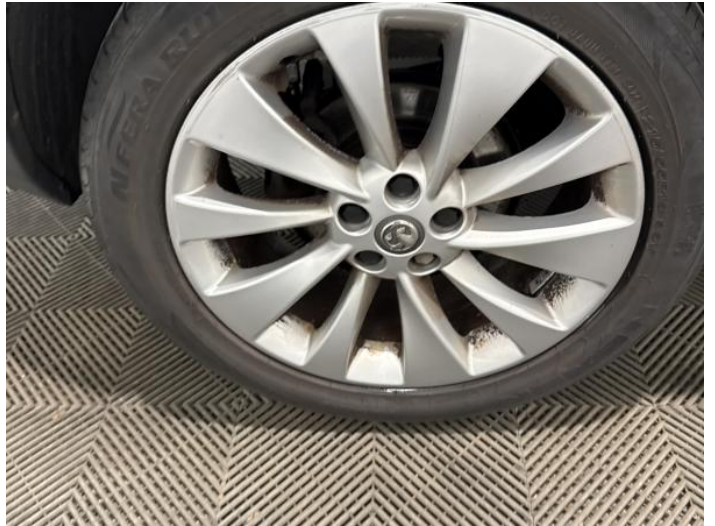
10: Wheel osr  
Scratched  
Up To 50mm

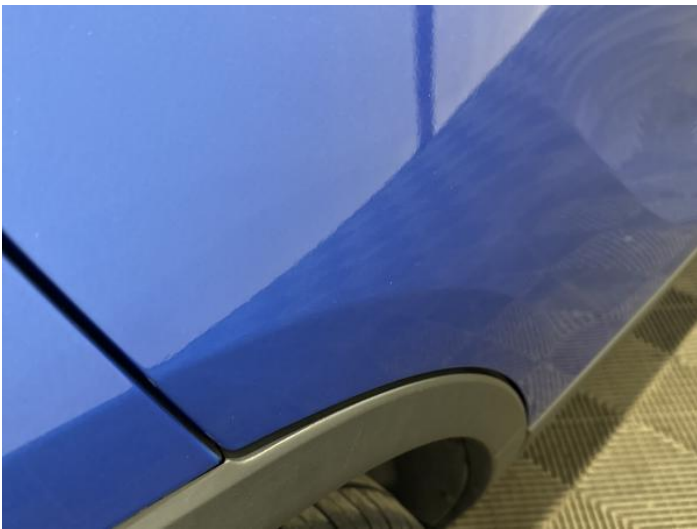
11: Door osr  
Dented  
Between 10mm + 30mm

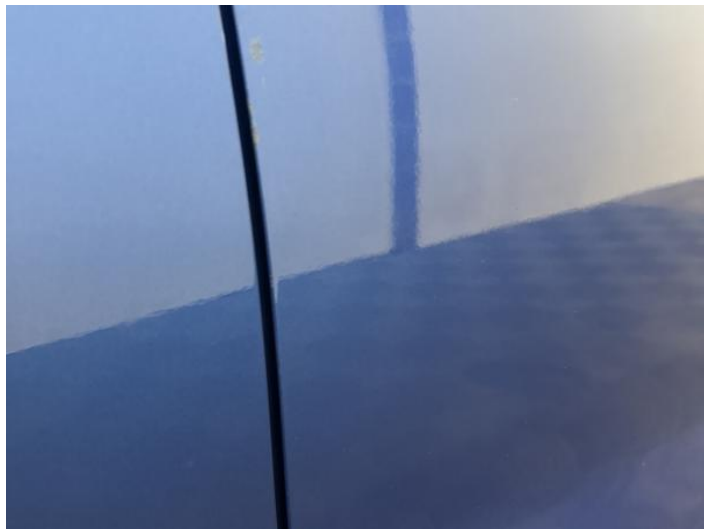
12: Door osf  
Dented  
2 Or Less UpTo 10mm

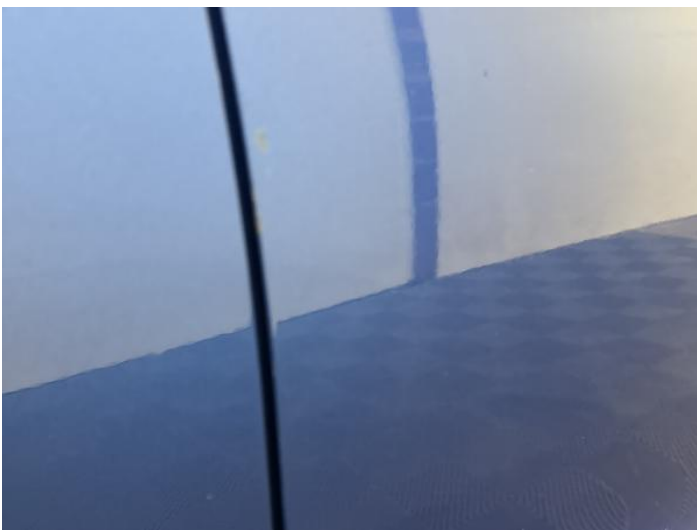
13: Door osf  
Scratched  
UpTo 25mm Thru Paint

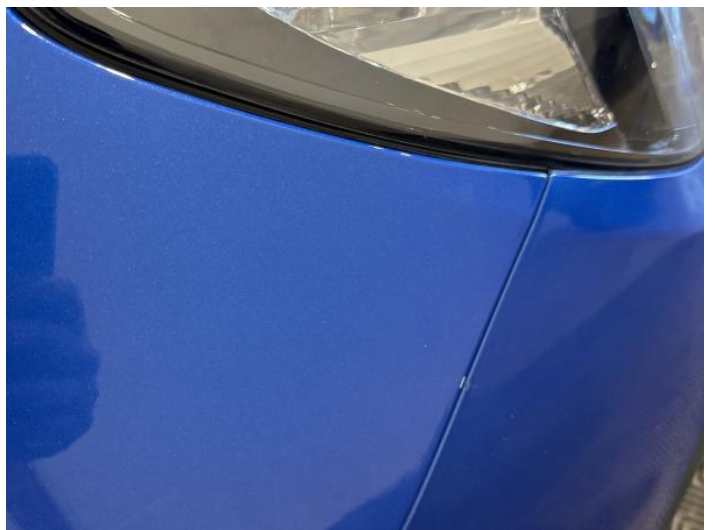
14: Wing osf  
Chipped  
1 To 5

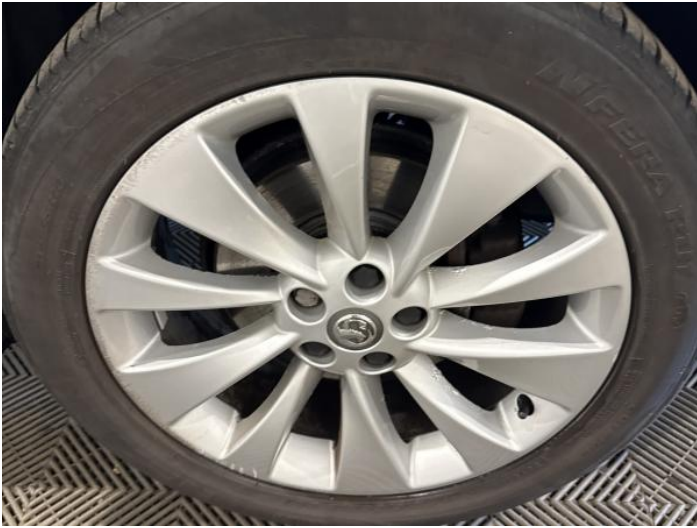
15: Wheel of  
Scratched  
Over 50mm

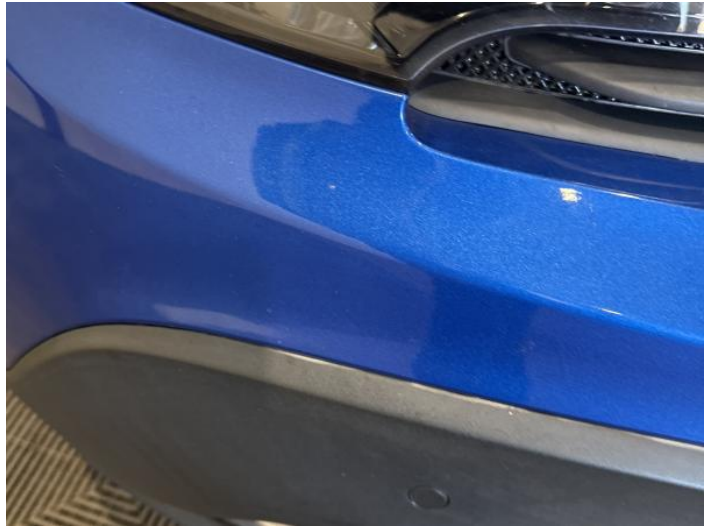
16: Bumper Front  
Chipped  
1 To 5

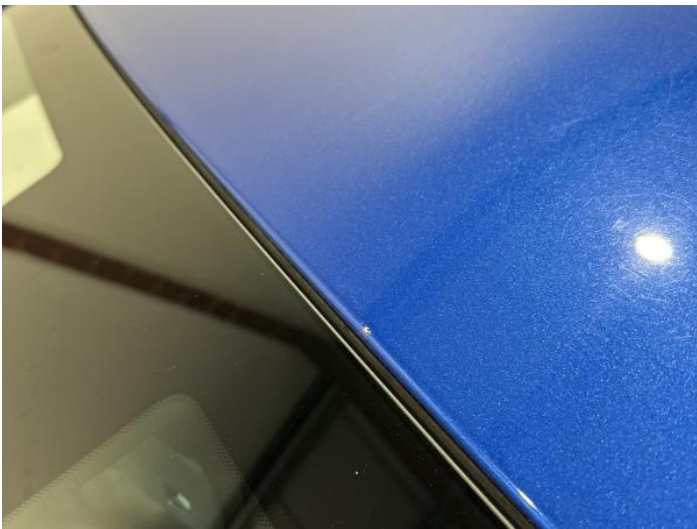
17: Roof  
Chipped  
Edge Chip
