VEHICLE INSPECTION REPORT

DY66GXA

Vauxhall Astra 1.0T 12V ecoFLEX SRi 5dr

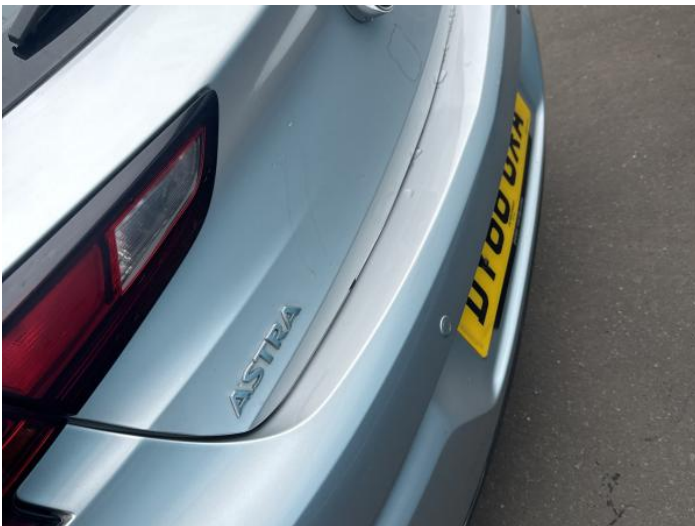
1: Bumper Rear
Scratched
25 to 100mm Thru Paint

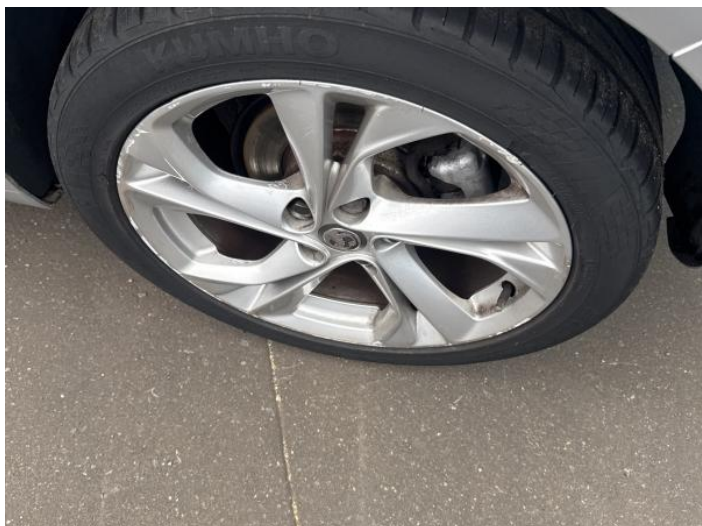
3: Wheel nsr
Scratched
Over 50mm

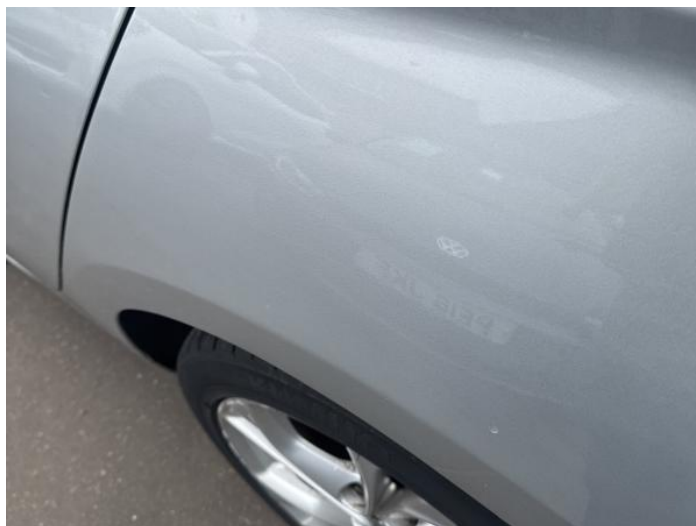
4: Qtr Panel nsr
Dented
Over 2 UpTo 10mm

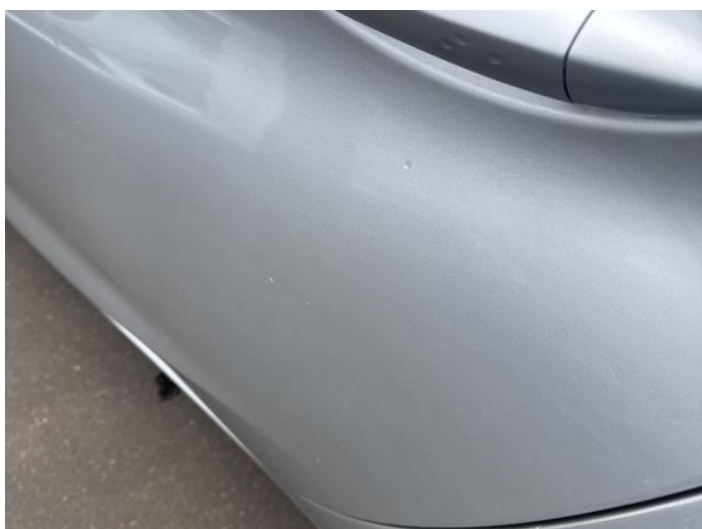
5: Door nsr
Chipped
Multiple Chips

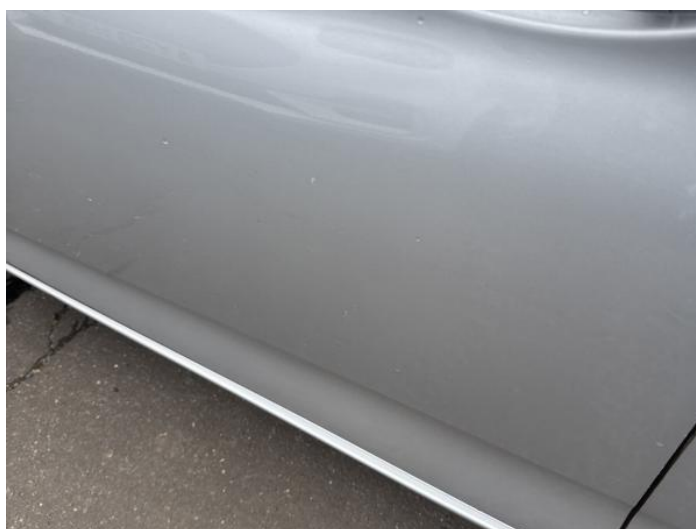
6: Door nsf
Chipped
1 To 5

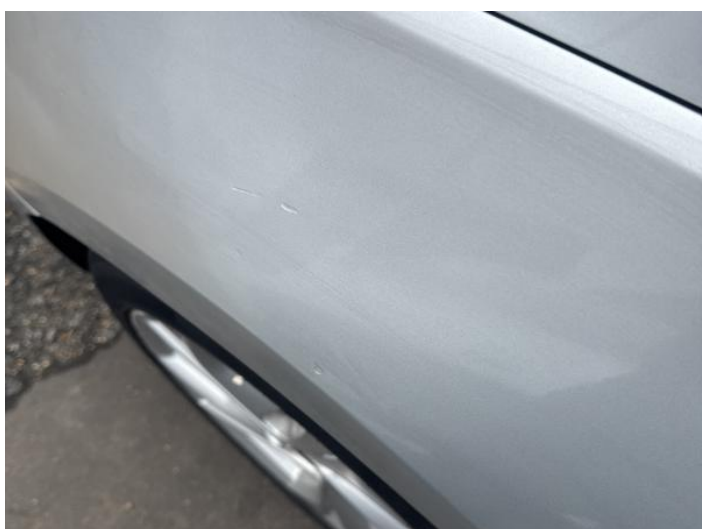
7: Wing nsf
Poor Previous Repair
Poor Paint

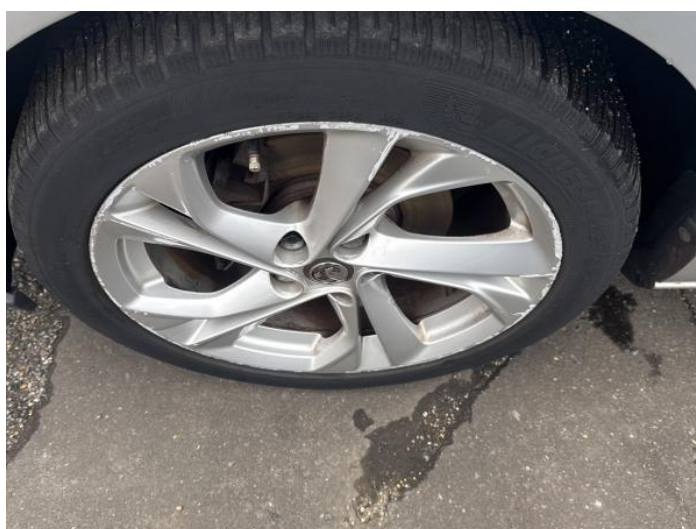
8: Wheel nsf
Scratched
Over 50mm

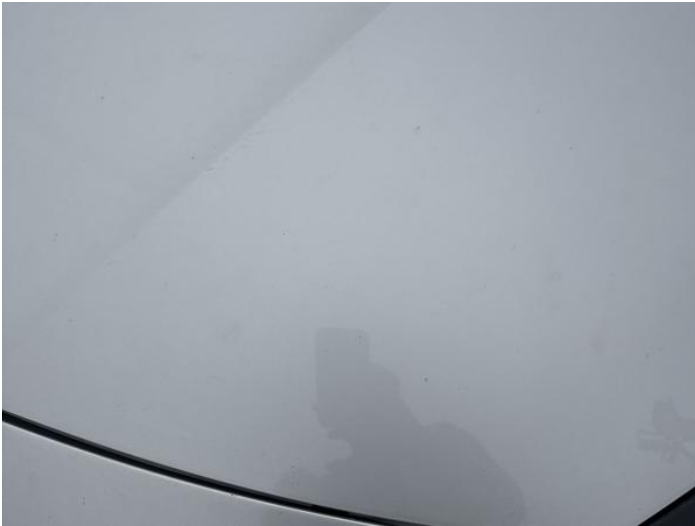
9: Bonnet
Chipped
Multiple Chips

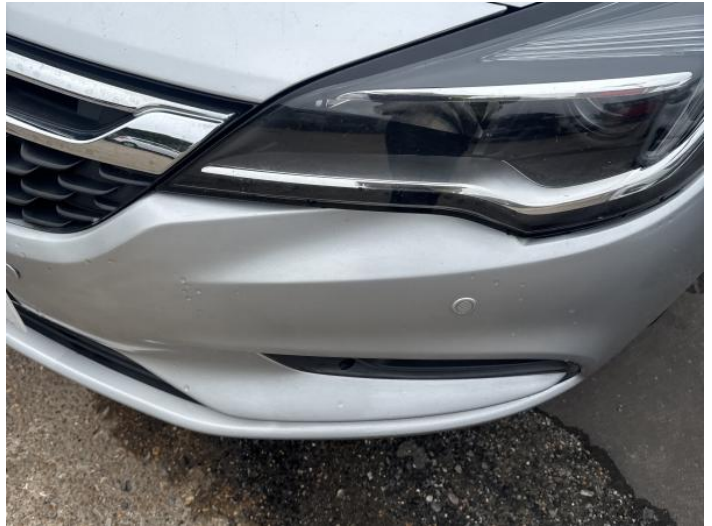
10: Bumper Front
Cracked
UpTo 25mm

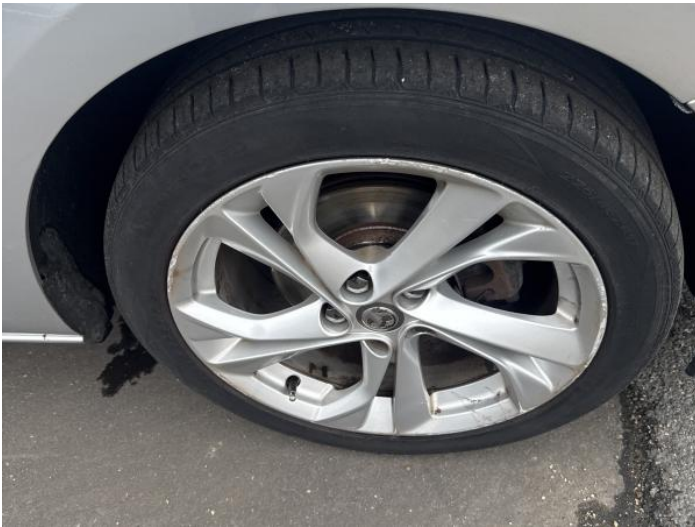
11: Wheel osf
Scratched
Over 50mm

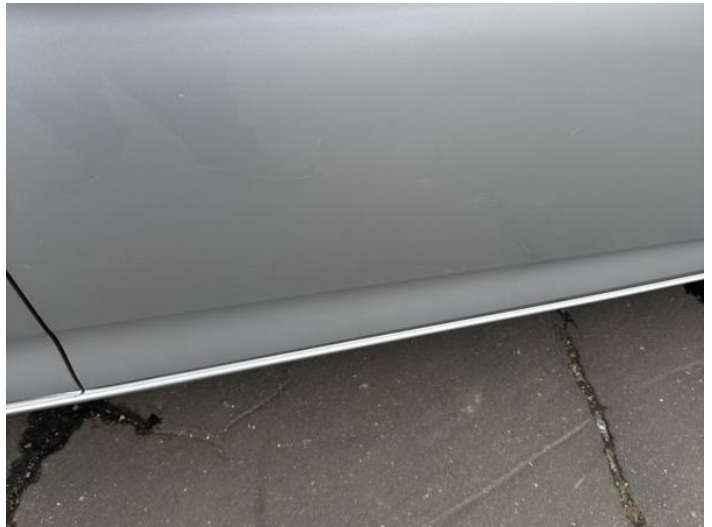
12: Door osf
Chipped
1 To 5

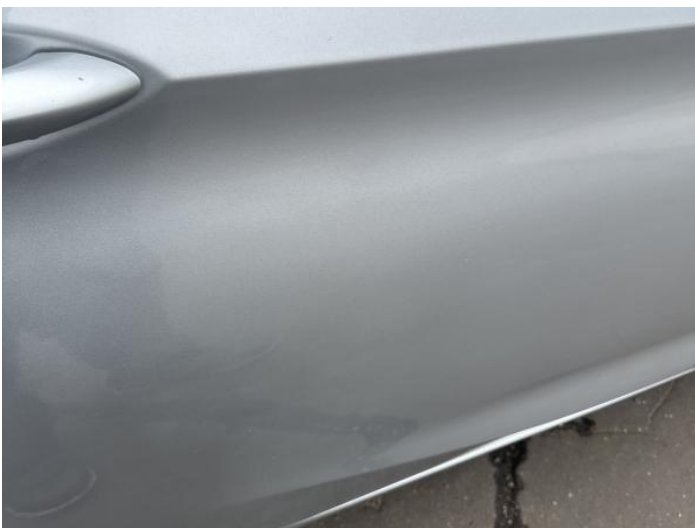
13: Door osr
Poor Previous Repair
Poor Paint

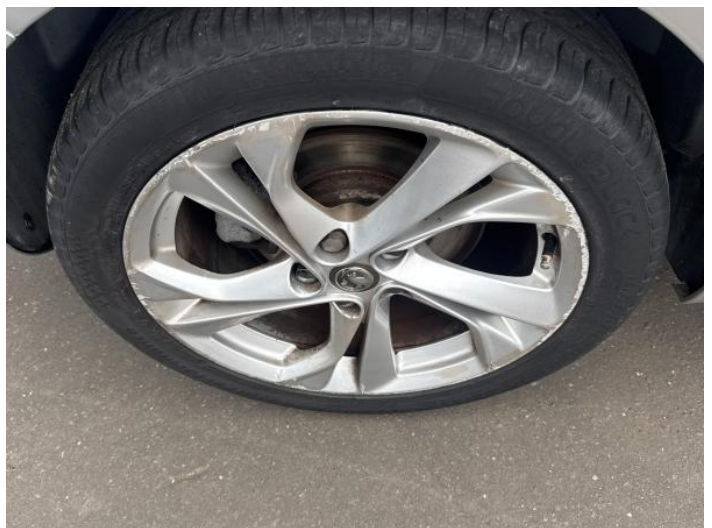
14: Wheel osr
Scratched
Over 50mm
