VEHICLE INSPECTION REPORT

KP68LGA

Skoda Superb 2.0 TDI CR 190 Sport Line 4X4 5dr DSG [7 Speed]

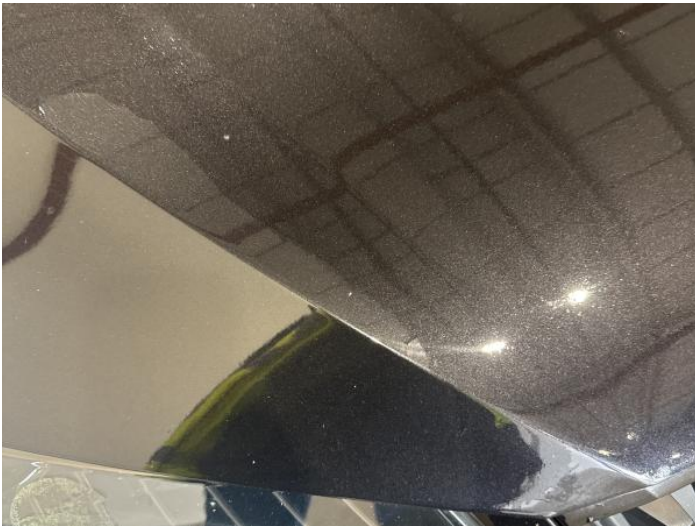
1: Bonnet
Chipped
Multiple Chips

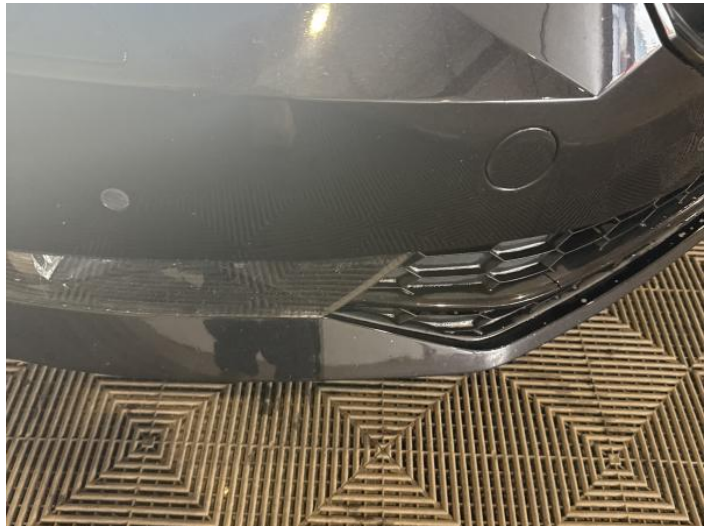
2: Bumper Front
Chipped
Multiple Chips

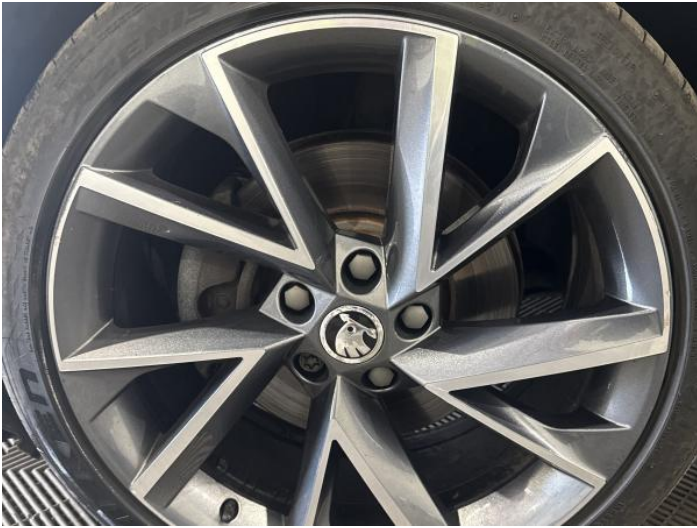
3: Wheel nsf
Scratched
Over 50mm

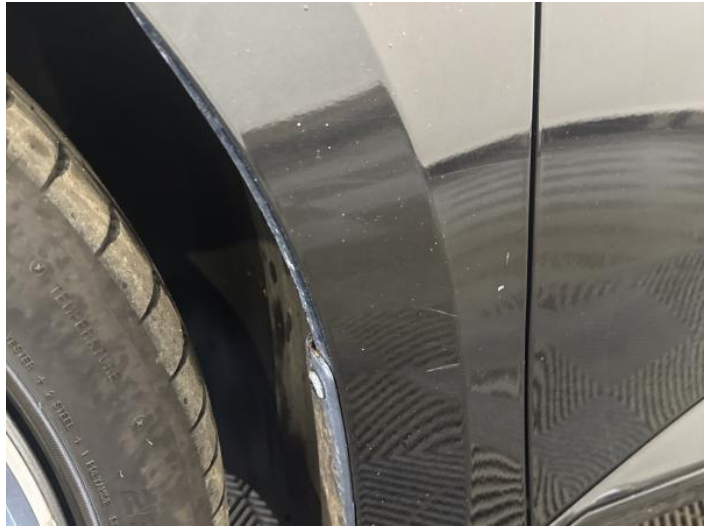
4: Wing nsf
Scratched
Over 25mm Thru Paint

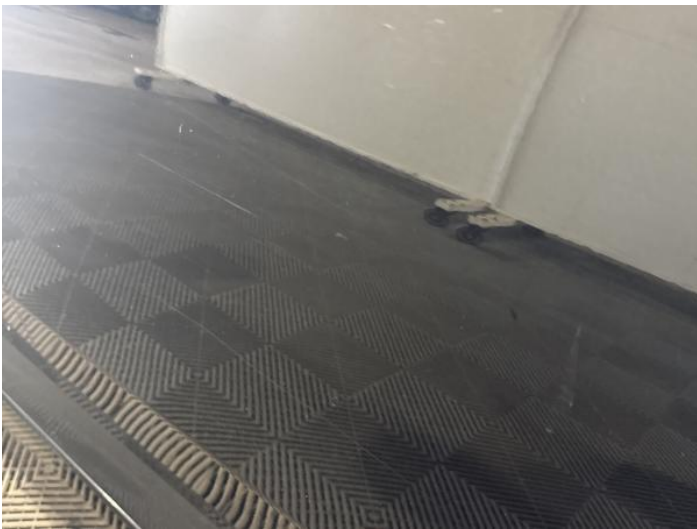
5: Door nsf
Scratched
Over 25mm Thru Paint

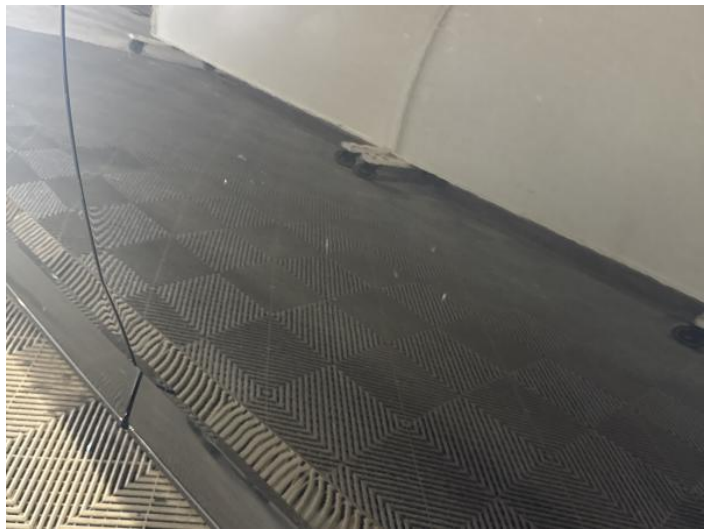
6: Door nsr
Scratched
Over 25mm Thru Paint

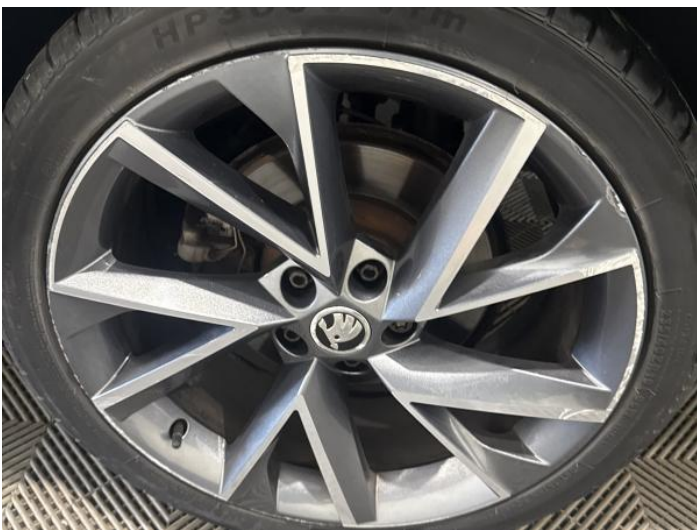
7: Wheel nsr
Scratched
Up To 50mm

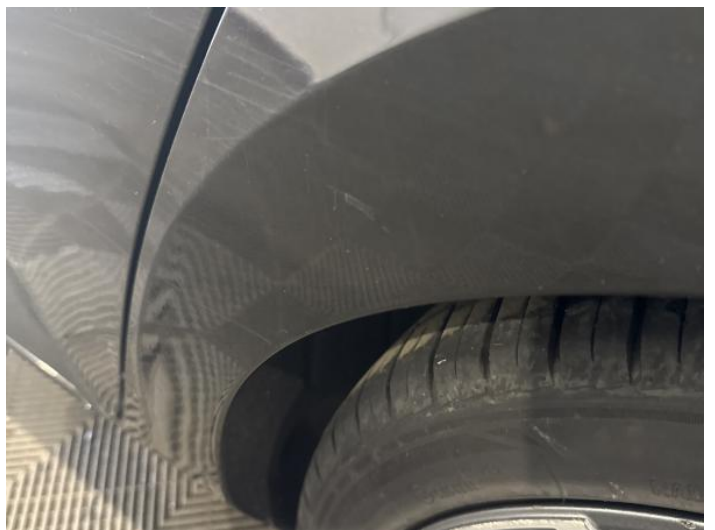
8: Qtr Panel nsr
Scratched
Up To 25mm Thru Paint

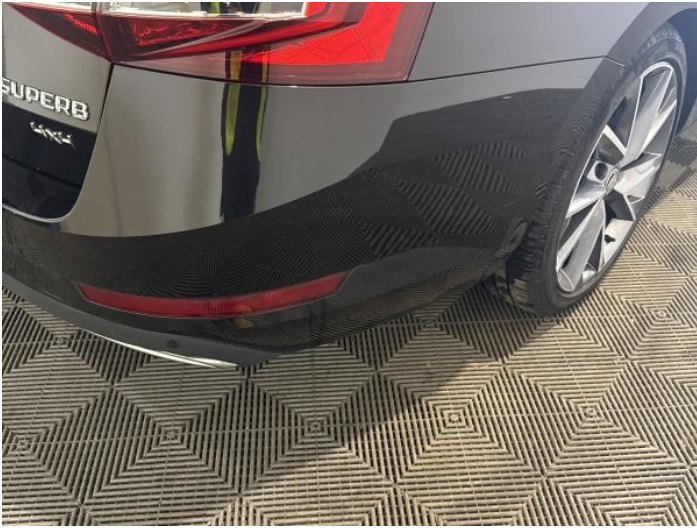
9: Bumper Rear
Scratched
25 to 100mm Thru Paint

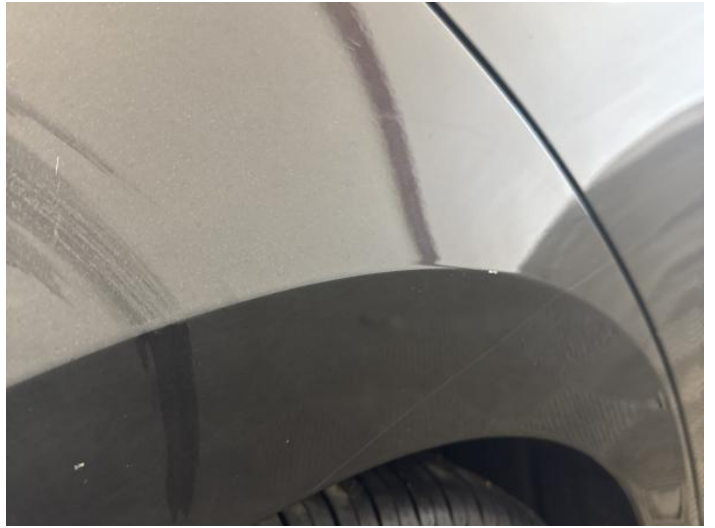
10: Qtr Panel osr
Chipped
1 To 5

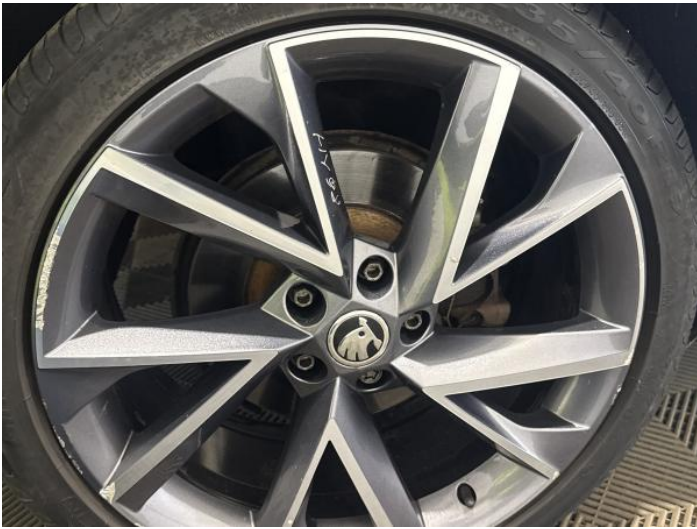
11: Wheel osr
Scratched
Over 50mm

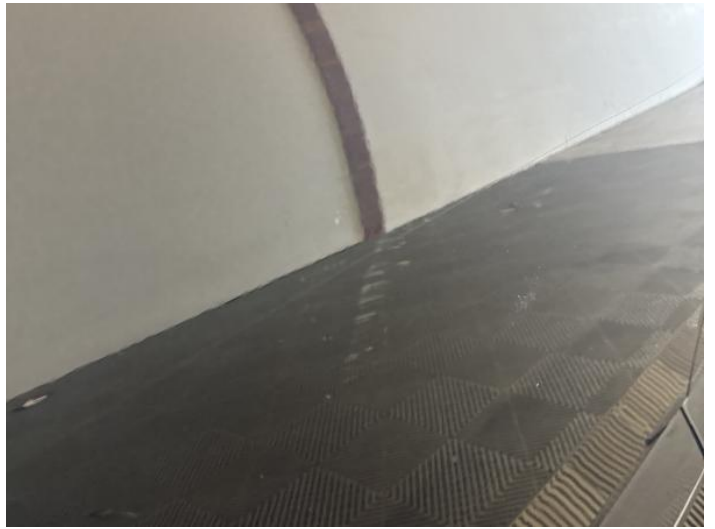
12: Door osr
Scratched
Over 25mm Thru Paint

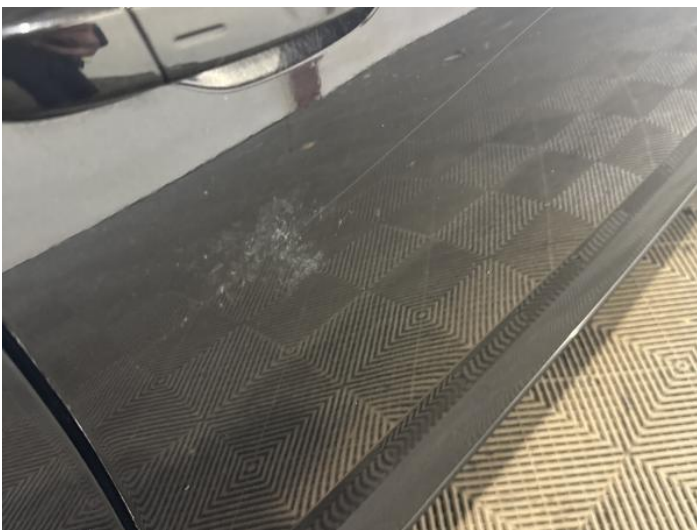
13: Door osf
Scratched
Over 25mm Thru Paint

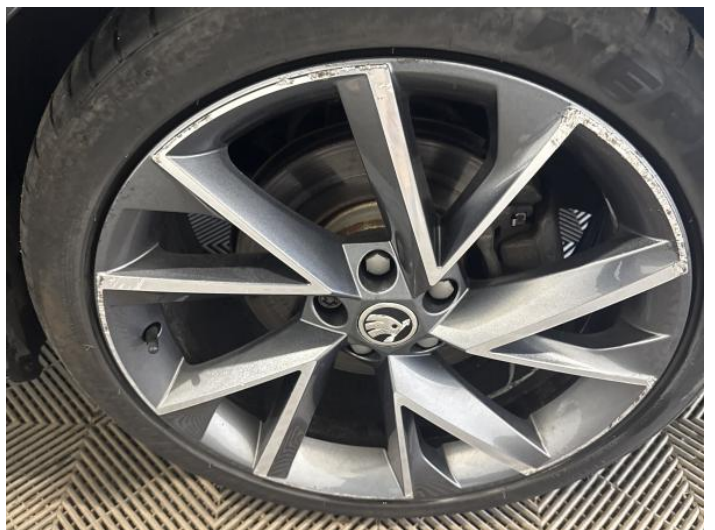
14: Wheel osr
Scratched
Over 50mm

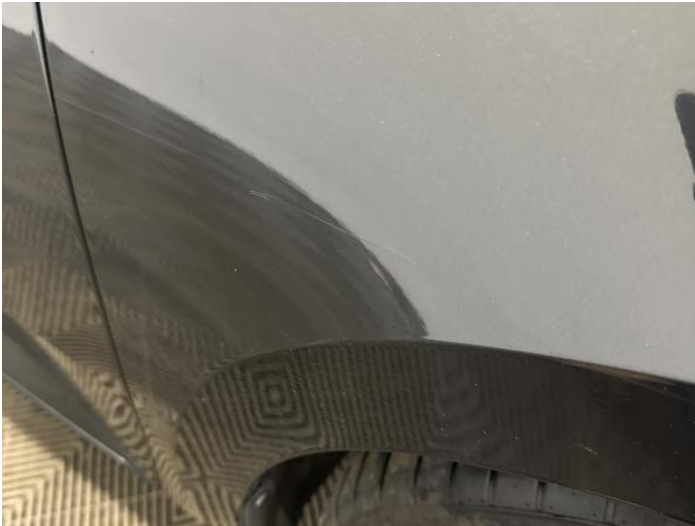
15: Wing osf
 Scratched
 Over 25mm Thru Paint

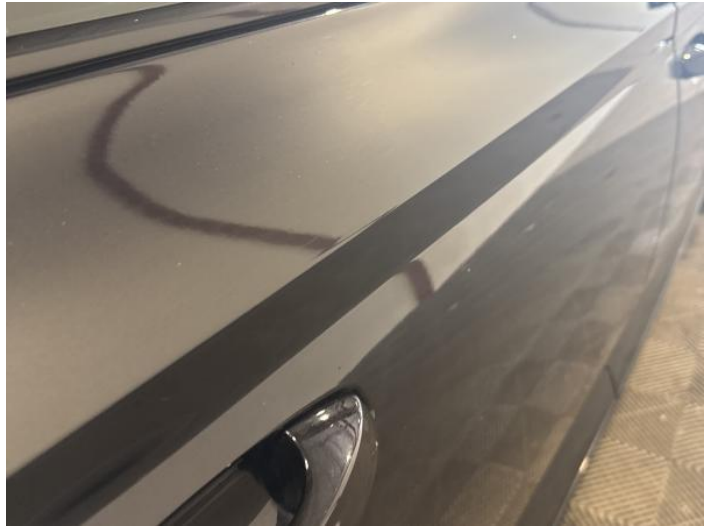
16: Door osr
 Dented
 Between 10mm + 30mm
