# VEHICLE INSPECTION REPORT

**MT10FHY**

## Volkswagen Golf 1.4 S 5dr

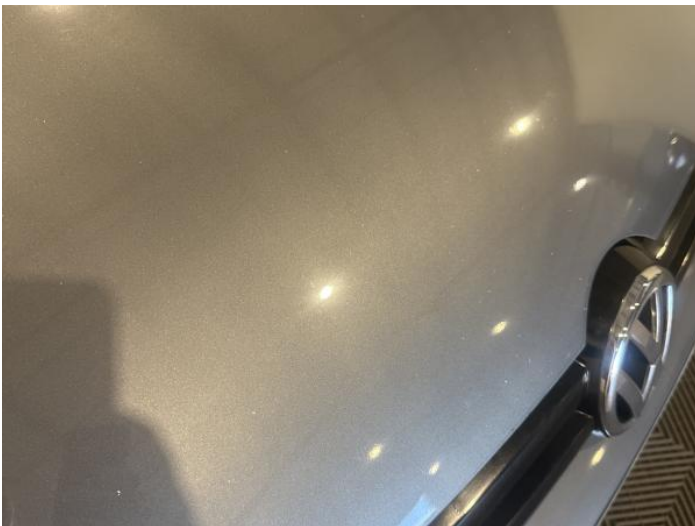
1: Bonnet  
Poor Previous Repair  
Poor Paint

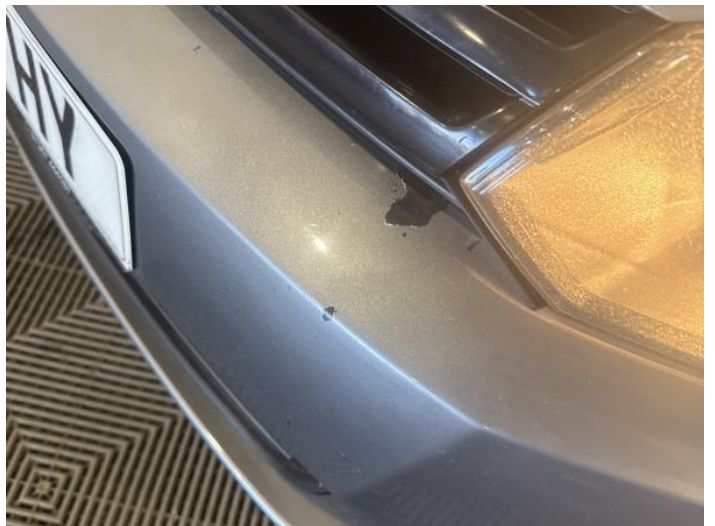
2: Bumper Front  
Poor Previous Repair  
Paint Flake

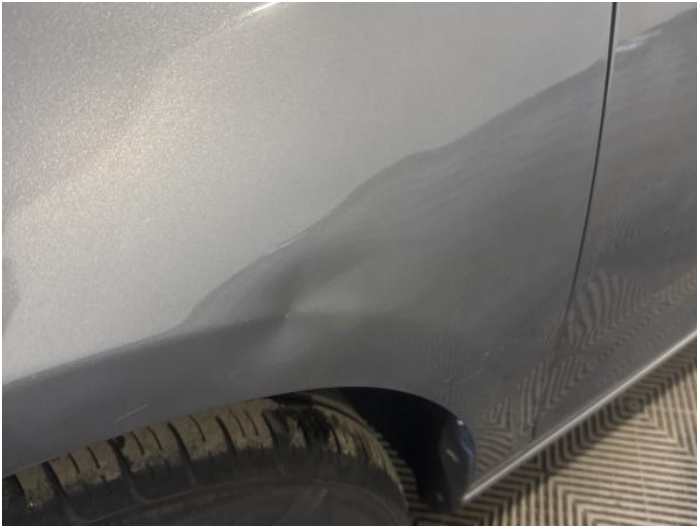
3: Wing nsf  
Dented  
Over 30mm

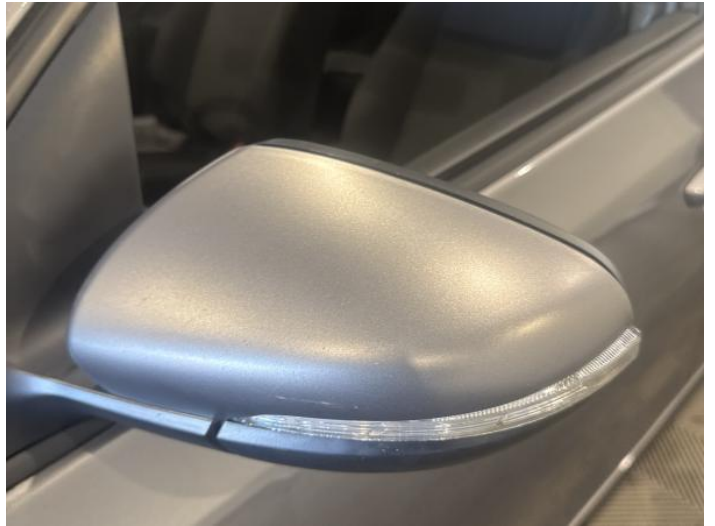
4: Door Mirror Assy nsf  
Scratched (Painted)  
Over 25mm Thru Paint

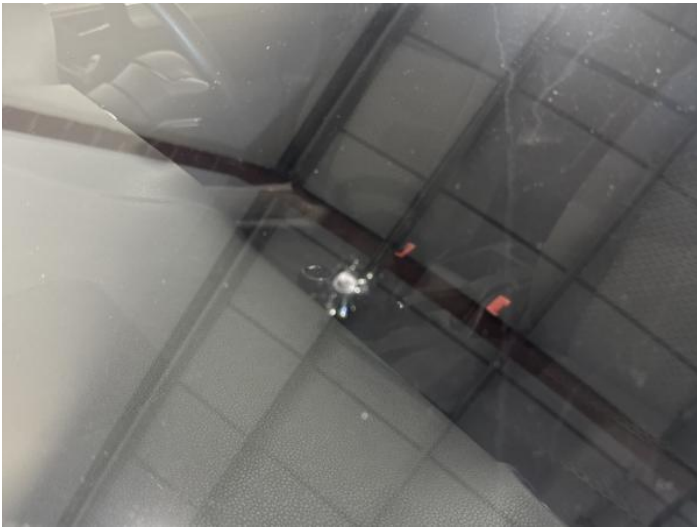
5: Screen Front  
Cracked  
Replace

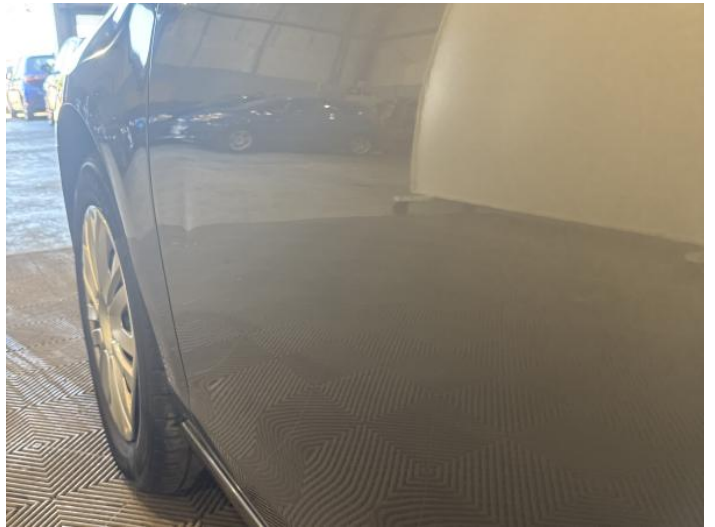
6: Door nsf  
Dented  
With Paint Damage

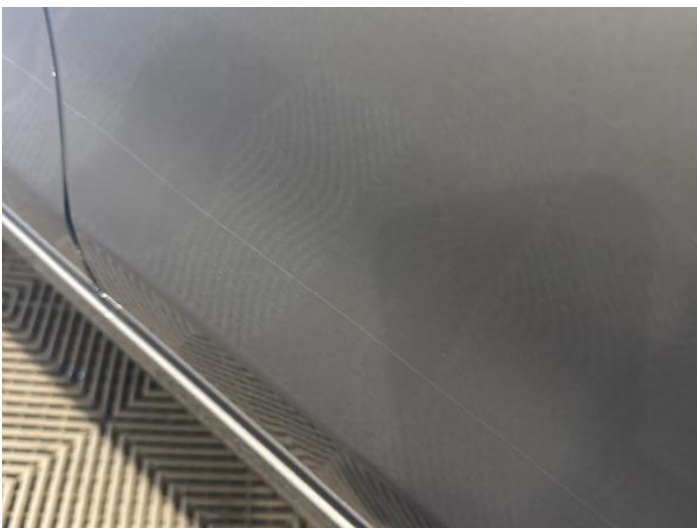
7: Door nsr  
Scratched  
Over 25mm Thru Paint

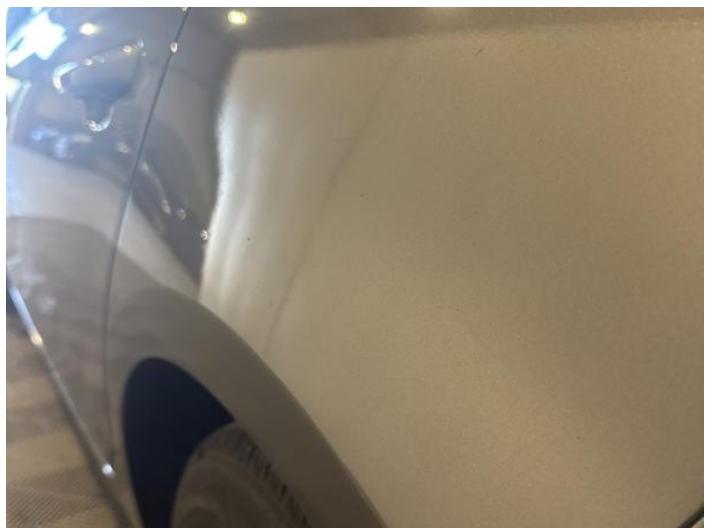
8: Qtr Panel nsr  
Poor Previous Repair  
Poor Paint

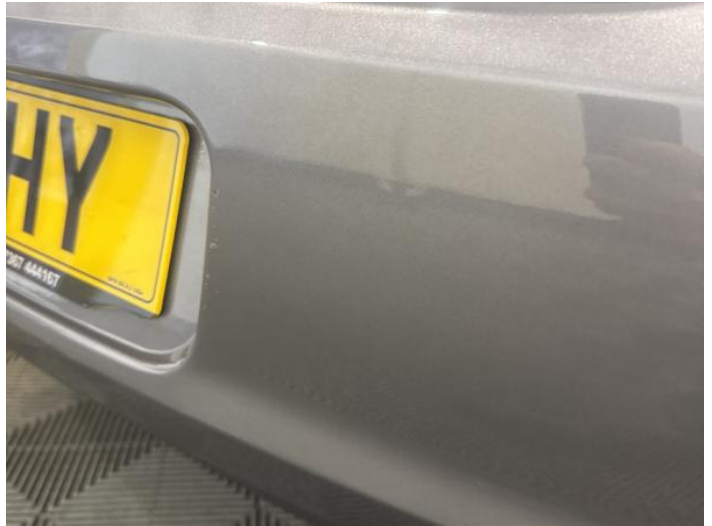
10: Bumper Rear  
Scratched  
25 to 100mm Thru Paint

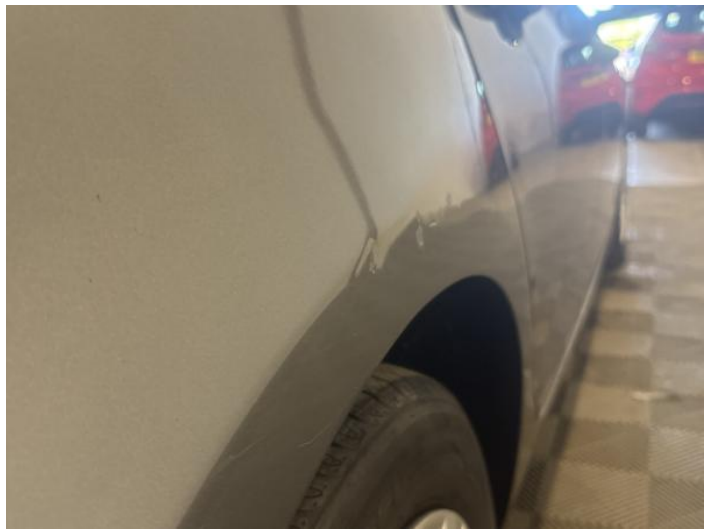
12: Qtr Panel nsr  
Dented  
With Paint Damage

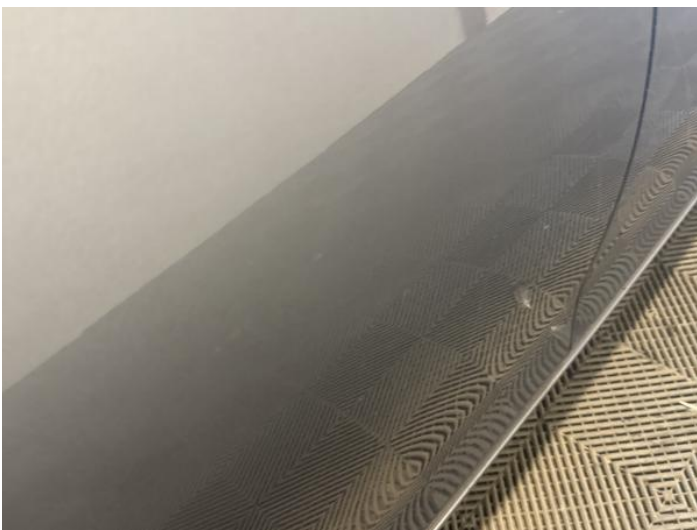
13: Door osr  
Chipped  
1 To 5

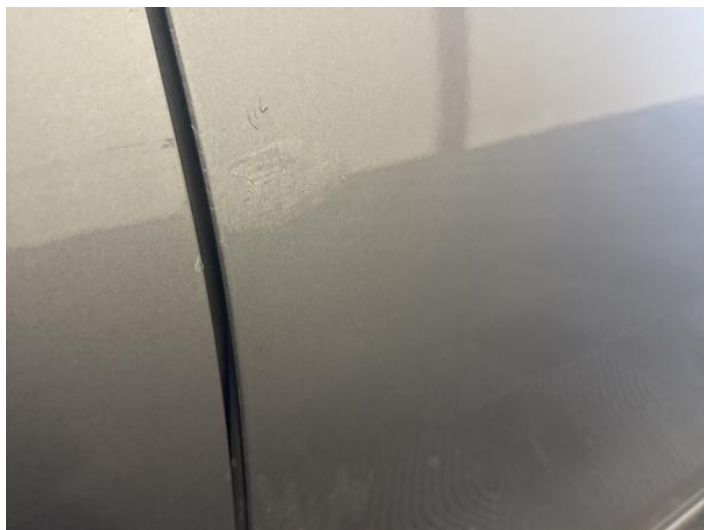
14: Door osf  
Scratched  
Over 25mm Thru Paint

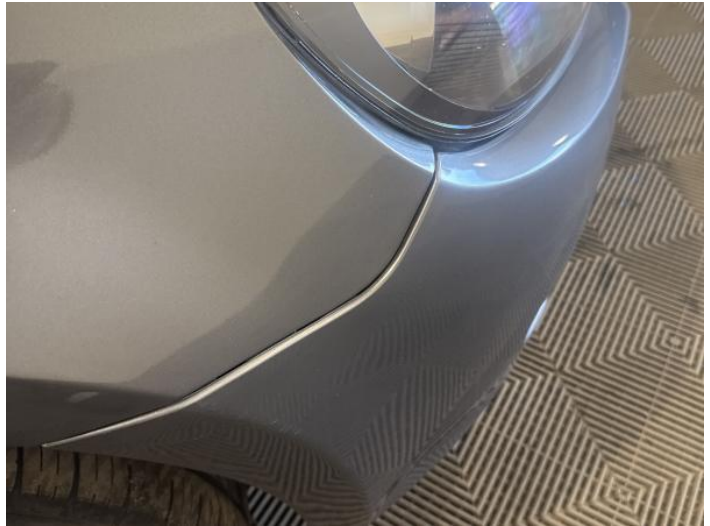
16: Bumper Front  
Insecure  
Action Required
