VEHICLE INSPECTION REPORT

VN64XMP

Nissan Pulsar 1.5 dCi N-Tec 5dr

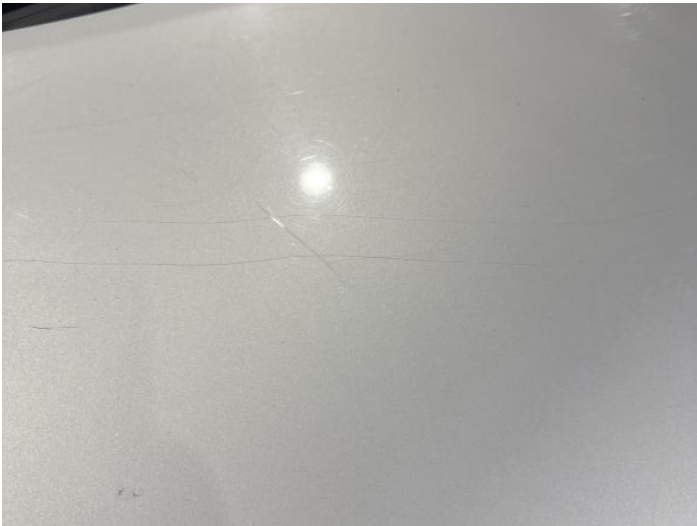
1: Bonnet
Scratched
Over 25mm Thru Paint

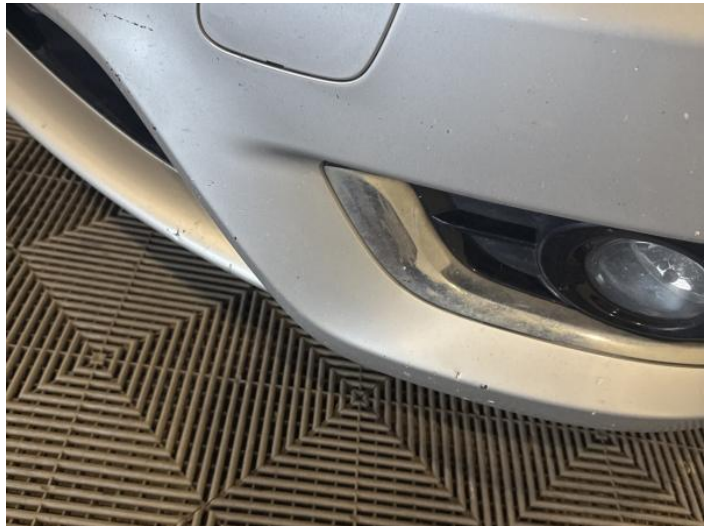
2: Bumper Front
Dented
With Paint Damage
