# VEHICLE INSPECTION REPORT

**MJ12REU**

## Seat Leon 1.6 TDI CR SE Copa 5dr

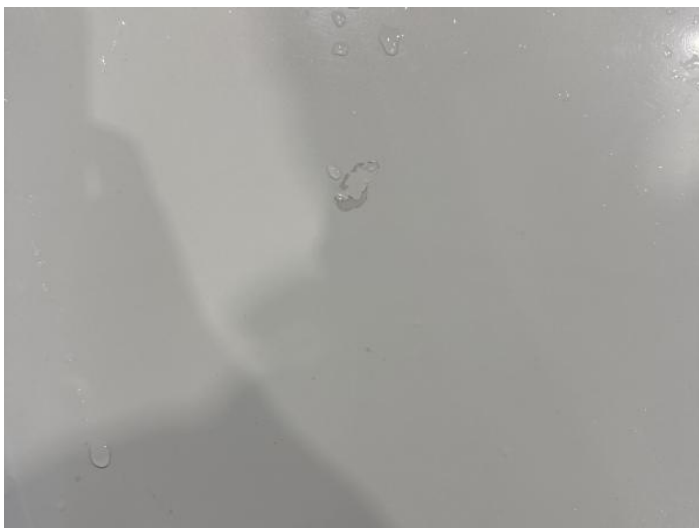
1: Bonnet  
Poor Previous Repair  
Paint Flake

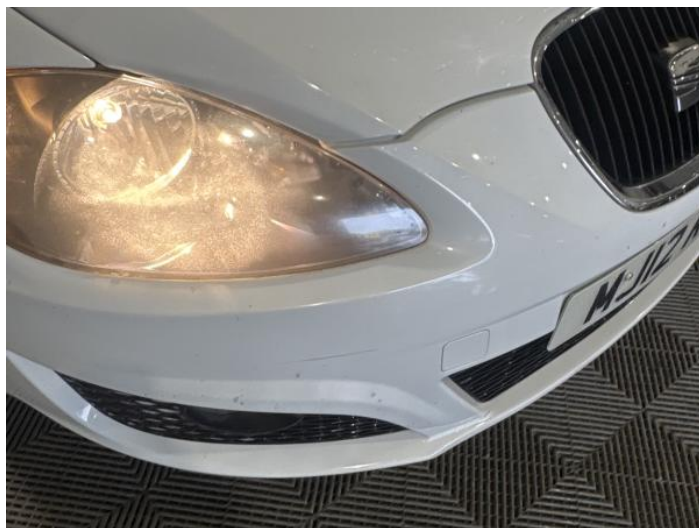
2: Bumper Front  
Poor Previous Repair  
Paint Flake

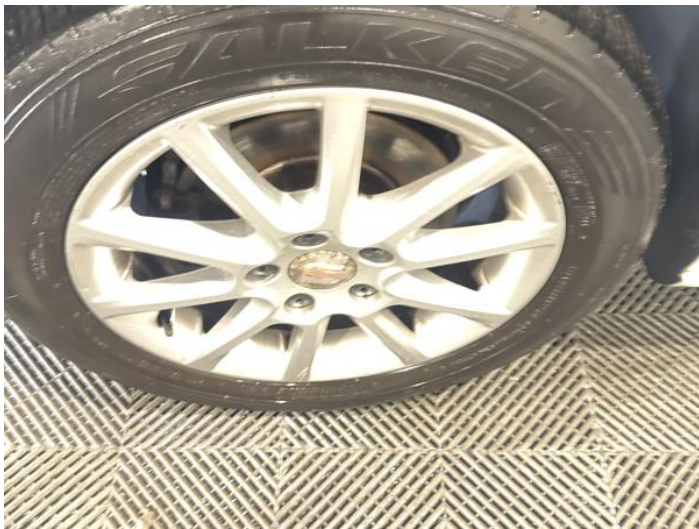
3: Wheel nsf  
Scratched  
Over 50mm

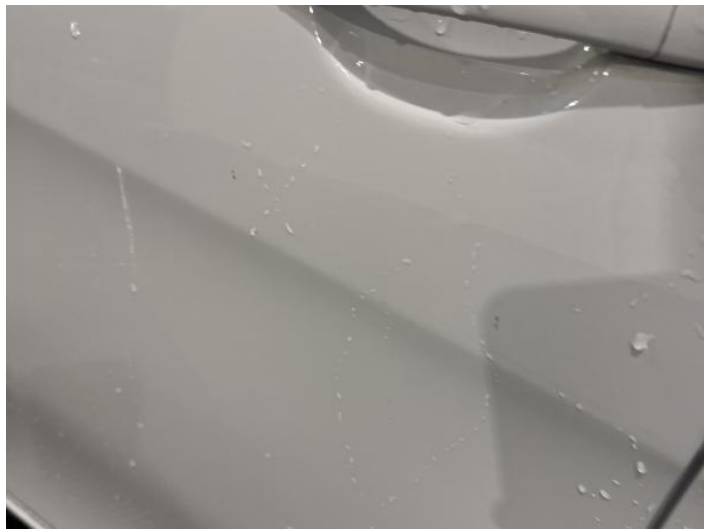
4: Door nsr  
Chipped  
1 To 5

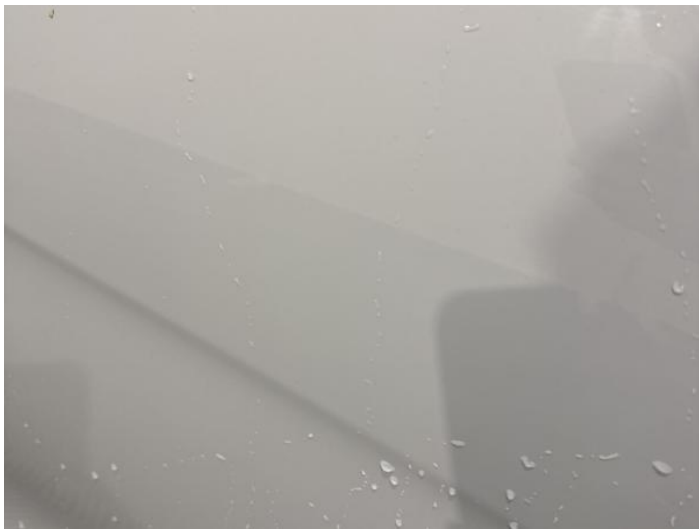
5: Door nsr  
Chipped  
1 To 5

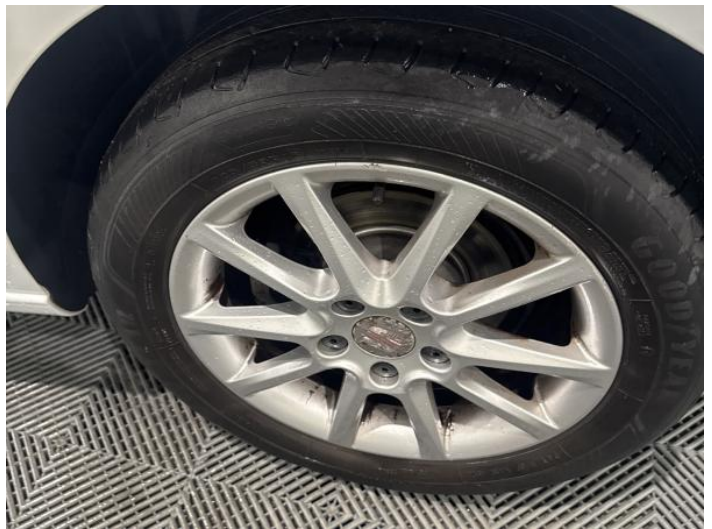
6: Wheel nsr  
Scratched  
Over 50mm

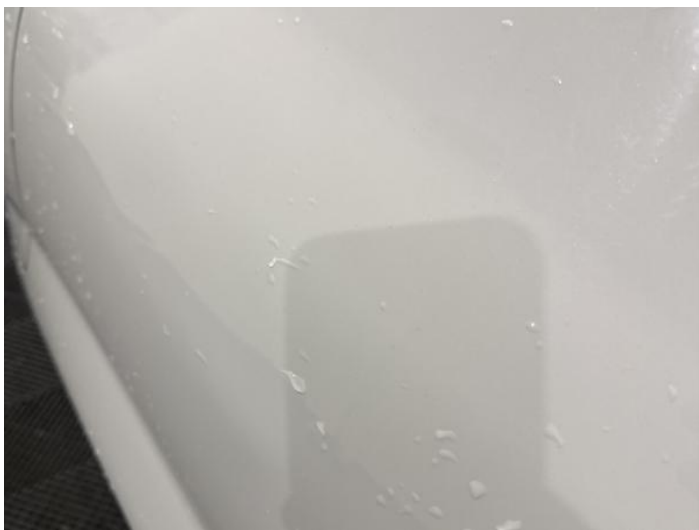
7: Qtr Panel nsr  
Dented  
Over 30mm

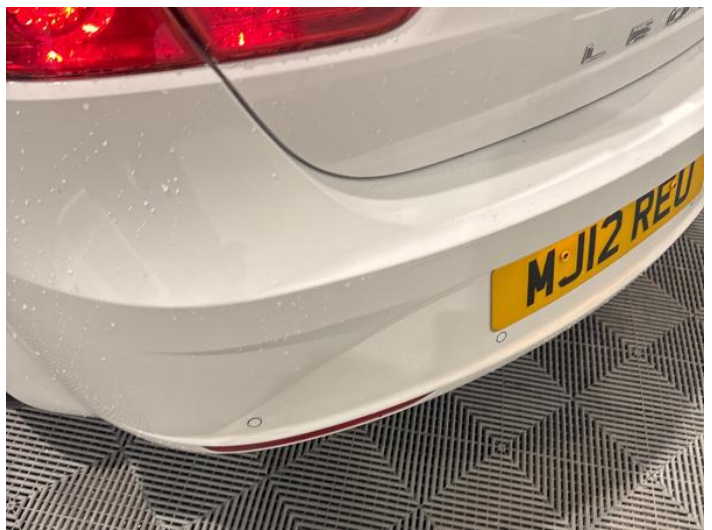
8: Bumper Rear  
Scratched  
25 to 100mm Thru Paint

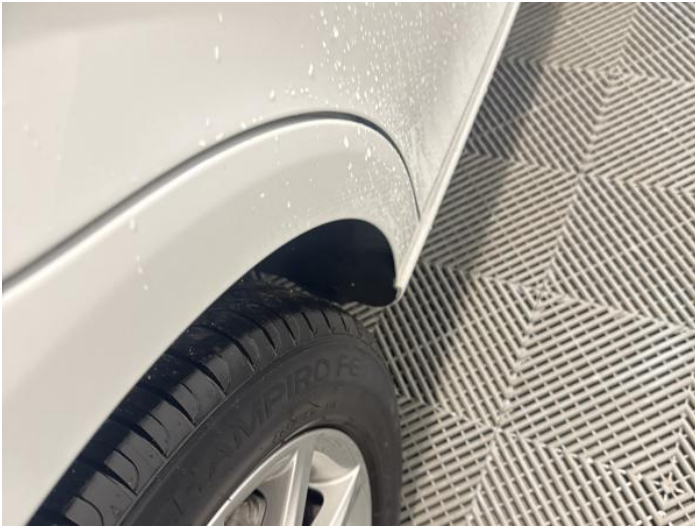
9: Qtr Panel osr  
Dented  
2 Or Less UpTo 10mm

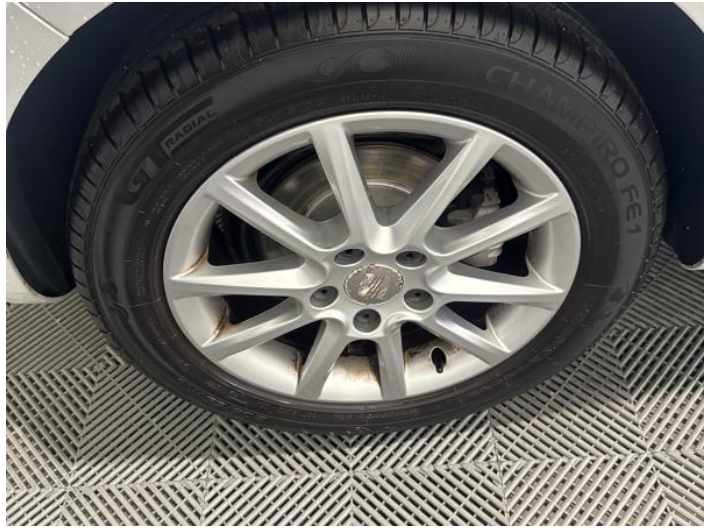
10: Wheel osr  
Scratched  
Up To 50mm

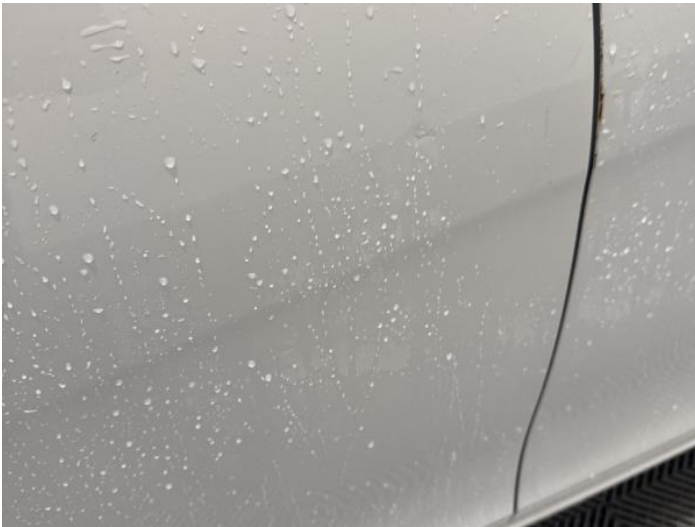
11: Door osr  
Chipped  
1 To 5

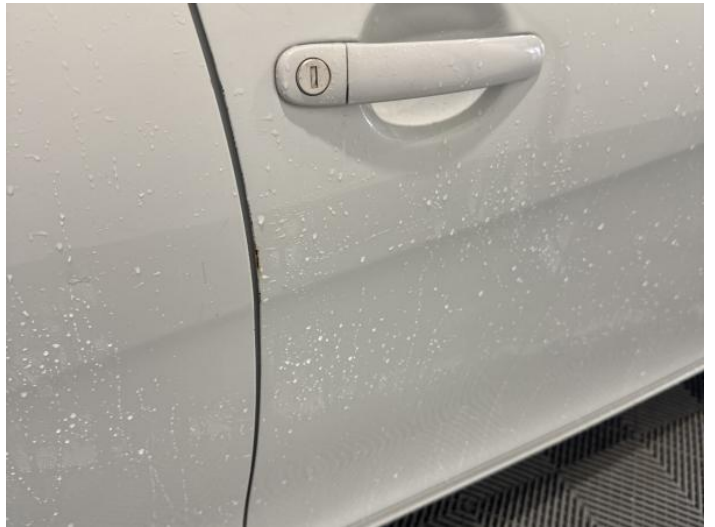
12: Door osf  
Chipped  
Multiple Chips

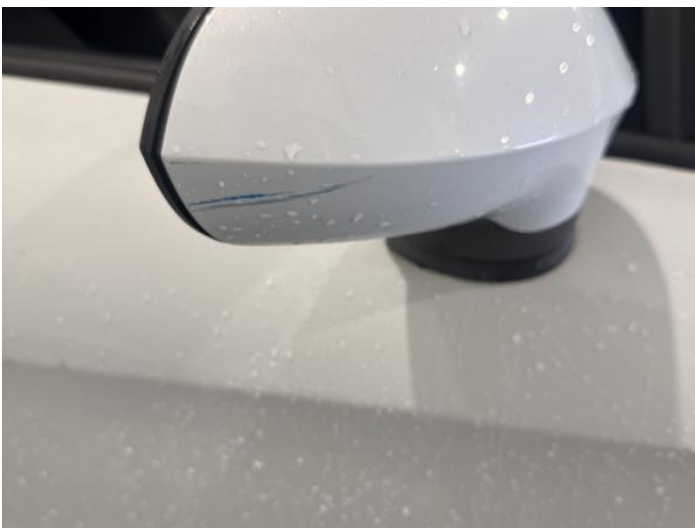
13: Door Mirror Assy osf  
Scratched (Painted)  
Over 25mm Thru Paint

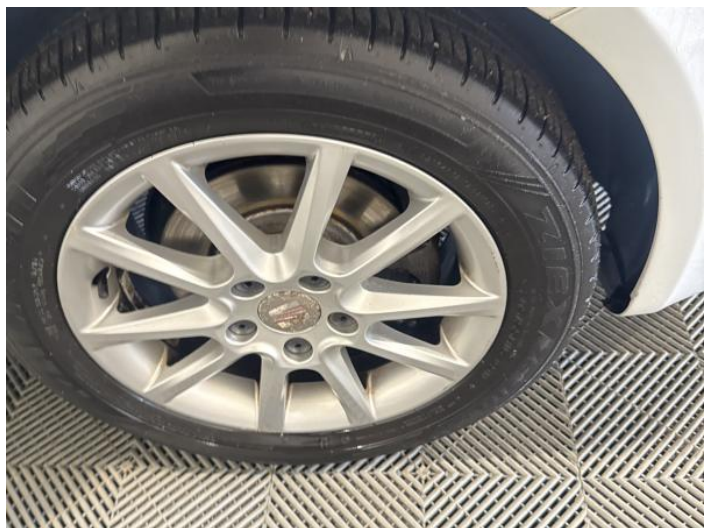
14: Wheel osf  
Scratched  
Up To 50mm

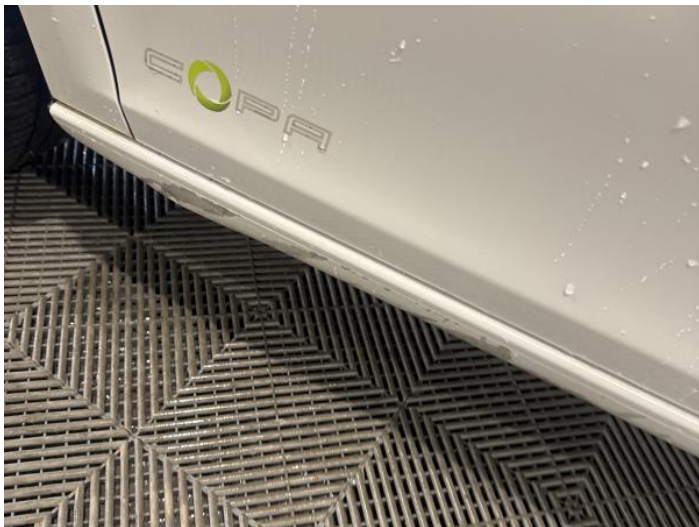
15: Sill ns  
Dented  
With Paint Damage
