VEHICLE INSPECTION REPORT

GP16PVJ

Skoda Fabia 1.2 TSI SE L 5dr

nama
GRADE
5

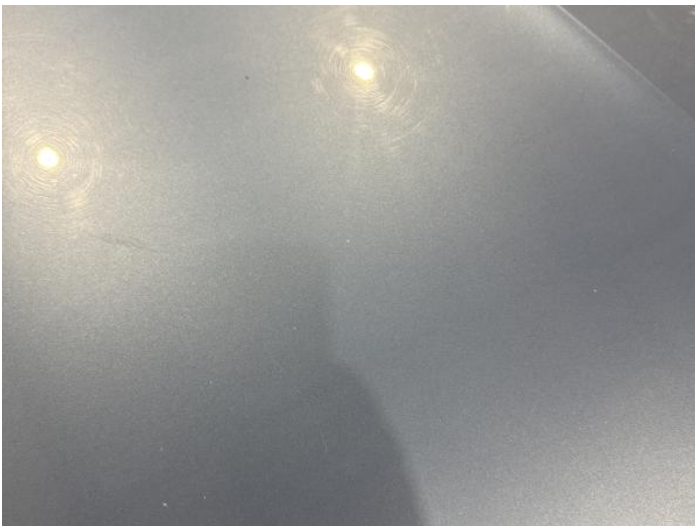
1: Bonnet
Dented
With Paint Damage

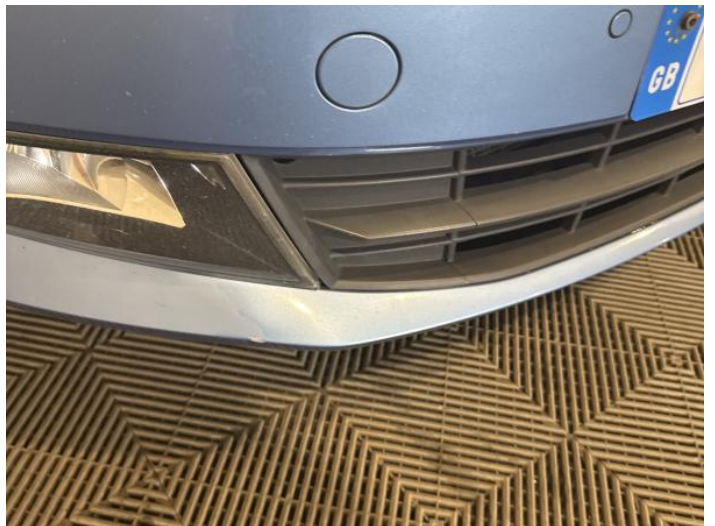
2: Bumper Front
Dented
With Paint Damage

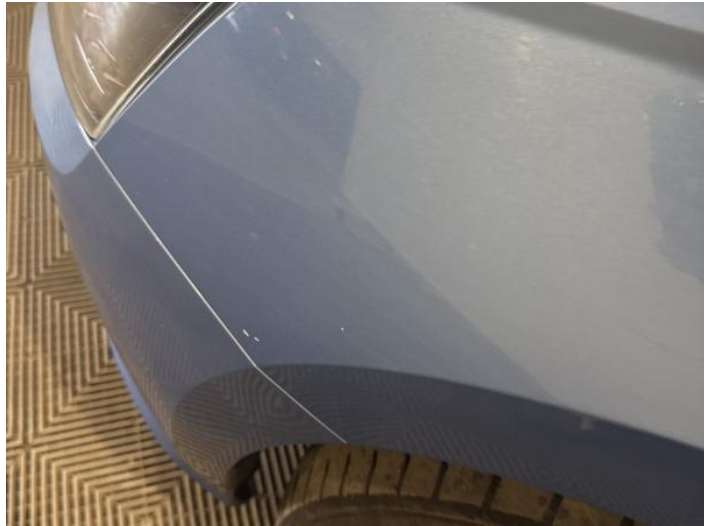
4: Wing nsf
Chipped
1 To 5

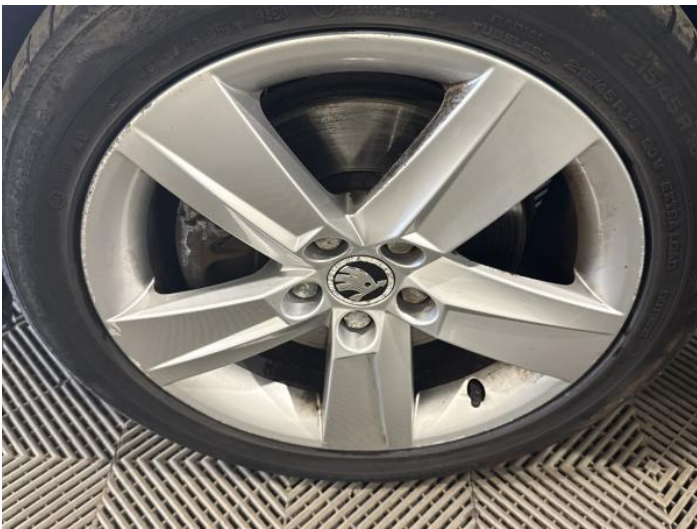
5: Wheel nsf
Scratched
Over 50mm

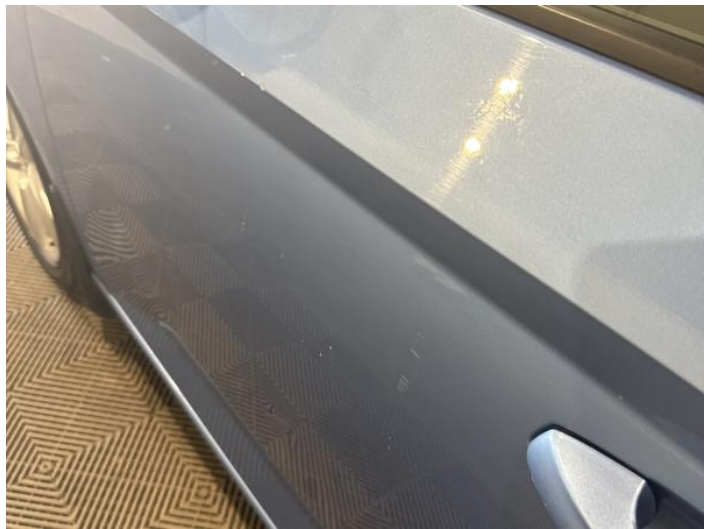
6: Door nsf
Dented
With Paint Damage

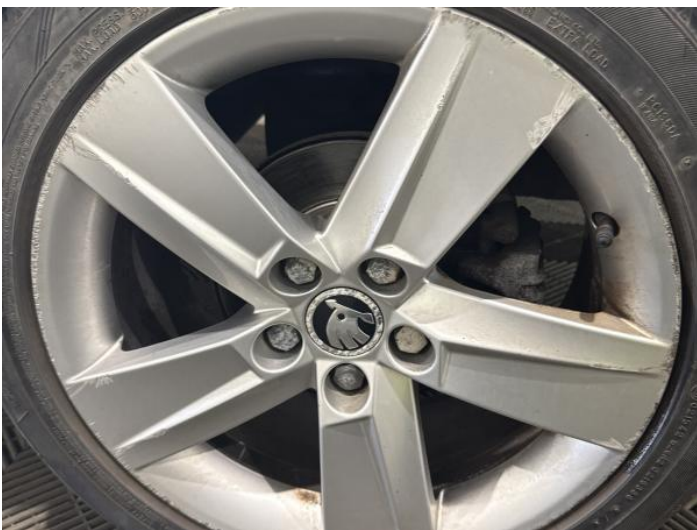
7: Wheel nsr
Scratched
Over 50mm

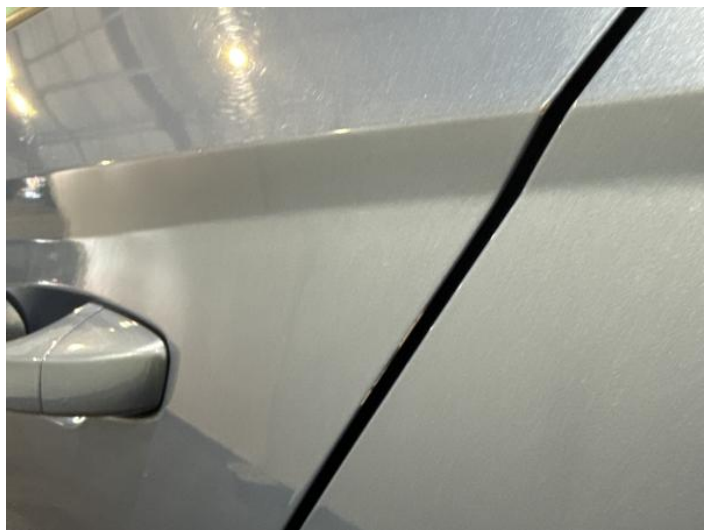
8: Door nsr
Chipped
Edge Chip

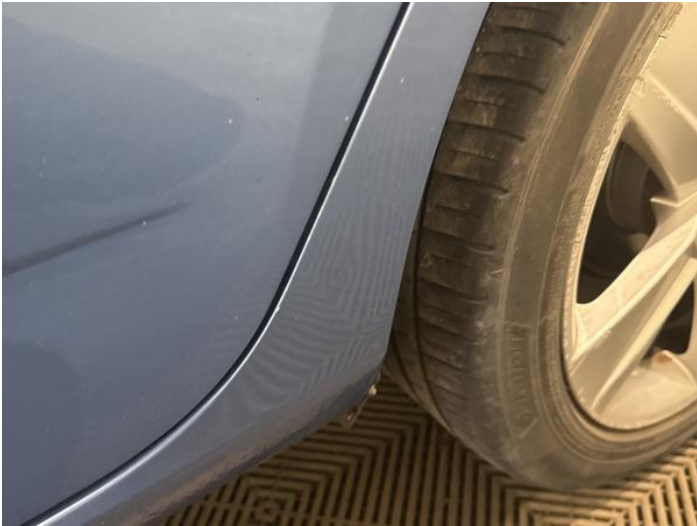
9: Qtr Panel nsr
Dented
With Paint Damage

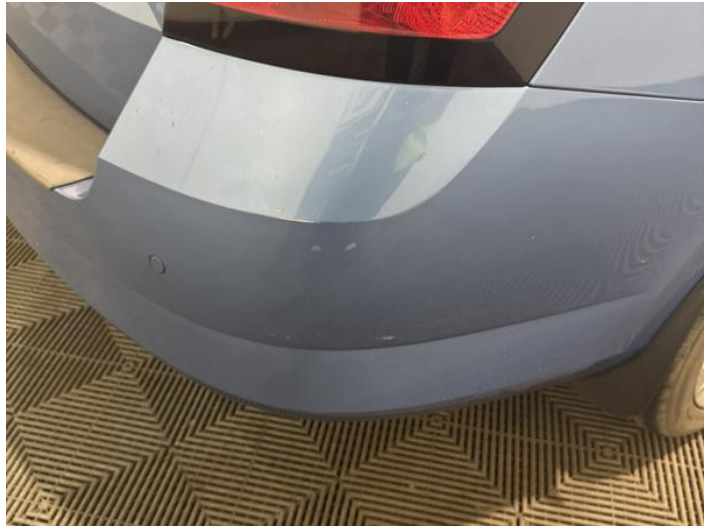
10: Bumper Rear
Scratched
25 to 100mm Thru Paint

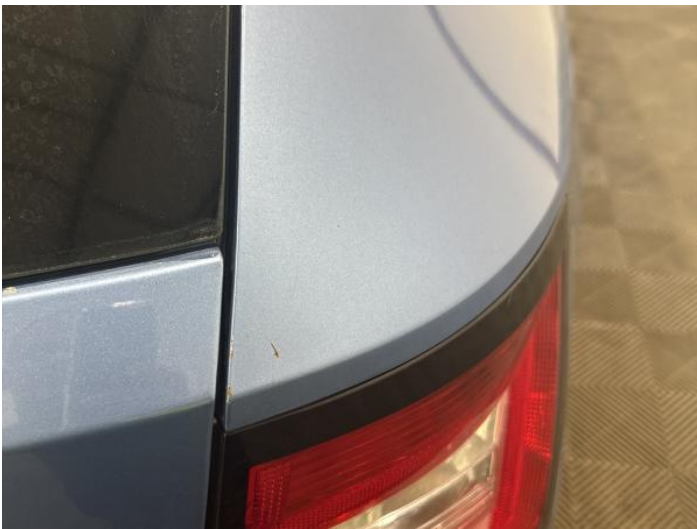
11: Qtr Panel osr
Scratched
Rusted

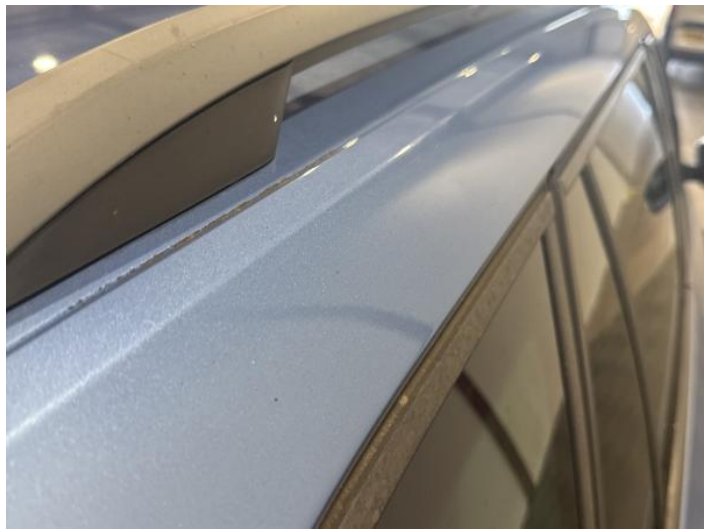
12: C Post os
Dented
Between 10mm + 30mm

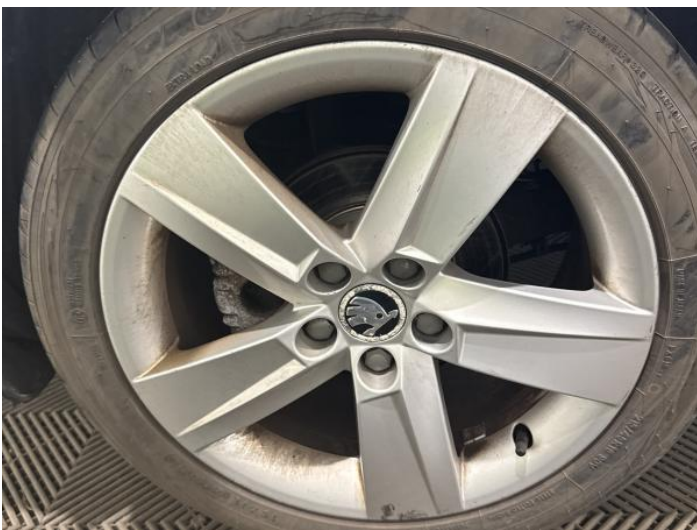
13: Wheel osr
Scratched
Up To 50mm

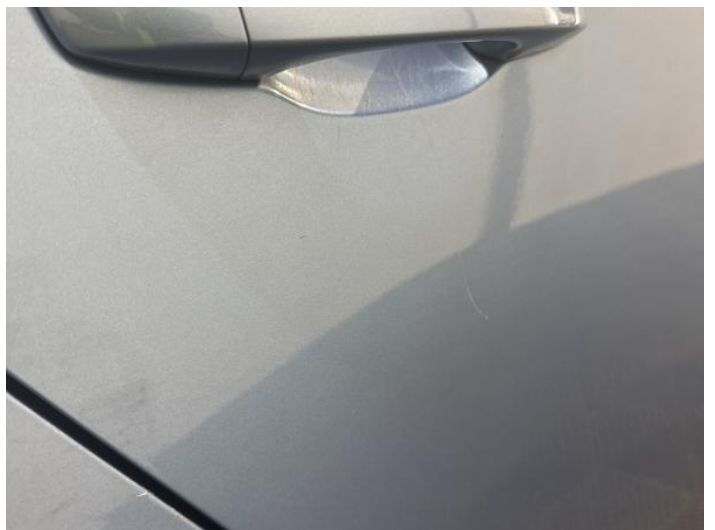
14: Door osr
Scratched
Up To 25mm Thru Paint

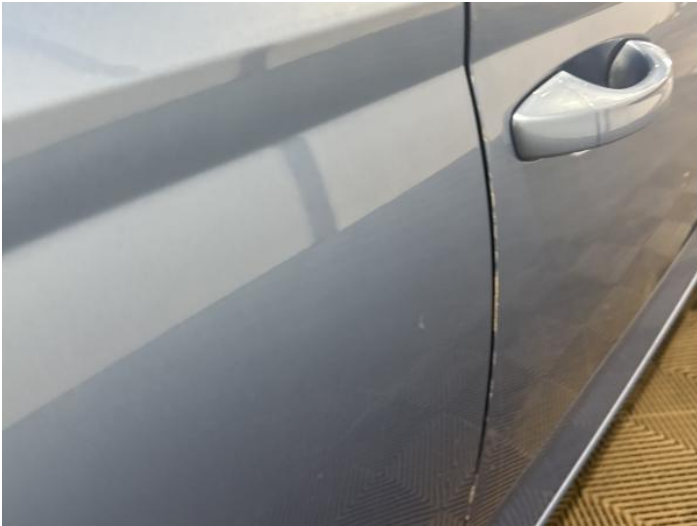
15: Door osr
Dented
Between 10mm + 30mm

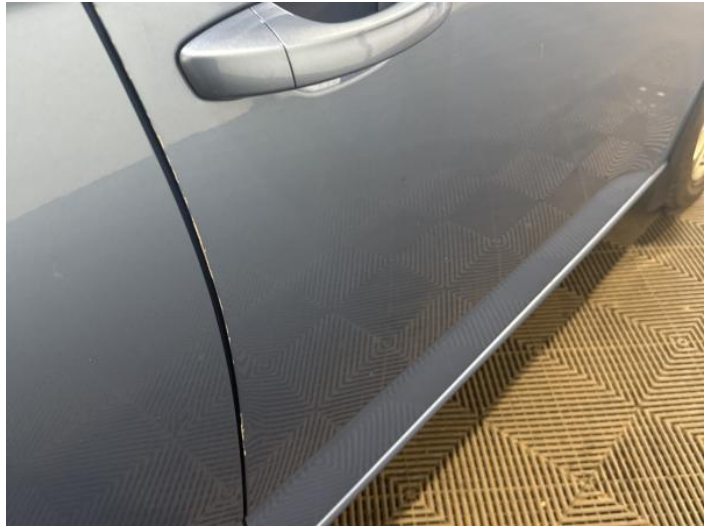
16: Door osf
Dented
With Paint Damage

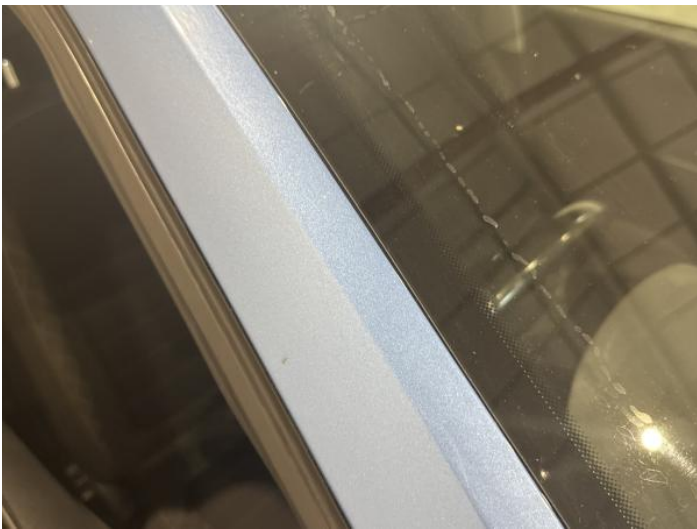
17: A Post os
Chipped
1 To 5

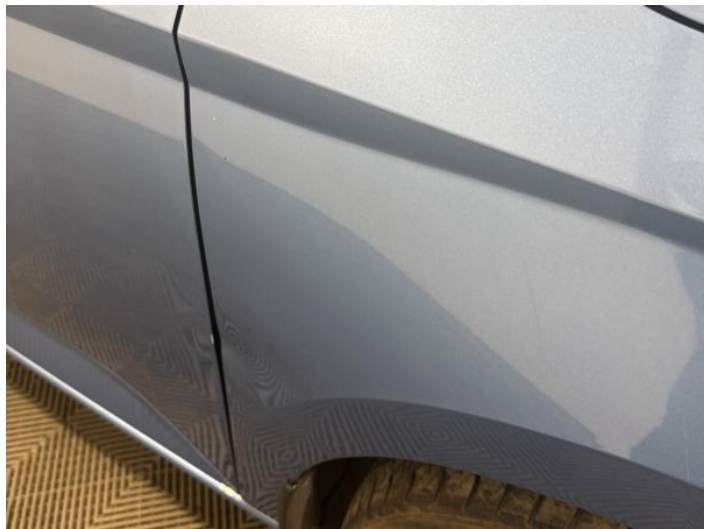
18: Wing nsf
Dented
Over 30mm

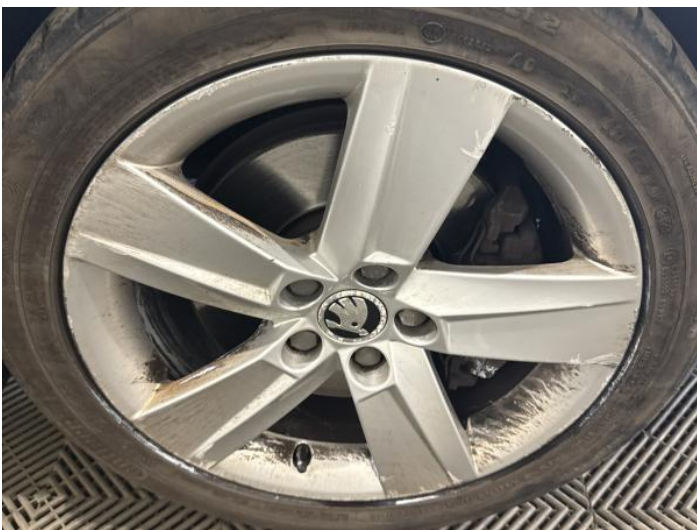
19: Wheel osf
Scratched
Over 50mm

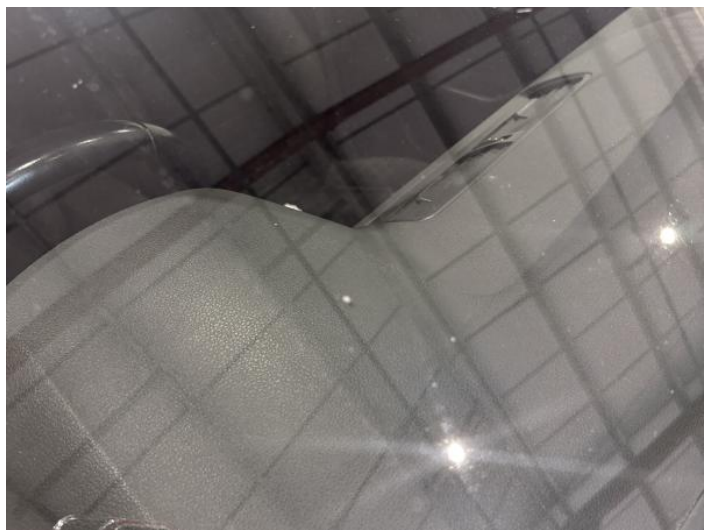
20: Screen Front
Chipped
UpTo 10mm

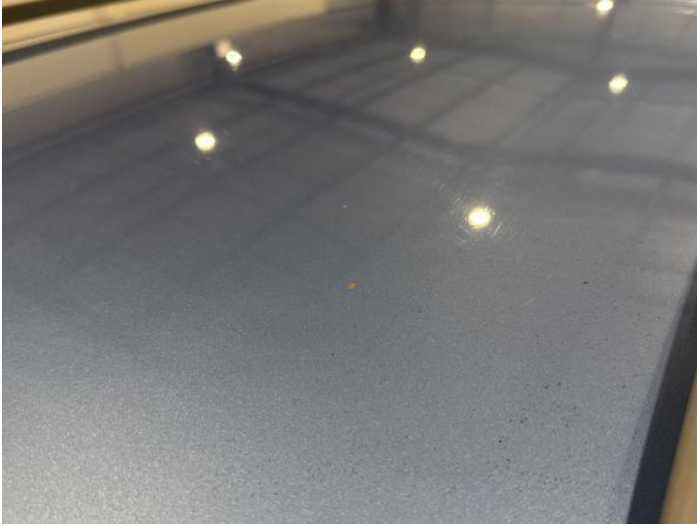
21: Roof
Dented
Over 30mm
