VEHICLE INSPECTION REPORT

HG14WYB

Kia Carens 1.7 CRDi 3 5dr

nama
GRADE
5

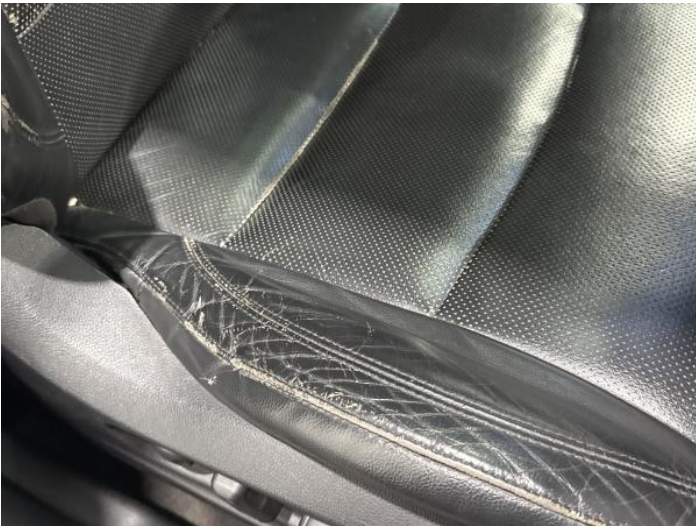
1: Seat Back Cover osf
Scuffed
Over 25mm

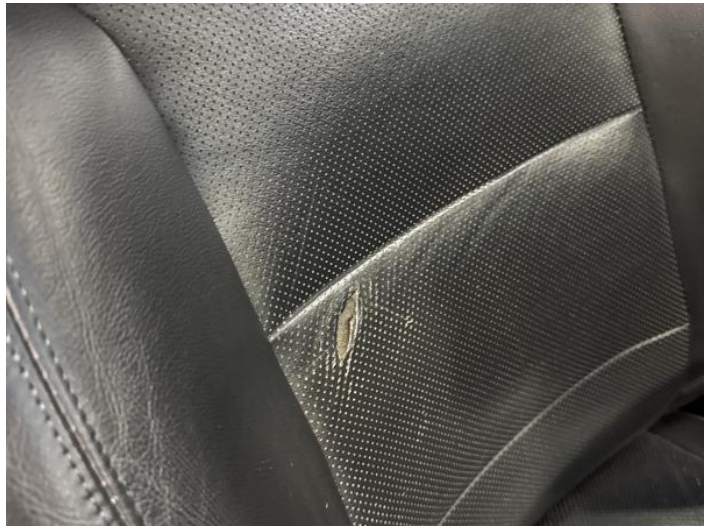
2: Seat Back Cover osf
Torn
Over 3mm

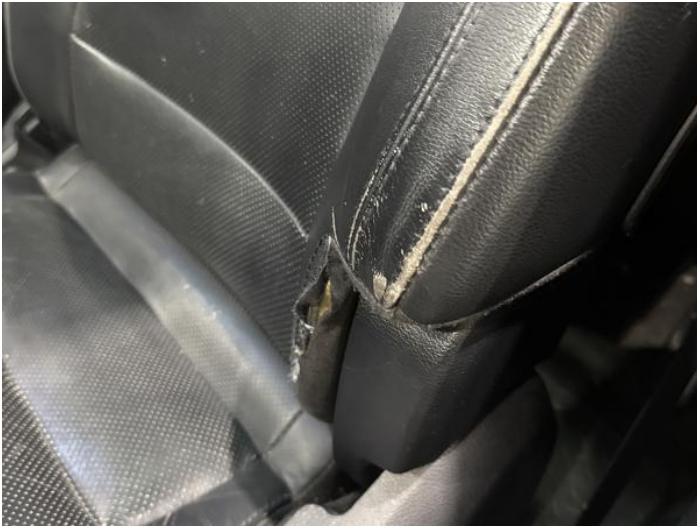
3: Seat Back Cover nsf
Torn
Over 3mm

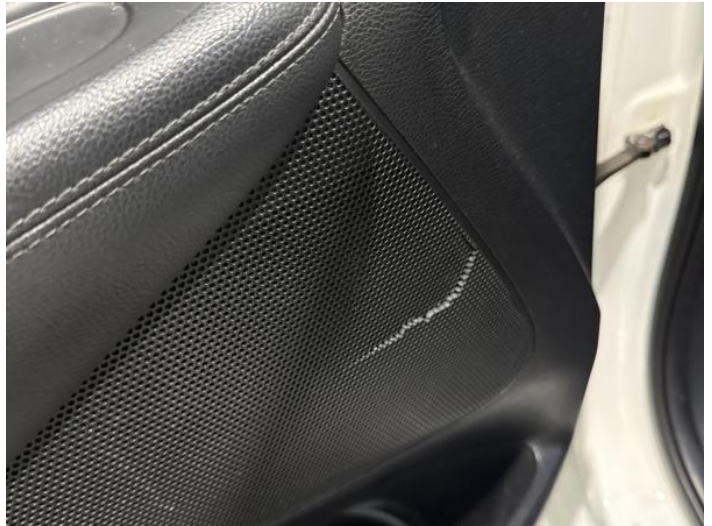
4: Door Pad nsf
Broken
Replace

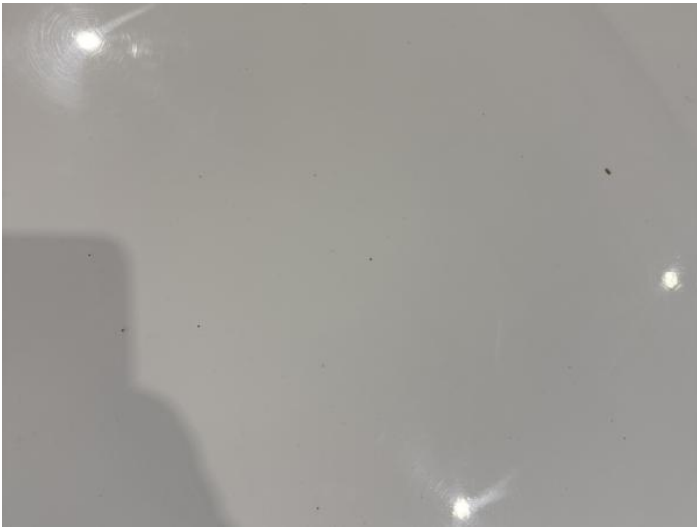
5: Bonnet
Chipped
Multiple Chips

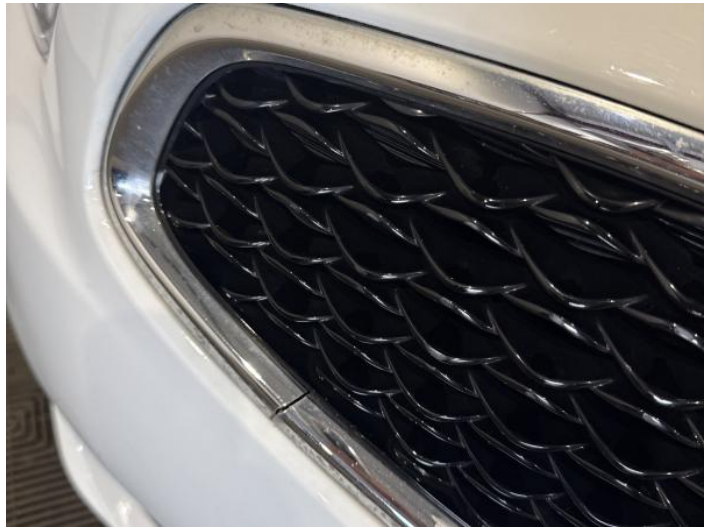
6: Bumper Front Grill
Broken
Replace

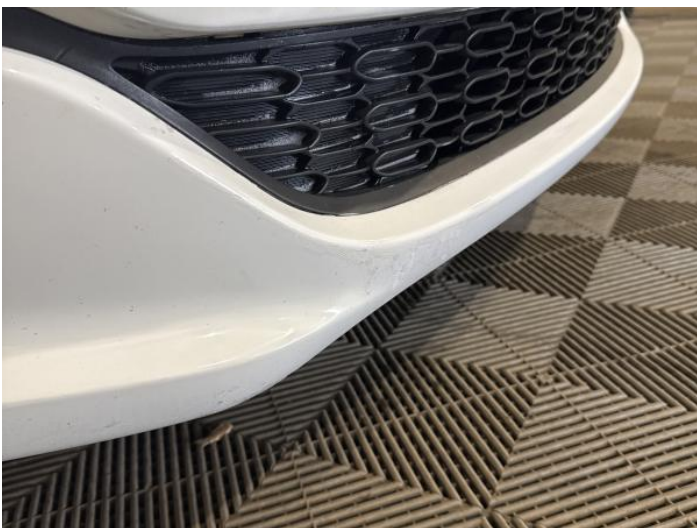
7: Bumper Front
Scratched
25 to 100mm Thru Paint

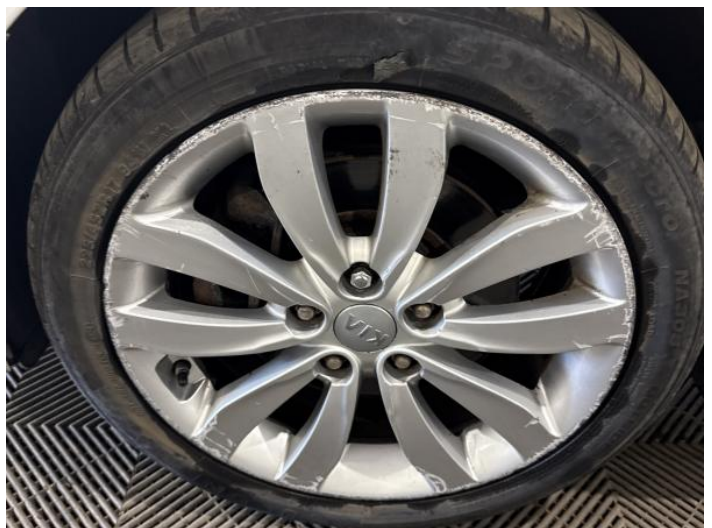
8: Wheel nsf
Scratched
Over 50mm

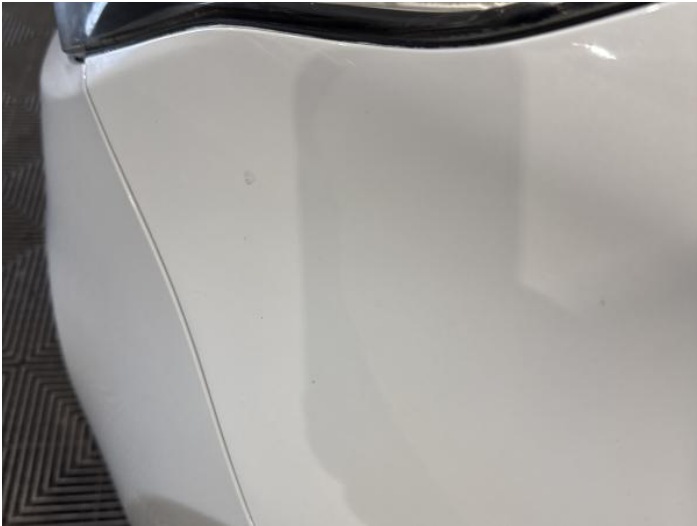
9: Wing nsf
Chipped
Over 5mm

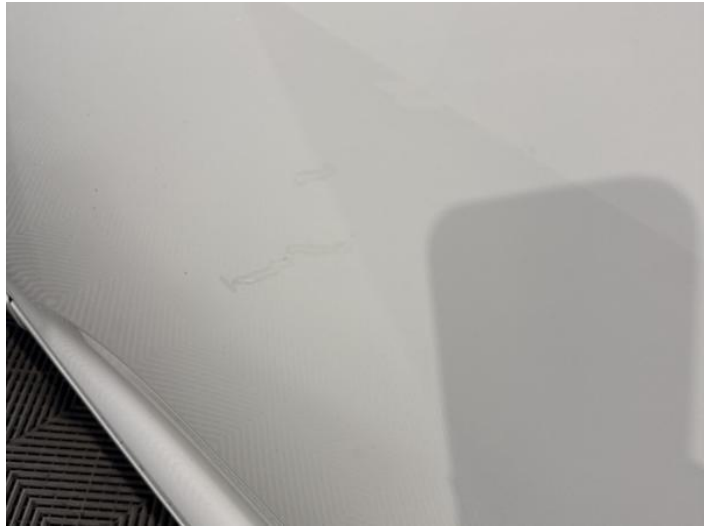
10: Door nsf
Dented
With Paint Damage

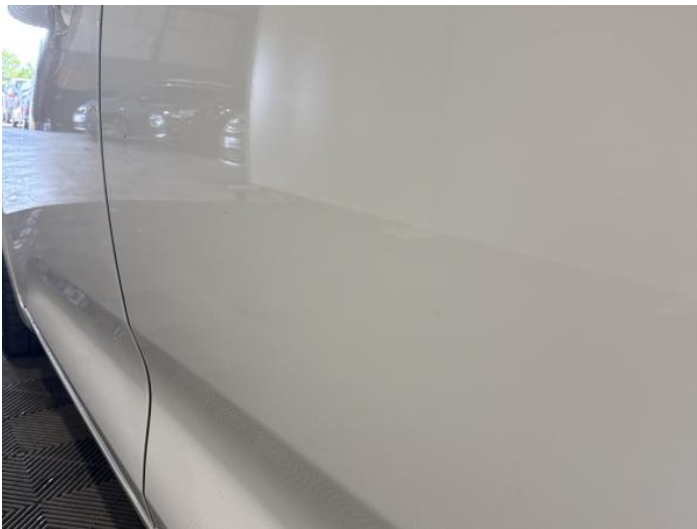
11: Door nsr
Dented
With Paint Damage

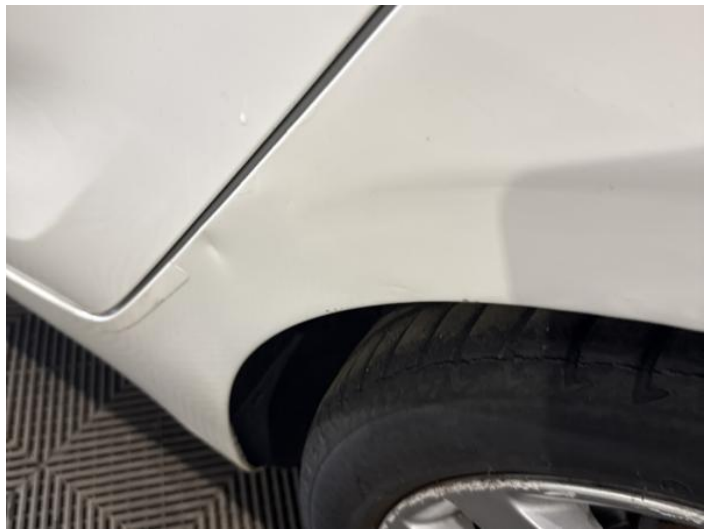
12: Qtr Panel nsr
Dented
With Paint Damage

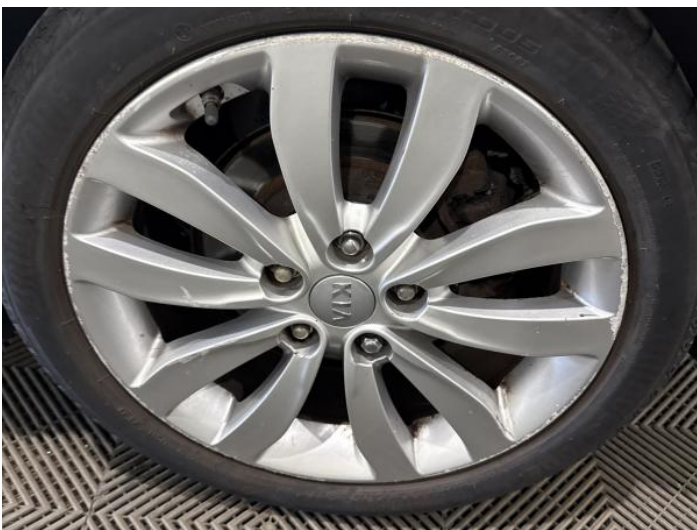
13: Wheel nsr
Scratched
Over 50mm

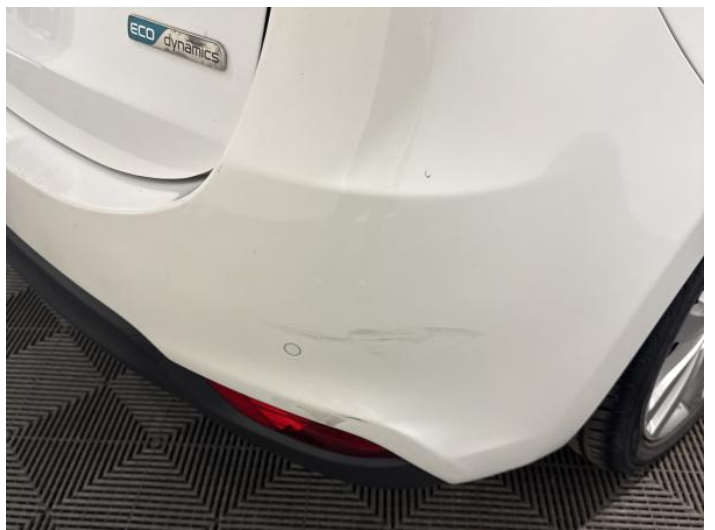
14: Bumper Rear
Scratched
Over 100mm Thru Paint

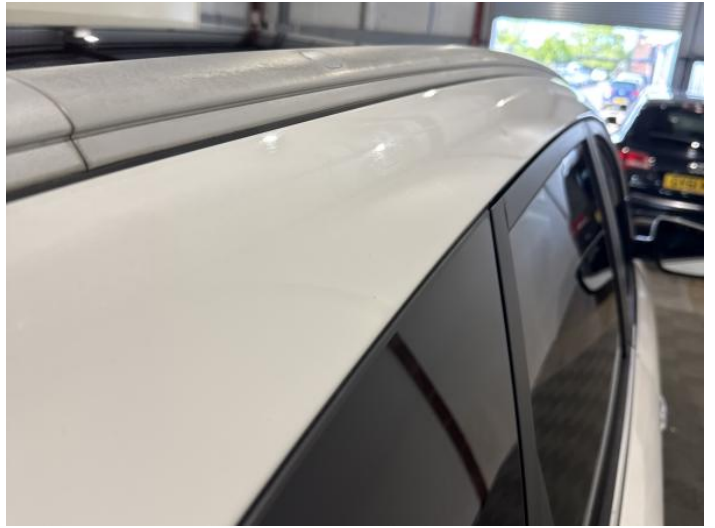
16: B Post os
Dented
Over 30mm

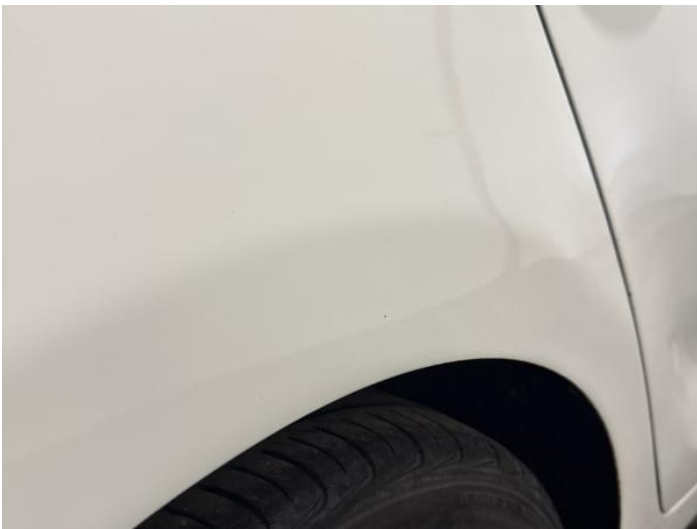
17: Qtr Panel osr
Rusted
Over 5mm

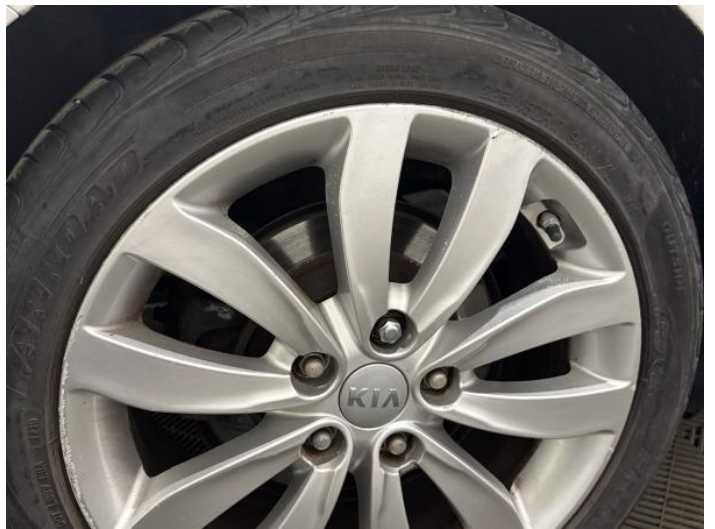
18: Wheel osr
Scratched
Over 50mm

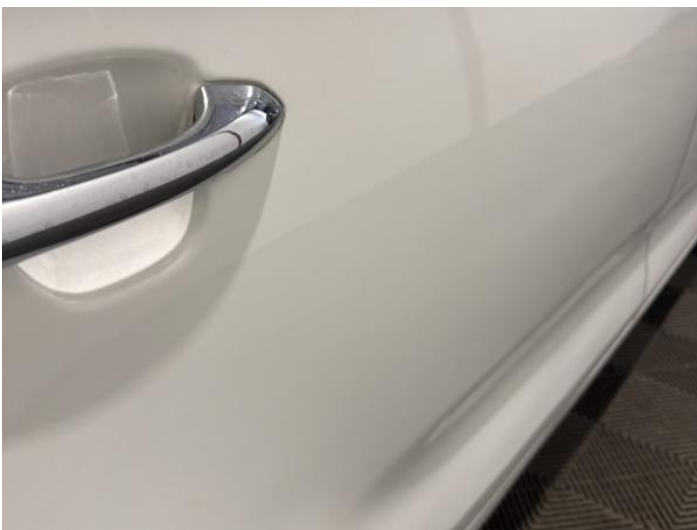
19: Door osr
Poor Previous Repair
Rippled UpTo 30%

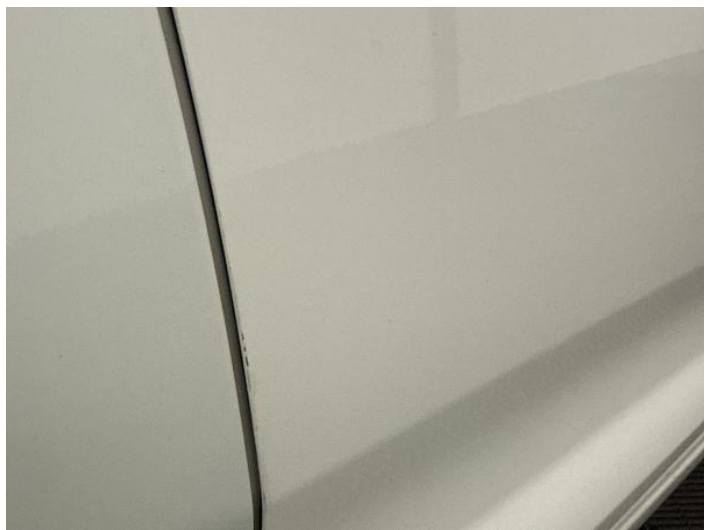
20: Door osf
Chipped
Edge Chip

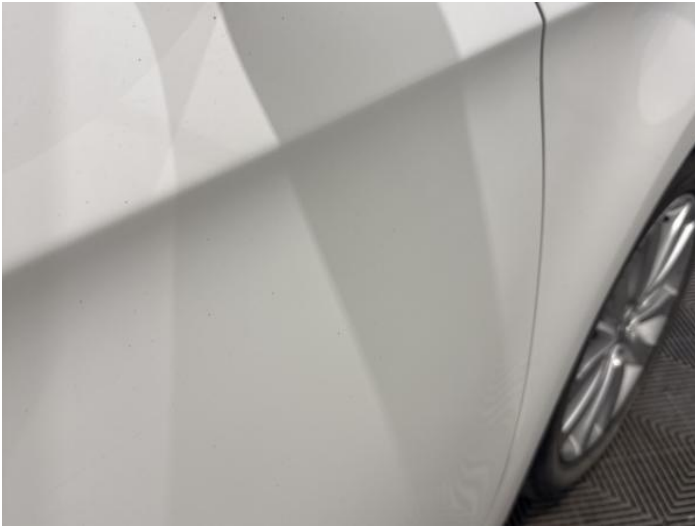
21: Door osf
Dented
Between 10mm + 30mm

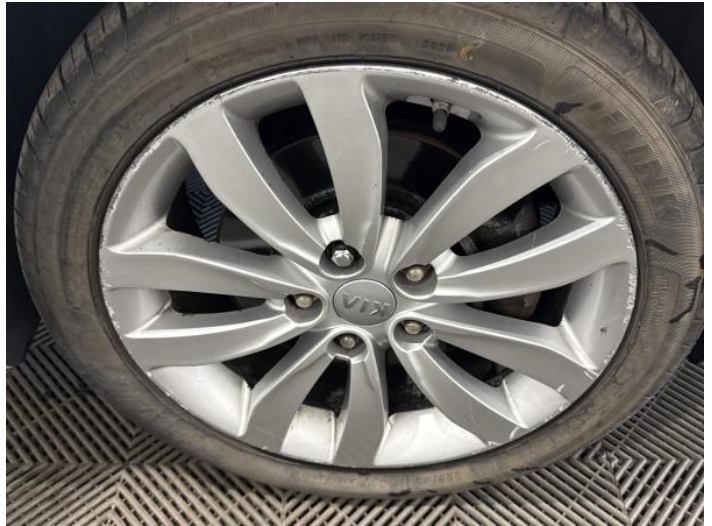
22: Wheel osf
Scratched
Over 50mm

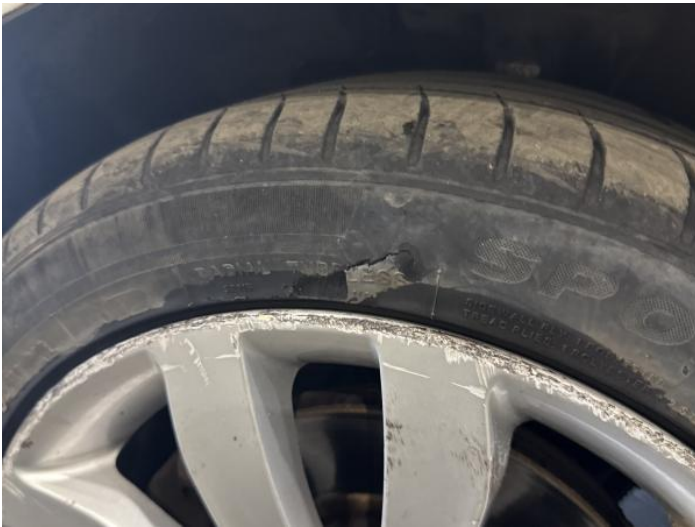
NSF	SUNNY	Damaged
NSR	BRIDGESTONE	Damaged
OSF	BUDGET	5.0mm
OSR	FARROAD	4.0mm
Spare

23: Tyre nsf
Damaged
Replace

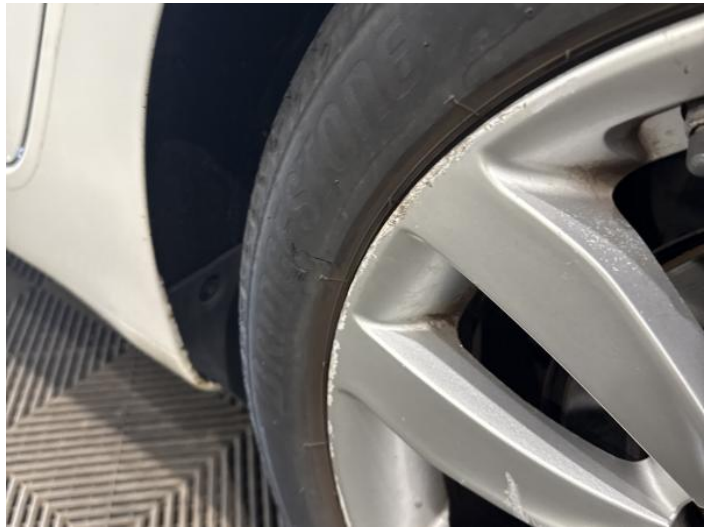
24: Tyre nsr
Damaged
Replace
