VEHICLE INSPECTION REPORT

FM14EJE

Skoda Yeti Outdoor 2.0 TDI CR [140] Laurin + Klement 4x4 5dr DSG

nama
 GRADE
2

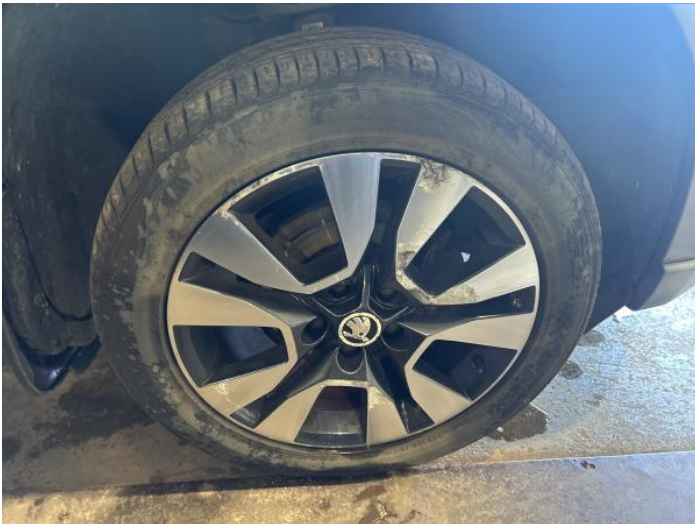
1: Wheel osf
Corroded
Light

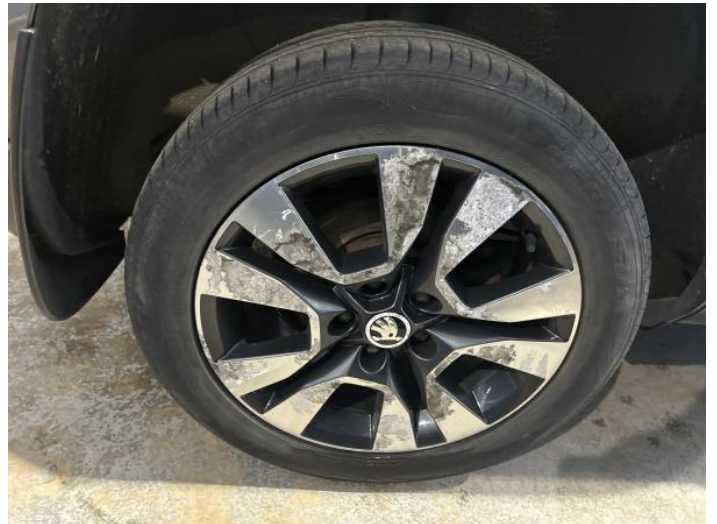
2: Wheel osr
Corroded
Light

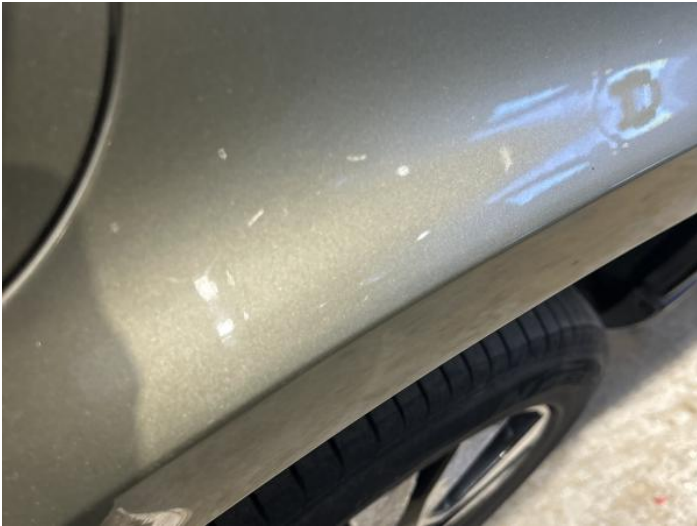
3: Qtr Panel osr
Chipped
1 To 5

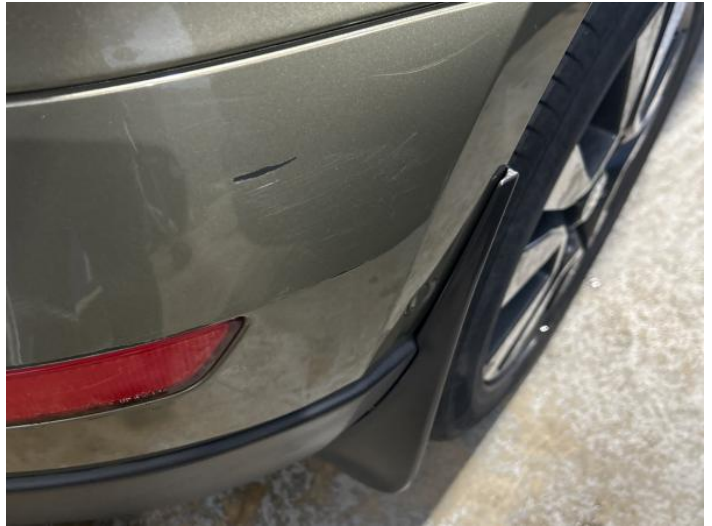
4: Bumper Rear
Scratched
25 to 100mm Thru Paint

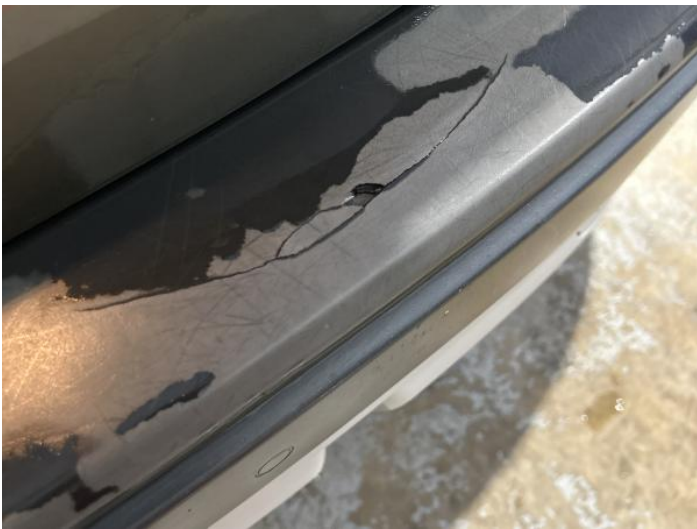
5: Bumper Rear Moulding
Broken
Replace

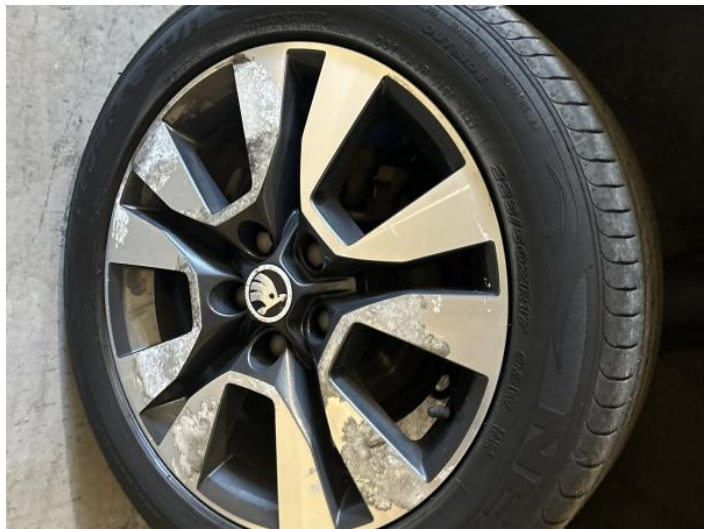
6: Wheel nsr
Corroded
Light

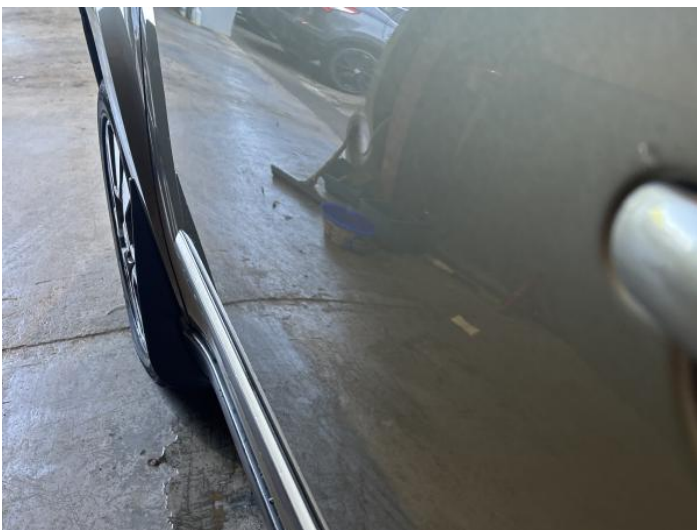
7: Door nsf
Dented
Over 2 UpTo 10mm

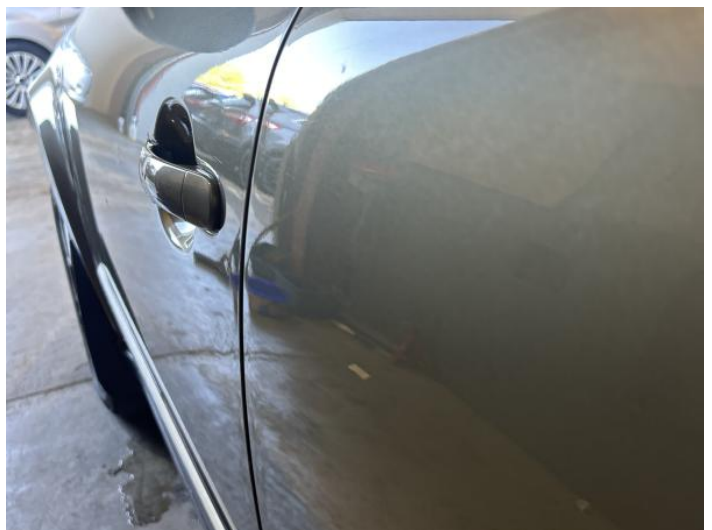
8: Door nsr
Dented
2 Or Less UpTo 10mm

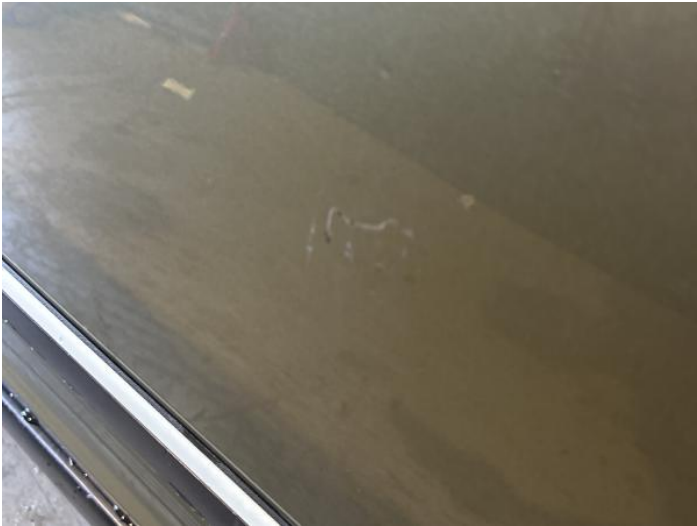
9: Door nsf
Scratched
UpTo 25mm Thru Paint

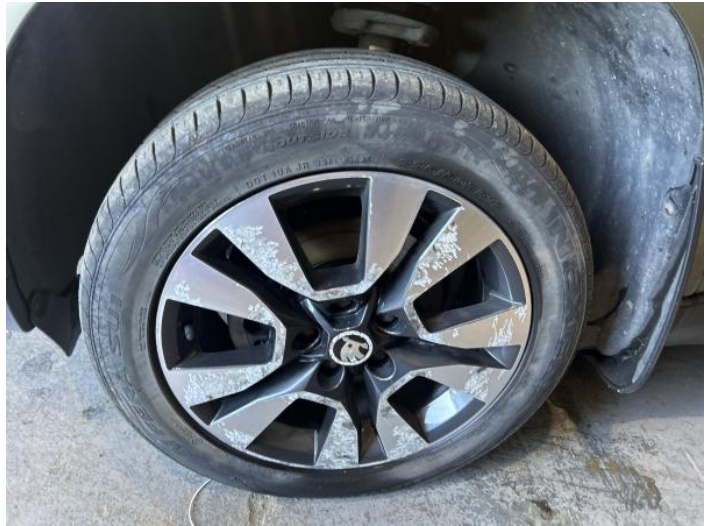
10: Wheel nsf
Corroded
Light

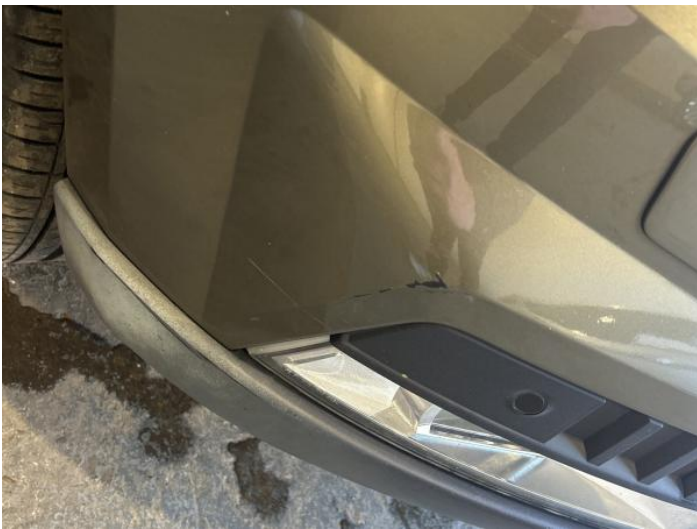
11: Bumper Front
Scratched
Over 100mm Thru Paint

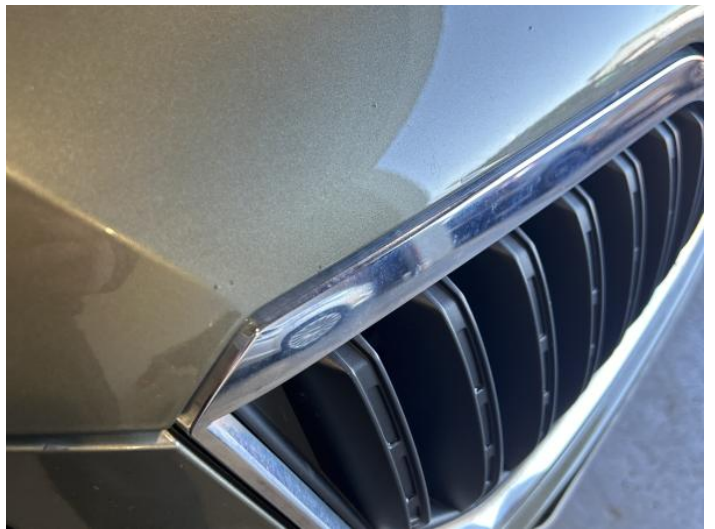
12: Bonnet
Chipped
1 To 5

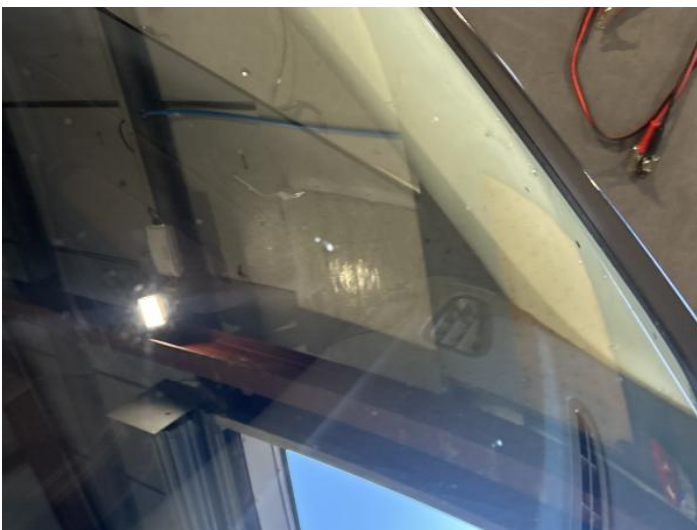
13: Screen Front
Chipped
UpTo 10mm
