VEHICLE INSPECTION REPORT

BT16GJX

Kia Sportage 1.7 CRDi ISG 2 5dr

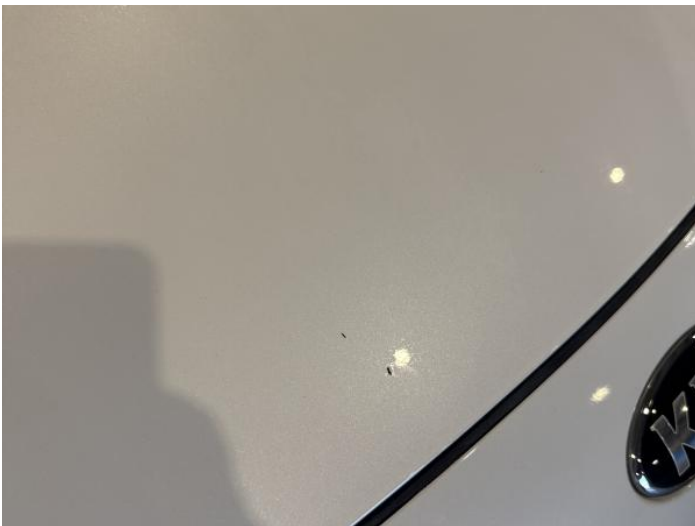
1: Bonnet
Chipped
1 To 5

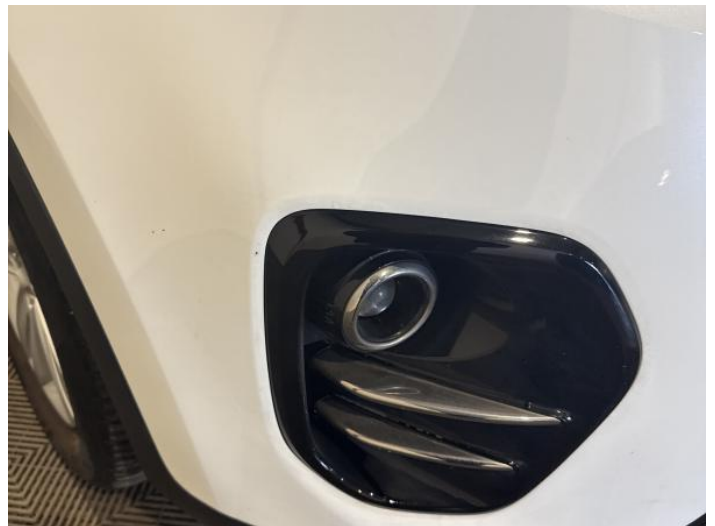
2: Bumper Front
Scratched
25 to 100mm Thru Paint

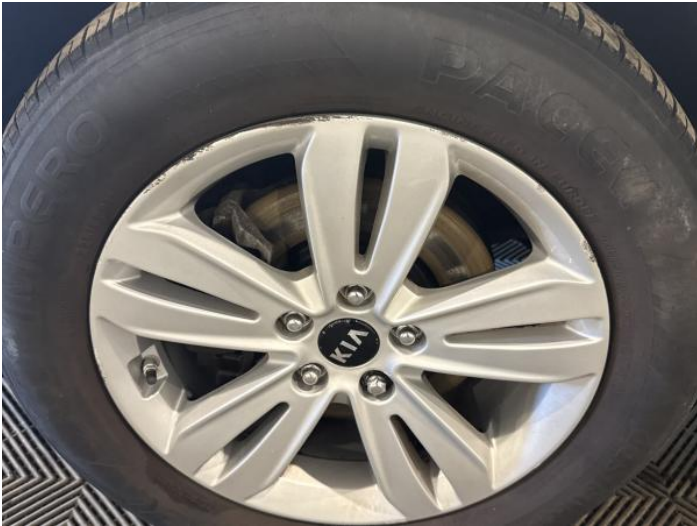
3: Wheel nsf
Scratched
Over 50mm

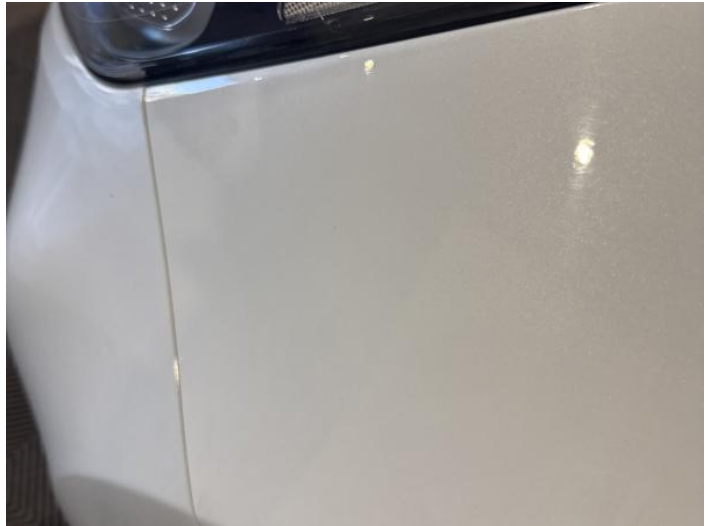
4: Wing nsf
Chipped
1 To 5

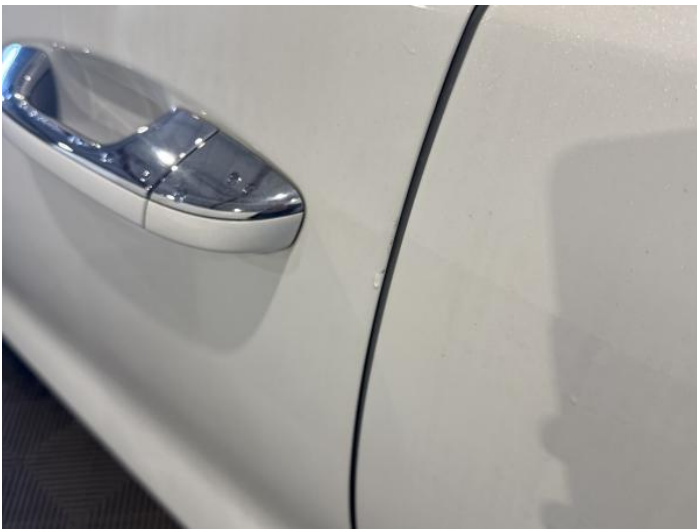
5: Door nsf
Chipped
Edge Chip

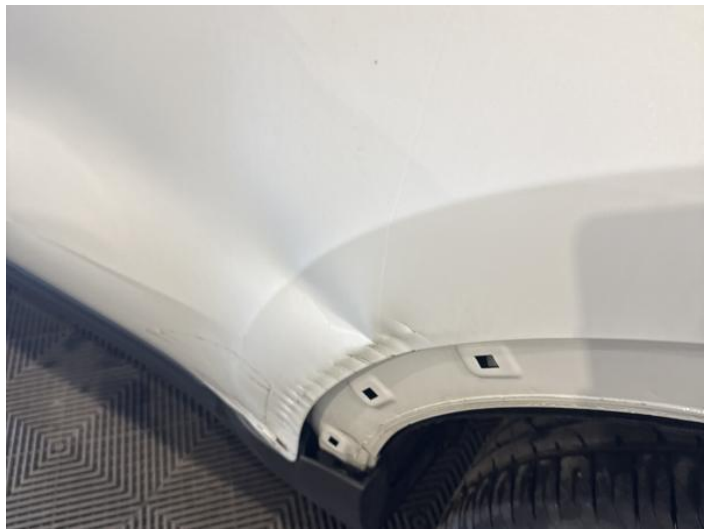
6: Door nsr
Dented
With Paint Damage

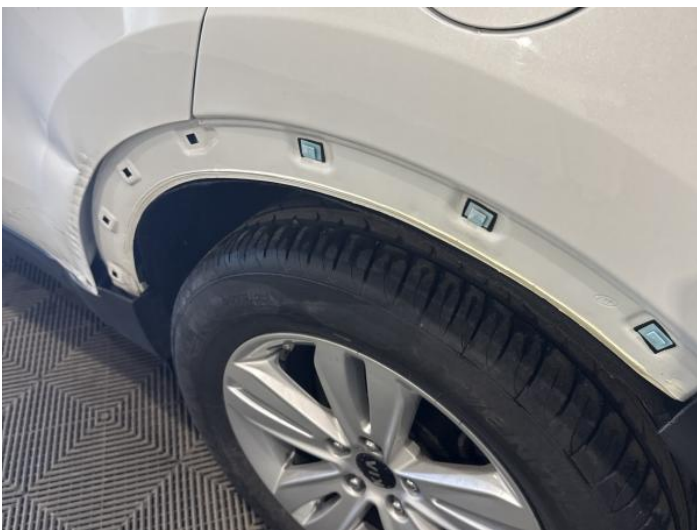
7: Qtr Panel Arch Extension ns
Missing
Replace

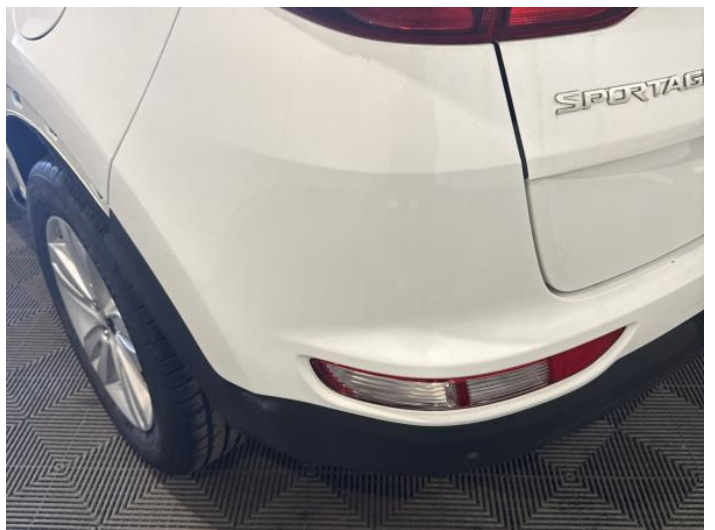
8: Bumper Rear
Scratched
25 to 100mm Thru Paint

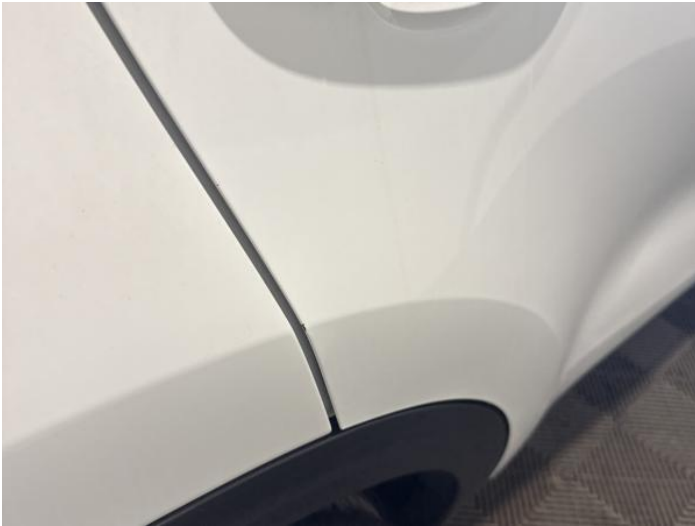
9: Door osr
Chipped
Edge Chip

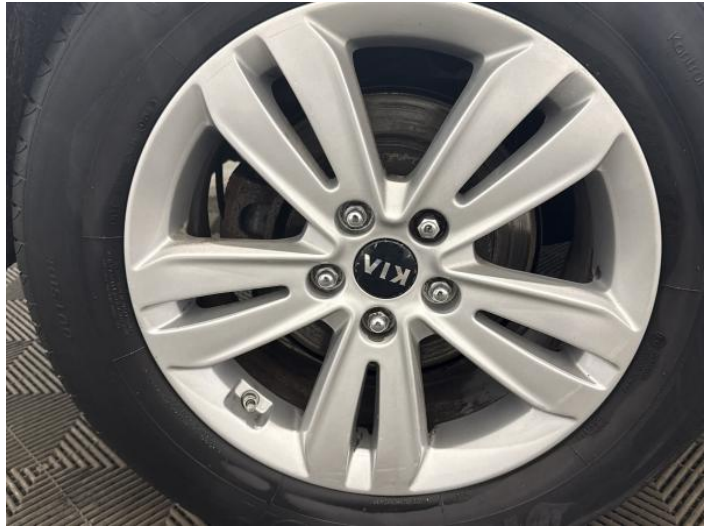
10: Wheel osr
Scratched
Up To 50mm

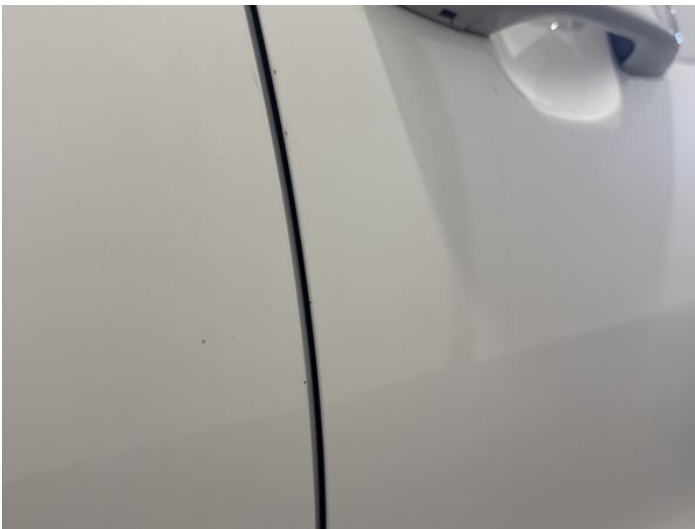
11: Door osf
Chipped
Edge Chip

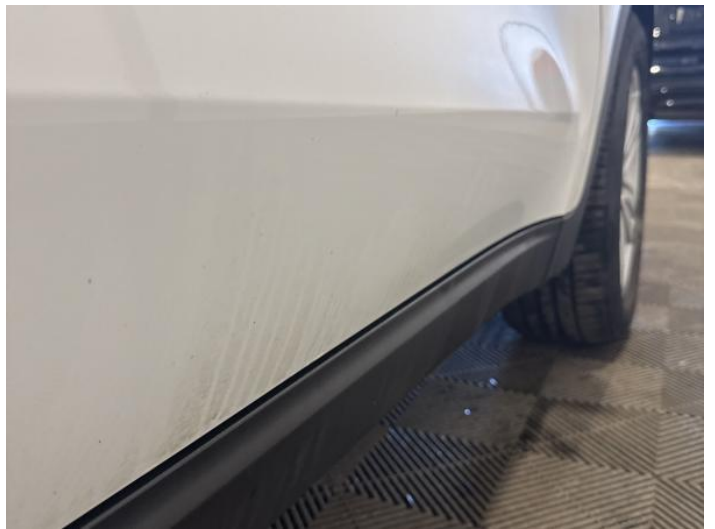
12: Door osf
Dented
2 Or Less UpTo 10mm

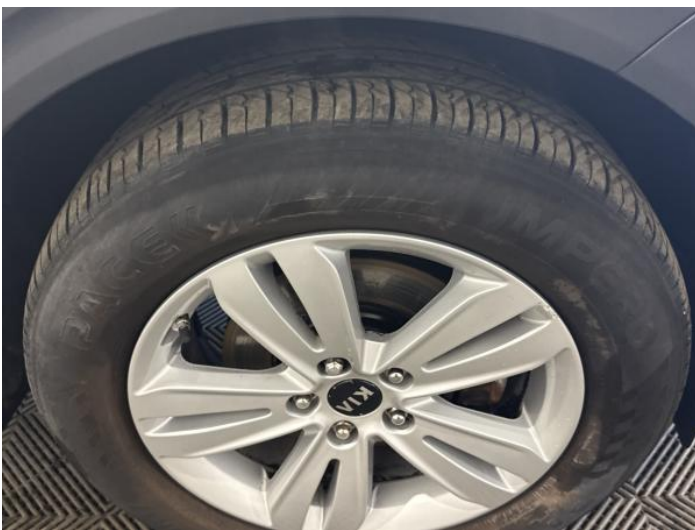
13: Wheel osf
Scratched
Over 50mm
