VEHICLE INSPECTION REPORT

GU62ZVA

Hyundai I10 1.2 Active 5dr

nama
GRADE
3

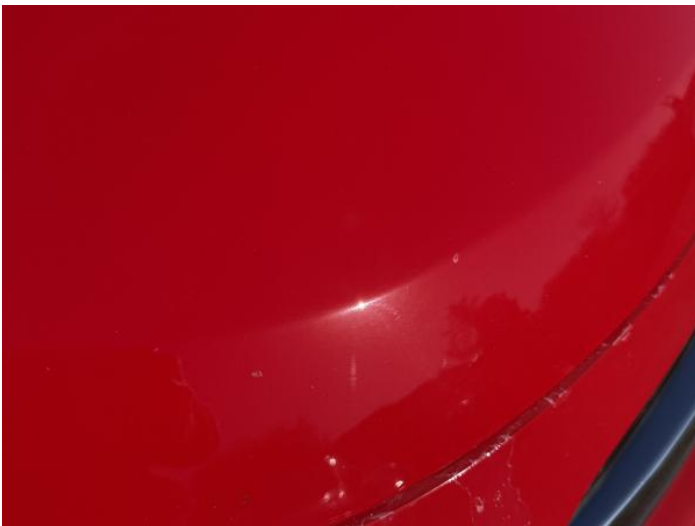
1: Bonnet
Chipped
Multiple Chips

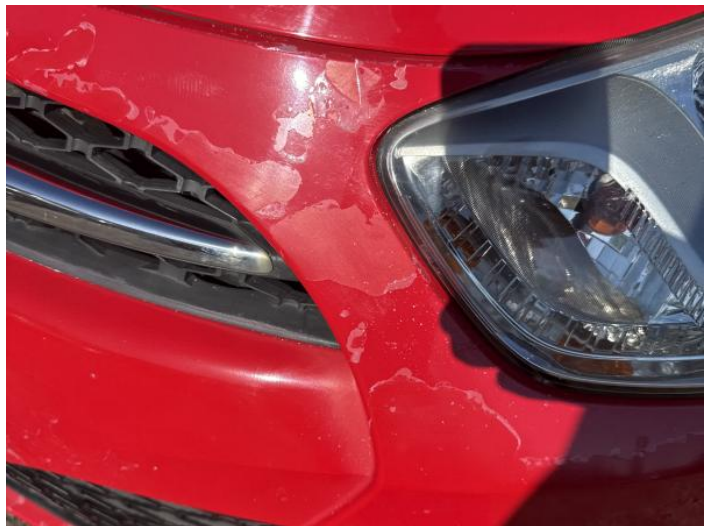
2: Bumper Front
Poor Previous Repair
Paint Flake

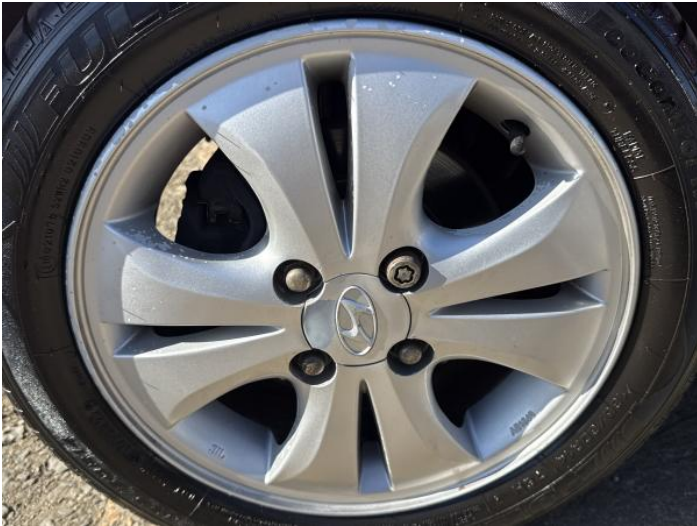
3: Wheel nsf
Scratched
Over 50mm

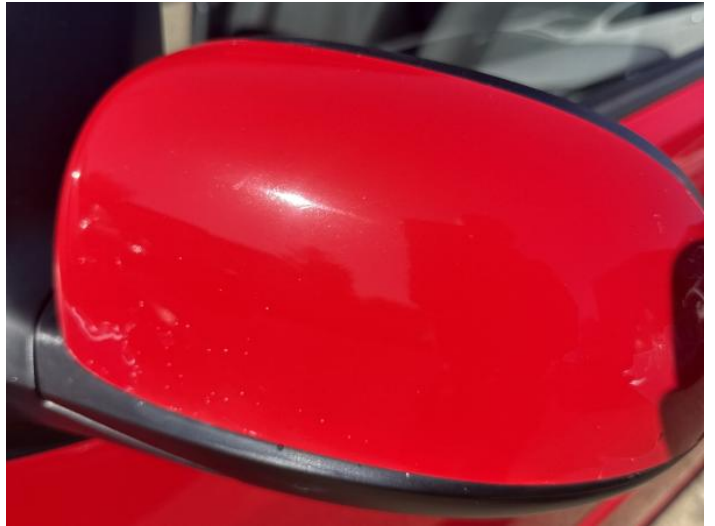
4: Door Mirror Assy nsf
Scratched (Painted)
Over 25mm Thru Paint

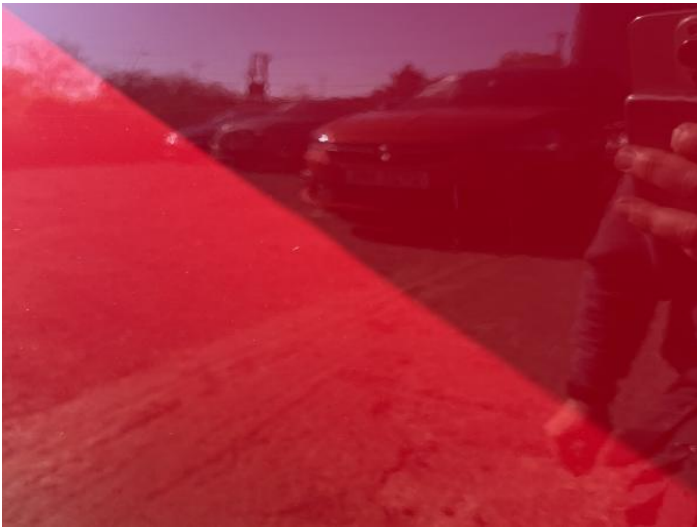
5: Door nsf
Chipped
1 To 5

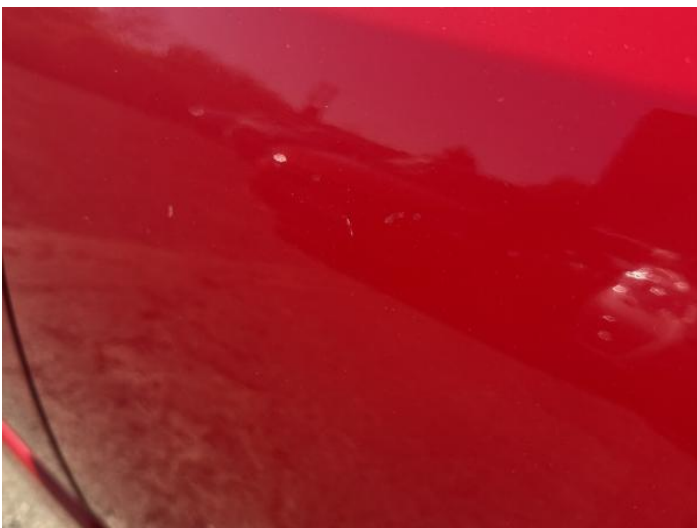
7: Door nsr
Chipped
1 To 5

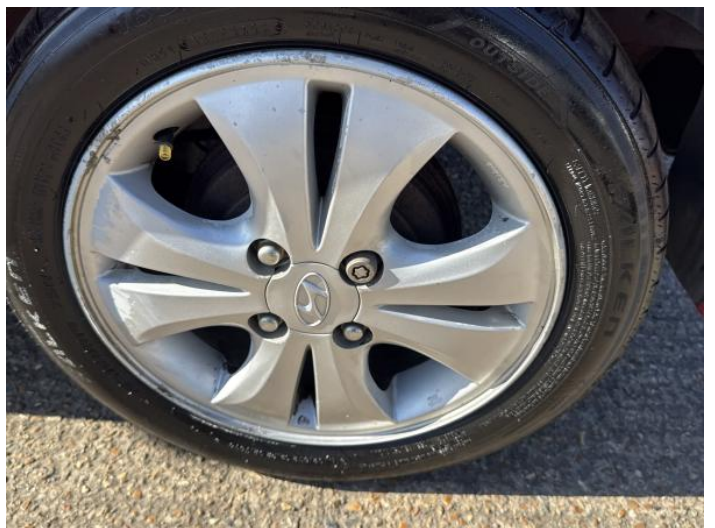
8: Wheel nsr
Scratched
Over 50mm

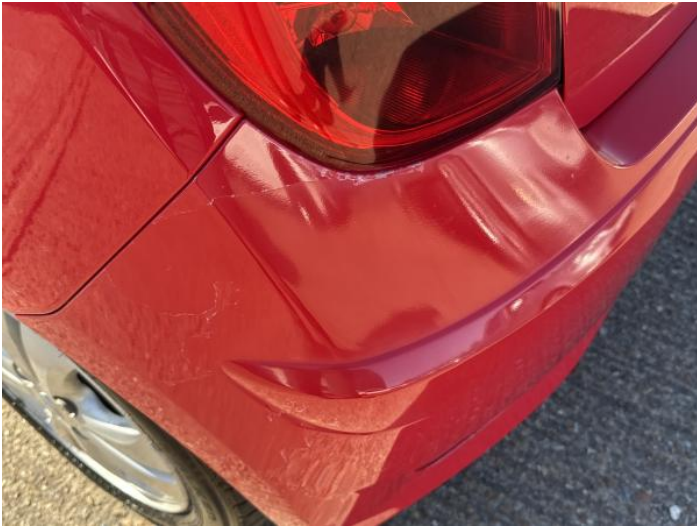
9: Bumper Rear
Poor Previous Repair
Paint Flake

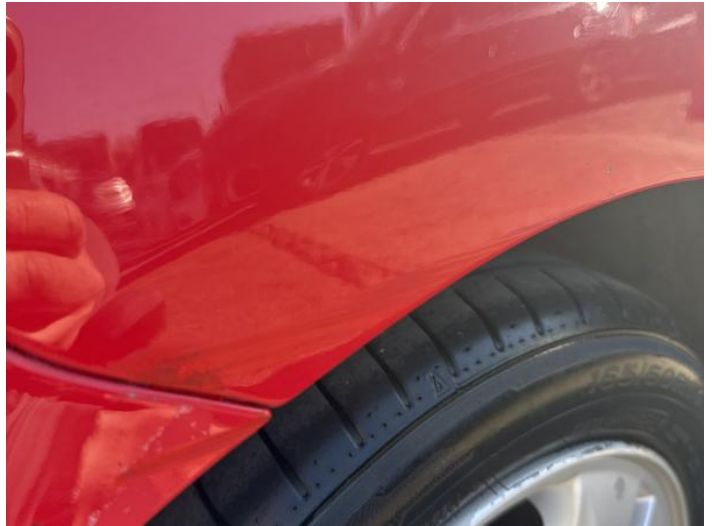
10: Qtr Panel osr
Scratched
Over 25mm Thru Paint

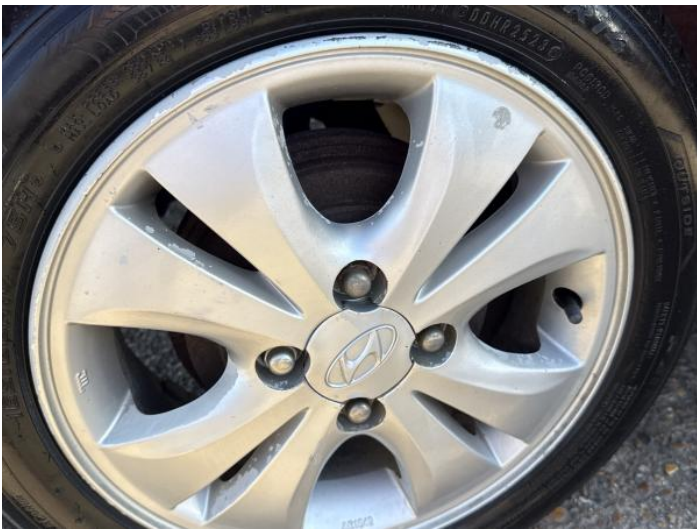
11: Wheel osr
Scratched
Over 50mm

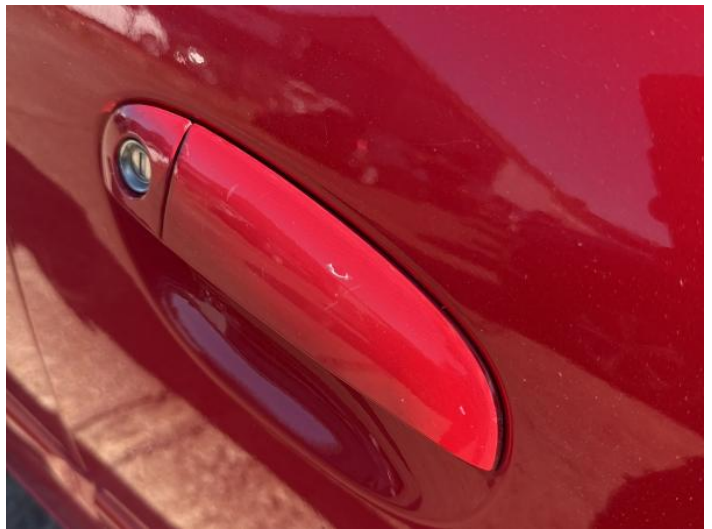
12: Door osf
Scratched
UpTo 25mm Thru Paint

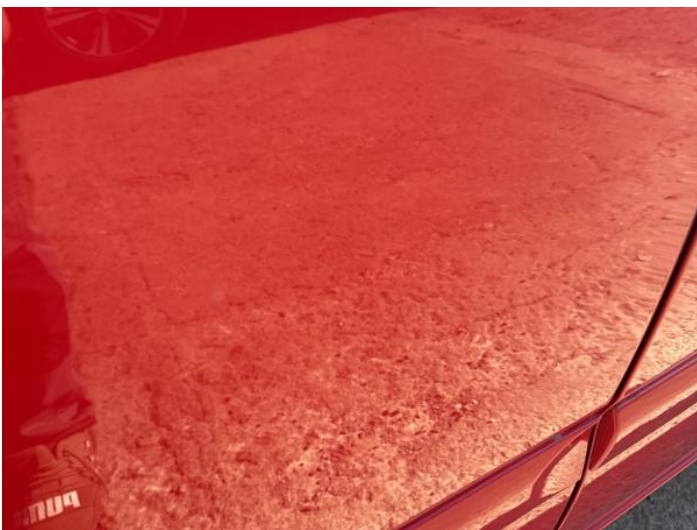
13: Door osr
Chipped
1 To 5

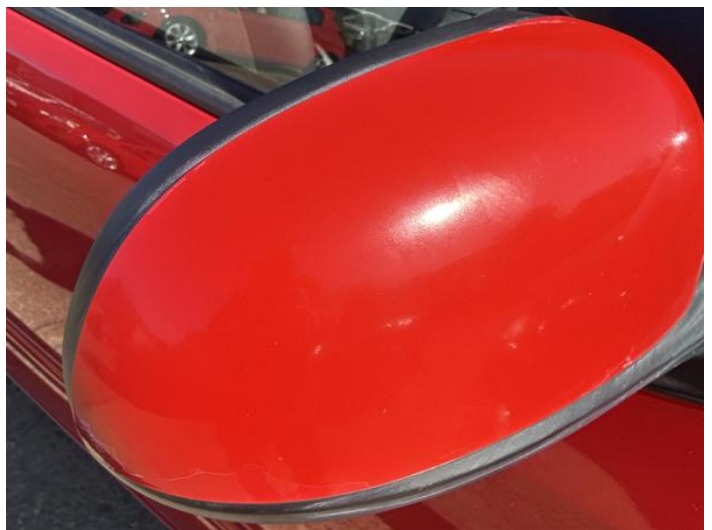
14: Door Mirror Assy osf
Scratched (Painted)
Over 25mm Thru Paint

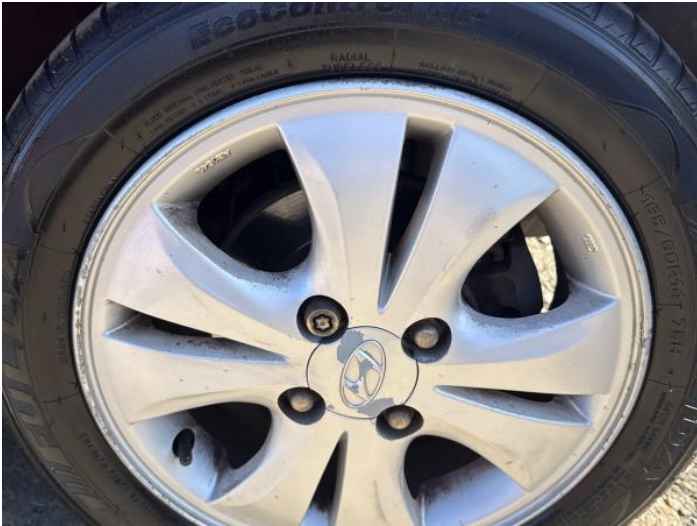
15: Wheel of
Scratched
Over 50mm

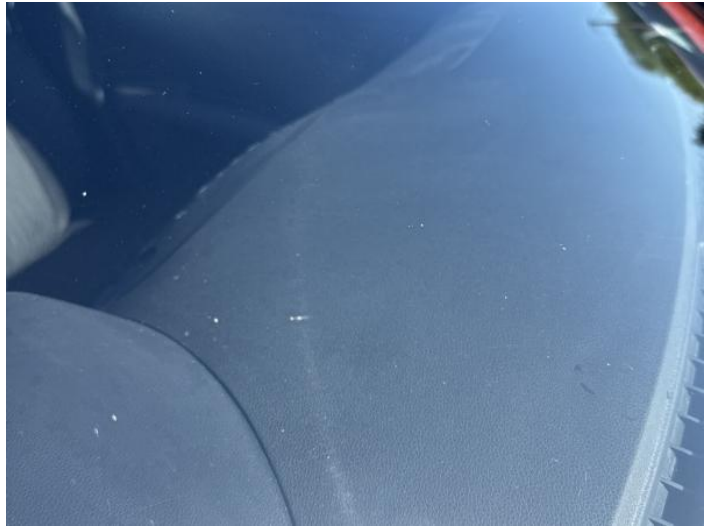
16: Screen Front
Chipped
UpTo 10mm

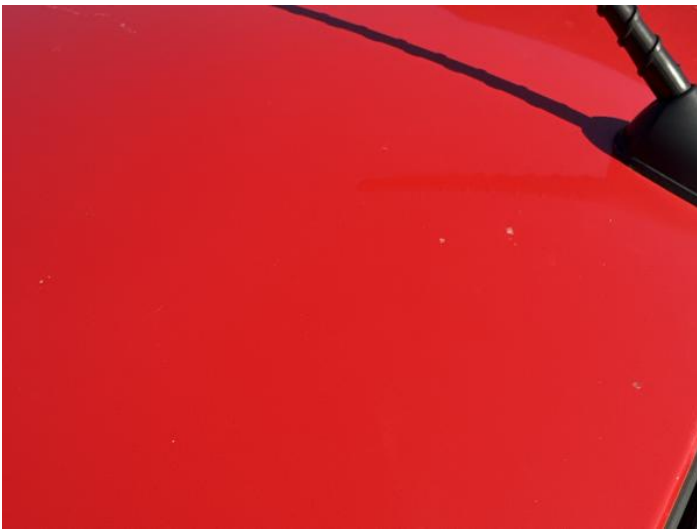
17: Roof
Chipped
1 To 5
