VEHICLE INSPECTION REPORT

GL12DYV

Skoda Octavia 1.4 TSI Elegance 5dr DSG

nama
GRADE
4

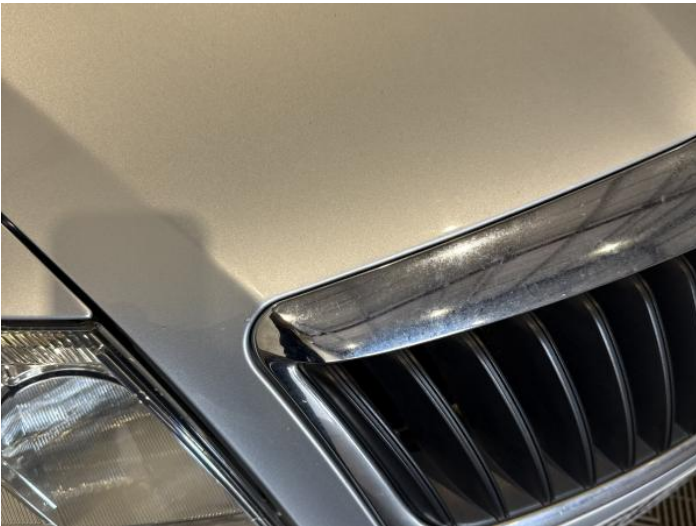
1: Bonnet
Chipped
Multiple Chips

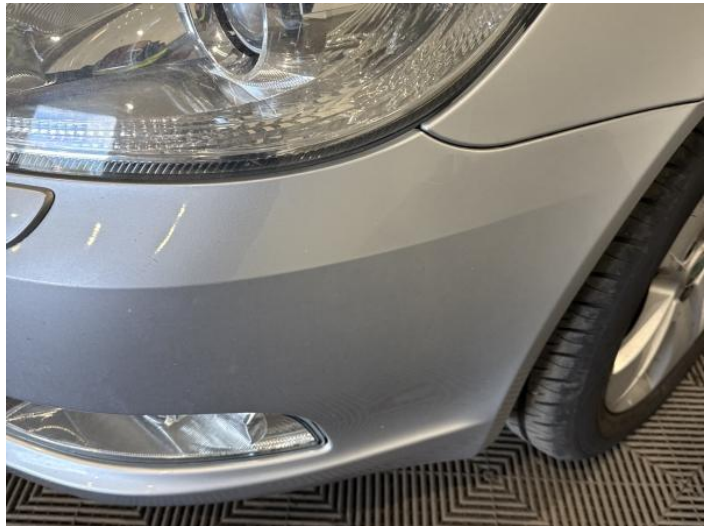
2: Bumper Front
Scratched
25 to 100mm Thru Paint

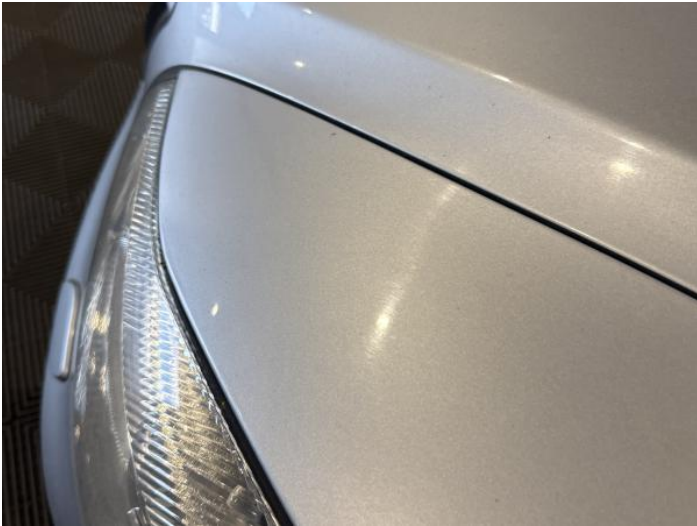
3: Wing nsf
Chipped
1 To 5

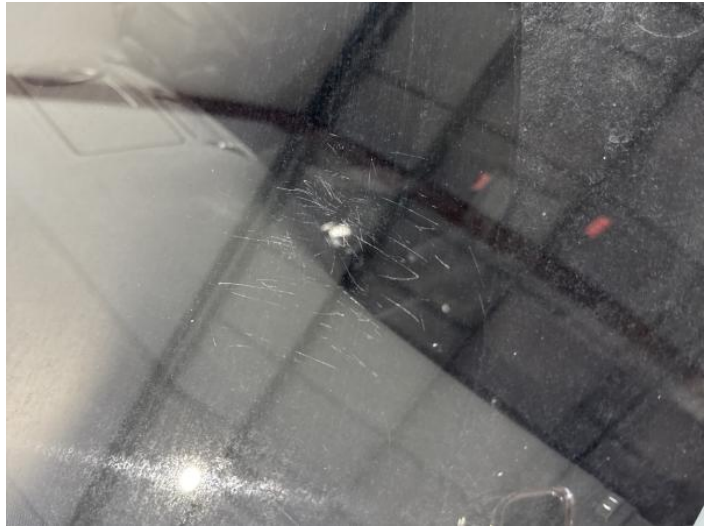
4: Screen Front
Scratched
Over 30mm

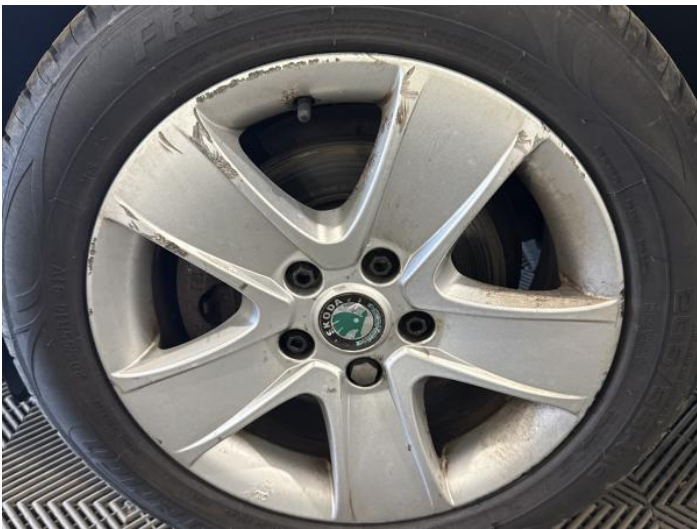
5: Wheel nsf
Scratched
Over 50mm

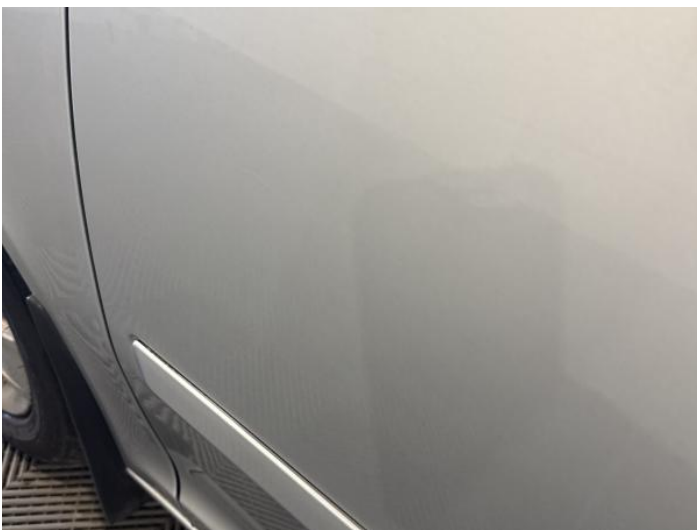
7: Door nsf
Scratched
Over 25mm Thru Paint

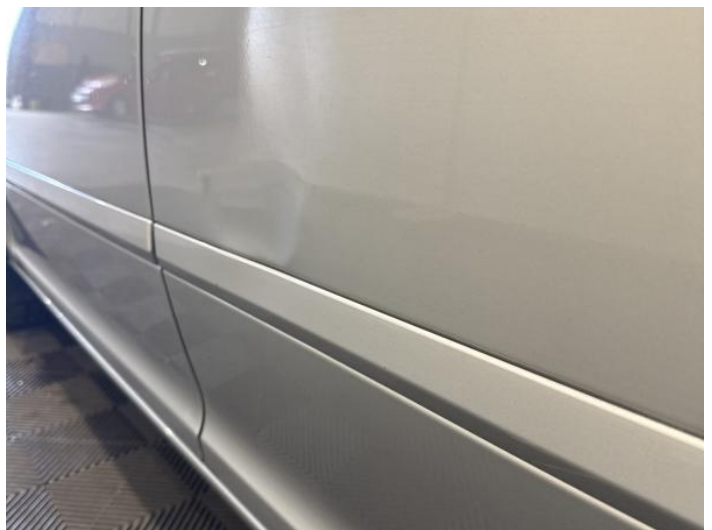
8: Door nsr
Dented
Over 30mm

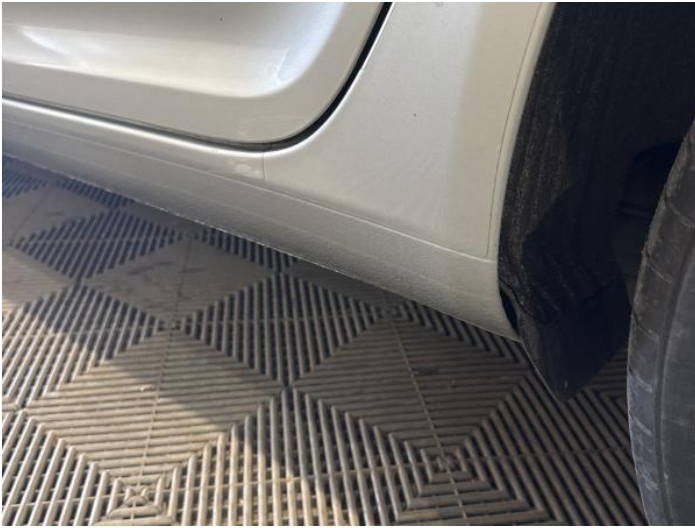
9: Sill ns
Scratched
Over 25mm Thru Paint

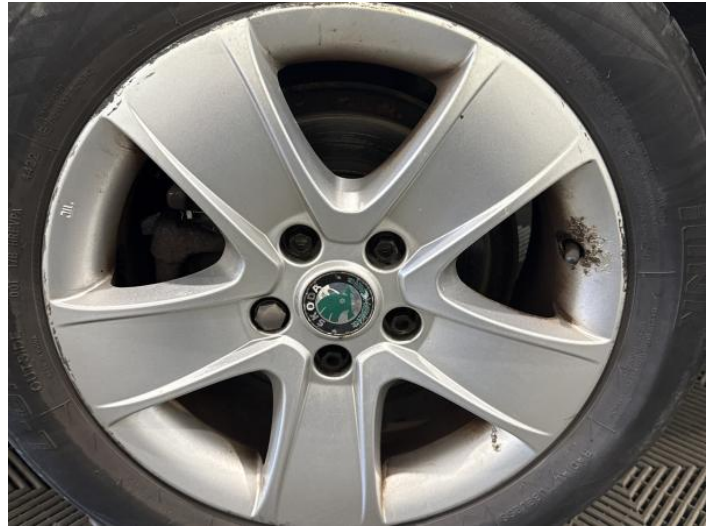
10: Wheel nsr
Scratched
Over 50mm

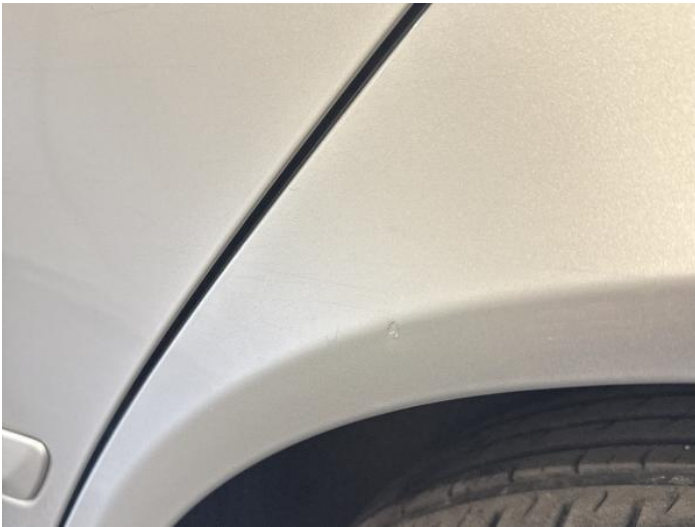
11: Qtr Panel nsr
Chipped
Over 5mm

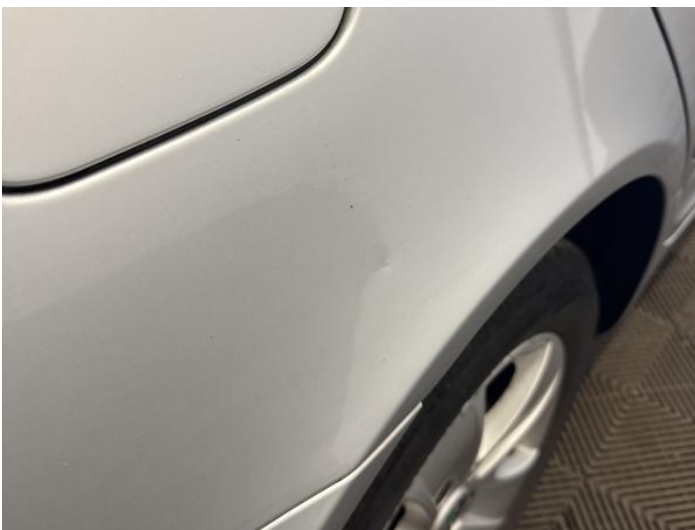
13: Qtr Panel osr
Dented
Between 10mm + 30mm

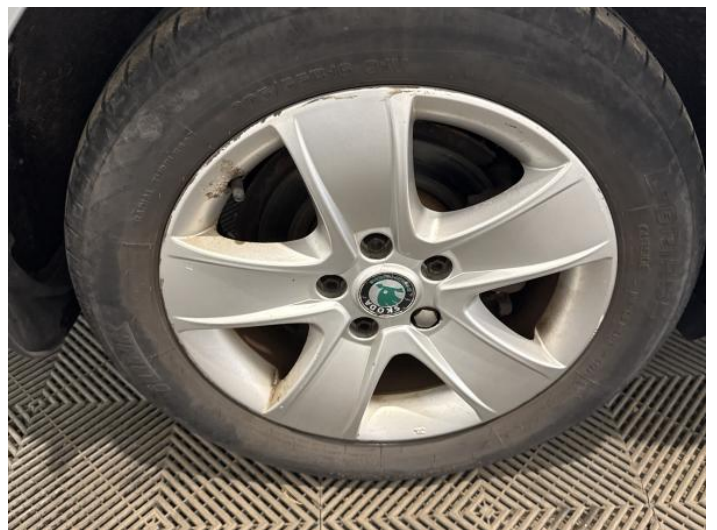
14: Wheel osr
Scratched
Over 50mm

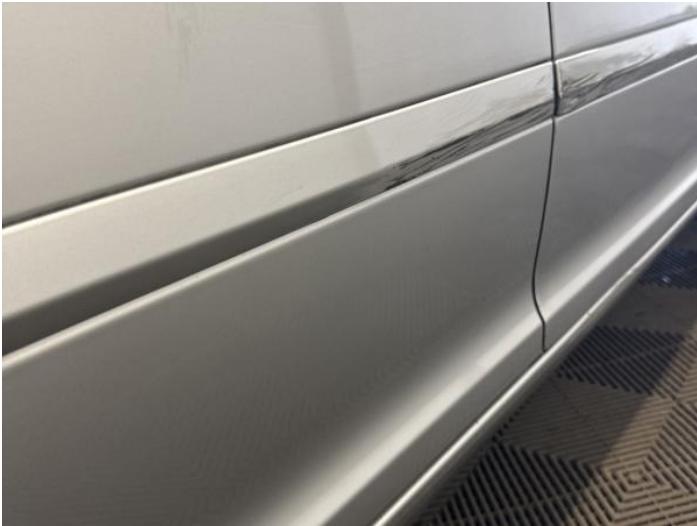
15: Door osr
Scratched
Over 25mm Thru Paint

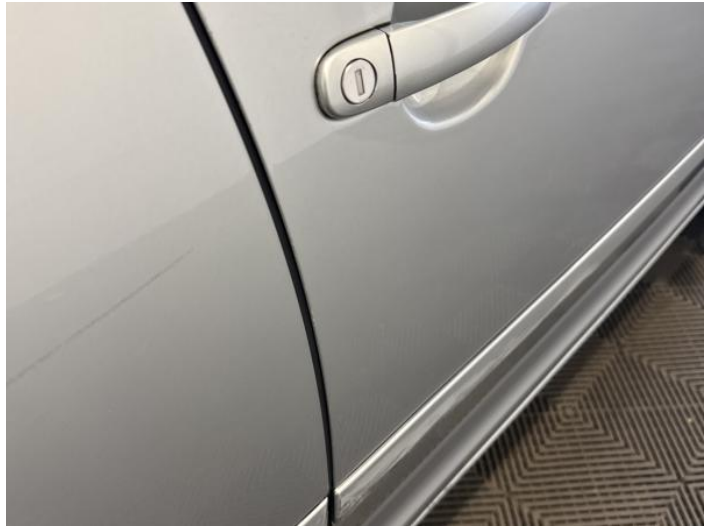
16: Door osf
Chipped
Edge Chip

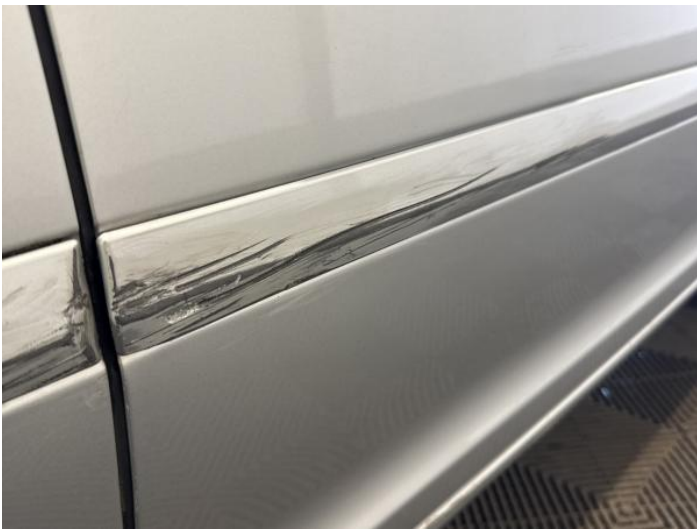
17: Door Moulding osf
Scratched (Painted)
Over 25mm Thru Paint

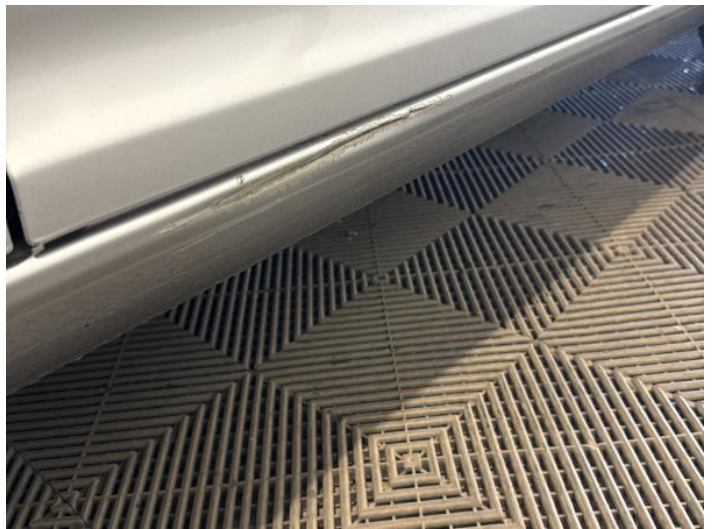
18: Sill ns
Dented
With Paint Damage

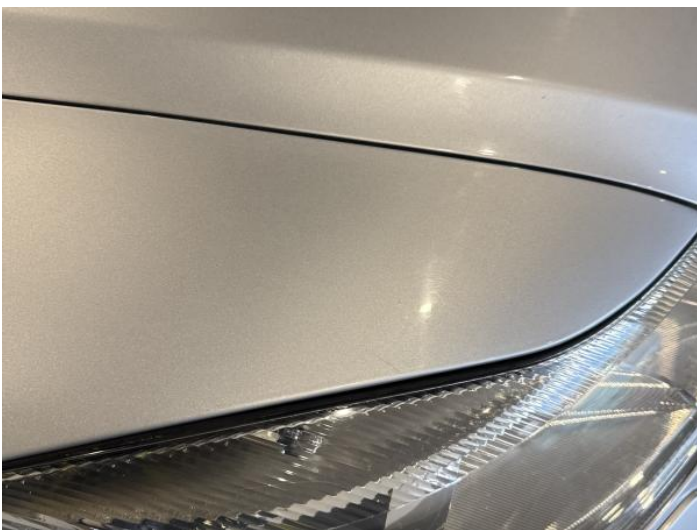
19: Wing osf
Chipped
1 To 5

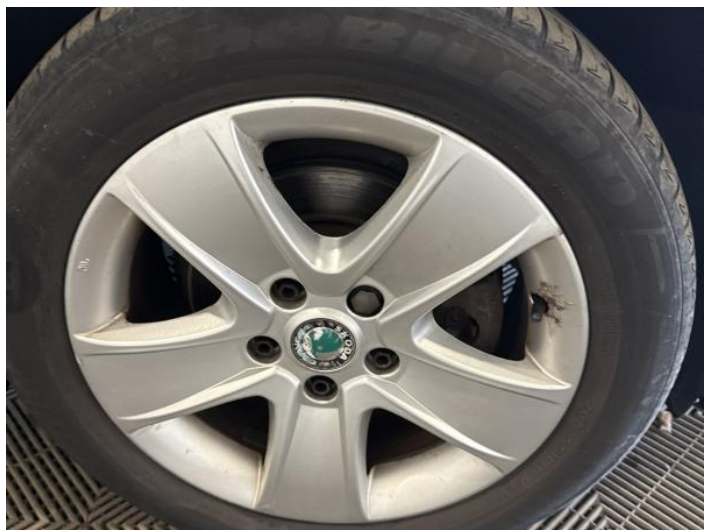
20: Wheel osf
Scratched
Over 50mm
