# VEHICLE INSPECTION REPORT

**GK14AEW**

## Kia Ceed 1.6 CRDi 3 EcoDynamics 5dr

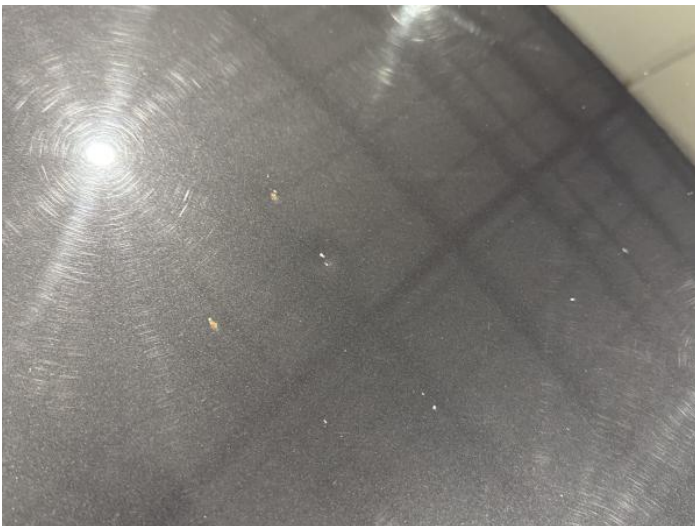
1: Bonnet  
Dented  
Between 10mm + 30mm

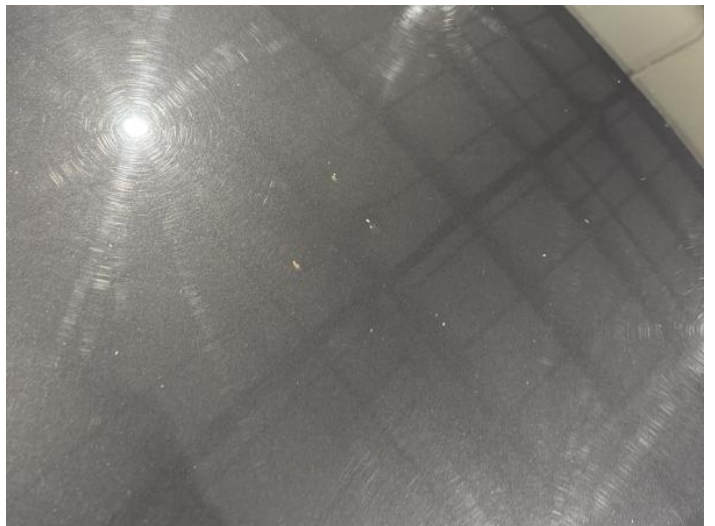
2: Bonnet  
Chipped  
Multiple Chips

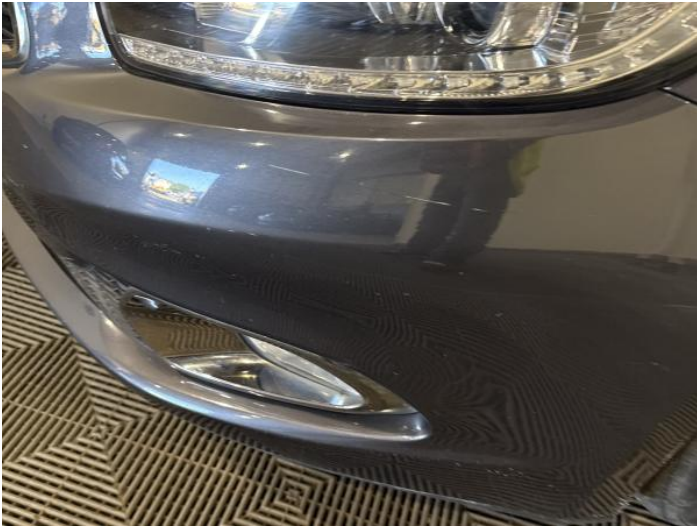
3: Bumper Front  
Scratched  
Over 100mm Thru Paint

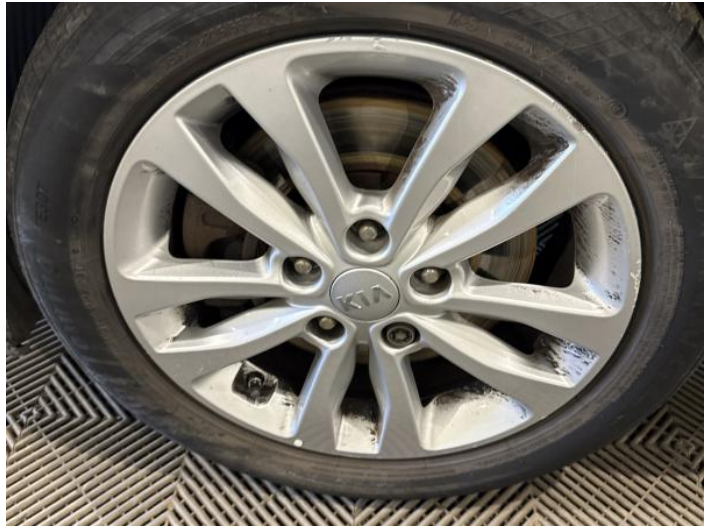
4: Wheel nsf  
Scratched  
Over 50mm

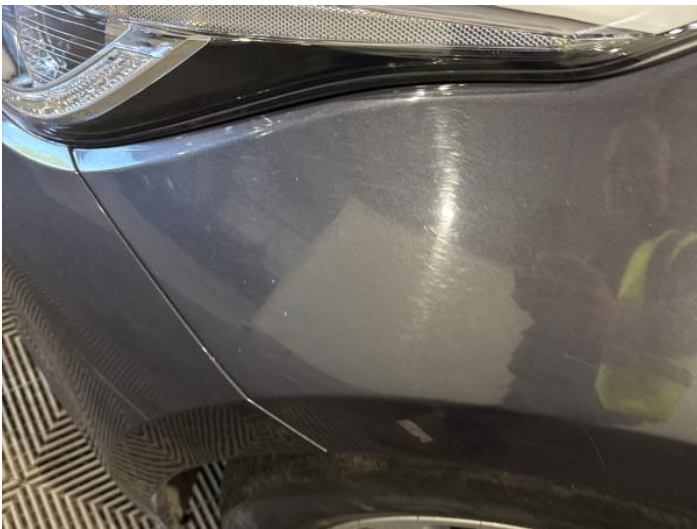
5: Wing nsf  
Chipped  
1 To 5

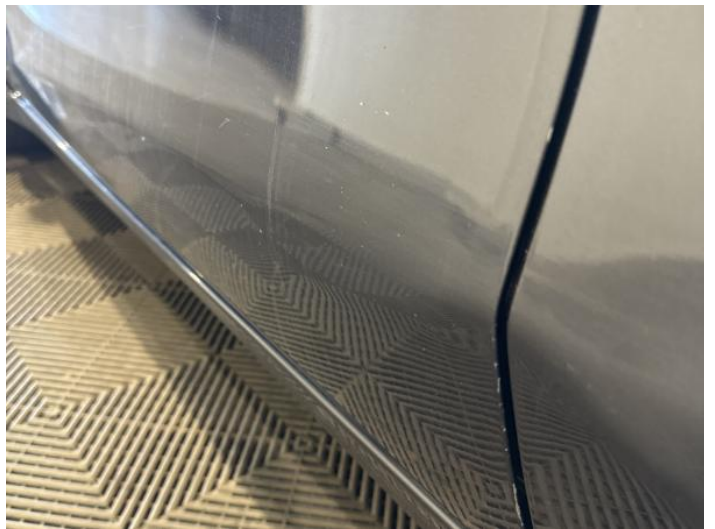
6: Door nsf  
Dented  
Over 30mm

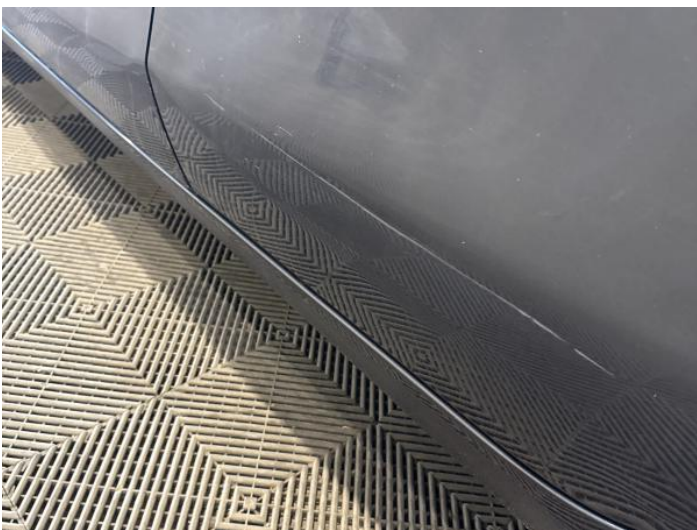
7: Door nsr  
Dented  
With Paint Damage

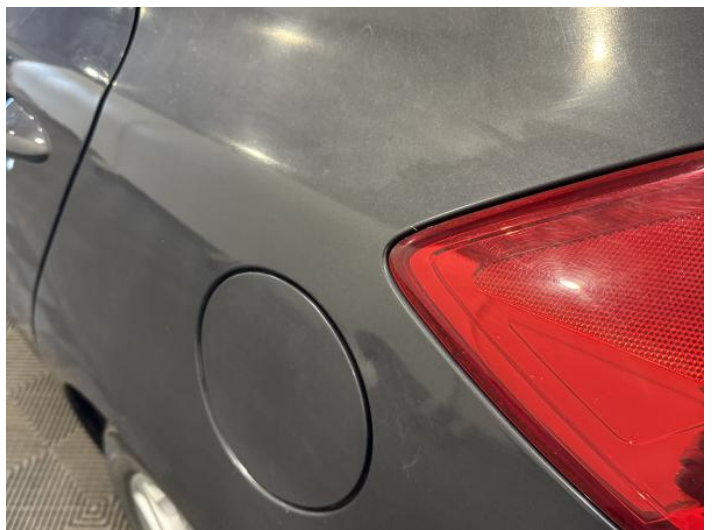
8: Qtr Panel nsr  
Dented  
With Paint Damage

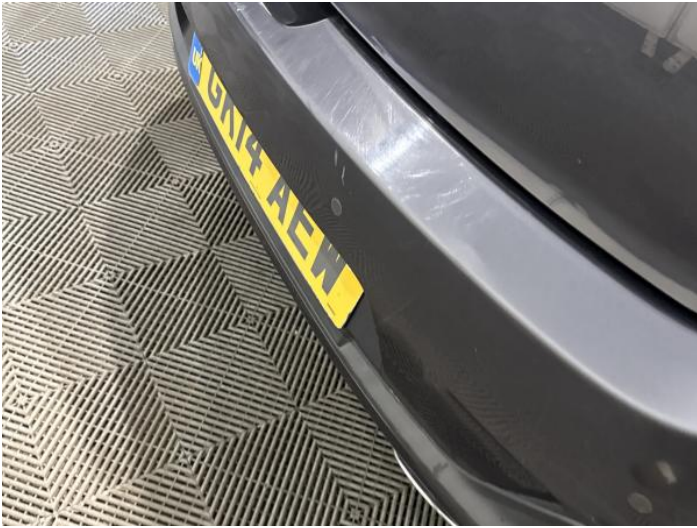
9: Bumper Rear  
Scratched  
25 to 100mm Thru Paint

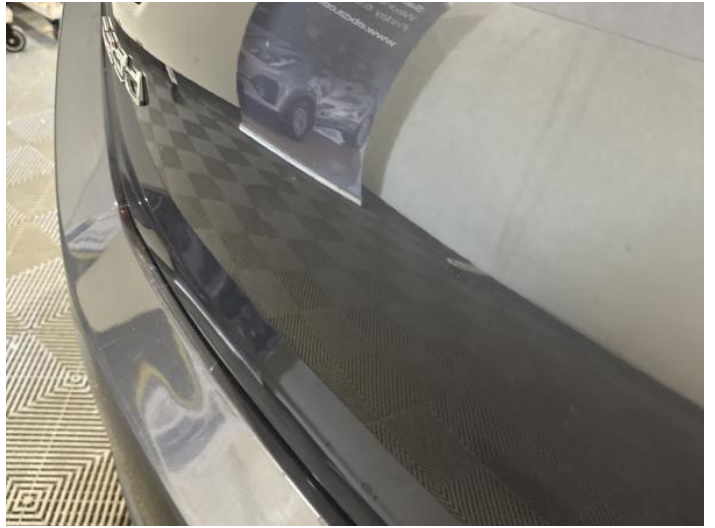
10: Tailgate  
Dented  
Between 10mm + 30mm

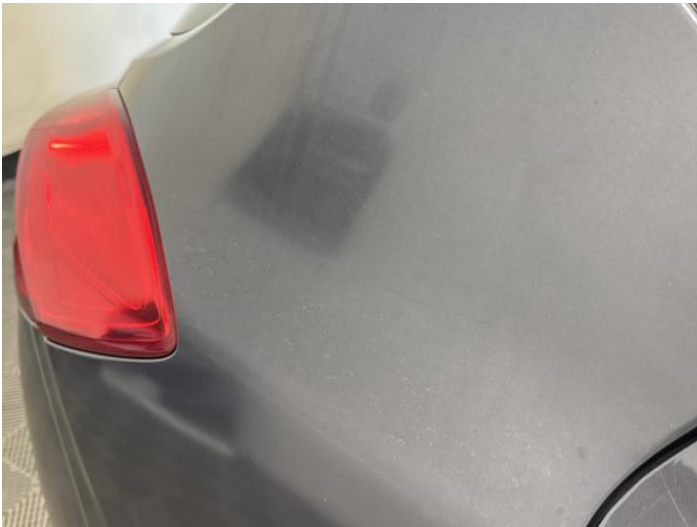
11: Qtr Panel osr  
Poor Previous Repair  
Poor Paint

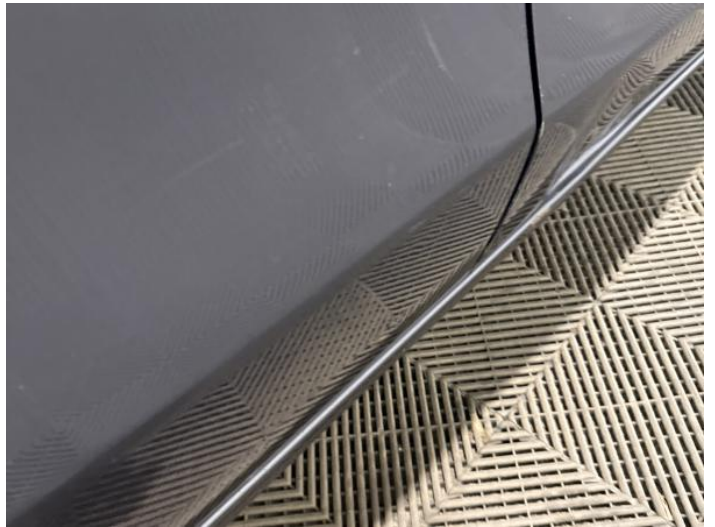
12: Door osr  
Scratched  
Over 25mm Thru Paint

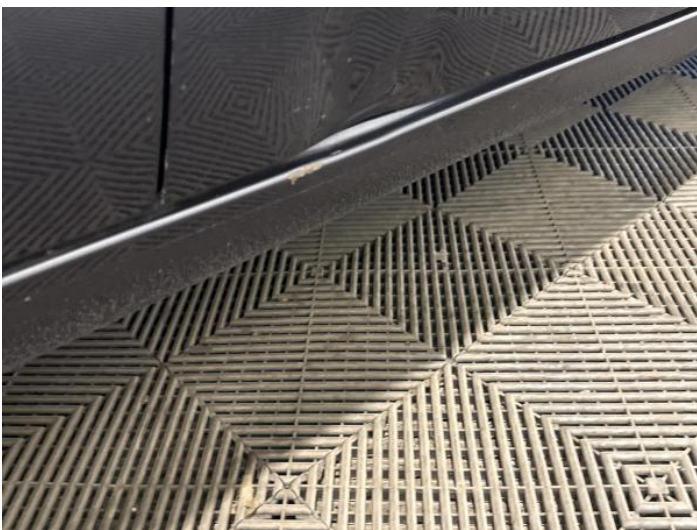
13: Sill os  
Scratched  
Over 25mm Thru Paint

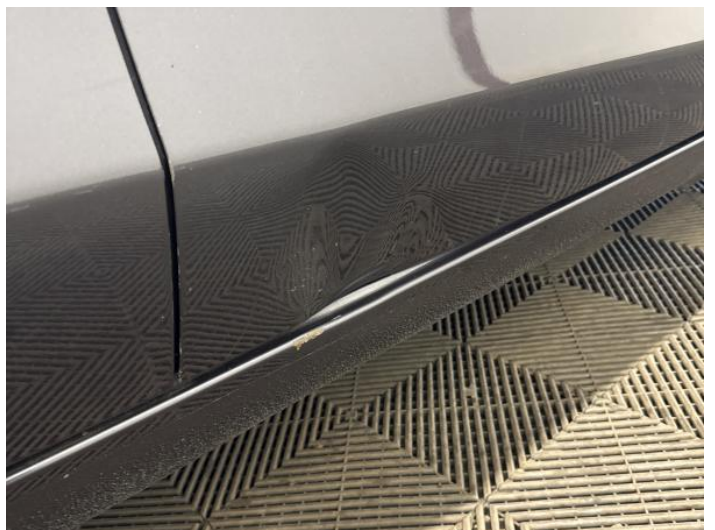
14: Door osf  
Dented  
Over 30mm

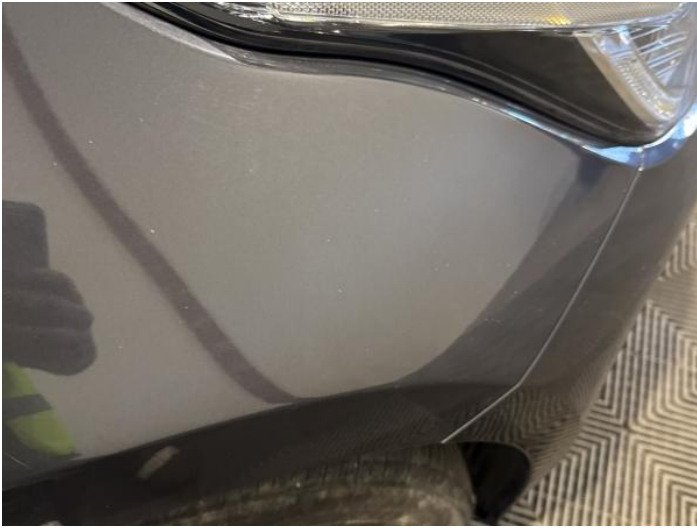
15: Wing osf  
Chipped  
Multiple Chips

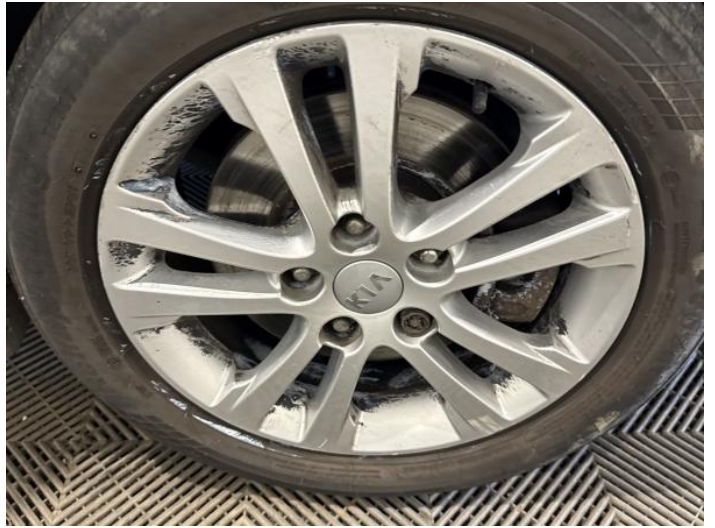
16: Wheel osf  
Scratched  
Over 50mm

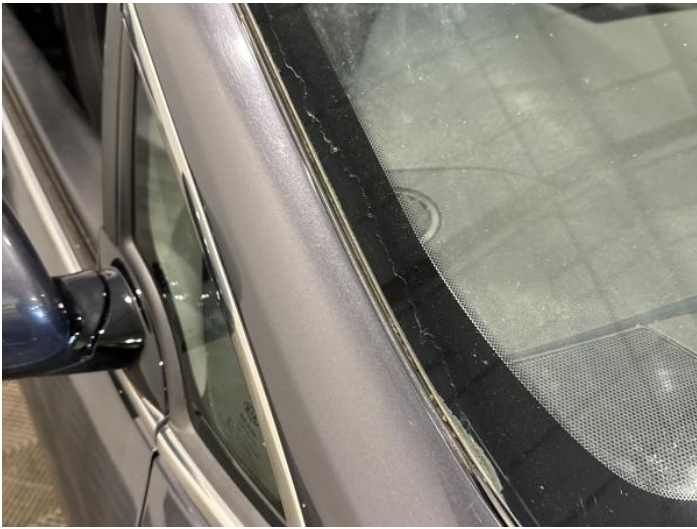
17: A Post os  
Scratched  
Over 25mm Thru Paint

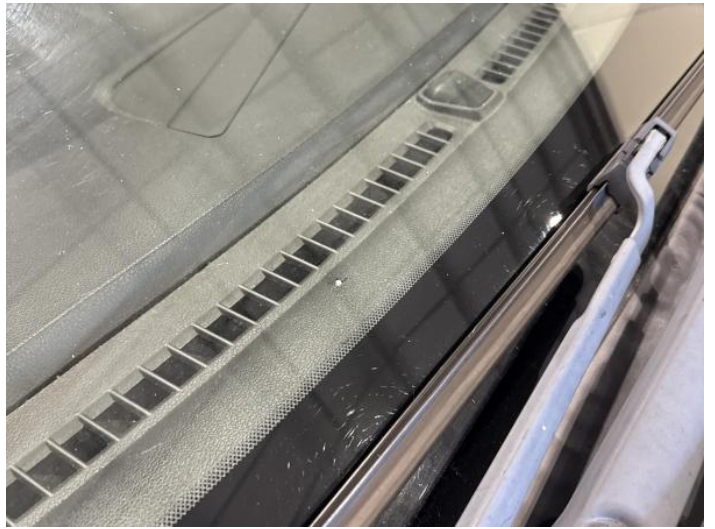
18: Screen Front  
Chipped  
Over 10mm

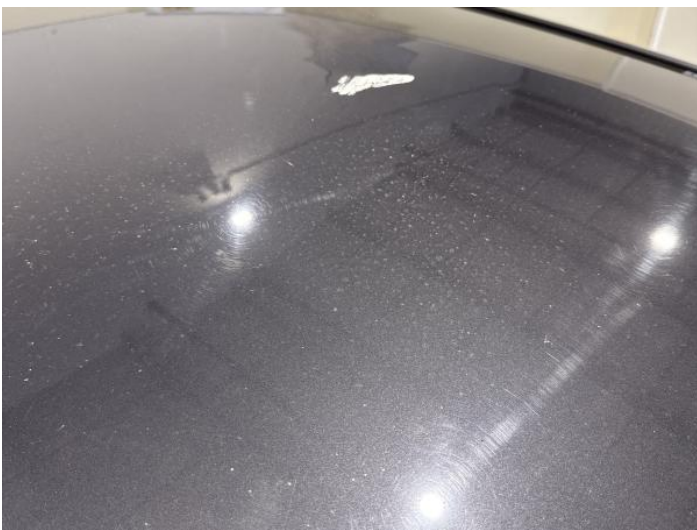
19: Roof  
Scratched  
Over 25mm Thru Paint

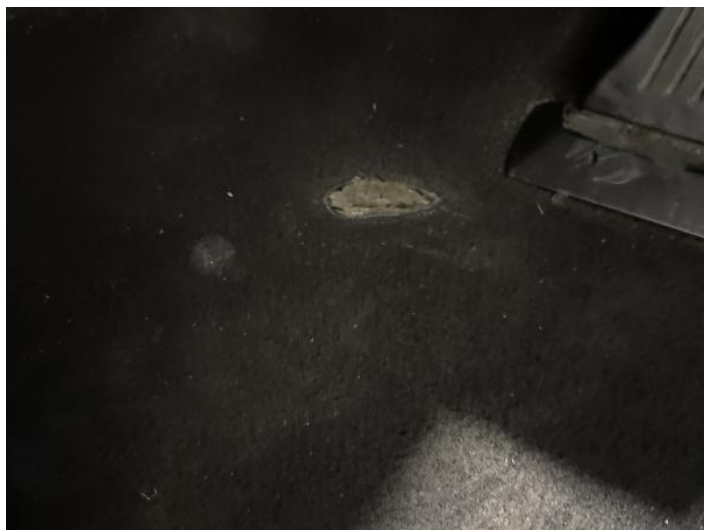
20: Carpets Front  
Holed  
Over 3mm
