VEHICLE INSPECTION REPORT

BV64FCD

Vauxhall Meriva 1.4i 16V Exclusiv 5dr

nama
GRADE
4

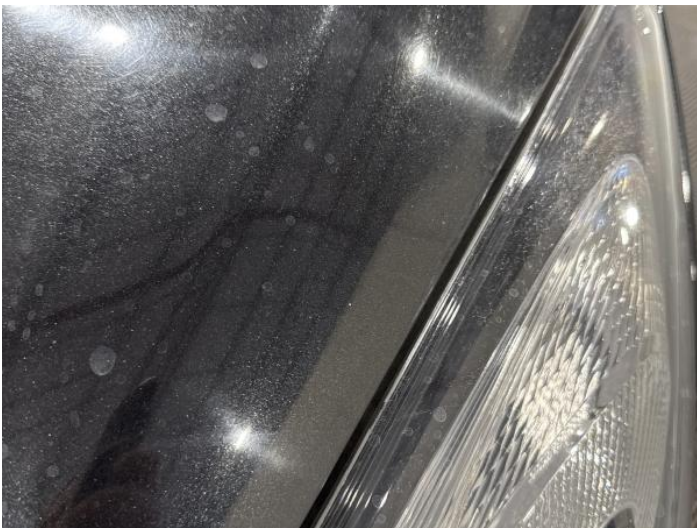
1: Bonnet
Chipped
1 To 5

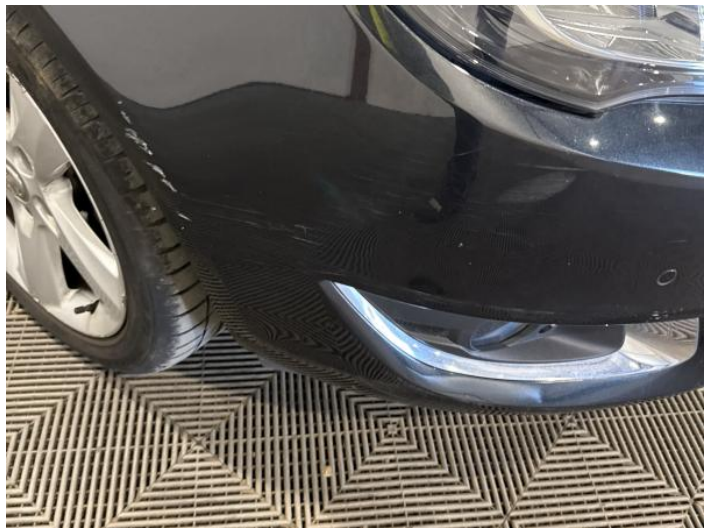
2: Bumper Front
Scratched
Over 100mm Thru Paint

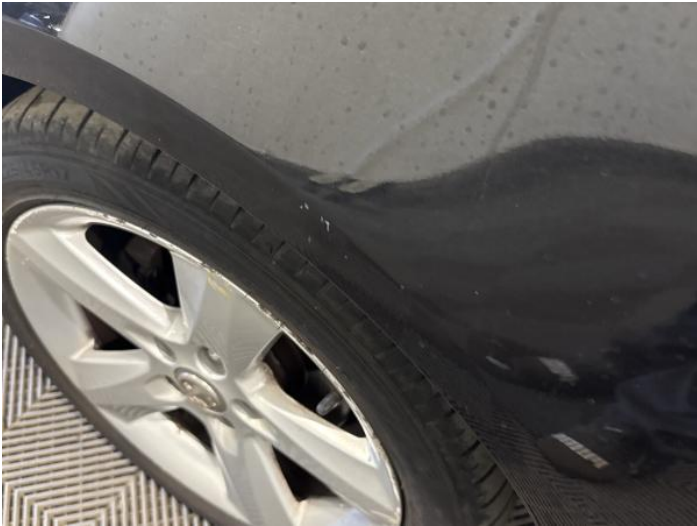
3: Wing nsf
Chipped
1 To 5

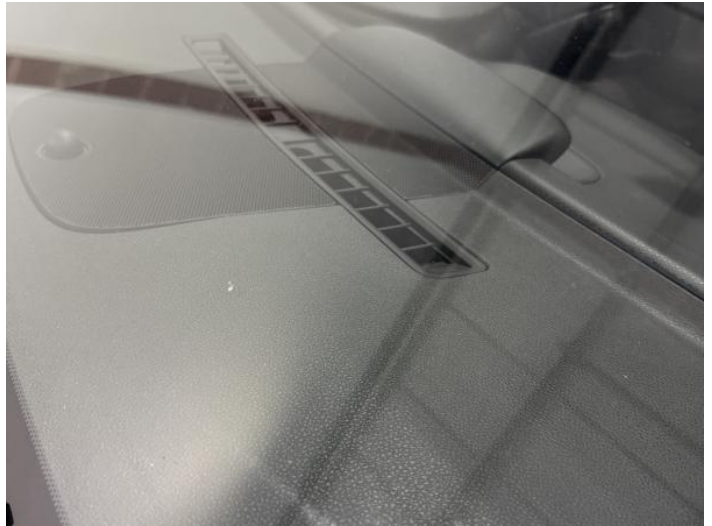
4: Screen Front
Chipped
UpTo 10mm

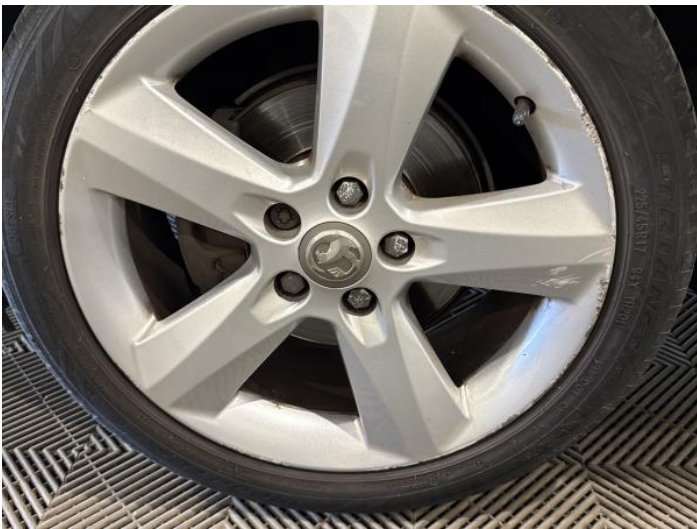
5: Wheel nsf
Scratched
Over 50mm

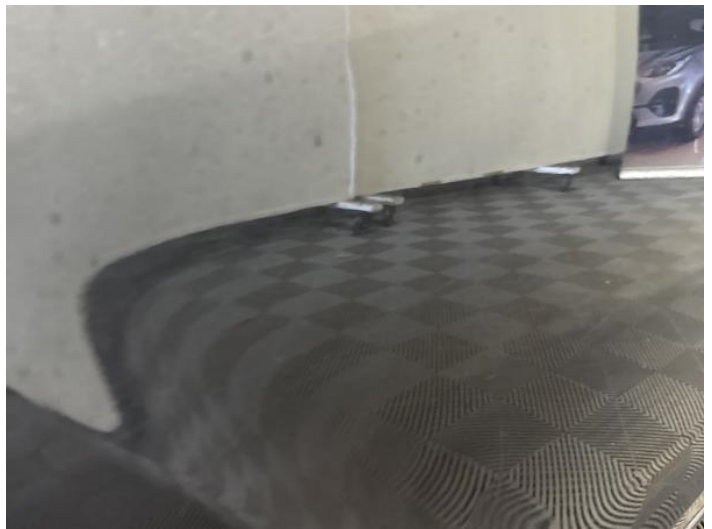
6: Door nsf
Dented
2 Or Less UpTo 10mm

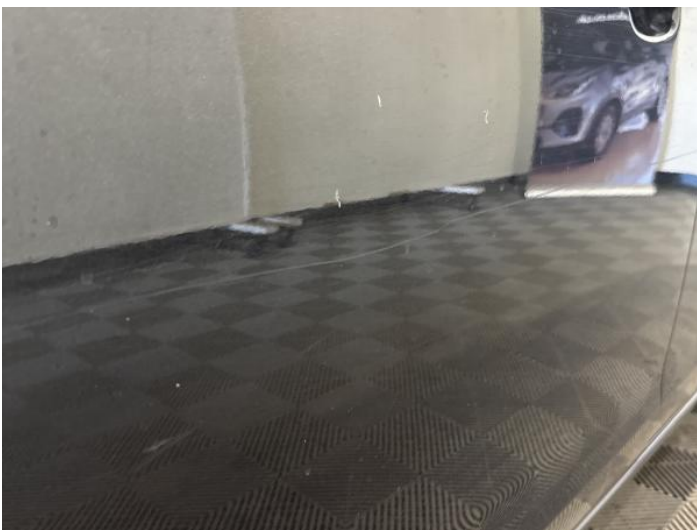
7: Door nsf
Scratched
Over 25mm Thru Paint

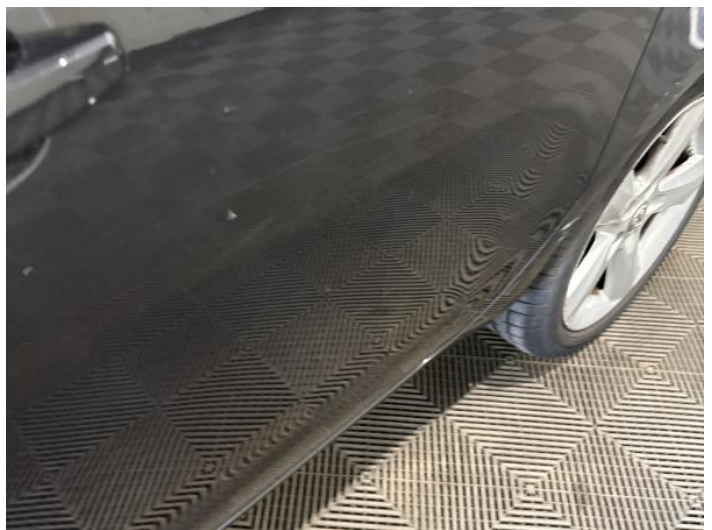
8: Door nsr
Scratched
Over 25mm Thru Paint

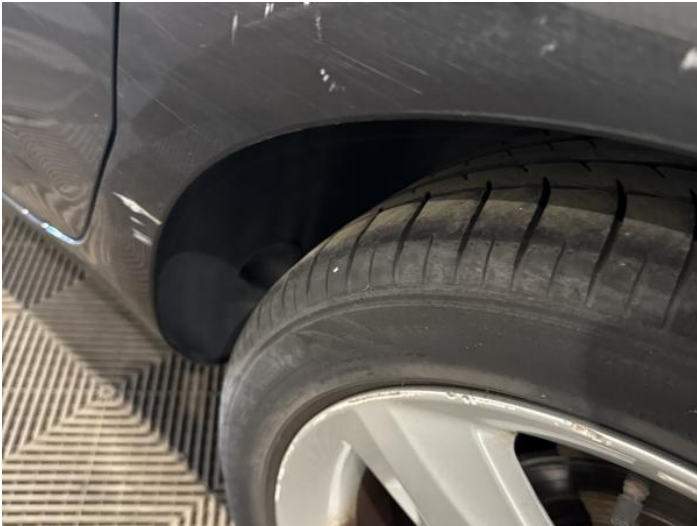
9: Qtr Panel nsr
Dented
With Paint Damage

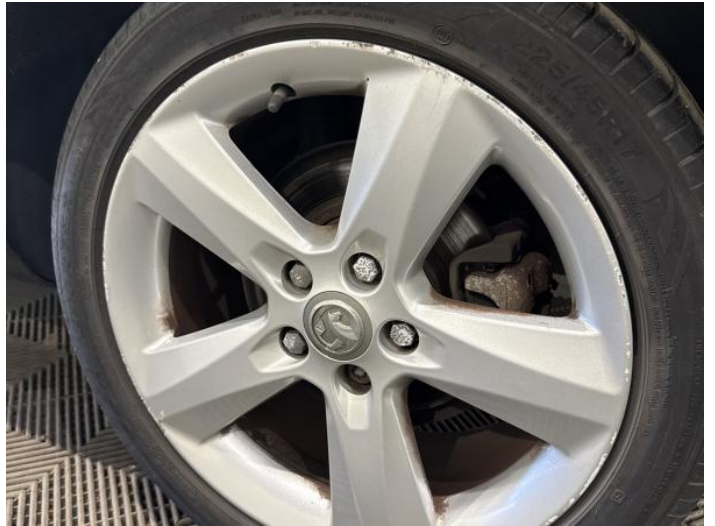
10: Wheel nsr
Scratched
Over 50mm

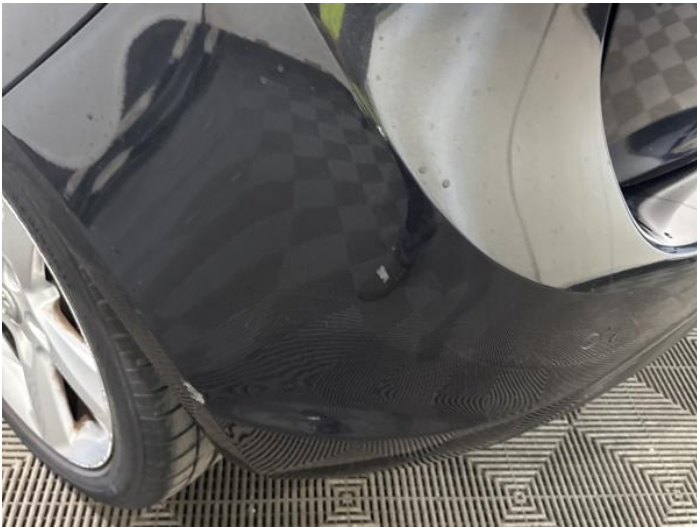
11: Bumper Rear
Scratched
25 to 100mm Thru Paint

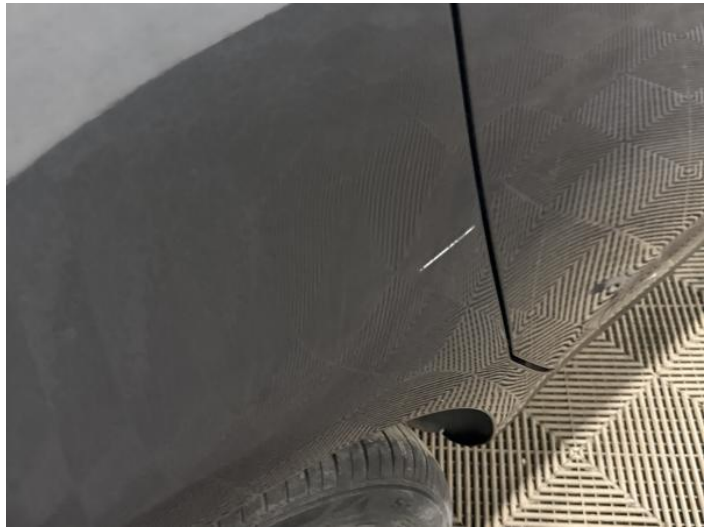
12: Qtr Panel osr
Scratched
Over 25mm Thru Paint

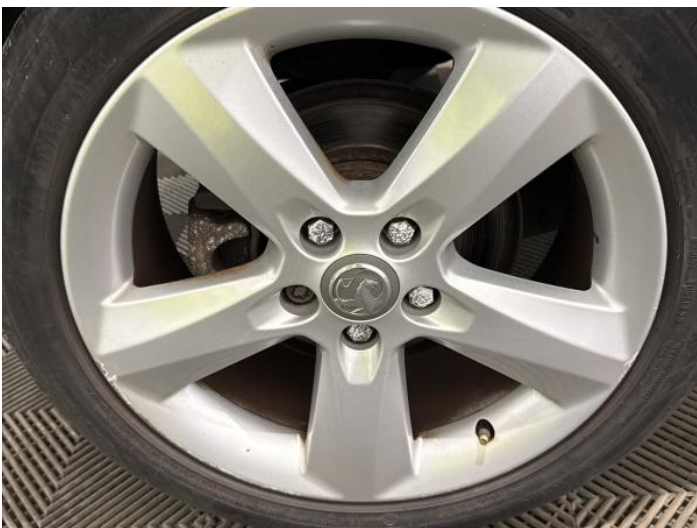
13: Wheel osr
Scratched
Over 50mm

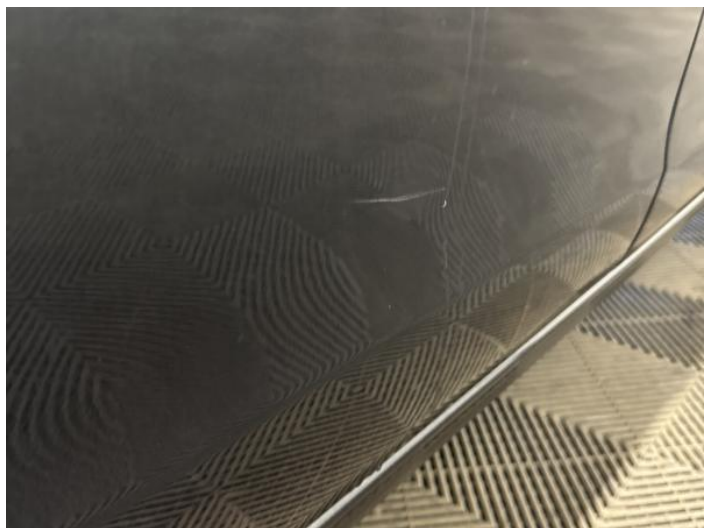
14: Door osr
Scratched
Over 25mm Thru Paint

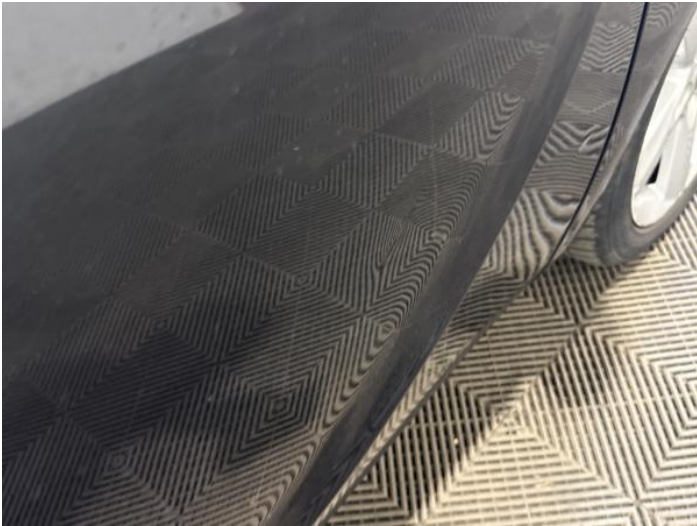
15: Door osf
Dented
With Paint Damage

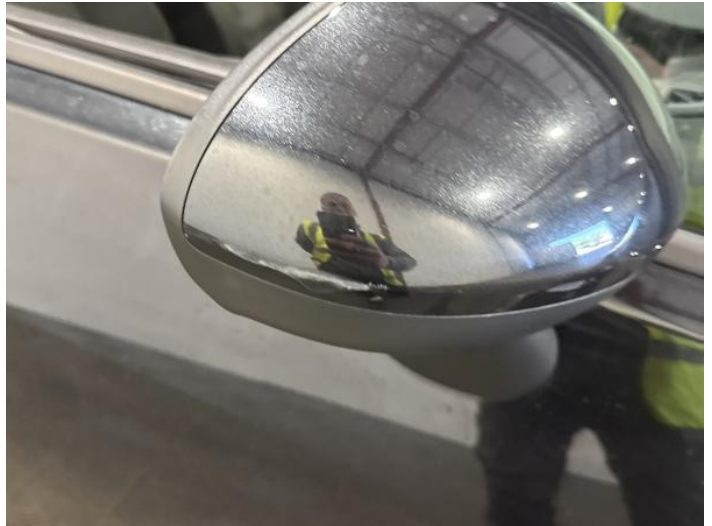
16: Door Mirror Assy osf
Scratched (Painted)
Over 25mm Thru Paint

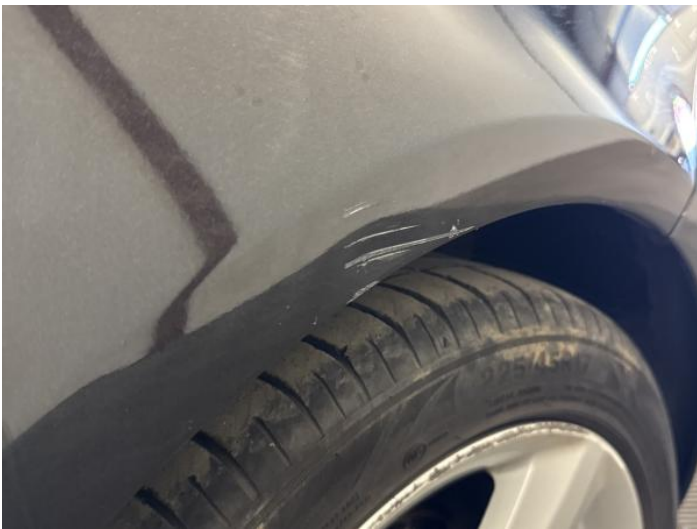
17: Wing osf
Scratched
Over 25mm Thru Paint

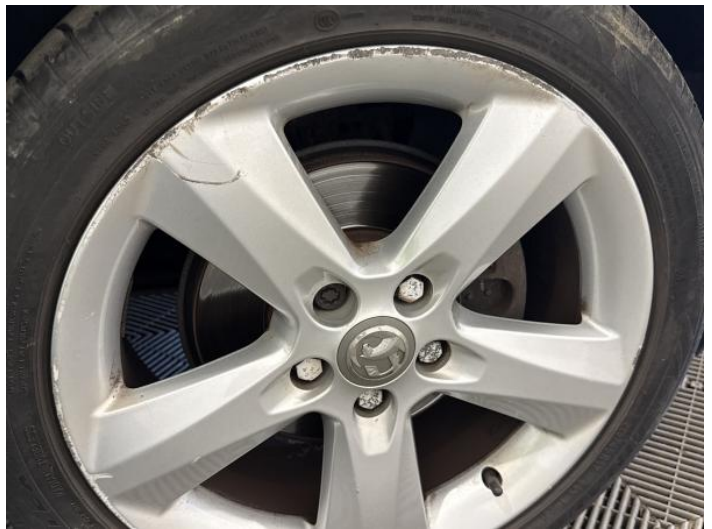
18: Wheel osf
Scratched
Over 50mm
