VEHICLE INSPECTION REPORT

GD08FBZ

Citroen C4 Grand Picasso 1.6HDi 16V SX 5dr EGS

nama
GRADE
4

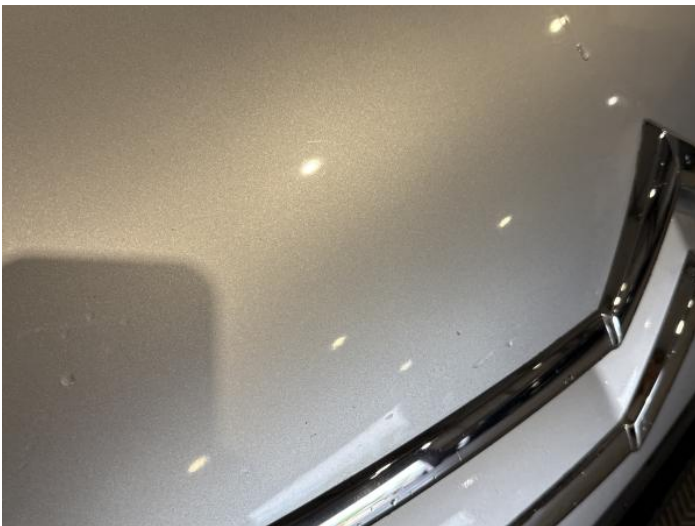
1: Bonnet
Chipped
1 To 5

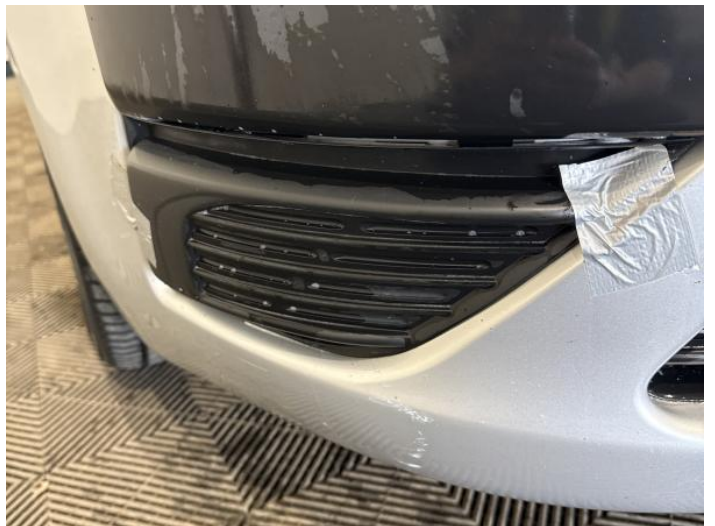
2: Bumper Front Moulding
Broken
Replace

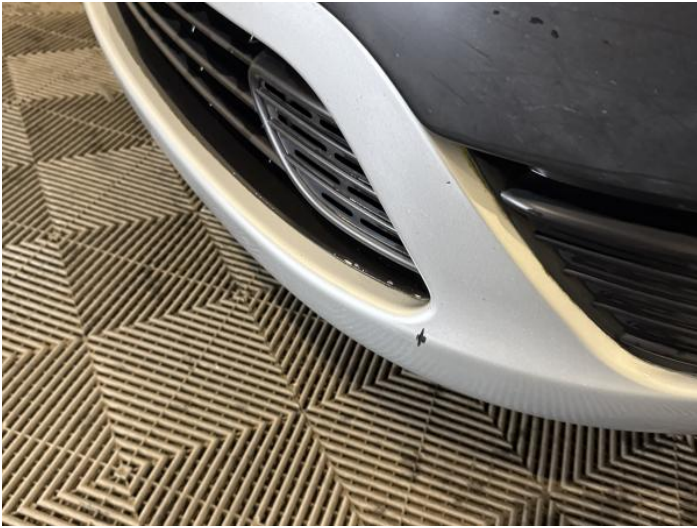
3: Bumper Front
Scratched
Over 100mm Thru Paint

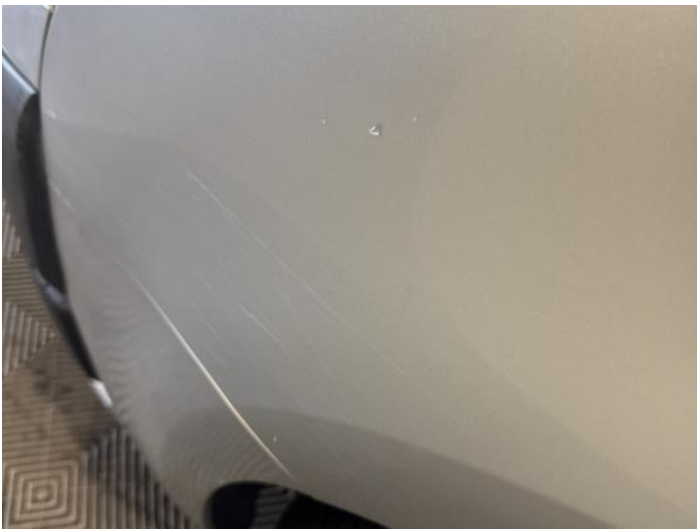
5: Wing nsf
Scratched
Over 25mm Thru Paint

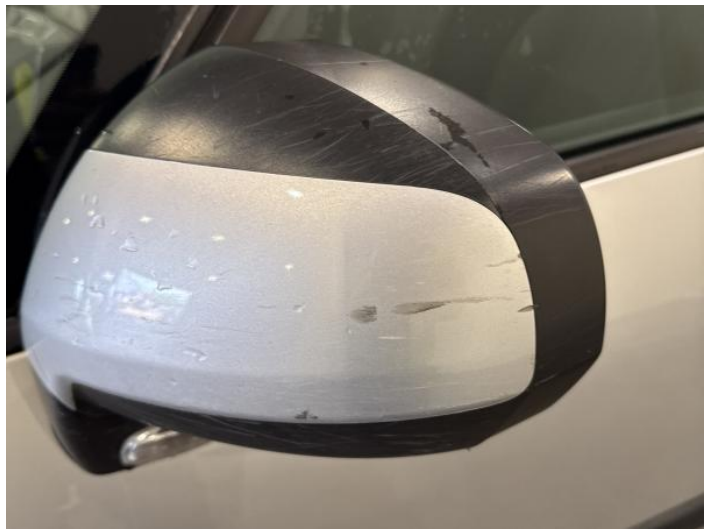
6: Door Mirror Assy nsf
Scratched (Painted)
Over 25mm Thru Paint

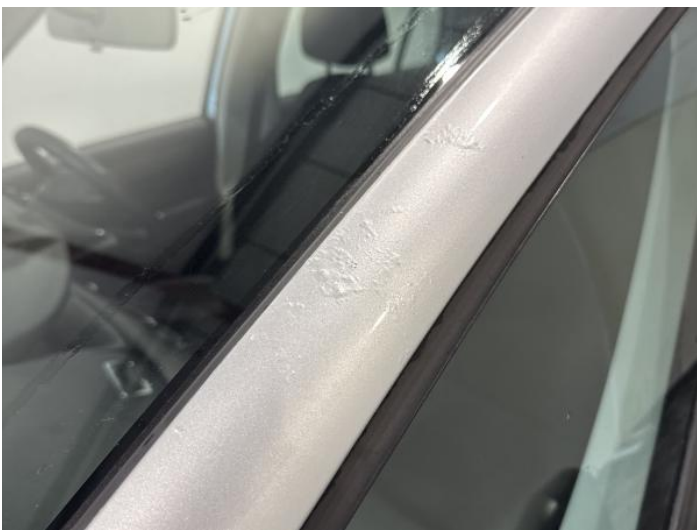
7: A Post ns
Rusted
Over 5mm

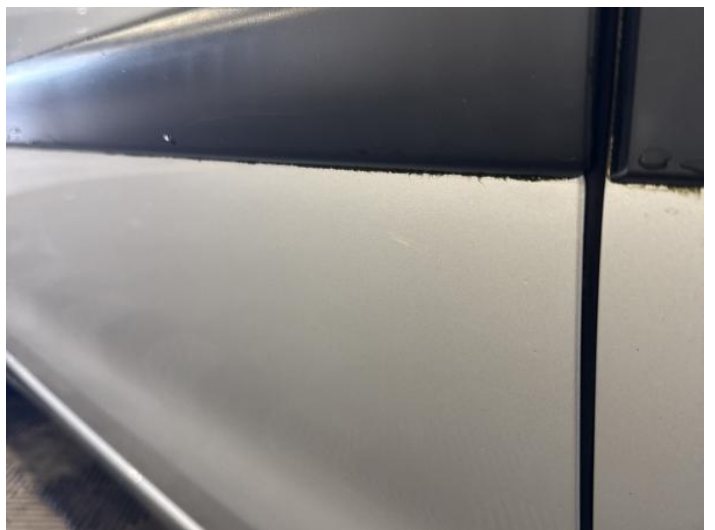
8: Door nsf
Scratched
UpTo 25mm Thru Paint

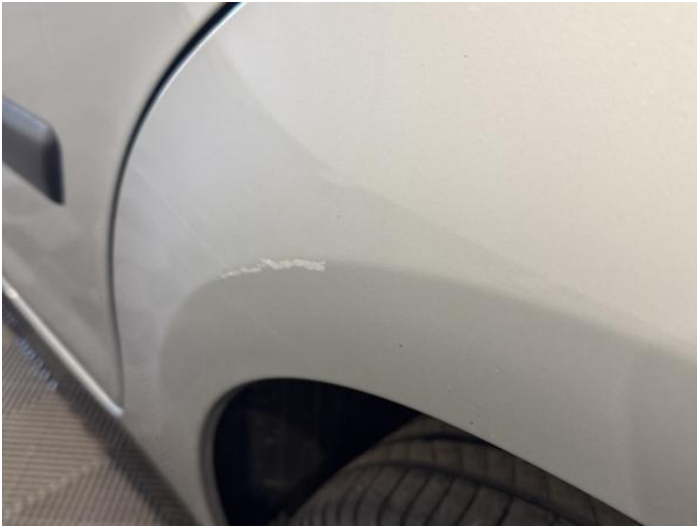
9: Qtr Panel nsr
Scratched
Over 25mm Thru Paint

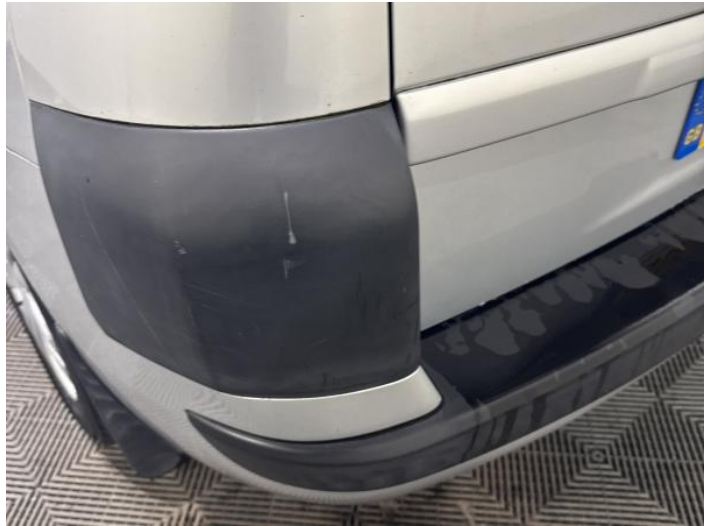
10: Bumper Rear Moulding
Scuffed (Unpainted)
UpTo 100mm

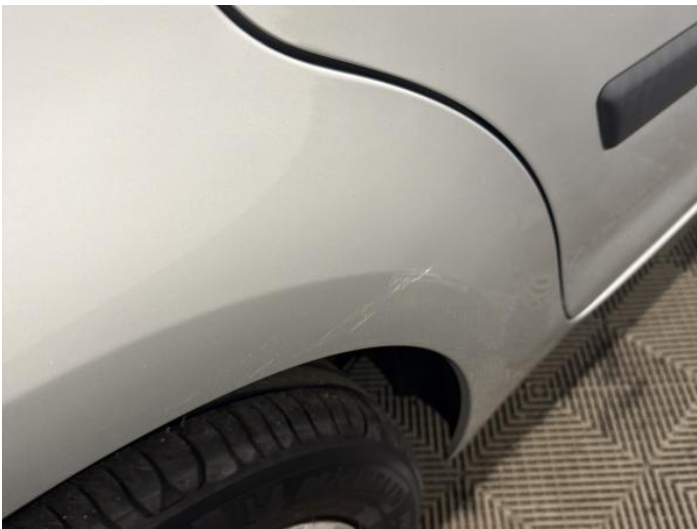
11: Qtr Panel osr
Scratched
Over 25mm Thru Paint

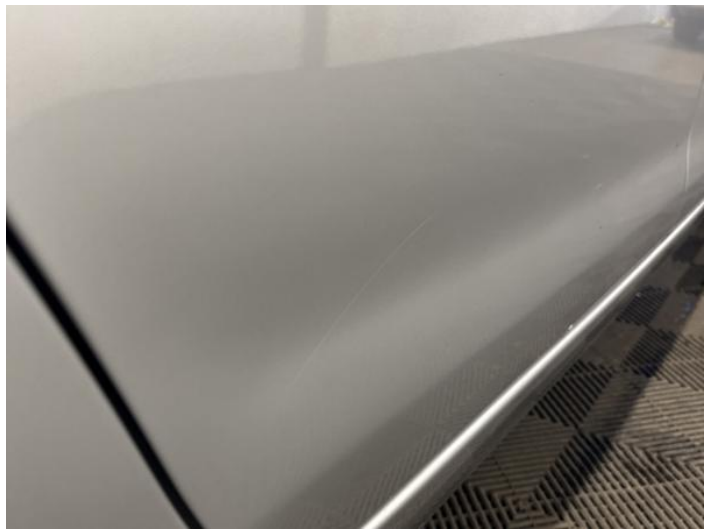
12: Door osr
Scratched
Over 25mm Thru Paint

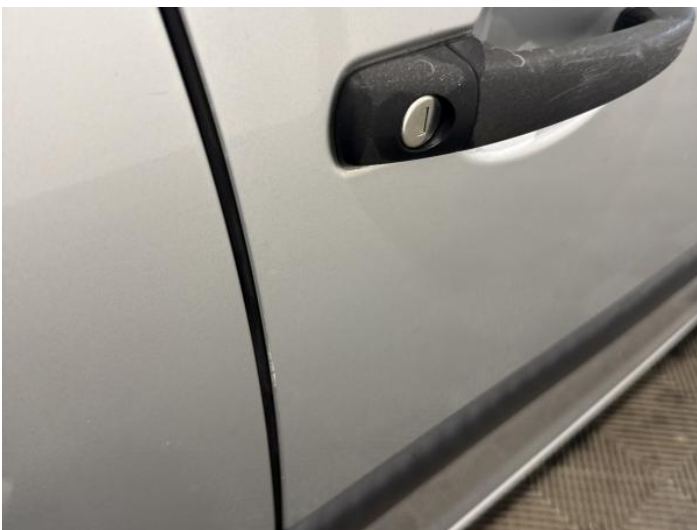
13: Door osf
Chipped
Edge Chip

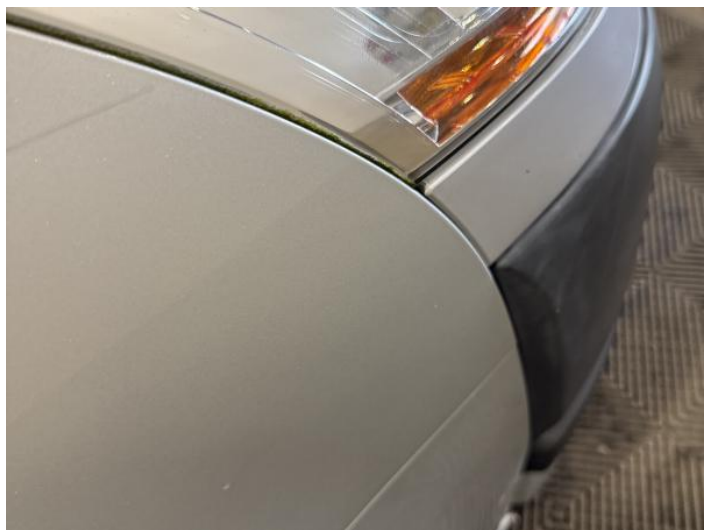
14: Wing osf
Chipped
1 To 5

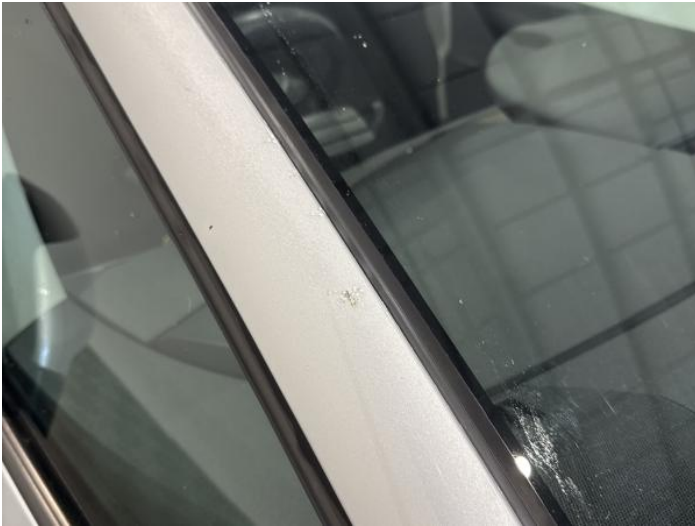
15: A Post os
Rusted
Over 5mm

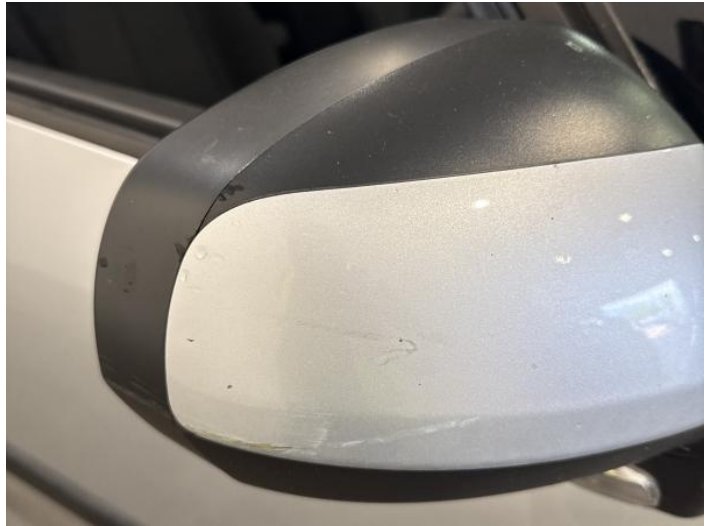
16: Door Mirror Assy osf
Scratched (Painted)
Over 25mm Thru Paint

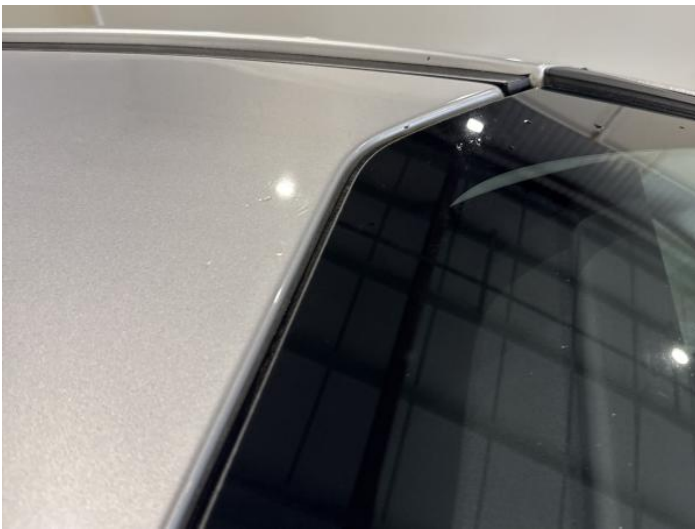
17: Roof
Chipped
Edge Chip

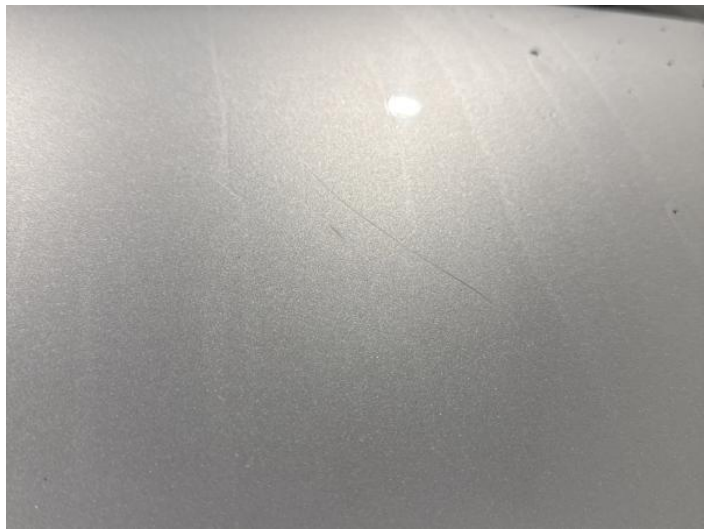
18: Tailgate
Scratched
Over 25mm Thru Paint
