# VEHICLE INSPECTION REPORT

**WF56CDE**

## Vauxhall Astra 1.4i 16V SXi 3dr

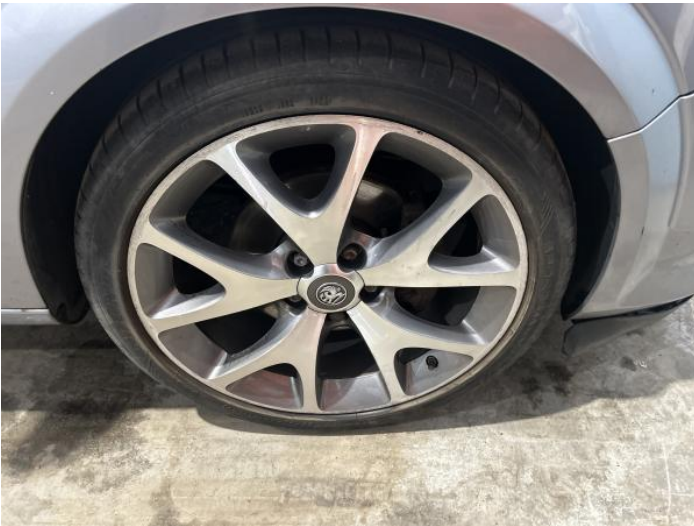
1: Wheel osf  
Scratched  
Over 50mm

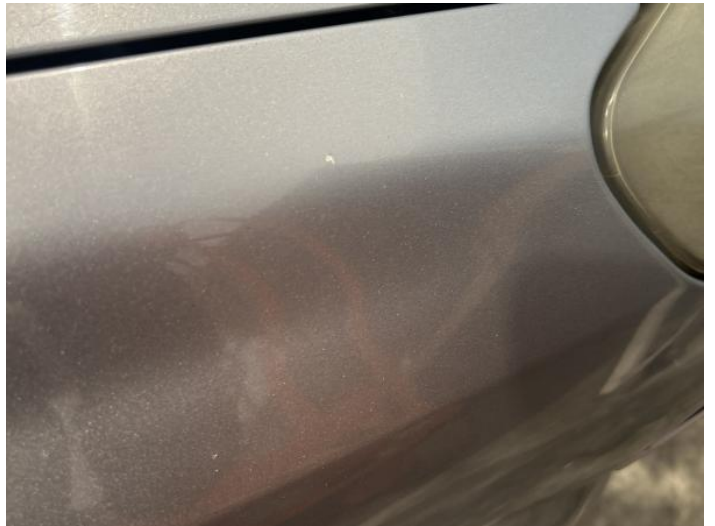
2: Wing osf  
Chipped  
1 To 5

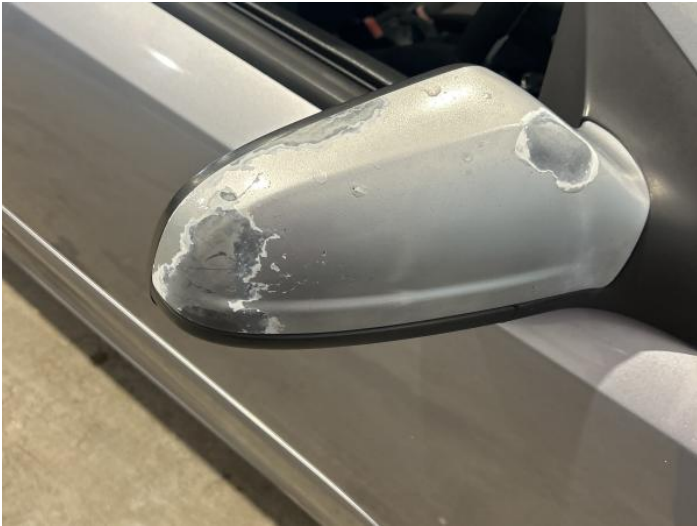
3: Door Mirror Assy osf  
Scratched (Painted)  
Over 25mm Thru Paint

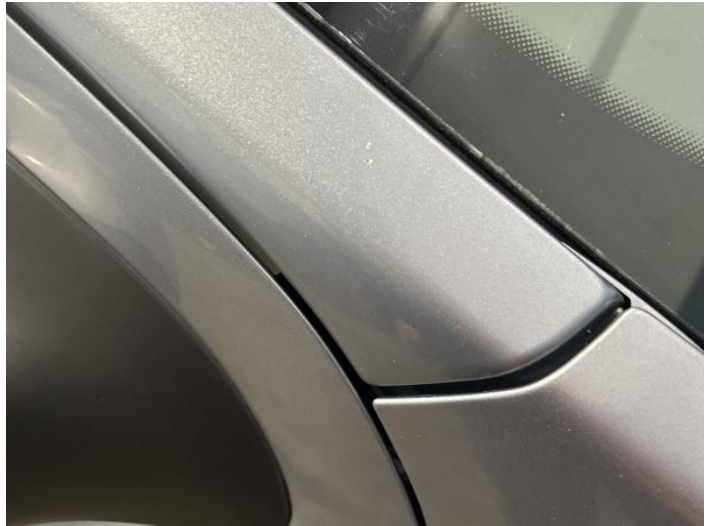
4: A Post os  
Chipped  
1 To 5

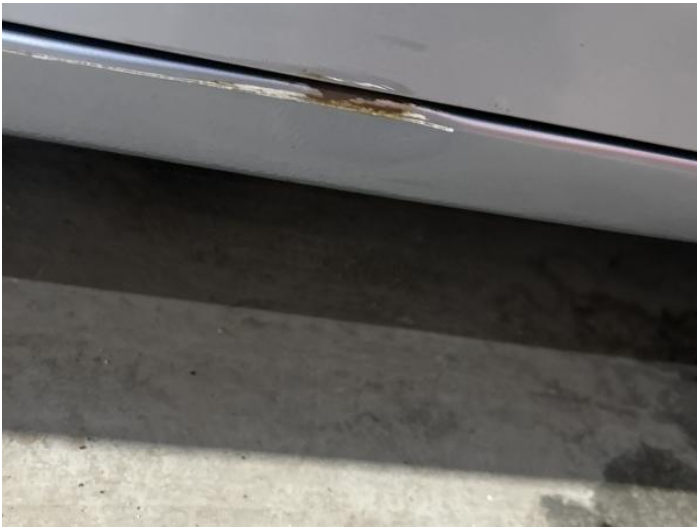
5: Sill os  
Dented  
With Paint Damage

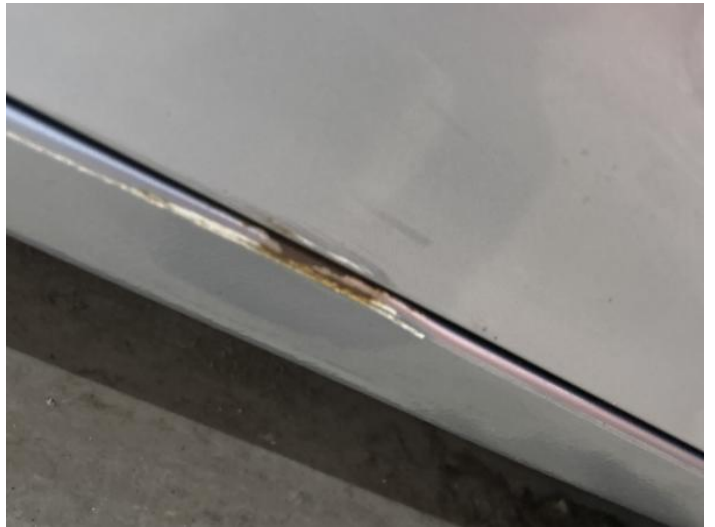
6: Door osf  
Scratched  
UpTo 25mm Thru Paint

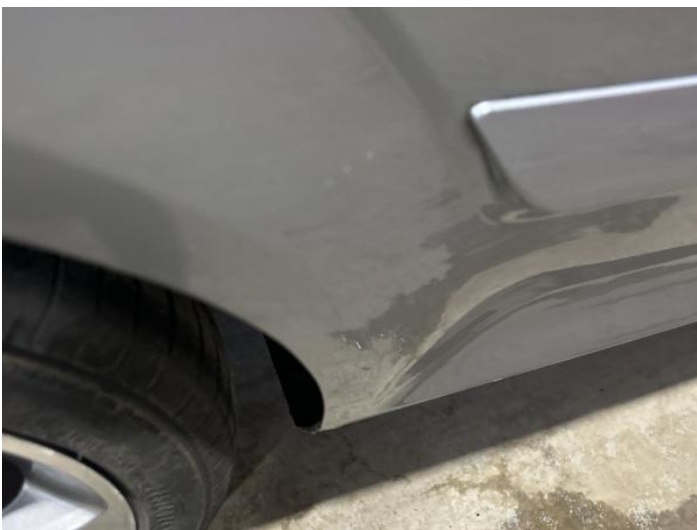
7: Qtr Panel osr  
Chipped  
1 To 5

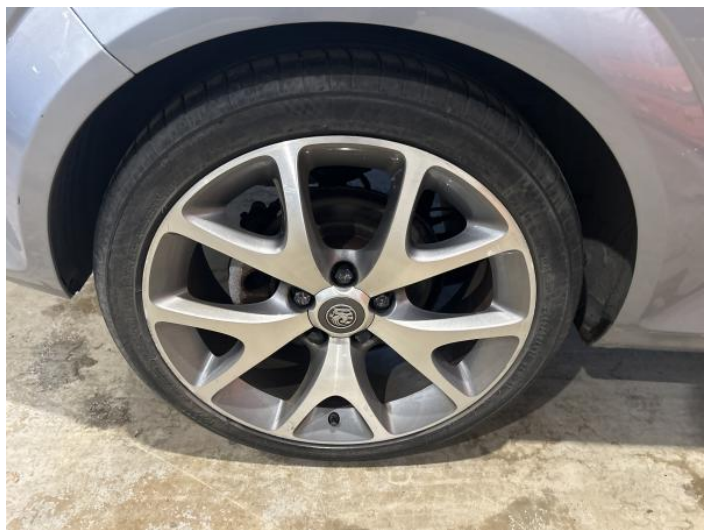
8: Wheel osr  
Scratched  
Over 50mm

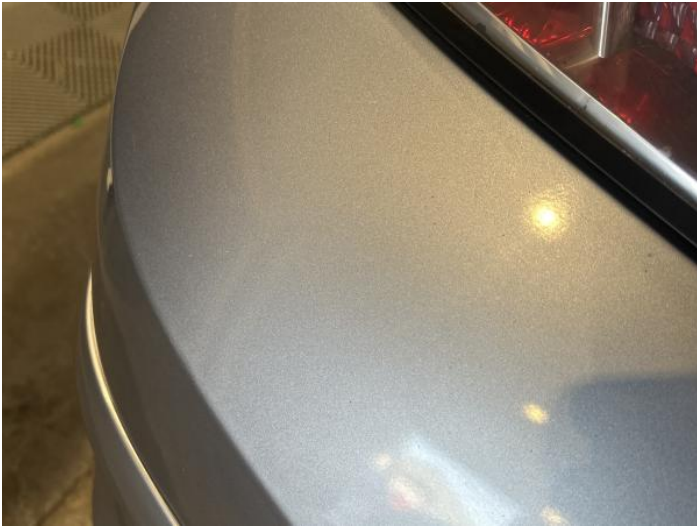
9: Bumper Rear  
Poor Previous Repair  
Poor Paint

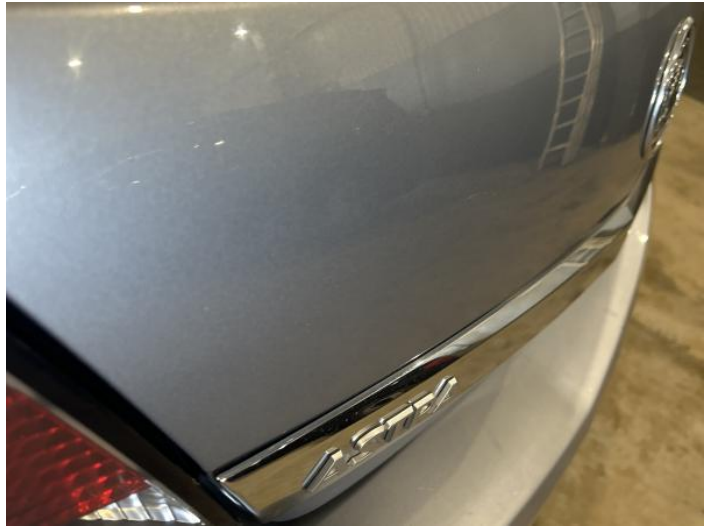
10: Tailgate  
Dented  
Between 10mm + 30mm

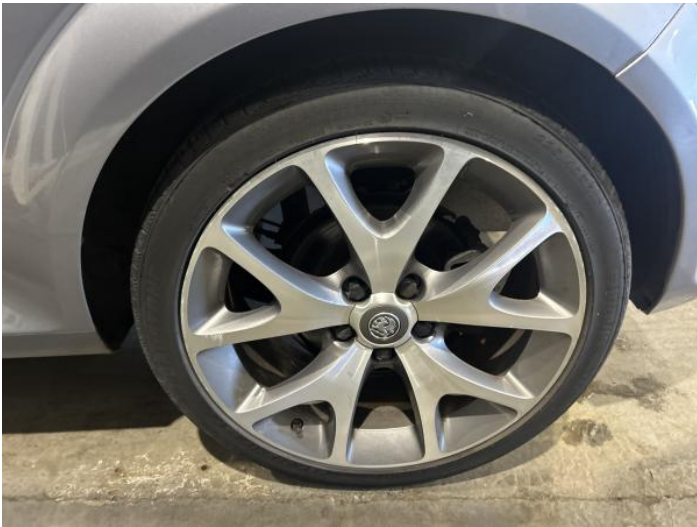
11: Wheel nsr  
Scratched  
Over 50mm

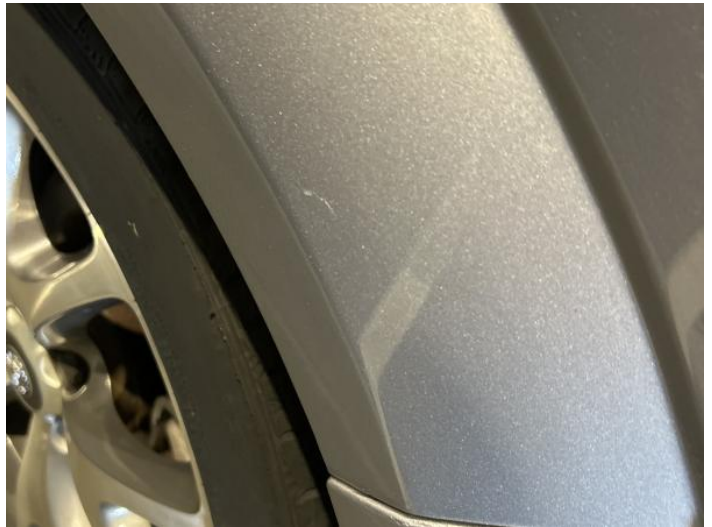
12: Qtr Panel nsr  
Chipped  
1 To 5

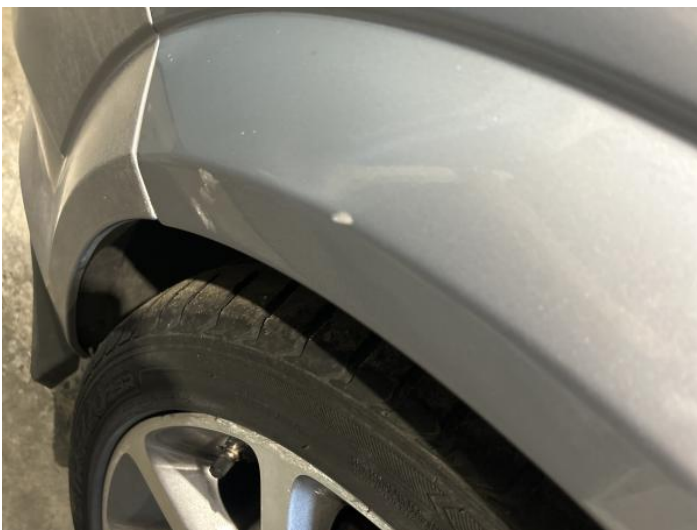
13: Wing nsf  
Dented  
With Paint Damage

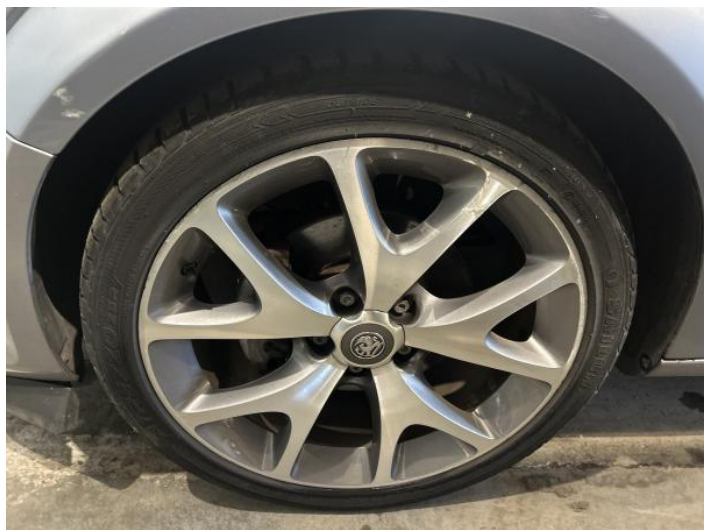
14: Wheel nsf  
Scratched  
Over 50mm

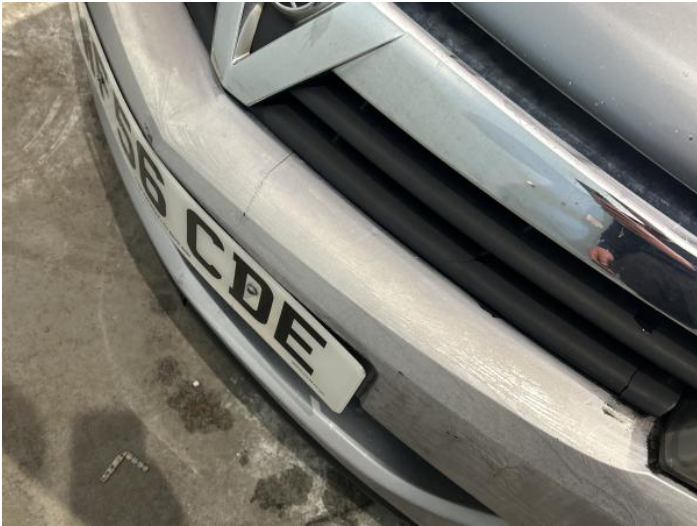
15: Bumper Front  
Cracked  
Over 25mm

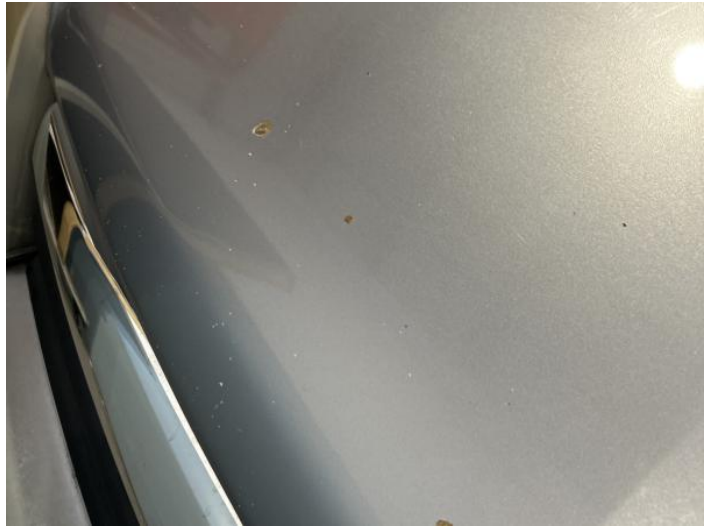
16: Bonnet  
Chipped  
Multiple Chips

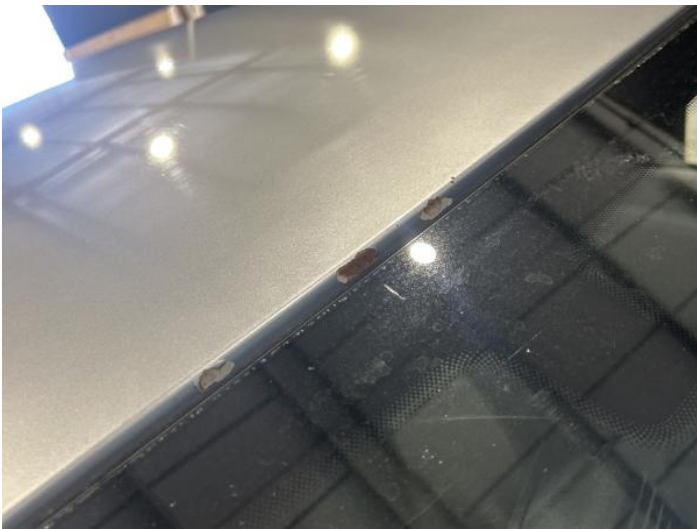
17: Roof  
Dented  
With Paint Damage
