VEHICLE INSPECTION REPORT

LY16BVA

Nissan Qashqai 1.2 DiG-T Tekna [Non-Panoramic] 5dr

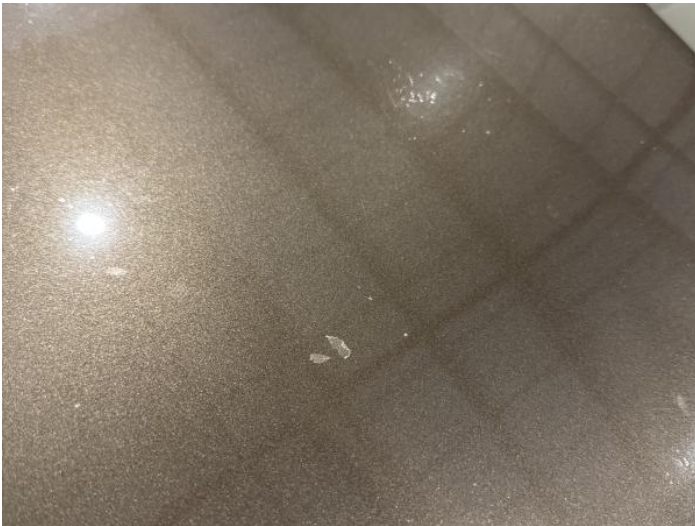
1: Bonnet
Scratched
Over 25mm Thru Paint

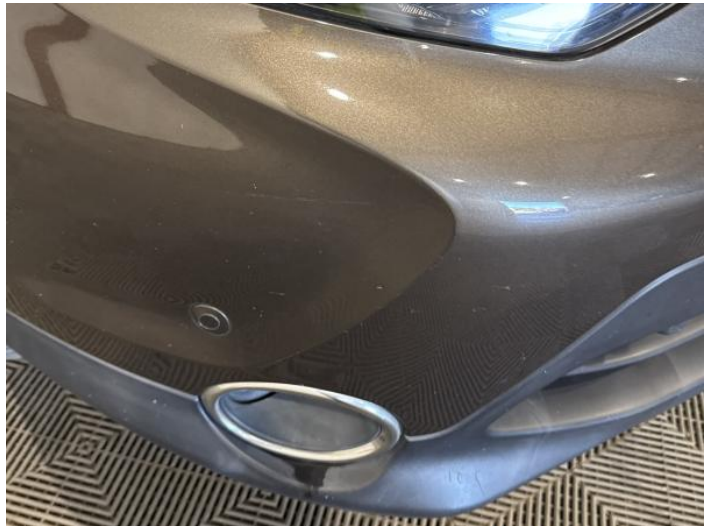
2: Bumper Front
Scratched
25 to 100mm Thru Paint

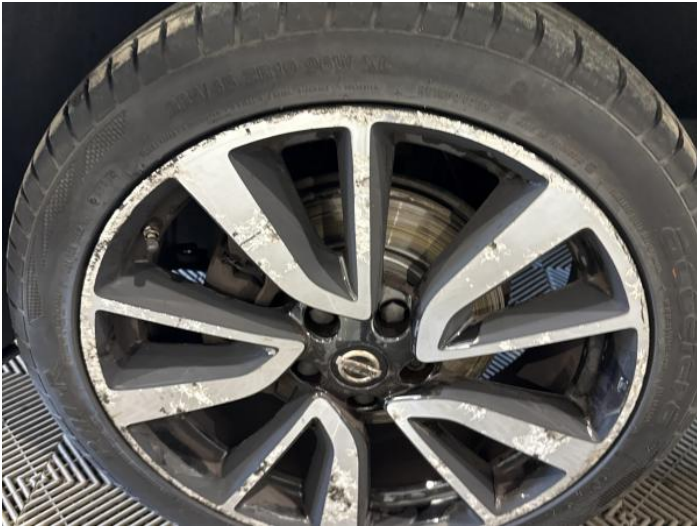
3: Wheel nsf
Scratched
Over 50mm

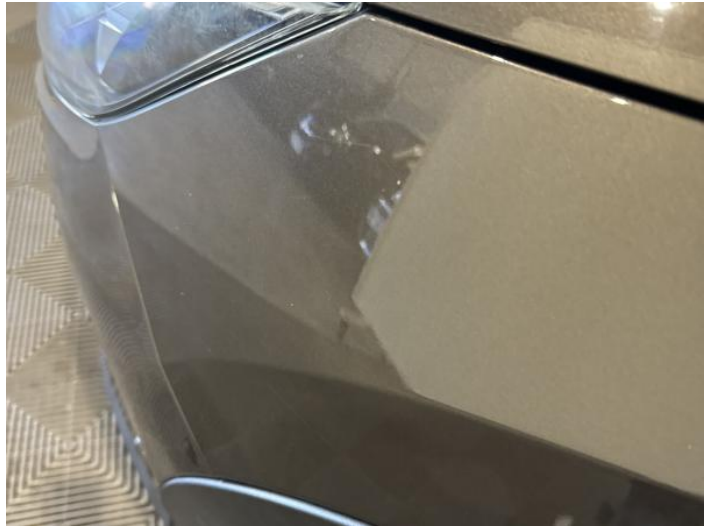
4: Wing nsf
Chipped
1 To 5

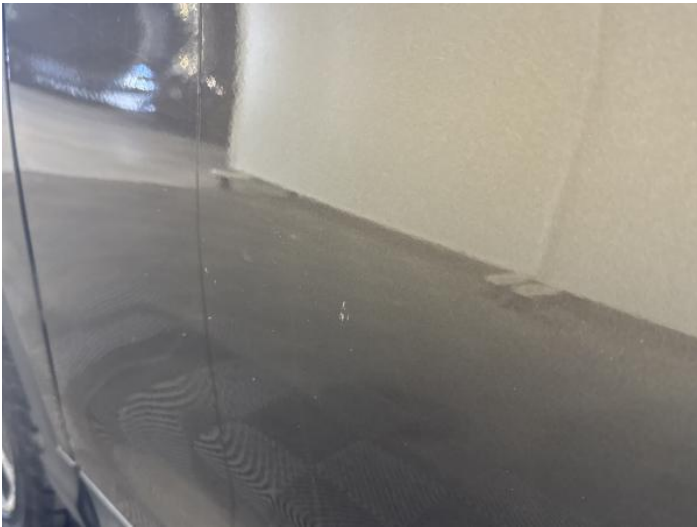
5: Door nsf
Scratched
Up To 25mm Thru Paint

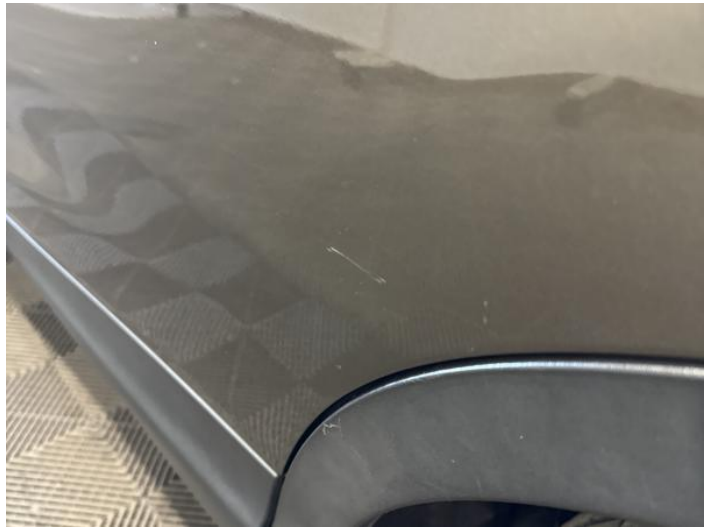
6: Door nsr
Scratched
Over 25mm Thru Paint

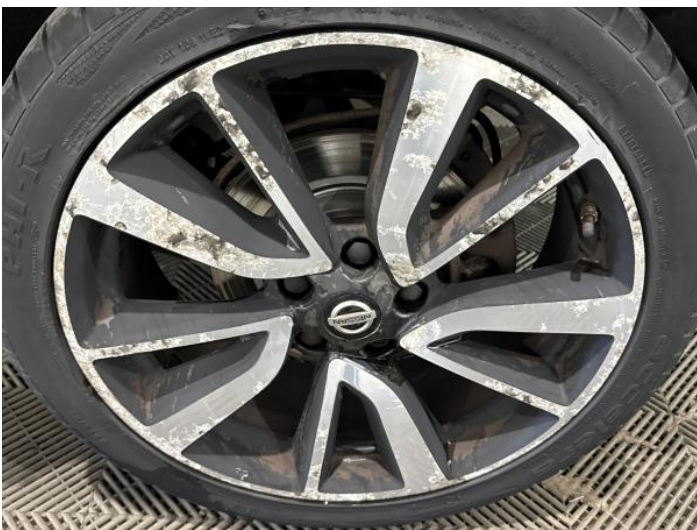
7: Wheel nsr
Scratched
Over 50mm

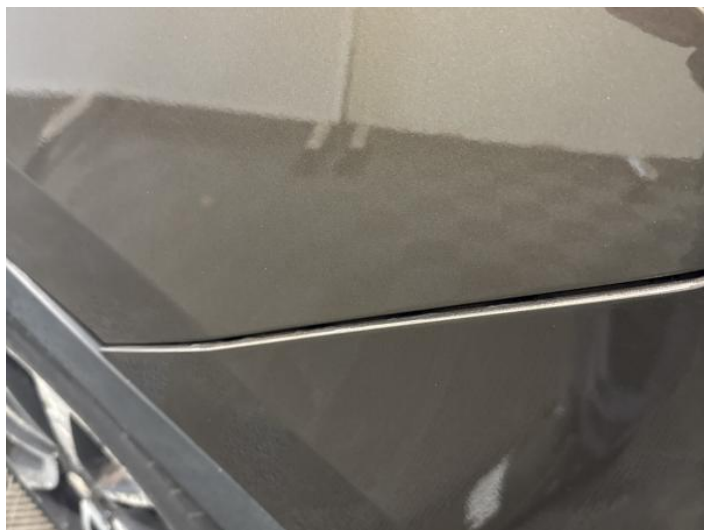
8: Bumper Rear
Insecure
Action Required

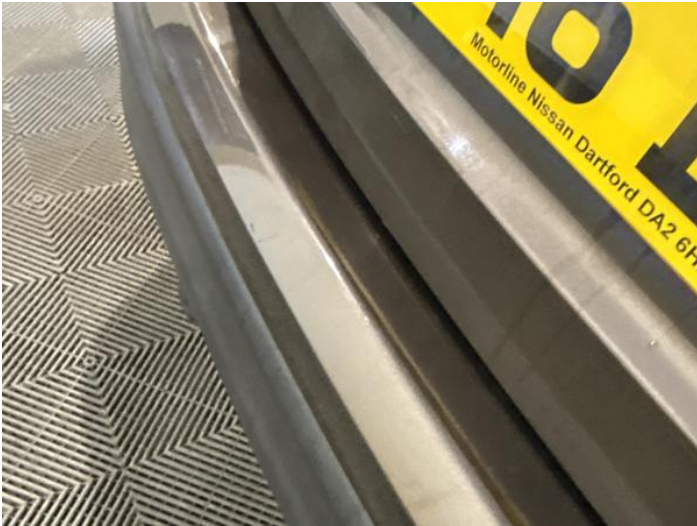
9: Bumper Rear
Scratched
25 to 100mm Thru Paint

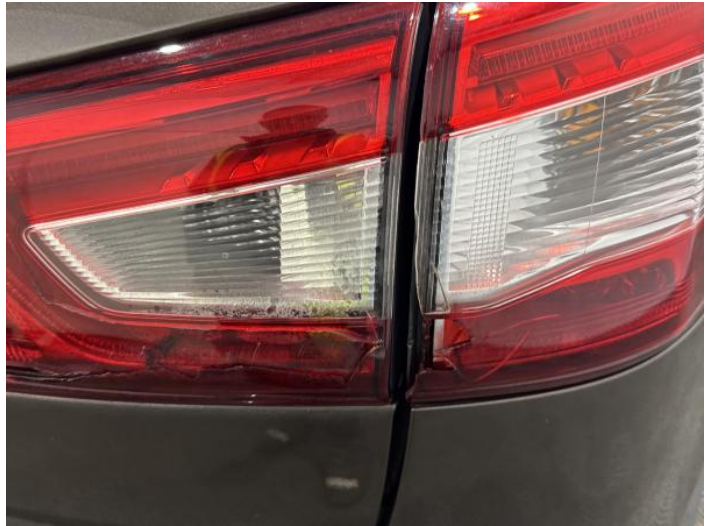
10: Lamp osr
Broken
Replace

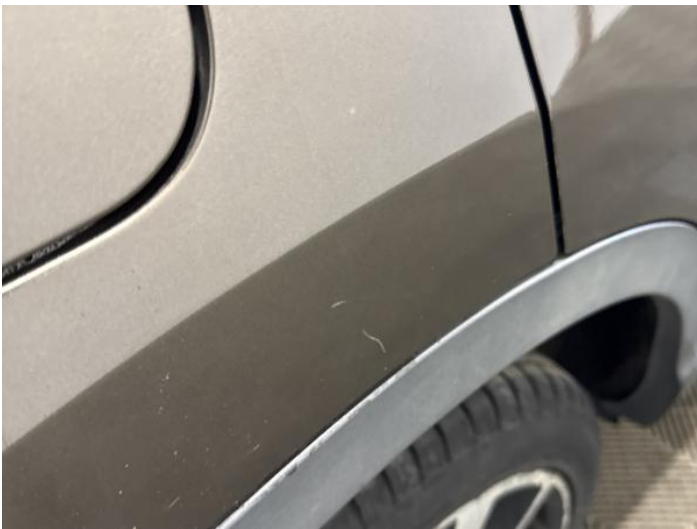
11: Qtr Panel osr
Scratched
UpTo 25mm Thru Paint

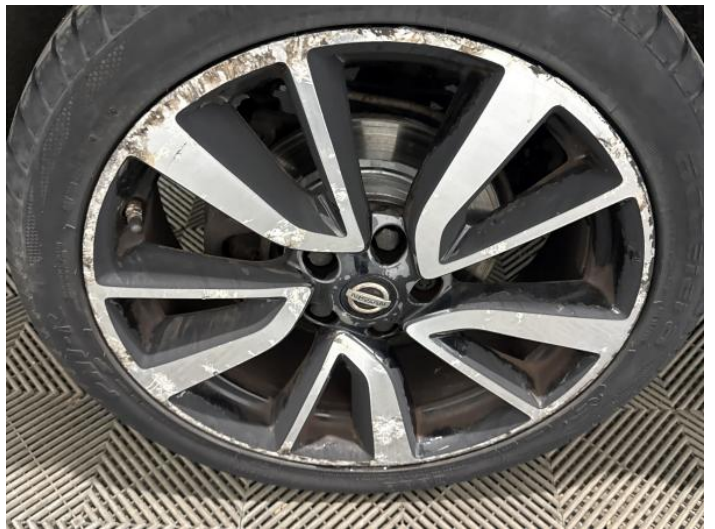
12: Wheel osr
Scratched
Over 50mm

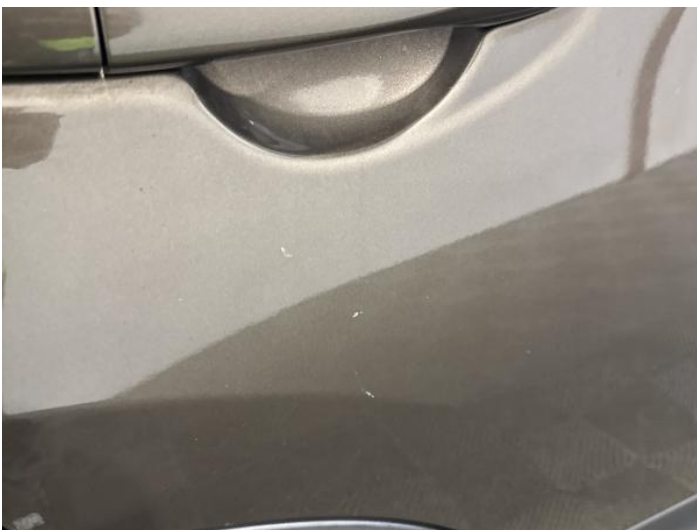
13: Door osr
Chipped
Multiple Chips

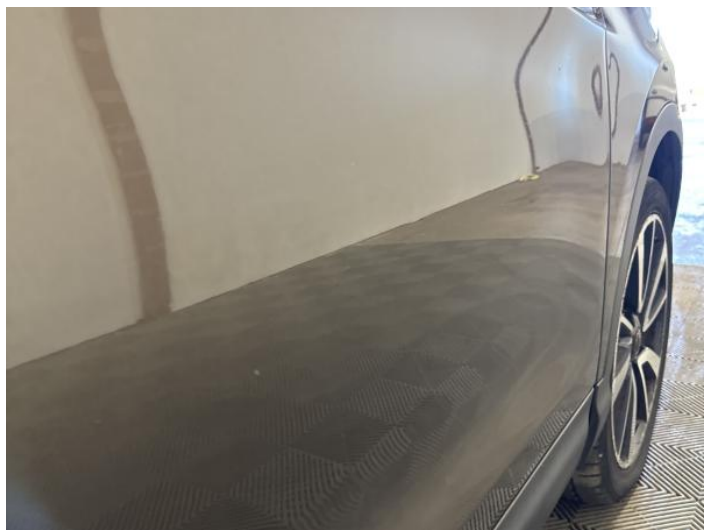
14: Door osf
Dented
Between 10mm + 30mm

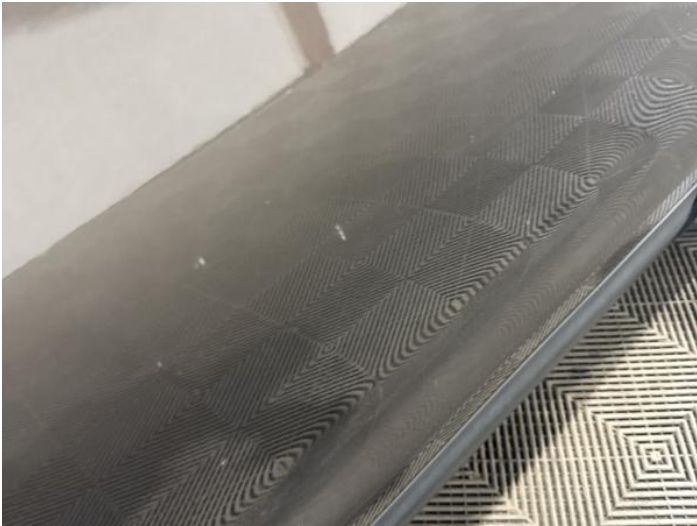
15: Door osf
 Scratched
 UpTo 25mm Thru Paint

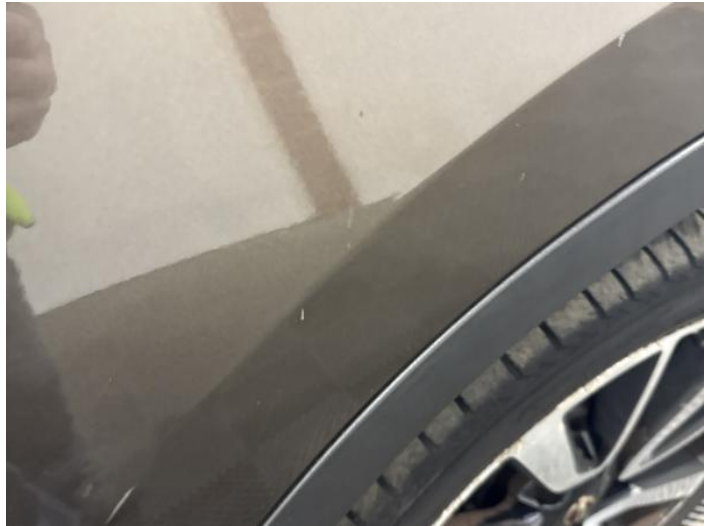
16: Wing osf
 Scratched
 UpTo 25mm Thru Paint

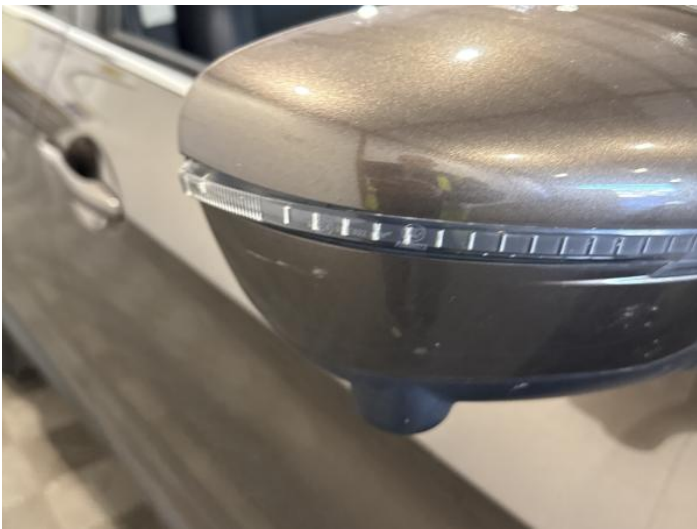
17: Door Mirror Assy osf
 Scratched (Painted)
 UpTo 25mm Thru Paint

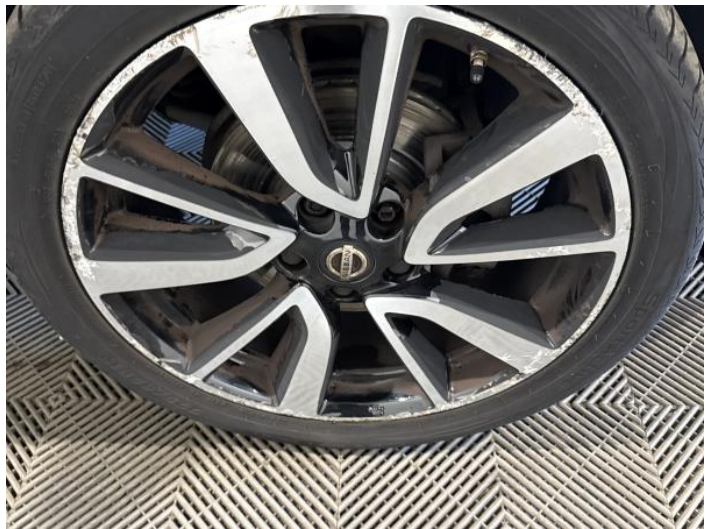
18: Wheel osf
 Scratched
 Over 50mm
