VEHICLE INSPECTION REPORT

GX15RRU

Ford B-Max 1.6 Zetec 5dr Powershift

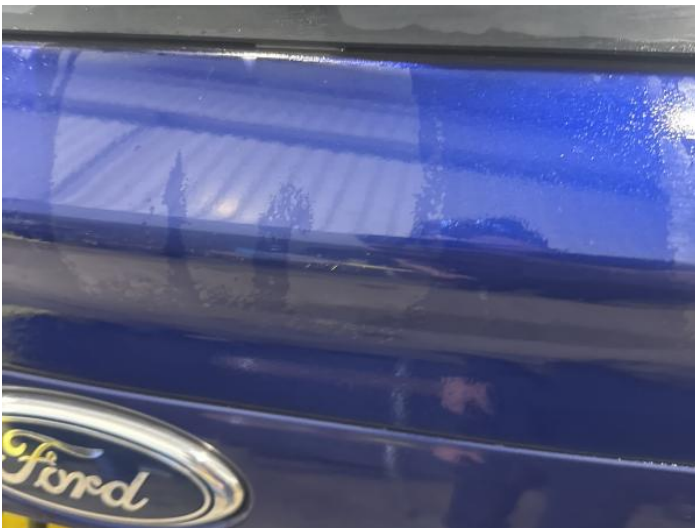
1: Boot Lid
Chipped
1 To 5

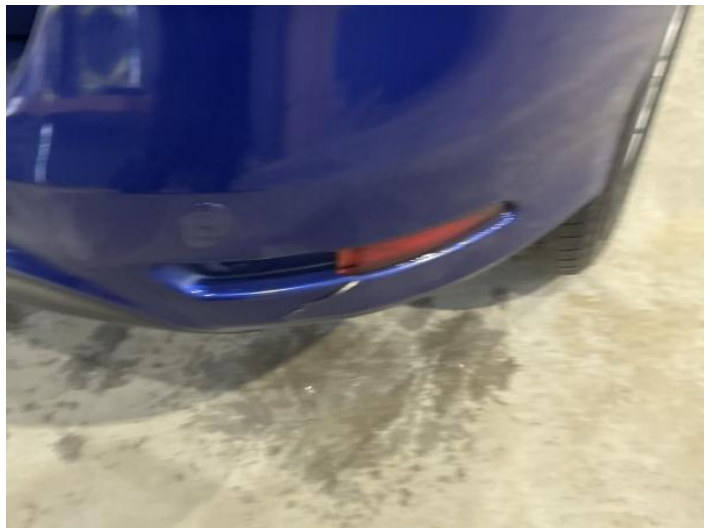
2: Bumper Rear
Cracked
Over 25mm

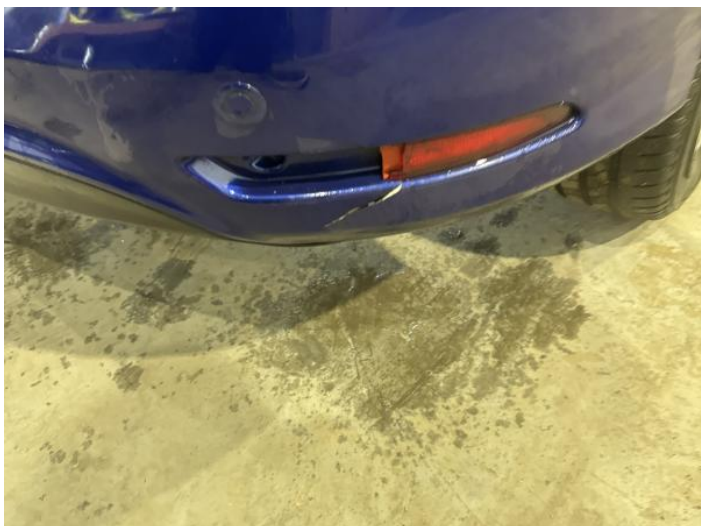
3: Bumper Reflector osr
Broken
Replace

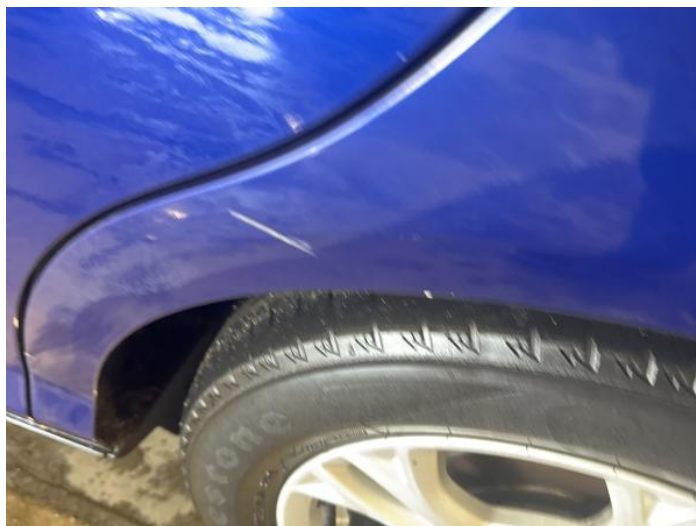
4: Qtr Panel nsr
Scratched
Over 25mm Thru Paint

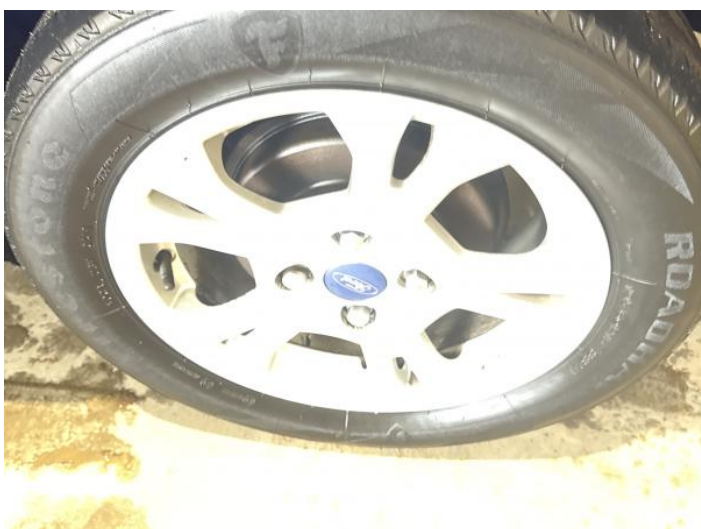
5: Wheel nsr
Scratched
Up To 50mm

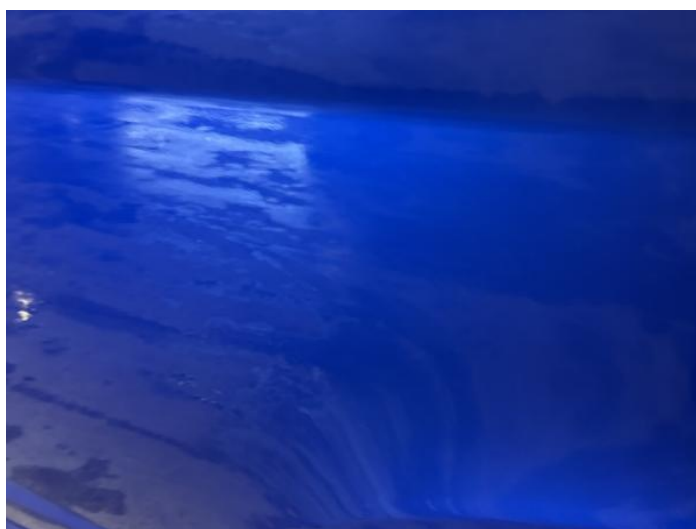
6: Door nsr
Chipped
1 To 5

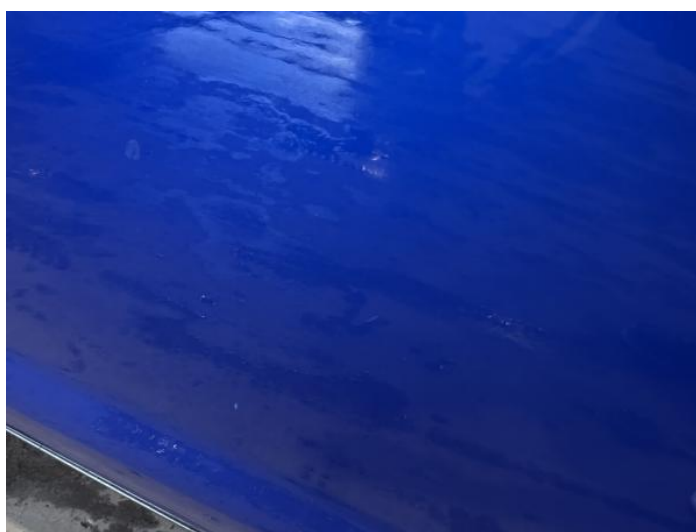
8: Door nsf
Chipped
1 To 5

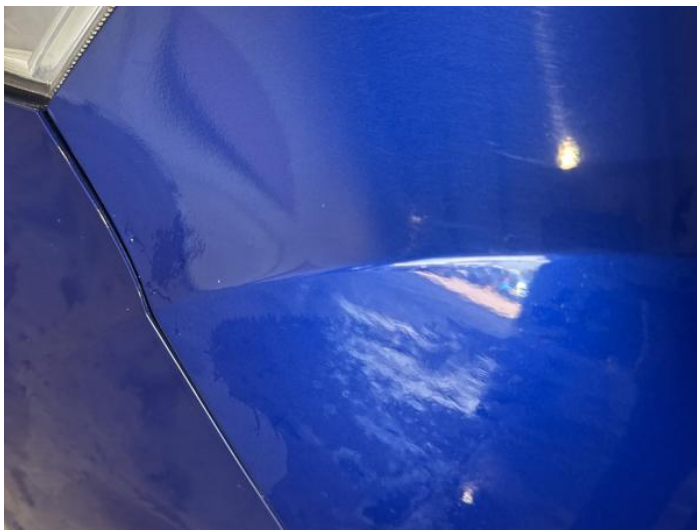
11: Wing nsf
Chipped
1 To 5

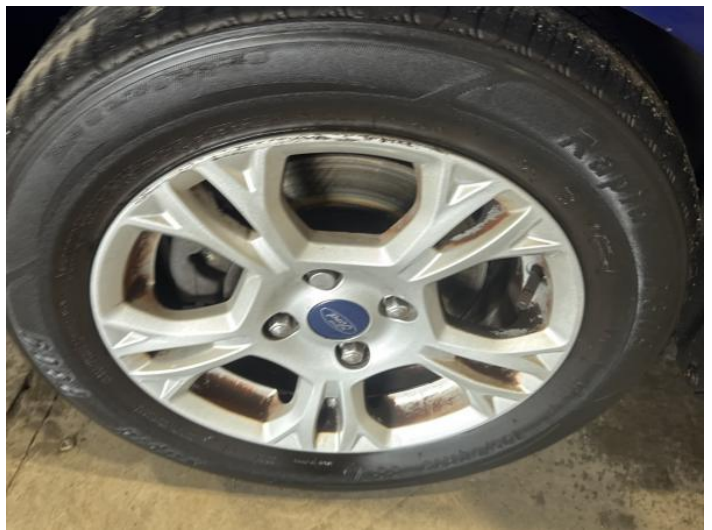
12: Wheel nsf
Scratched
Over 50mm

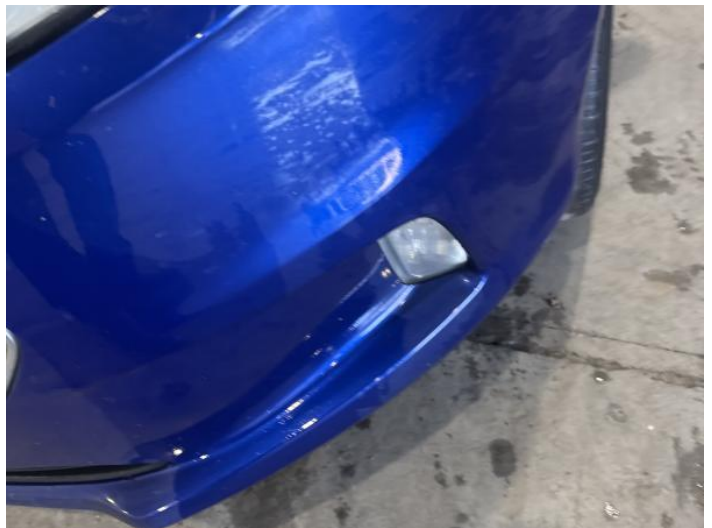
14: Bumper Front
Scratched
25 to 100mm Thru Paint

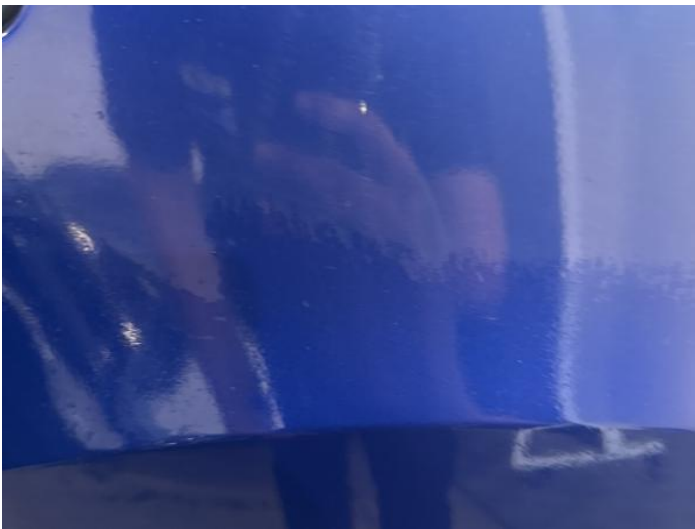
17: Wing osf
Chipped
1 To 5

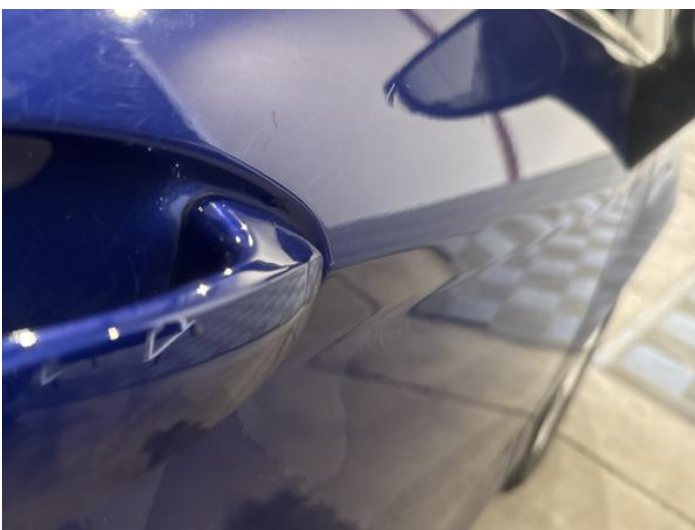
19: Door osf
Dented
Over 2 UpTo 10mm
