# VEHICLE INSPECTION REPORT

**AO16NKT**

## Ford Fiesta 1.0 EcoBoost Zetec Black 5dr

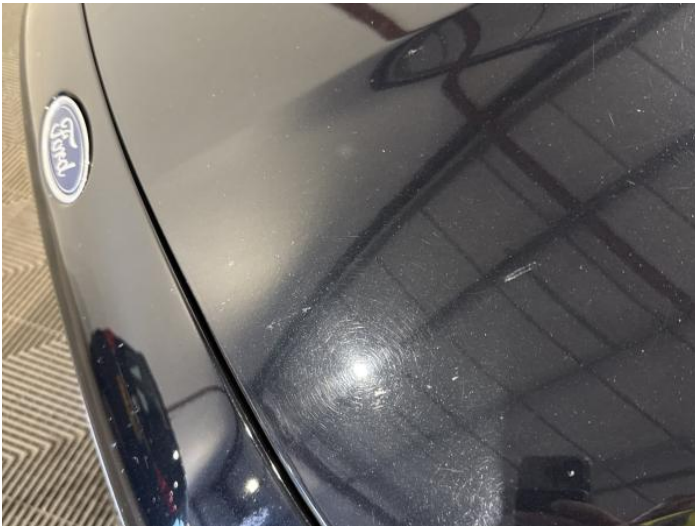
1: Bonnet  
Chipped  
1 To 5

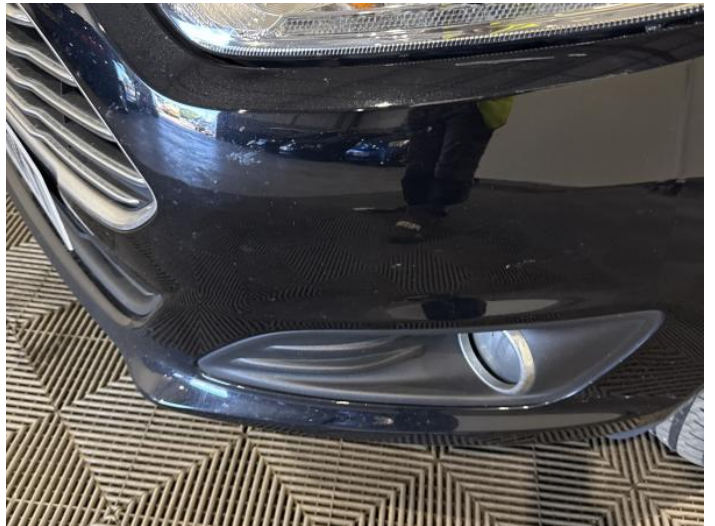
2: Bumper Front  
Scratched  
25 to 100mm Thru Paint

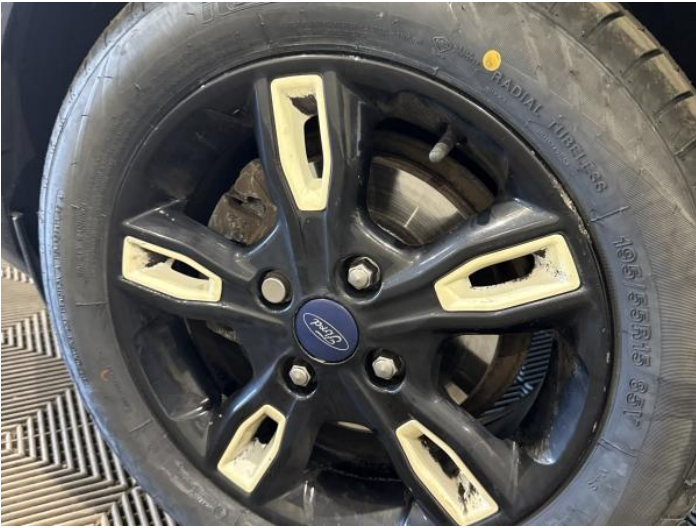
3: Wheel nsf  
Scratched  
Over 50mm

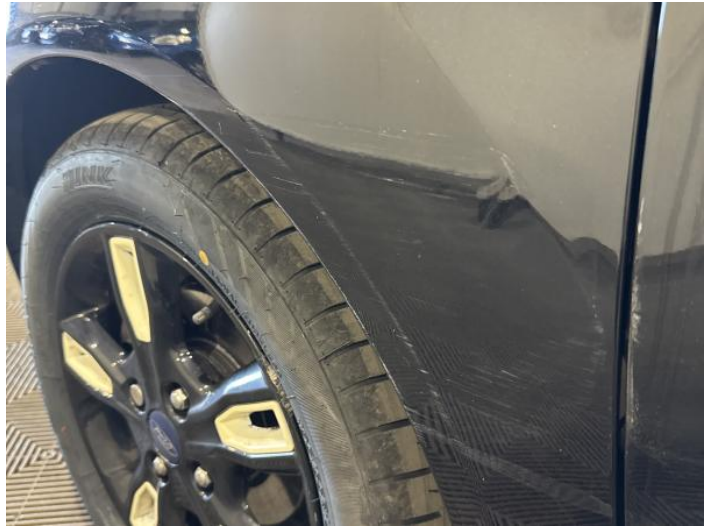
4: Wing nsf  
Dented  
With Paint Damage

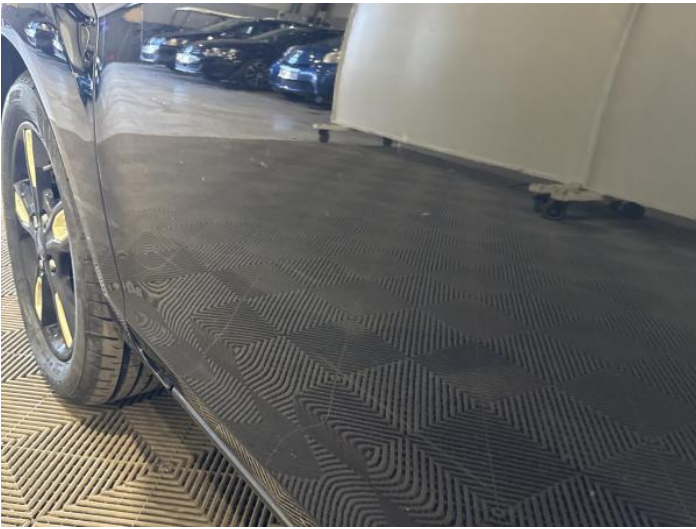
5: Door nsf  
Scratched  
Over 25mm Thru Paint

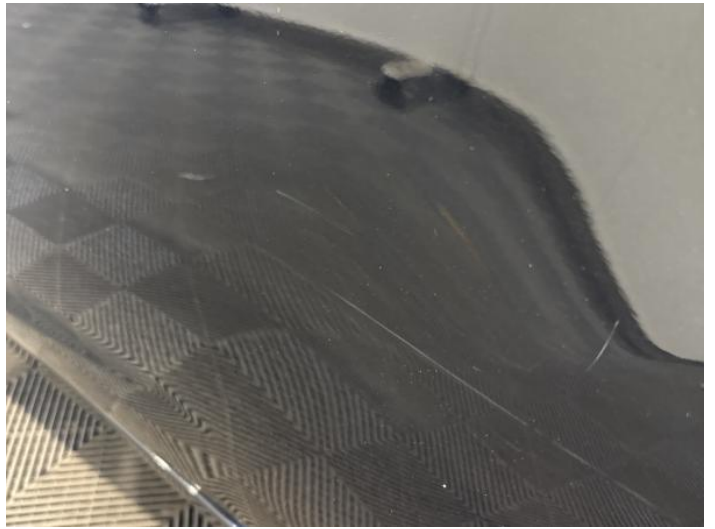
6: Door nsr  
Scratched  
Over 25mm Thru Paint

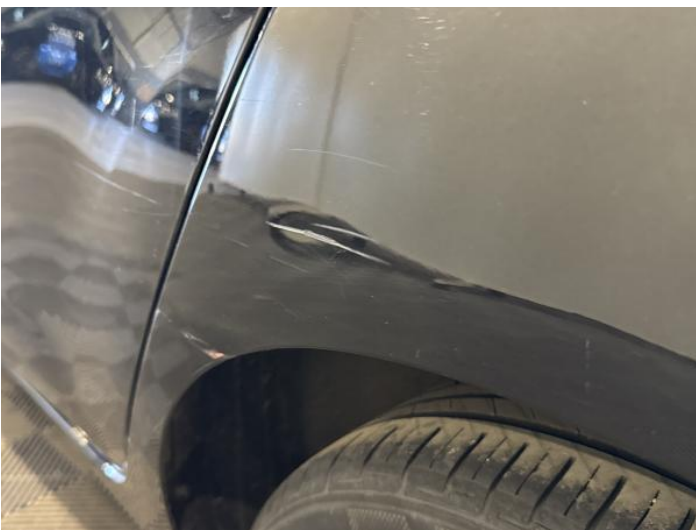
7: Qtr Panel nsr  
Dented  
With Paint Damage

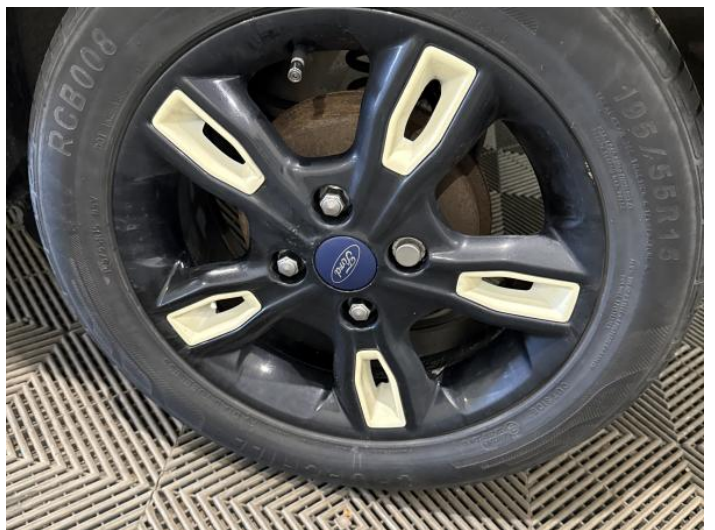
8: Wheel nsr  
Scratched  
Up To 50mm

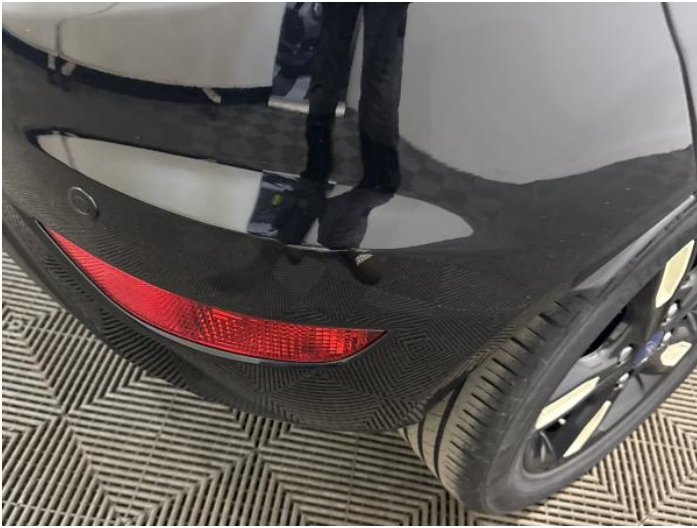
9: Bumper Rear  
Scratched  
25 to 100mm Thru Paint

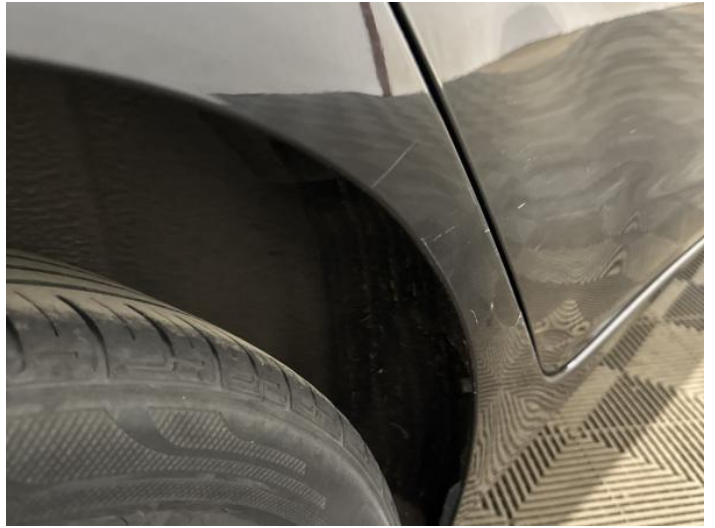
10: Qtr Panel osr  
Dented  
With Paint Damage

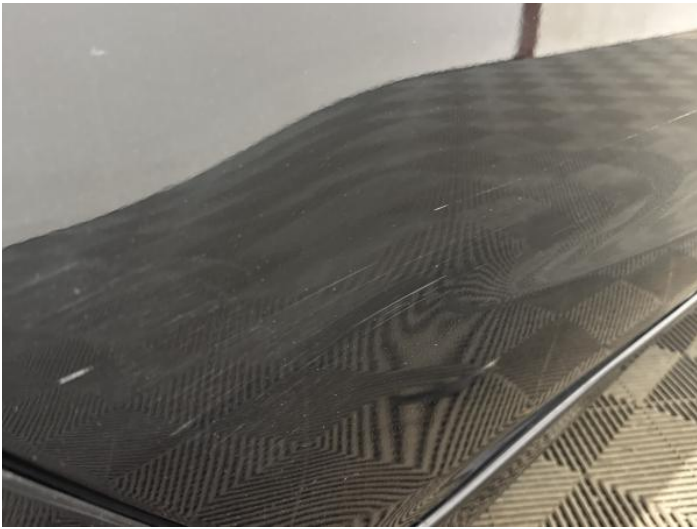
11: Door osr  
Scratched  
Over 25mm Thru Paint

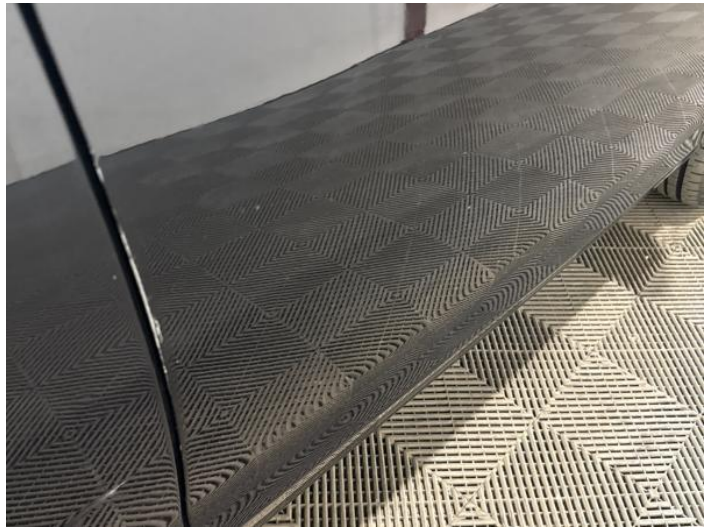
12: Door osf  
Scratched  
Over 25mm Thru Paint

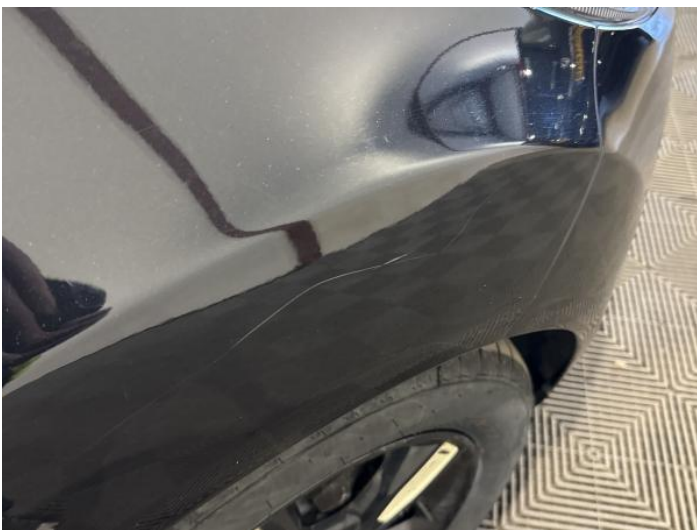
13: Wing nsf  
Scratched  
Over 25mm Thru Paint

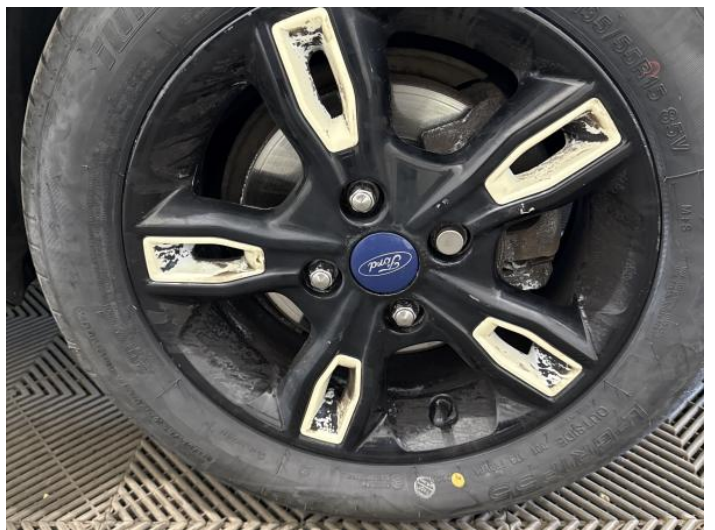
14: Wheel osf  
Scratched  
Over 50mm

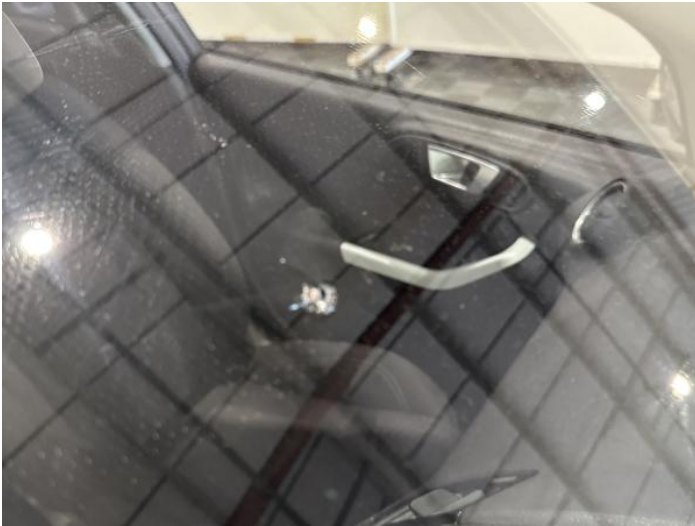
15: Screen Front  
Cracked  
Replace

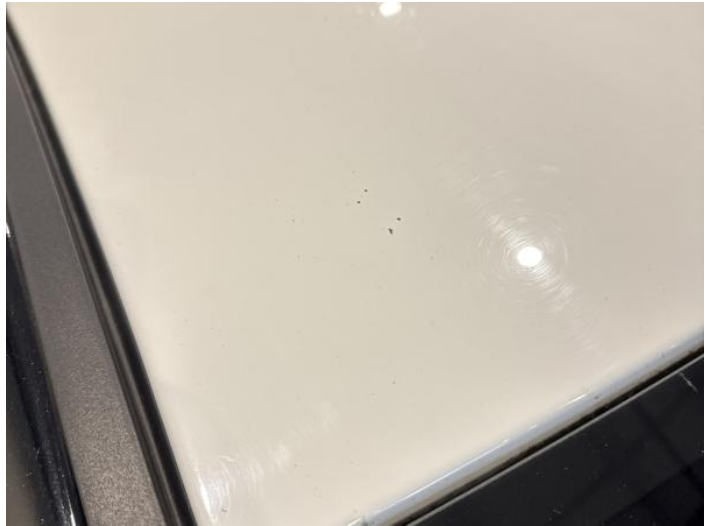
16: Roof  
Chipped  
1 To 5
